CALIFORNIA PUBLIC UTILITIES COMMISSION
Safety and Enforcement Division
Wildfire Safety and Enforcement Division

Incident Investigation Report

Incident Number: E20220602-03

Regulated Utility Involved: Pacific Gas and Electric Company

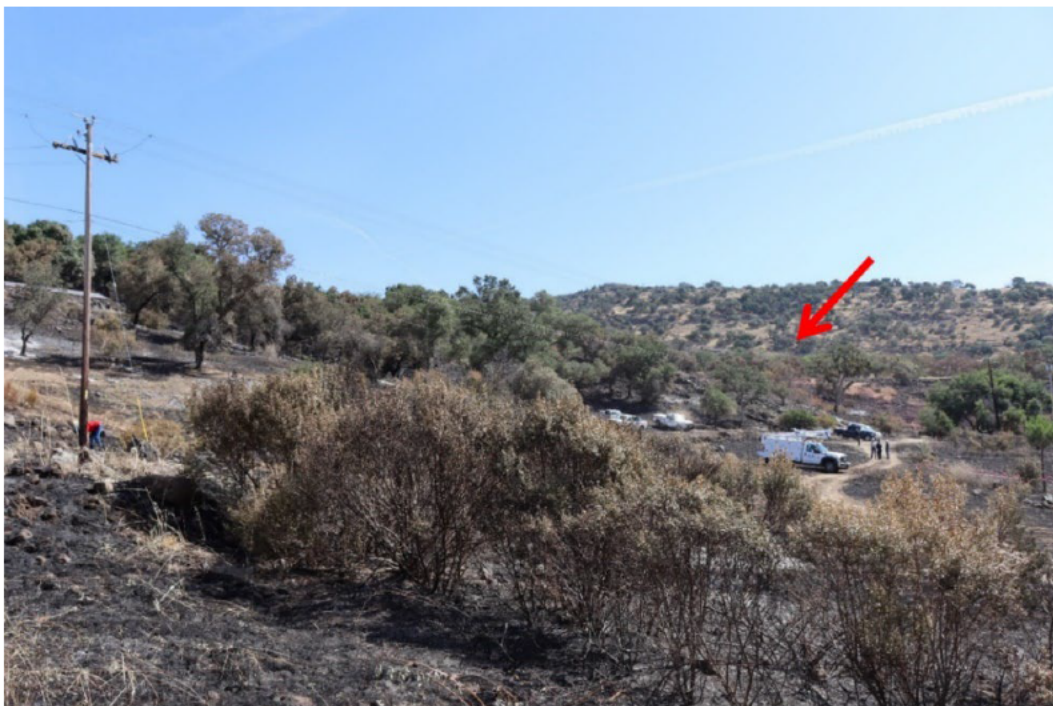
Figure 3: View of Incident Location and approximate location where the pitting was observed.

CAL FIRE collected one segment from the south conductor and one segment from the middle conductor from the span in question. Figure 3 below shows the entire span and indicates the location where the segments were collected. SED observed pitting in both the south and middle segments (as shown below in Figures 4 and 5) after they were collected by CAL FIRE. SED was unable to observe from the ground whether pitting occurred on any other conductor section due to the distance from the ground and because SED could not observe the top of the conductors from the ground. However, SED understands that CAL FIRE collected, and allowed SED to observe, all portions of the conductors that showed pitting. SED closely observed the two segments of the conductors once they were brought to the ground. The segment collected from the middle conductor was substantially longer than the segment from the south conductor, and SED understands that CAL FIRE took a longer section of the middle phase because a longer section of the middle phase had pitting compared to the south conductor pitting. The largest pit in the conductor appeared to be opposite the largest pit in the adjacent conductor. Figure 4 and Figure 5 show some of the pitting observed on each conductor.

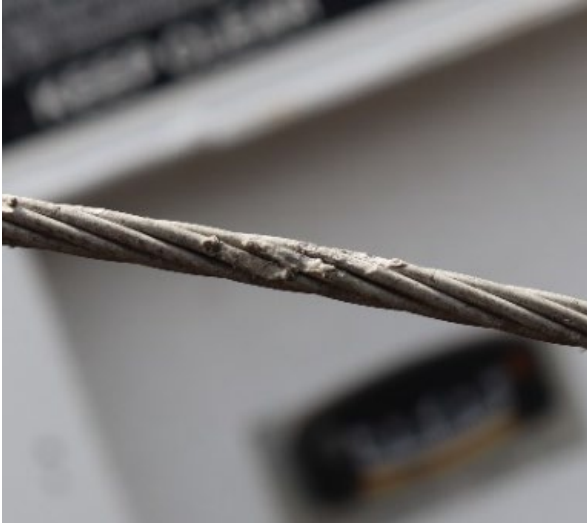
Figure 4: Pitting on the south conductor.

SED measured the span to be approximately 397 feet pole to pole. The pitting on both conductor sections was located 168 feet from the western pole, which is labeled Pole 121270661. The eastern pole was burned, so the pole number could not immediately be determined (Figure 6 below). However, PG&E later provided the eastern pole number which was labeled Pole 103949547.²⁸

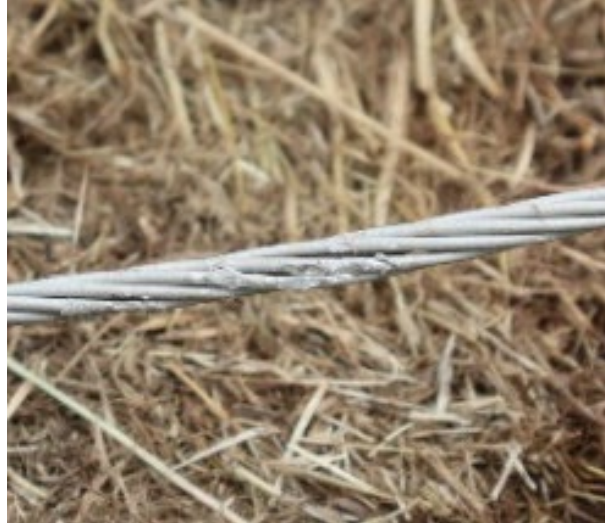
Figure 5: Pitting on the middle conductor.

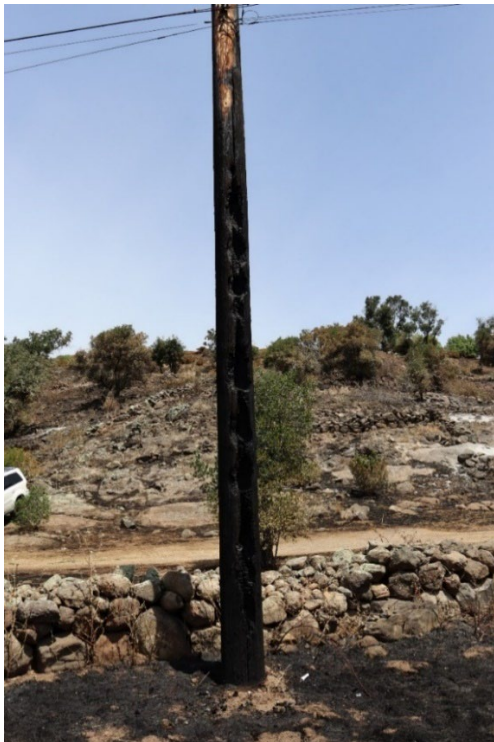
Figure 6: Burnt pole at east end of span.

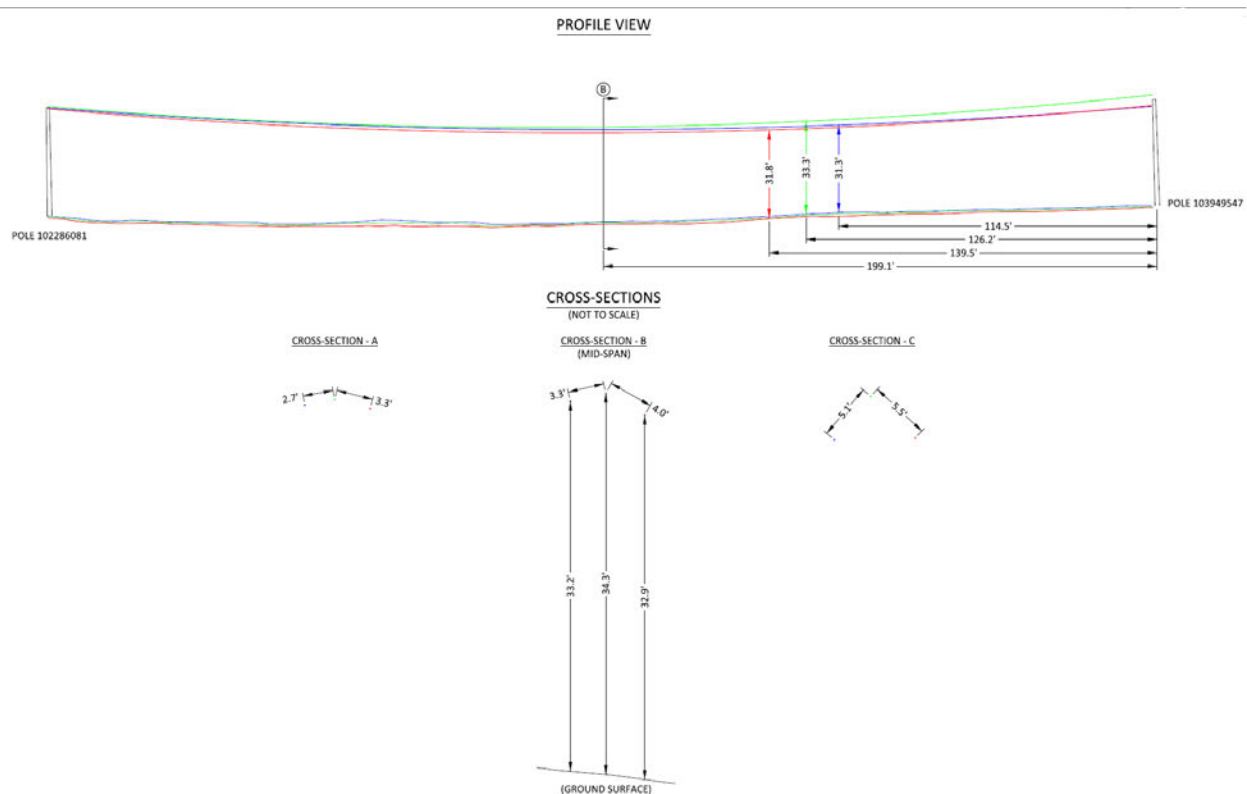
Figure 7: Clearance Dimensions from August 28, 2019 LIDAR scan of Incident Location.

SED finds that PG&E failed to maintain a 5.4-inch minimum clearance for conductors at the Incident Location as required by GO 95 Rule 38. The CAL FIRE Report contains expert analysis of the physical evidence to sufficiently demonstrate that PG&E lines were in contact during the events which led to the Old Fire. Although PG&E provided simulated fault currents and oscillography data to support their claim that there was no direct line-to-line contact, this modeling exercise is less compelling evidence than the physical evidence and analysis of the

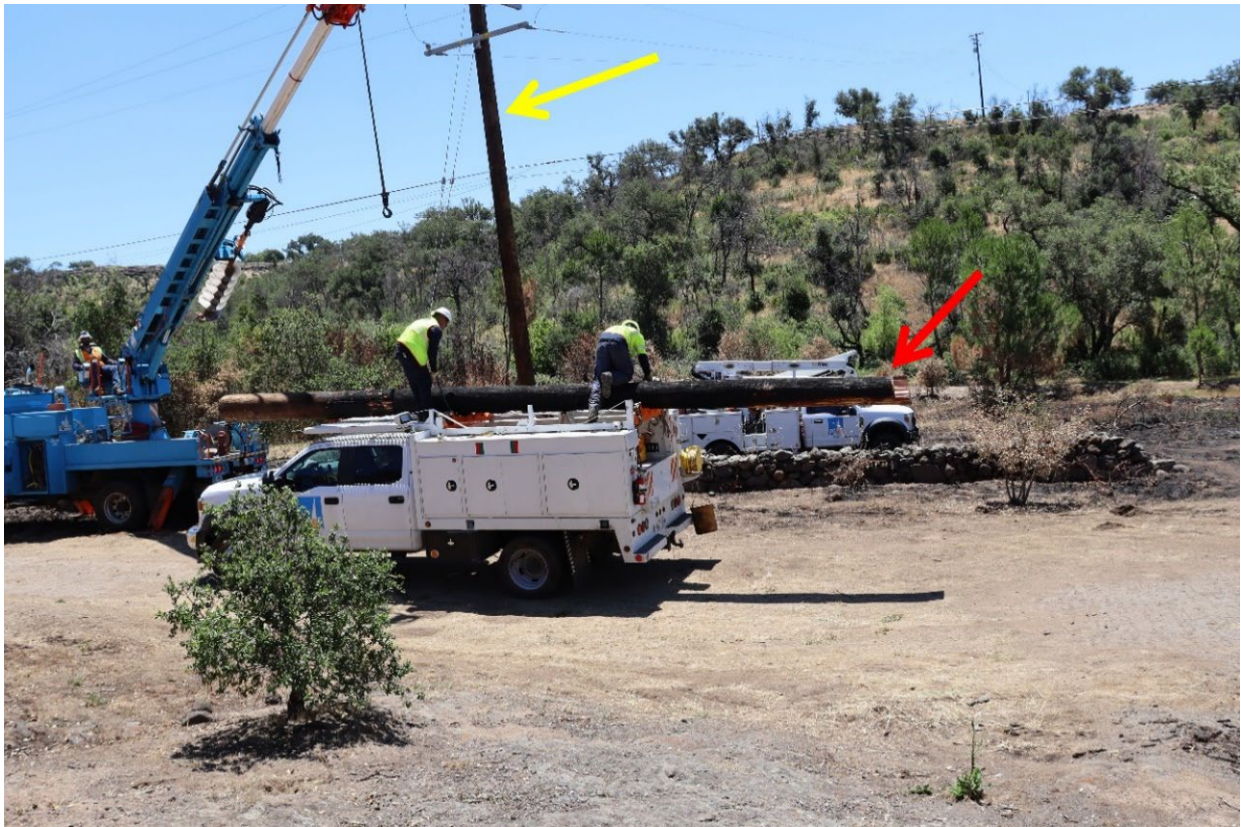
Figure 8: Burnt pole on east end of span (Pole #103949547) being removed and loaded into truck (red arrow). A new pole replacement installed directly adjacent to original pole location (yellow arrow).

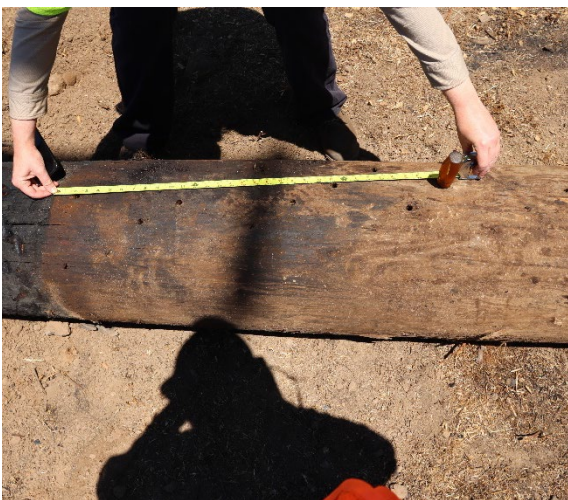
Figure 9: Probing Pole 103949547 below grade.

After Pole 103949547 was removed, PG&E used a screwdriver to probe the pole approximately one foot above grade and one foot, eight inches below grade, shown in Figure 9 below. SED did not observe decay before or during the probing. Before the pole was removed, the distance between the north and middle conductors was measured as 65 inches. The distance between the south and middle conductor was measured as 64 inches.

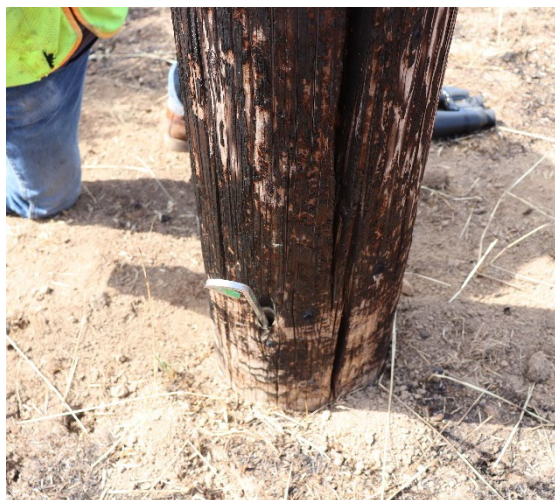
Figure 10: Probing Pole 102286081 above grade.

SED also observed the pole on the west end of the span at the Incident Location, Pole 102286081. SED probed two of the boring inspection holes used for intrusive testing: (1) the hole approximately 12 inches above grade, and (2) the hole approximately 24 inches above grade, shown in Figure 10 below. SED did not observe decay while probing either hole. SED did

not probe any of the holes below grade. PG&E stated that the most recent intrusive inspection report did not note any decay.

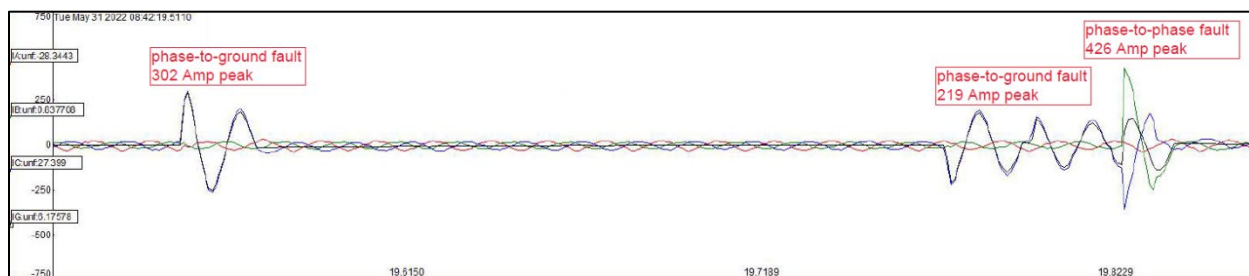
Figure 11: Oscillography Data from LR 696.

At 1531 hours on May 31, 2022, LR 696 recorded a phase-to-ground fault with a peak magnitude of 302 Amps, which was above the Minimum-to-Trip (MTT) amperage for LR 696. The fault duration lasted for 36 milliseconds. Then, 181 milliseconds later, another phase-to-ground fault was recorded by LR 696 with a peak magnitude of 219 Amps (above the MTT). The fault lasted for 88 milliseconds. In addition, for a single cycle (approximately 17 milliseconds), LR 696 recorded a phase-to-phase fault with a peak magnitude of 426 Amps.³⁷ Figure 11 below shows the oscillography data from the faults recorded by LR 696.³⁸

- a phase-to-ground fault of 302 Amps of a minimum of 689 milliseconds would cause the LR 696 to trip the circuit open,³⁹
- a phase-to-ground fault of 219 Amps of a minimum of 1350 milliseconds would cause the LR 696 to trip the circuit open,⁴⁰
- a phase-to-phase fault of 4000 Amps would be required to meet the High Current Lockout, or instantaneous trip, setting for a phase-to-phase fault which lasts only one cycle.⁴¹

Therefore, as noted above, the recorded duration of the phase-to-ground faults and the phase-to-phase fault did not meet or exceed the settings that would cause LR 696 to open the circuit.

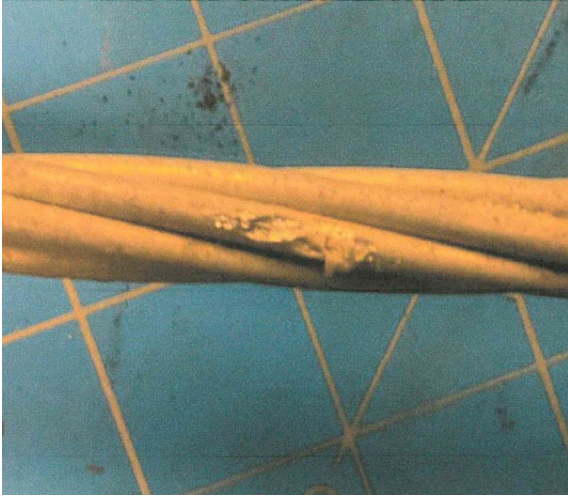
Evidence of arcing between aluminum conductors consists of mass loss on one conductor and deposition of mass on the other conductor. In this case, evidence of such arcing was observed in several locations. The arcing is produced when one conductor comes into contact with the other conductors and then the conductors part, causing a parting arc. In most cases, molten aluminum is ejected from the arcing location.

Figure 12: Arcing evidence on conductor, as photographed by EFI Global.

The EFI Global report concluded that both conductors showed evidence of direct contact, contrary to the conclusion of PG&E’s protection engineers’ review of the magnitude and waveform of the electrical fault.

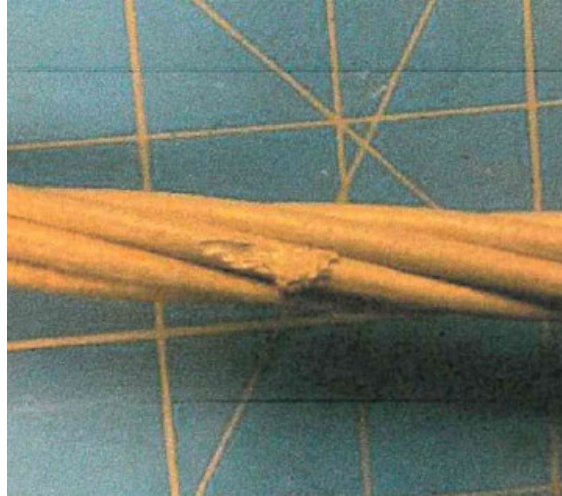
Figure 13: Arcing evidence on conductor, as photographed by EFI Global.

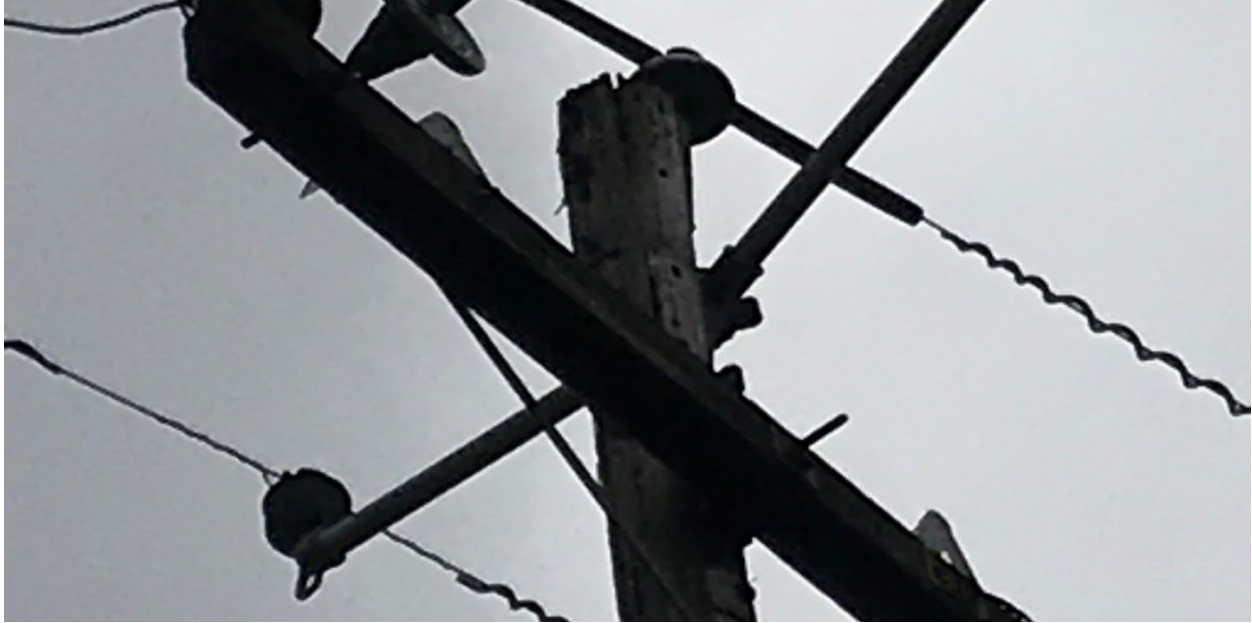
Figure 14: Damaged Top of Pole 102286081.⁶²

General Order Rule	Violations
1.	GO 95, Rule 18	PG&E failed to complete Level 2 work to address the decayed Pole 102286081, identified in EC Tag #116791710, by the due date required by GO 95 Rule 18.

- However, the pole was still not replaced by the time PG&E conducted a third FSR on August 3, 2022, which also states, “Pole, Decayed/Rotten, Replace,” “Condition still exists. No Change,” and “Need to replace pole. Pole top is starting to decay/rot and is starting to split, and there is some minors [sic] burn marks and some woodpecker damage as well.”⁵⁹

SED finds this damage created at least a moderate potential impact to safety or reliability and therefore qualifies as a Level 2 priority issue per GO 95 Rule 18. Figure 14 below shows the split pole top and a conductor attached to an insulator at the top of the pole, and PG&E noted significant additional damage.⁶⁰ GO 95 Rule 18 requires that PG&E correct the damage to Pole #102286081 no later than March 20, 2020, i.e. 12 months after PG&E observed pole damage and created EC Tag #116791710 on March 20, 2019. PG&E staff also stated multiple times in the comments of the EC tag that the pole needed replacement, as described above.⁶¹ Nonetheless, PG&E failed to meet the Rule 18 deadline.

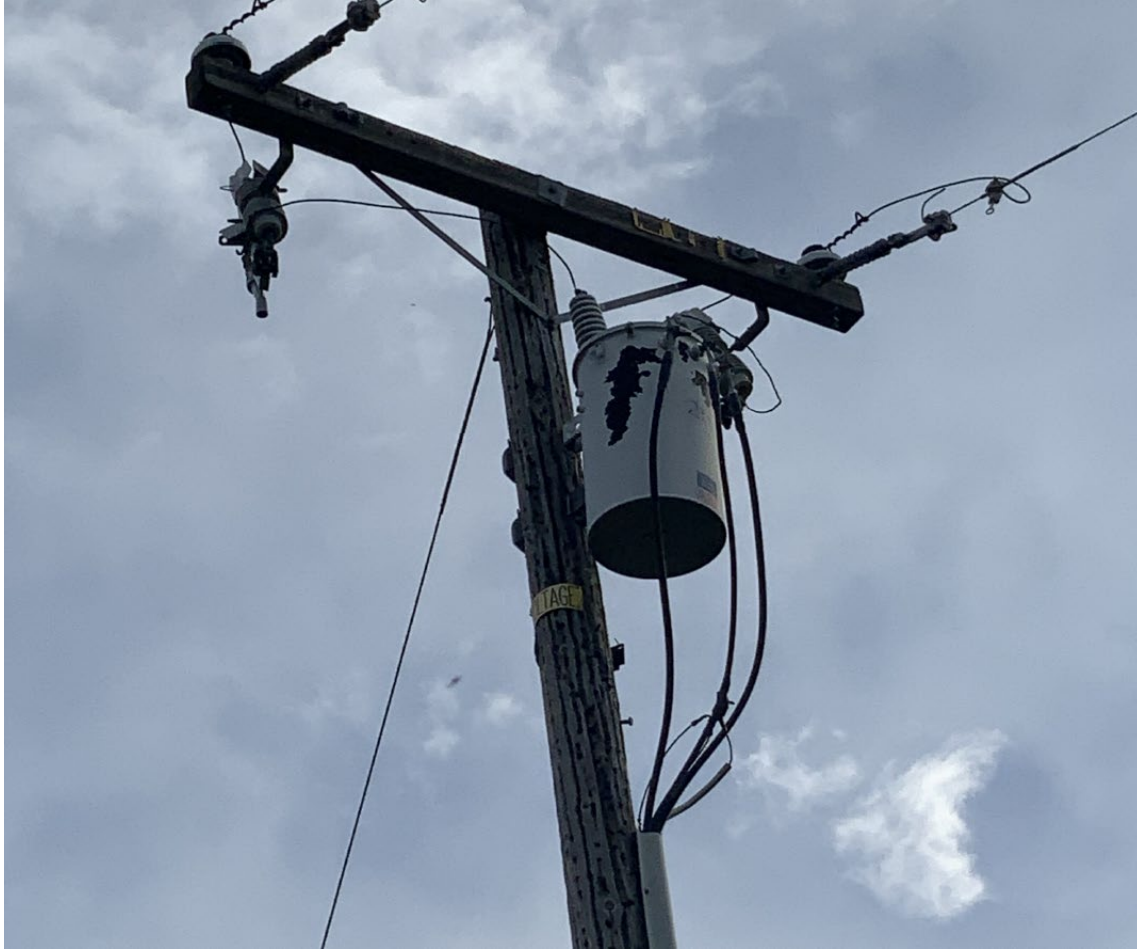
4.	GO 95, Rule 18	PG&E failed to complete Level 2 work to address heavy woodpecker damage on Pole 102285804, which was identified during a Field Safety Reassessment of EC Tag #112001375, by the due date required by GO 95 Rule 18.

EC Tag #112001375 identified missing high voltage signs at Pole 102285804 on September 13, 2016.⁷⁴ PG&E later identified that the pole was “badly split with heavy woodpecker damage” during an FSR on April 5, 2021.⁷⁵ Figure 16 below shows the damaged pole.

Figure 16: Pole 102285804 with signs of woodpecker damage. Photo taken by PG&E during 2021 FSR.⁷⁶

This pole is located at the boundary of the Tier 2 HFTD as shown in Figure 15. Failure of this pole has the potential to ignite a fire that could easily burn into a Tier 2 HFTD. GO 95 Appendix I lists damaged poles as a Level 2 issue, and the potential for the pole to fail poses a risk that could ignite a fire in a Tier 2 HFTD. Therefore, Rule 18 requires PG&E to address this issue within 12 months. PG&E set an April 6, 2022 deadline to correct the issue, but PG&E had not resolved the issue as of August 25, 2022.⁷⁷
