## **PROJECT MEMORANDUM SDG&E – MIGUEL-MISSION 230 kV #2 PROJECT**

**To:** Jensen Uchida, CPUC  
**From:** Vida Strong, Aspen Project Manager  
**Date:** February 8, 2005  
**Subject:** Weekly Report #27: January 30, 2004 – February 5, 2005  
**CPUC Environmental Monitor (EM):** Christopher Meyer

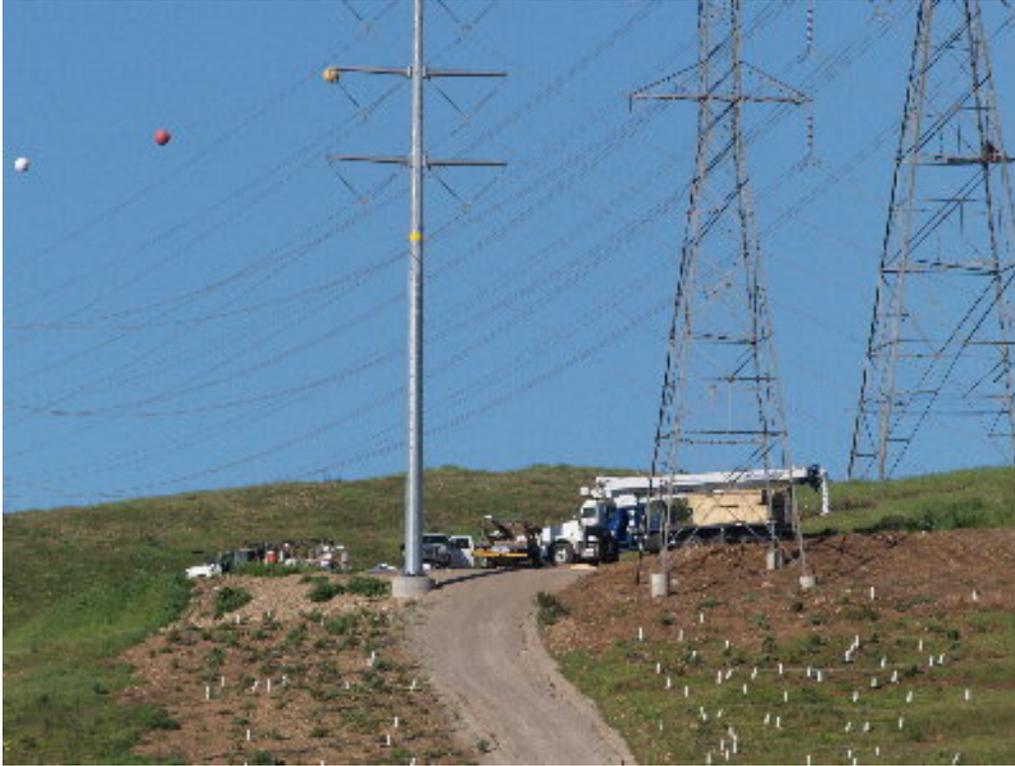
**Figure 1** – The transmission line crew worked on grounding issues above Santee Lakes during the subject week.

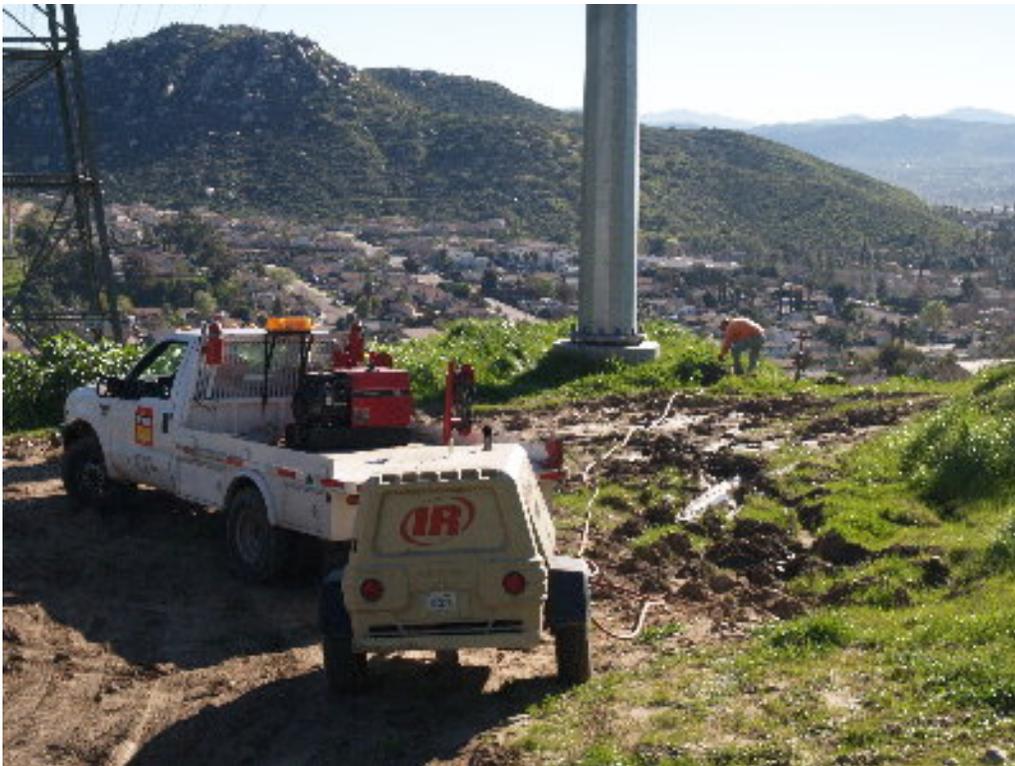
**Figure 2** – A small crew excavated the trench for the grounding cable above the Summit Road yard.

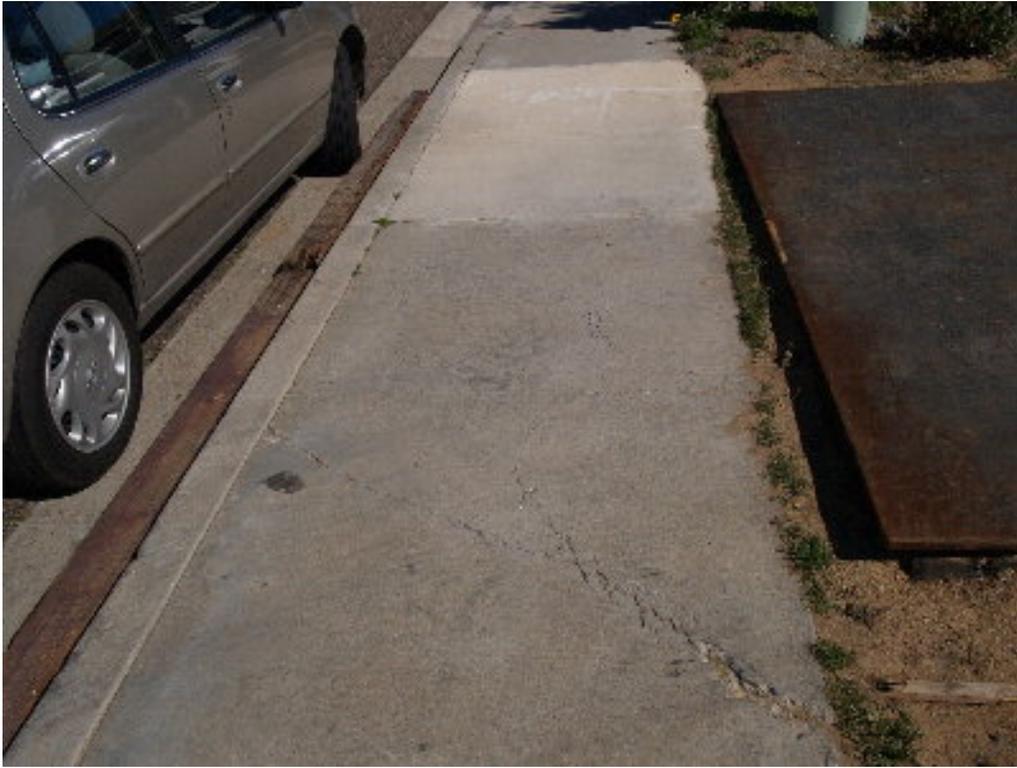
**Figure 3** – The sidewalk at the SDG&E access to Pole Site 481 along with any impacts outside the access easement, will be repaired at the end of the project.

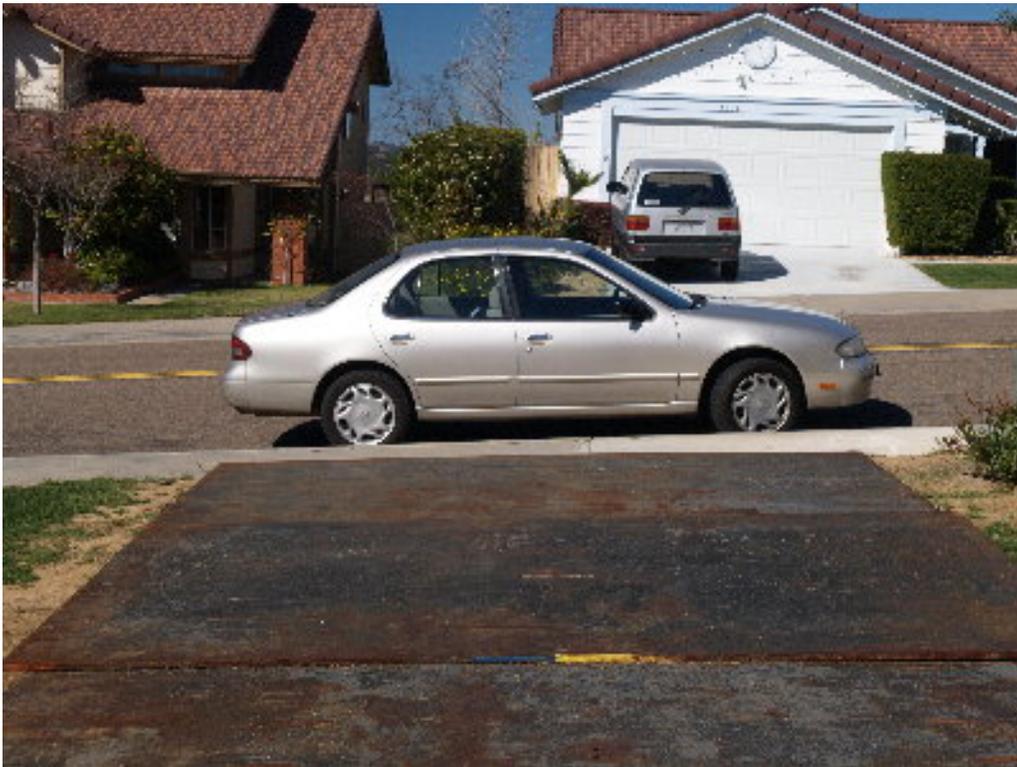
1. The CPUC EM met with the local property owners, a representative of a San Diego County Supervisor, and the SDG&E Project Manager and the transmission engineer to review site conditions at Tower Sites 481 and 493 on January 26. The in-field meeting was in response to the second letter from local residents and the County Supervisor received by the CPUC Project Manager with complaints about the pole location. The CPUC EM stayed after the field meeting to answer property owner questions and concerns. The CPUC EM verified that the location where the pad grading and foundation drilling had been started match the location in the project documents (Figures 2-2 and 4-10 in the Environmental Impact Report). The major concern of the local property owners, beyond the location of the poles, was notification and public involvement in the process. Aspen has obtained a list of the local property owners and checked the names against the property owners list provided by SDG&E and the list of Scoping Meeting participants. A summary of the field meeting was provided to the CPUC via email following the meeting. Property owners blocked access to this section of right-of-way on January 27 and SDG&E is pursuing a court order to gain access to the pole location. The incident was covered by the local print and television news services. No work was scheduled at the location during the subject week. Although the sidewalk has been damaged by heavy trucks and equipment, SDG&E will repair this once all construction in the area has been completed (see Figure 3). It was noted that a local car, not owned by the property owner, was parked in front of the access route to Pole 481 (see Figure 4). The CPUC EM has requested that SDG&E place sandbags or some other protection on the edges of the steel plates due to concerns over children playing in the area.

**Figure 4** – The access to Pole Site 481 continues to be blocked by local residents. The CPUC EM has requested protection be added to the edge of the steel plating.

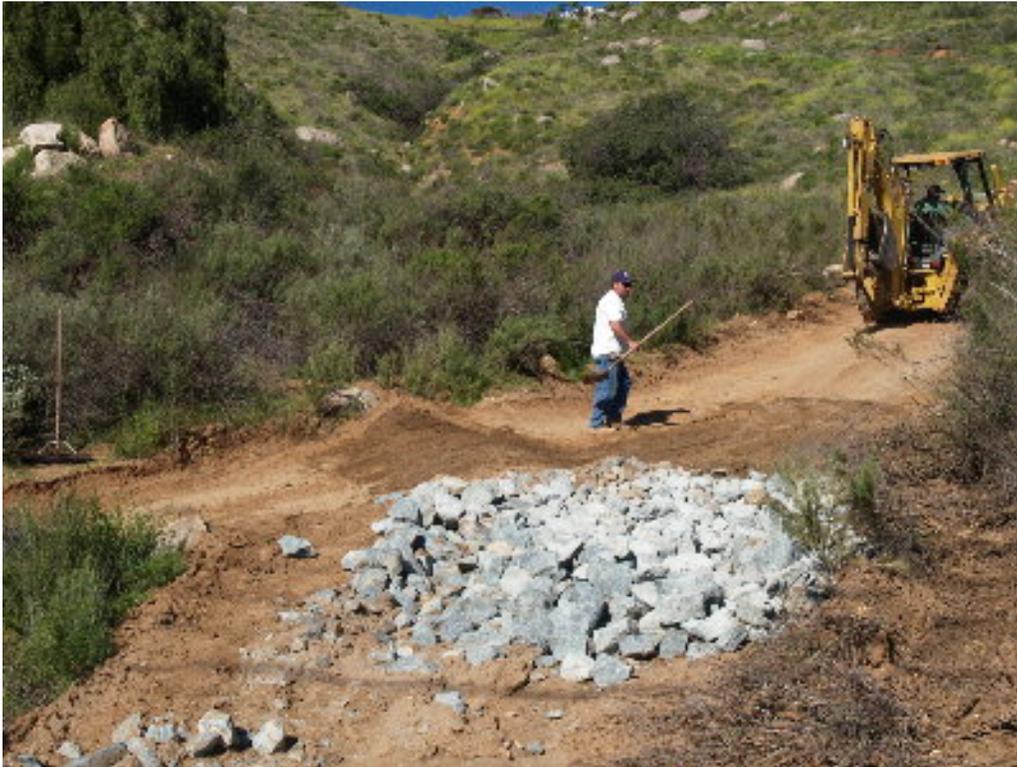
2. A crew from the subcontractor DMX worked on BMP issues at Pole Site 440 (see Figure 5). This location has been troublesome due to the slope and the deep cut of the access road. The water from the top of the hill was not being diverted off the right-of-way and the lower water bars were regularly overwhelmed in normal rain events. The CPUC EM reviewed this with the DMX foreman and the foreman had several suggestions to address the problem. Large rock is being used at this and other locations to trap sediment and slow down the water leaving the water bars. This issue was discussed in the February 3 meeting on BMPs. Overall, the BMPs on the project are steadily improving.

**Figure 5** – DMX worked to improve BMPs at Pole Site 440.  
The maintenance of the rock sediment traps is a concern.

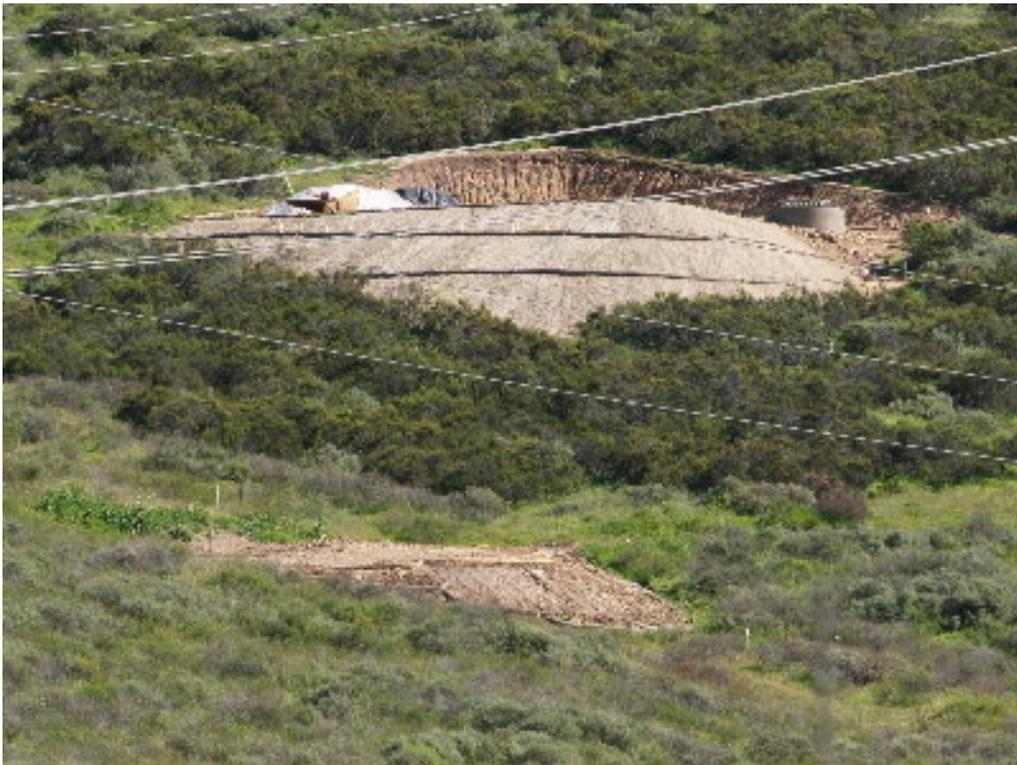
3. The foundations for Pole Sites 10 and 20 have been excavated and the concrete crew has poured. DMX has improved the BMPs at Pole Site 20; however, the rice rolls at the pad for Poles 5 and 7 continue to follow the base of the fill area with no sediment trap at the outlet or low spot in the roll (see Figure 6).

**Figure 6** – DMX improved the BMPs at Pole Site 10.  
Additional work may be required at the pad for Poles 5 and 7.

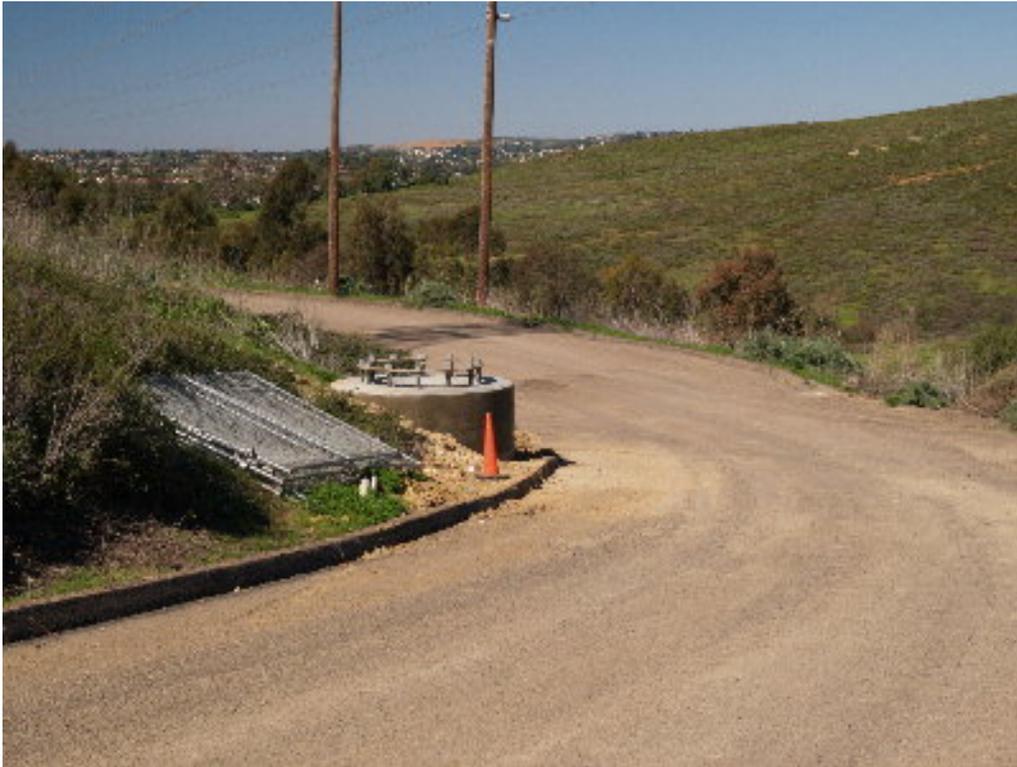
The majority of the mud from the drilling operation has been cleaned from the asphalt access road at Miguel Substation (see Figure 7).

**Figure 7** – The majority of the mud from the drilling operation has been cleaned from the asphalt access road at Miguel Substation.
