**PROJECT MEMORANDUM
PG&E SEVENTH STANDARD SUBSTATION PROJECT**

To: Monisha Gangopadhyay, CEQA Project Manager, CPUC
From: Vida Strong, Aspen Project Manager
Date: April 6, 2010
Subject: Report #3: March 21, 2010 – April 3, 2010

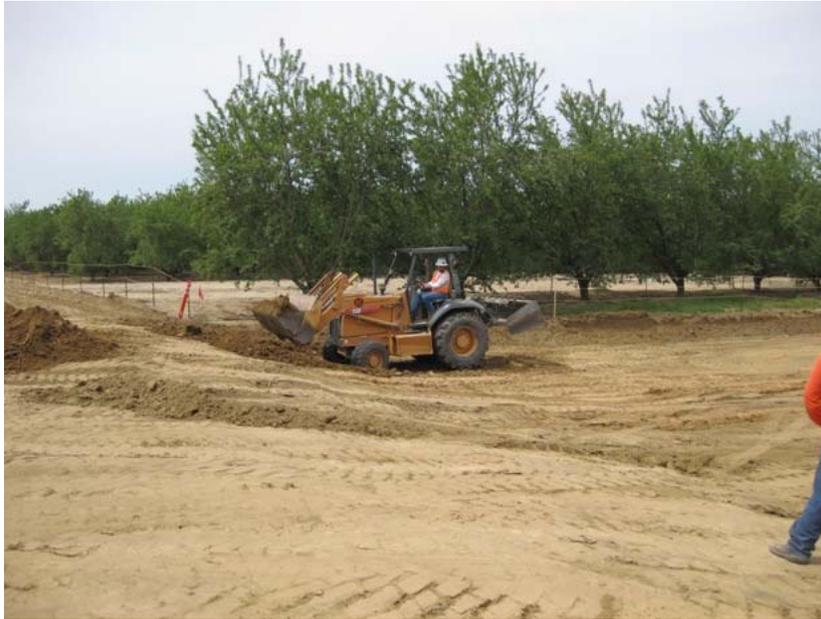
The access road has been excavated (see Figure 1), except for a section next to Seventh Standard Road (see Figure 2), which will be excavated soon in conjunction with coordination with the local roads department, including traffic control. The access road will be filled to grade with imported material and paved (sixteen foot width).

Figure 1: The access road (on the left) has been mostly excavated. The access road will be filled to grade with imported material, and then paved to a sixteen foot width. The photograph faces westward.

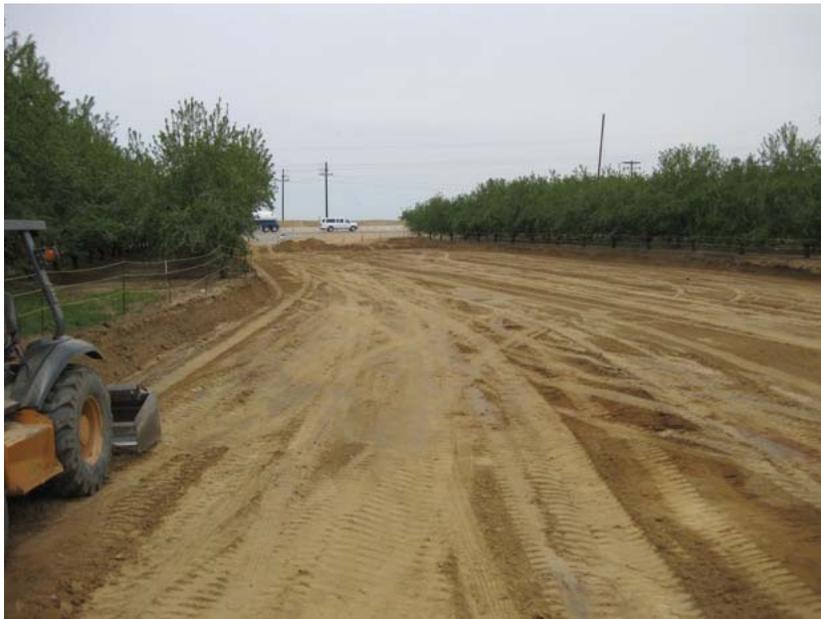
Figure 2: The access road has been excavated except for a section next to Seventh Standard Road (in the distance). This section will be excavated soon in conjunction with coordination with the local roads department, including traffic control. The access road will be filled to grade with imported material. The photograph faces northward.

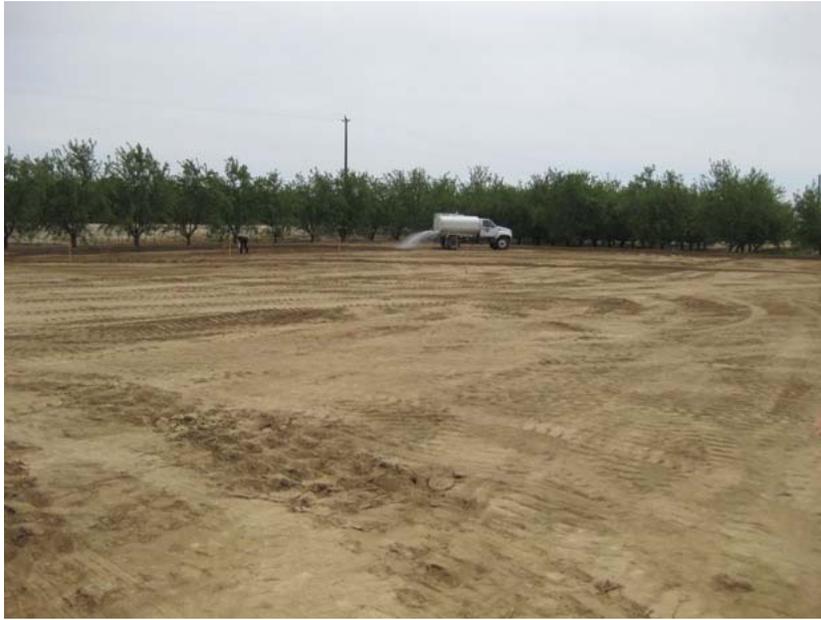
The contractor used a water truck for compaction (see Figure 3). So far, dust control has not been necessary because of recent winter rain events and continued cold temperature.

Figure 3: The substation site grading has been mostly completed to sub-grade level. An additional few inches of material will be imported from off site to reach grade. The contractor used a water truck for compaction. So far, dust control has not been necessary because of recent winter rain events and continued cold temperature. The photograph faces southeastward.
