**PROJECT MEMORANDUM
PG&E SEVENTH STANDARD SUBSTATION PROJECT**

To: Monisha Gangopadhyay, CEQA Project Manager, CPUC
From: Vida Strong, Aspen Project Manager
Date: June 28, 2010
Subject: Report #8: June 13, 2010 – June 26, 2010

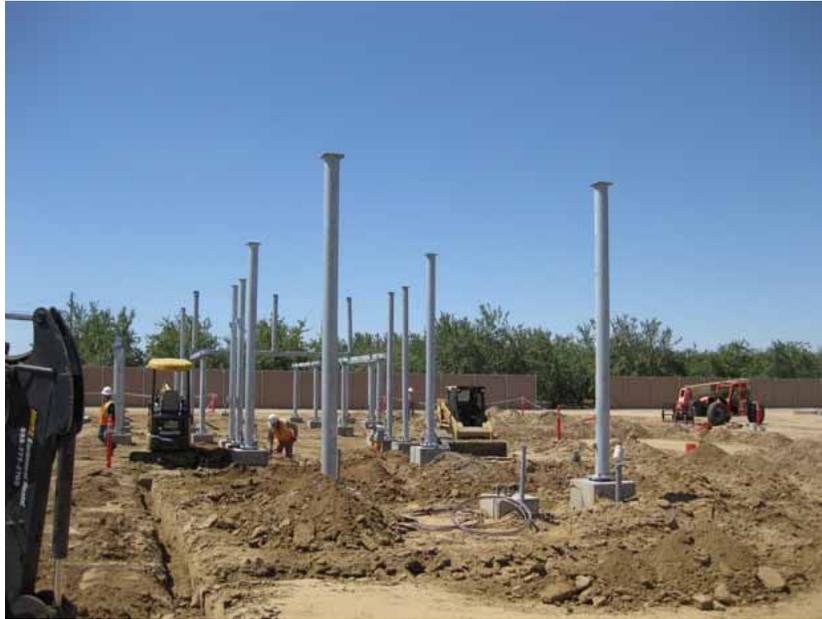
During the subject period, erection of structures began (see Figure 1). Construction of below-ground conduit trenches and the ground grid system continued (see Figure 2). The transformer was installed on the pad that had been placed during the prior reporting period (see Figure 3).

Figure 1: During the subject period, erection of structures began. Construction of below-ground conduit trenches and the ground grid system continued. The photograph faces southward.

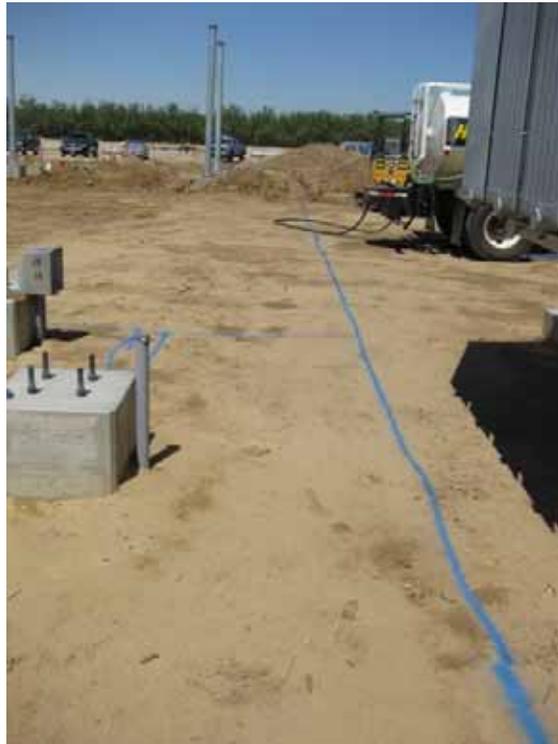
Figure 2: During the subject period, installation of the ground grid system continued. Narrow trenches were excavated along the blue lines. If left open overnight, they were checked by the biological monitor for animals before commencement of work in the morning. The photograph faces westward.

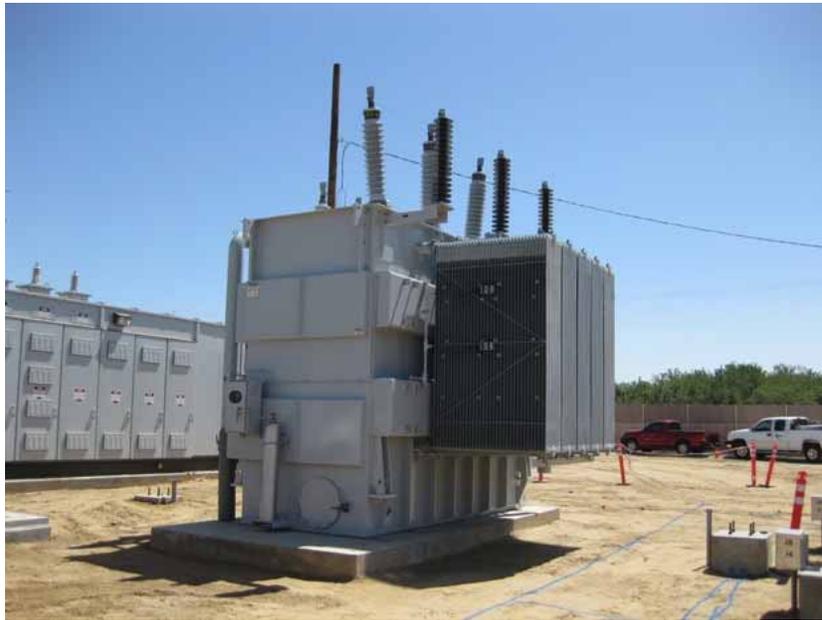
Figure 3: The transformer was hauled onsite and installed on the previously poured pad. The electrical controls enclosure is behind the transformer on the left. The photograph faces northeastward.

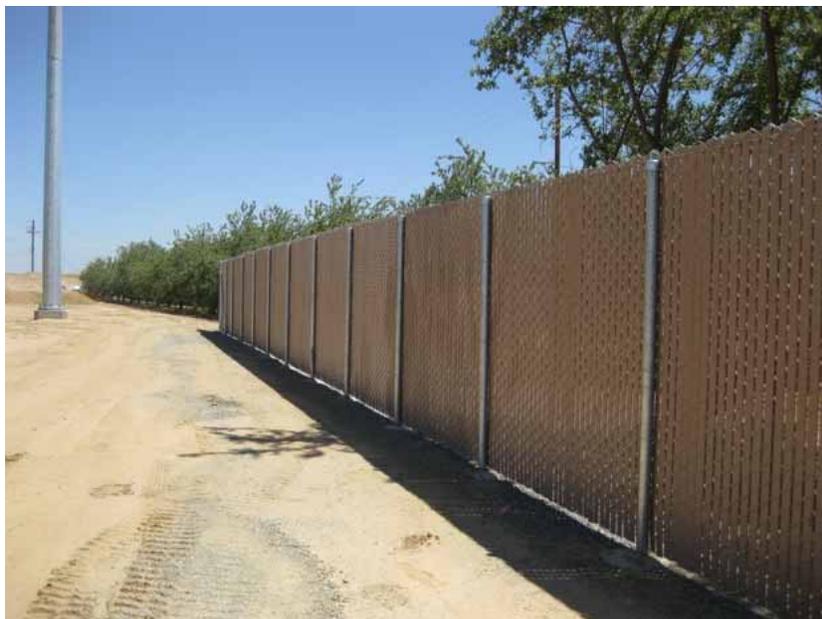
Work on the perimeter chain link fencing continued during the subject period (see Figure 4). The eight-foot high chain link fencing arrived during the subject period, and has been partially installed. Chain link perimeter fence will be placed on both sides of the access road and along the south, north and east boundaries of the substation. A concrete paneled wall will be placed along the perimeter of the west edge of the substation site in anticipation of future home development in that area. Supports for the concrete wall paneling have been placed. The prefab concrete panels for the wall will be arriving on site within the next few weeks.

Figure 4: Construction of the perimeter chain-link fence continued during the subject period. The photograph faces northward toward the access road and Seventh Standard Road. One of the three recently installed tubular towers stands in the middle distance.
