## **PROJECT MEMORANDUM PG&E – TRI-VALLEY 2002 CAPACITY INCREASE PROJECT**

**To:** Ken Lewis, CPUC  
**From:** Vida Strong, Aspen Project Manager  
**Date:** February 26, 2004  
**Subject:** Erosion and Revegetation Monitoring Report #3, 1/23/04 – 2/22/04  
**CPUC Environmental Monitor (EM):** Anne Sweet

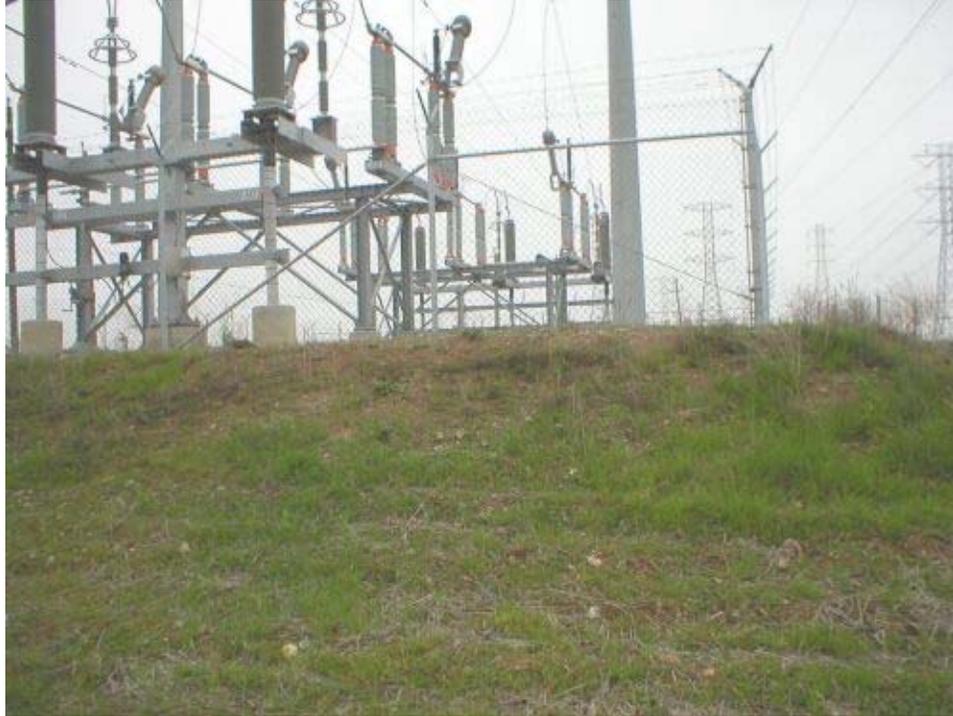
At the Transition Station, the seed, which was planted in the late spring of last year, has grown in some areas but shows little growth in others. One area of particular concern lies on a high slope area approaching the station pad. This area is upslope of a sensitive creek area and signs of some erosion are already evident. After inspections, PG&E reported that the area should be seeded in order to protect the station pad from further erosion (see Figure 1). A contractor has bid the work and seeding along the south and west sides of the slope are scheduled for completion by the end of this month.

**Figure 1** – Transition Station slope area pre-seed application, Phase One.

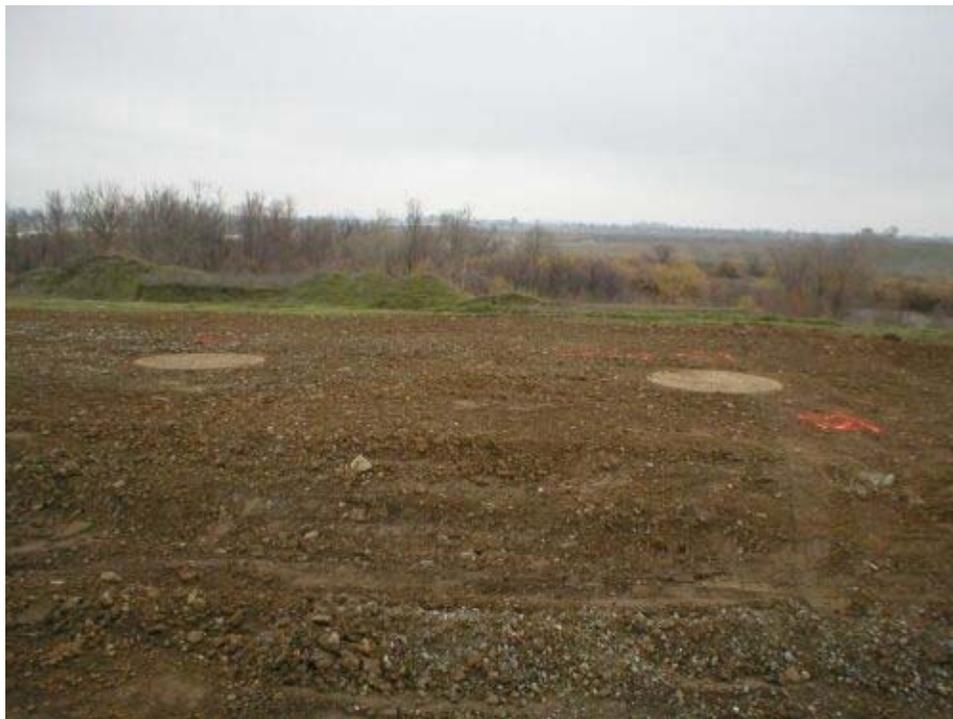
On January 1, sinkholes, slumping, and compaction issues throughout the Phase One alignment were identified at vault locations and along the length of the New Vineyard road trench line. PG&E called Mueller Pipeliners (the original contractor) back to the site to restore the areas. At the vault locations Mueller removed wet soils, backfilled with dry fill, and compacted the area. During the tour on January 22, the EM observed that the land sinkage problems at all of the vault locations had been filled in and recontoured (see Figure 2).

**Figure 2** –Repaired sinkage problems at Vault locations along New Vineyard Road, Phase One.

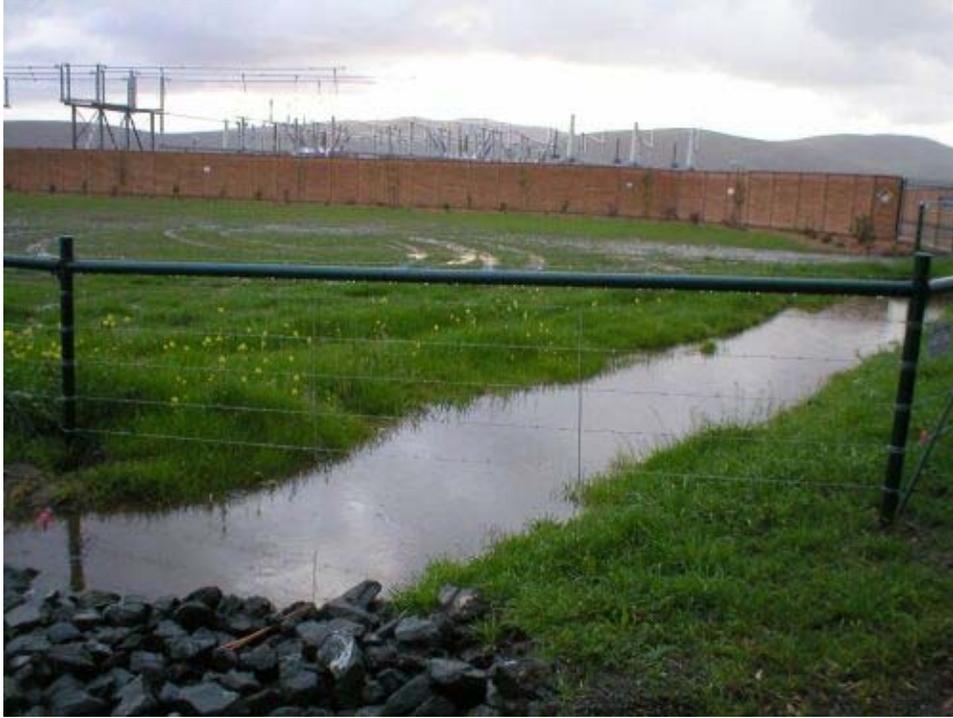
Restoration, including hydro-seeding and mulching, along the Phase Two right-of-way has been completed. During the January 29 tour, the CPUC EM and the PG&E Planner inspected the entire area surrounding the Station and found that drains extending from the site were flooded and held standing water. During the February 22 tour, the CPUC EM again inspected the area surrounding the Substation, and the two drains extending from the site remain flooded and hold standing water (see Figure 3). PG&E was contacted and gave information that the Station contractor Burns & McDonald is currently working on the drain remediation plan.

**Figure 3** – Flooded drainage at the Cayatano Substation, Phase Two.

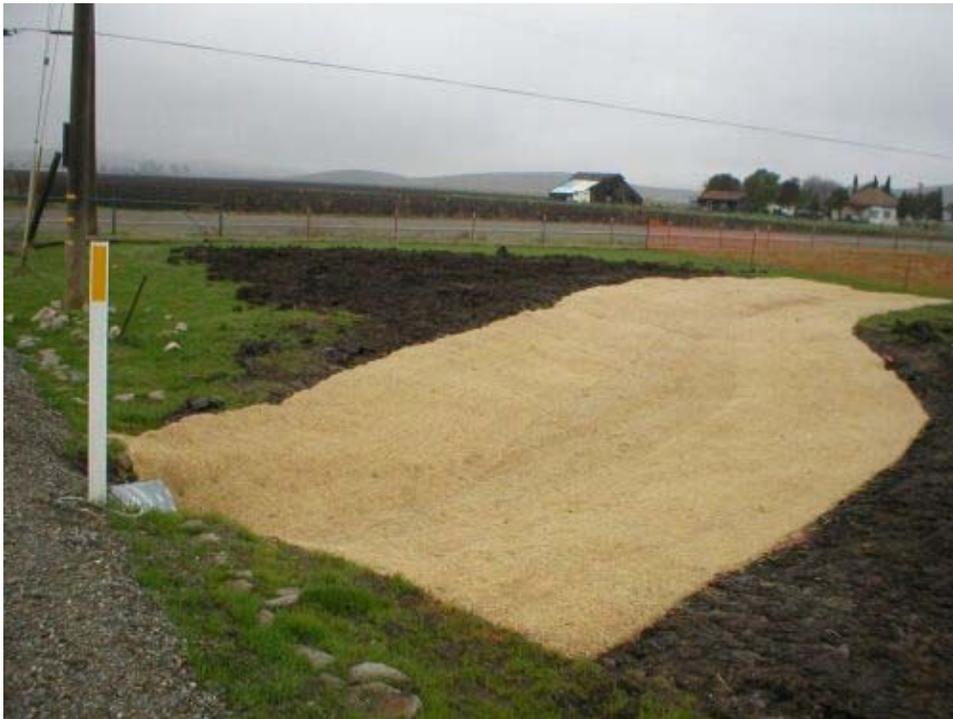
Continuing along May School and Dagnino Roads the right-of-way appears sound and seed mixes have sprouted; however, the heavy rains have flooded sections over the alignment. East from Dagnino Road along the access road that follows the alignment to the Transition Station, the recent rains have promoted growth of the applied seed. Erosion Controls were holding well. At PG&E's request, HT Harvey and Associates (the surrounding mitigation area planner) had installed more jute netting and hay bales within the drainages under the access road (see Figure 4). The Transition Station area was inspected and looked good.

**Figure 4** – Added erosion controls within drainage areas along the access road to the Transition Station, Phase Two.
