PROJECT MEMORANDUM PG&E – TRI-VALLEY 2002 CAPACITY INCREASE PROJECT

To: Roosevelt Grant, CPUC
From: Vida Strong, Aspen Project Manager
Date: May 15, 2003
Subject: Weekly Report #34: May 5, 2003 – May 11, 2003
CPUC Environmental Monitor (EM): Anne Sweet

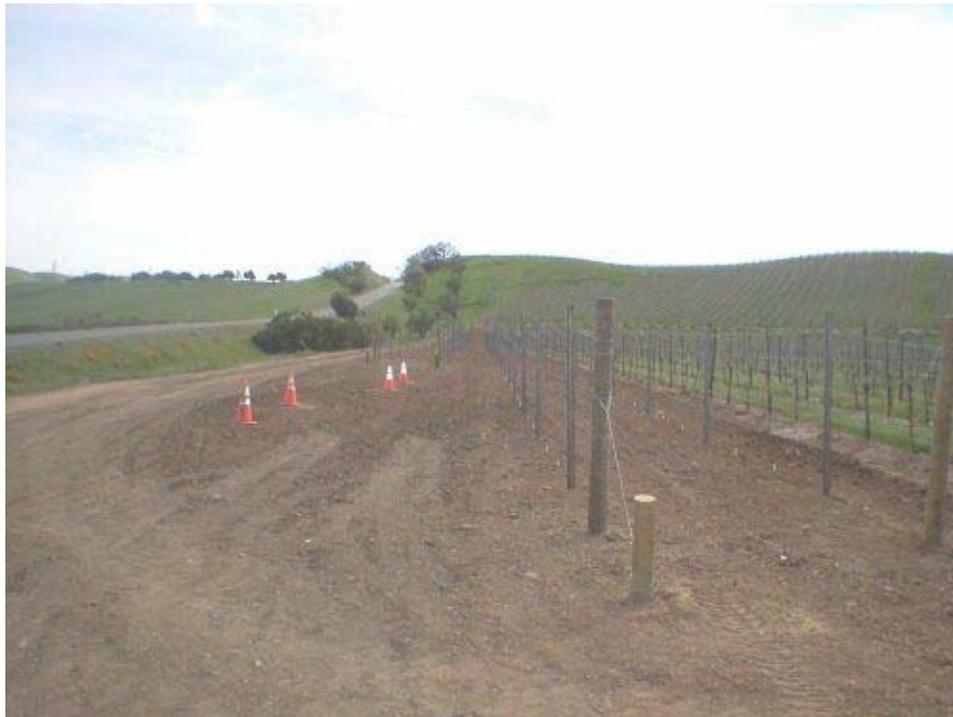
For the area between Highway 84 and the Transition Station, crews continue to do restoration work, as well as re-installing vine rows (see Figure 1). On Saturday, May 10, the Essex EI contacted the CPUC EM with information that a diesel spill had occurred near the Vault 4 area. While crews were stringing line from the Vault location under a project truck, over un-paved right-of-way, a fuel line broke. The line

Figure 1 – Restoration work along the right-of-way. The area has been graded and new vine rows have been installed up to the underground installation.

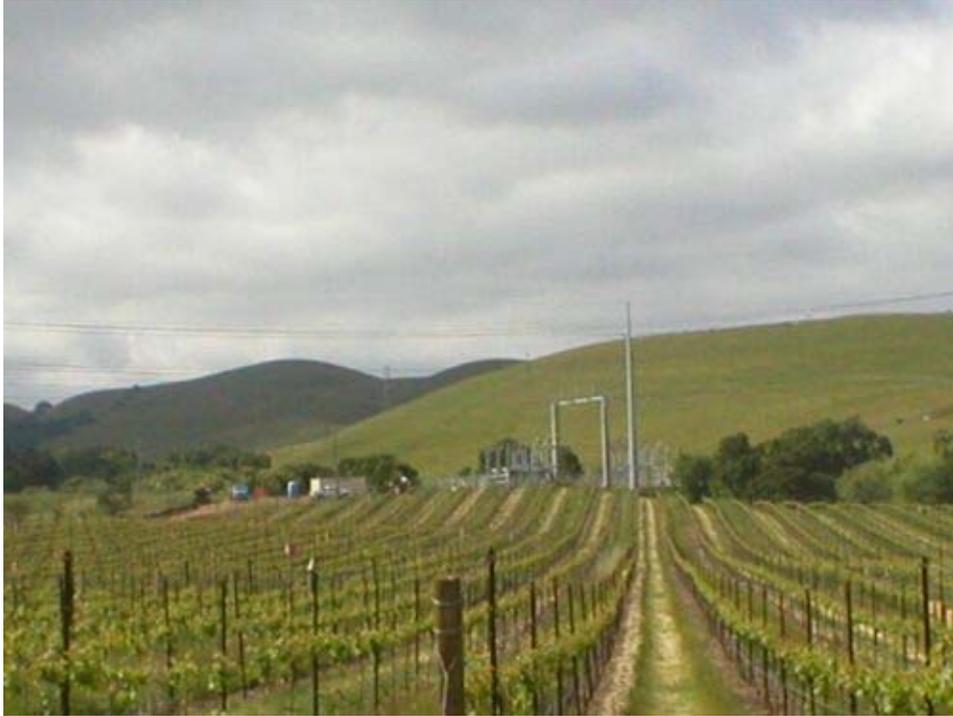
Crews have finished the Transition Station foundation work, and have installed cyclone fencing around the station. Insulating jackets and other equipment were mounted to the cable and H-frame structure. Minor clean-up activities and grading also occurred during the subject week (see Figures 2 and 3). Erosion control devices were inspected and are being maintained. Crews have installed base rock for a gravel road along the right-of-way leading to the station.

Figure 2 – Far view of the Transition Station.

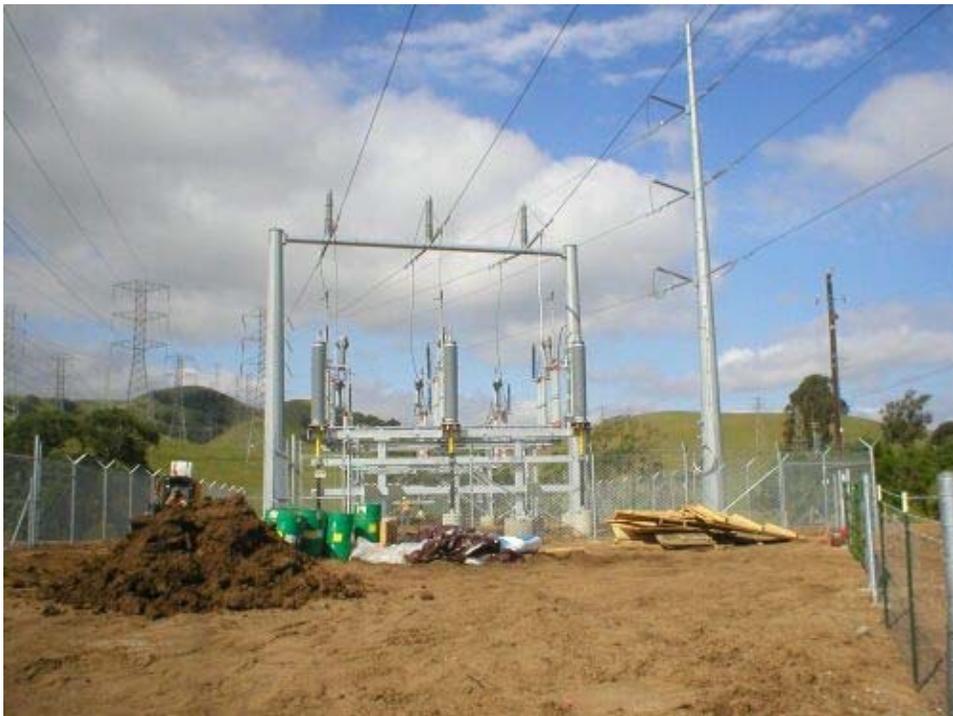
Figure 3 – Clean-up and grading activities at the Transition Station.
