Aliso Canyon Turbine Replacement Project Construction Non-Compliance Report

Incident Date:	November 1, 2014 through May 19, 2015	Report No.:	NCR-08
Date Submitted:	3/17/2016	Location:	Aliso Canyon Natural Gas Storage Field
Level:	Level 2 Non-Compliance	Relevant Plan/Measure:	MMCRP; NPDES General Permit (SWPPP); APM GE-2
Current Land Use:	Disturbed	Sensitive Resources:	Hydrology, Biology: drainages, riparian, oaks

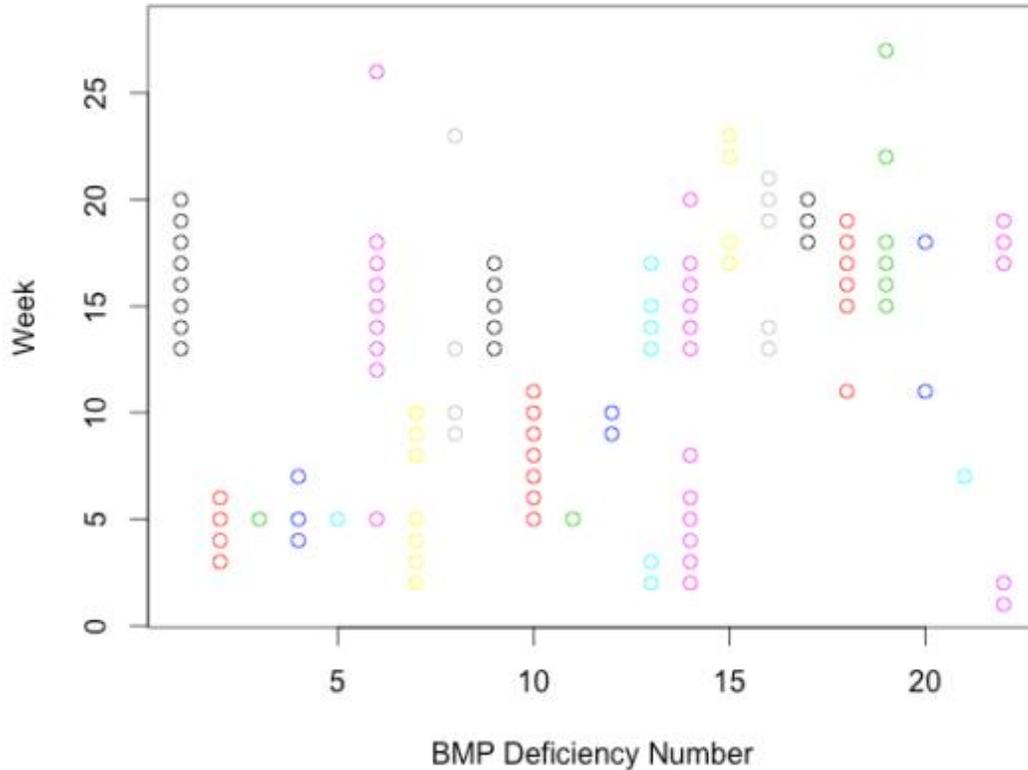
Figure 1: Recurring BMP Deficiencies by Week (November 2014 – May 2015)

Attachment 1 displays all the BMP deficiency items from November 3, 2014 through May 19, 2015 and the weeks they were documented by the QSP. In some cases many weeks passed between the first report of a deficiency and the last, indicating that BMP improvement or maintenance was not sufficiently resolved within the time frames required by the SWPPP. Some of the longer lasting deficiency items included:

The figure in Attachment 1 clearly shows BMP deficiencies were a reported problem that was left unaddressed by SCG for consecutive weeks-to-months. The substantial number (22) of recurring deficiencies and their multi-week duration demonstrate that SCG's SWPPP was not being followed, despite being identified as a high priority by the CPUC/E&E Team (see documentation in NCR-3, NCR-4, and NCR-6). Attachment 2 shows photo documentation of example recurring BMP deficiencies.

Figure 1: Repeated Best Management Practice (BMP) Deficiency Items for SoCalGas between November 3, 2014 (week 0) and May 19, 2015 (week 28). Weekly Storm Water Pollution Prevention (SWPPP) Reports, Pre-Storm and Post-Storm SWPPP Reports, and Rain Event Action Plans (REAPs) are completed by SCG’s Qualified SWPPP Practitioner (QSP). In each report the QSP identifies BMPs that need to be fixed, implemented, or changed. The ACTR Project’s SWPPP requires that within 72 hours BMP deficiencies must begin to be addressed and should be fully addressed “as soon as possible.” Figure 1 shows that throughout the storage field, the same BMP deficiency was left unaddressed for multiple weeks and in some cases more than a month. *Note: repeated BMP deficiencies associate with PS-42 Fill Site that were included under NCR-06 are not included in this dataset.*

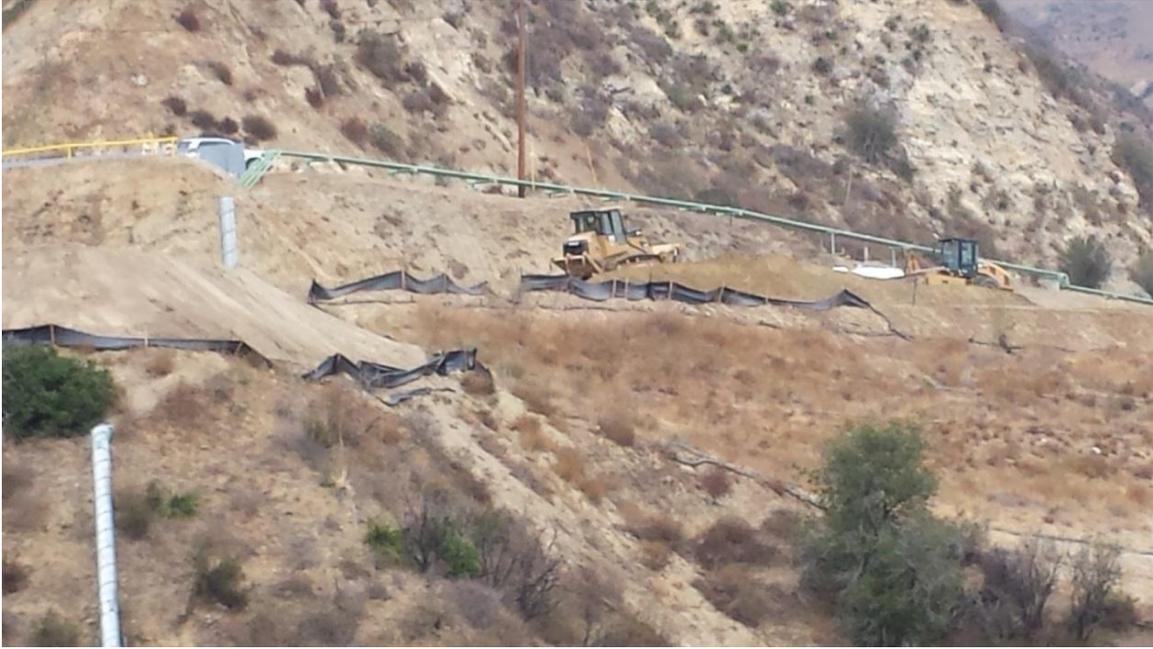
Photo 1: Maintain silt fence at P-32 Fill Site, November 11, 2014

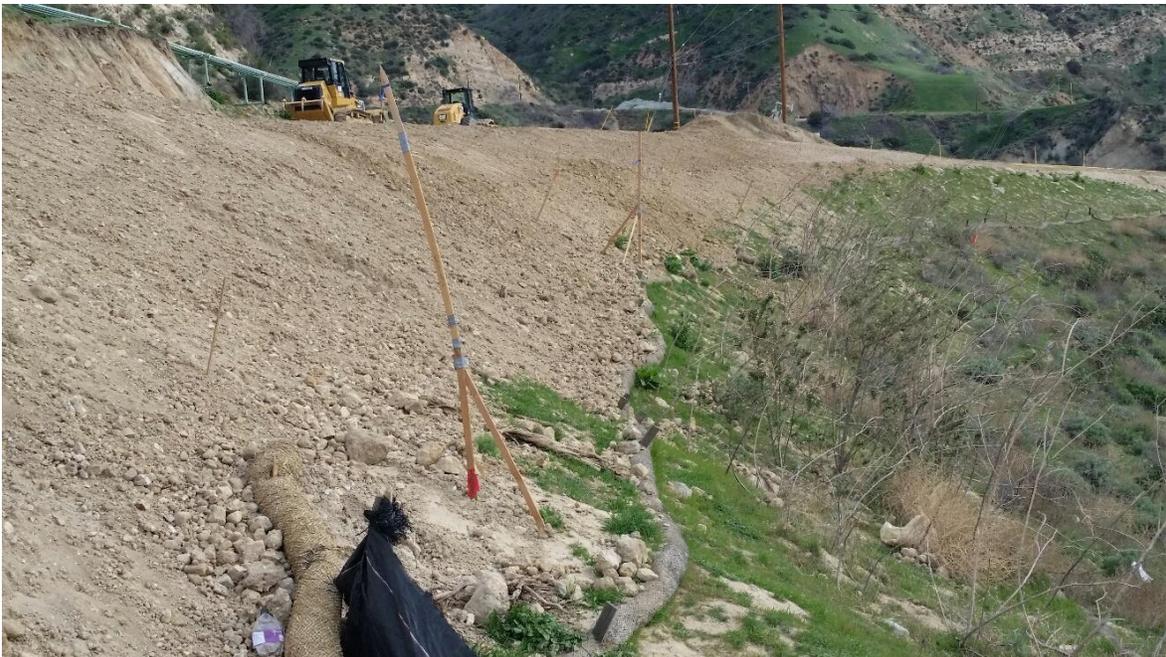
Photo 2: Maintain silt fence at P-32 Fill Site, January 26, 2015

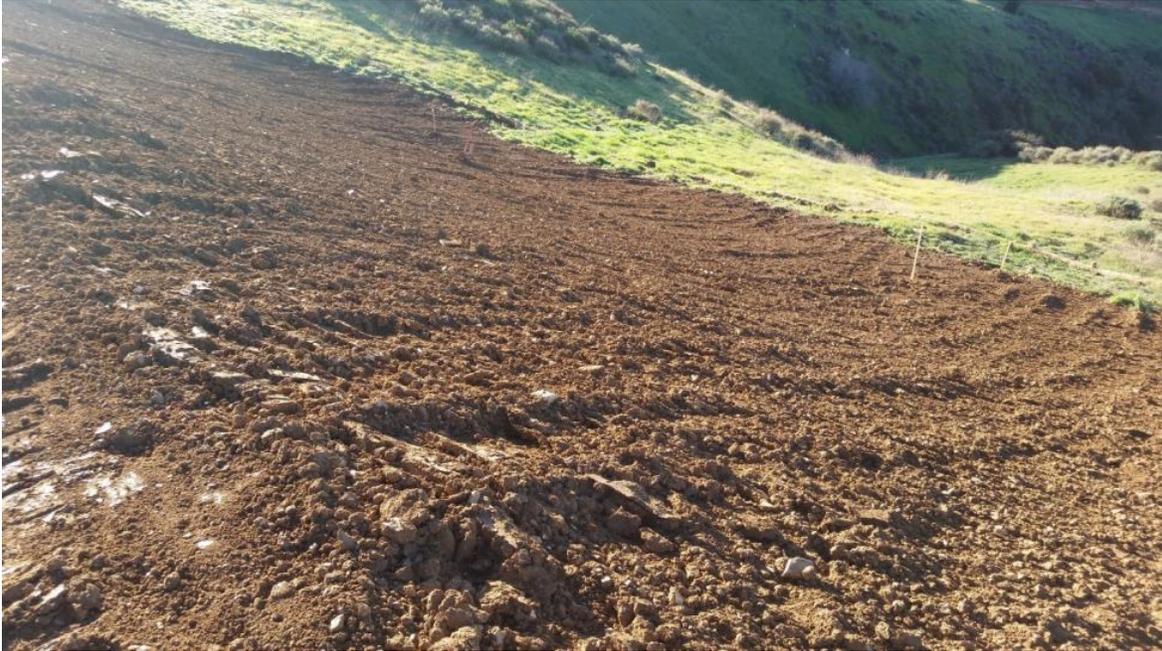
Photo 3: Provide cover for inactive slope and place fiber rolls every 10 ft. and trench in fiber rolls at the Natural Substation, February 9, 2015

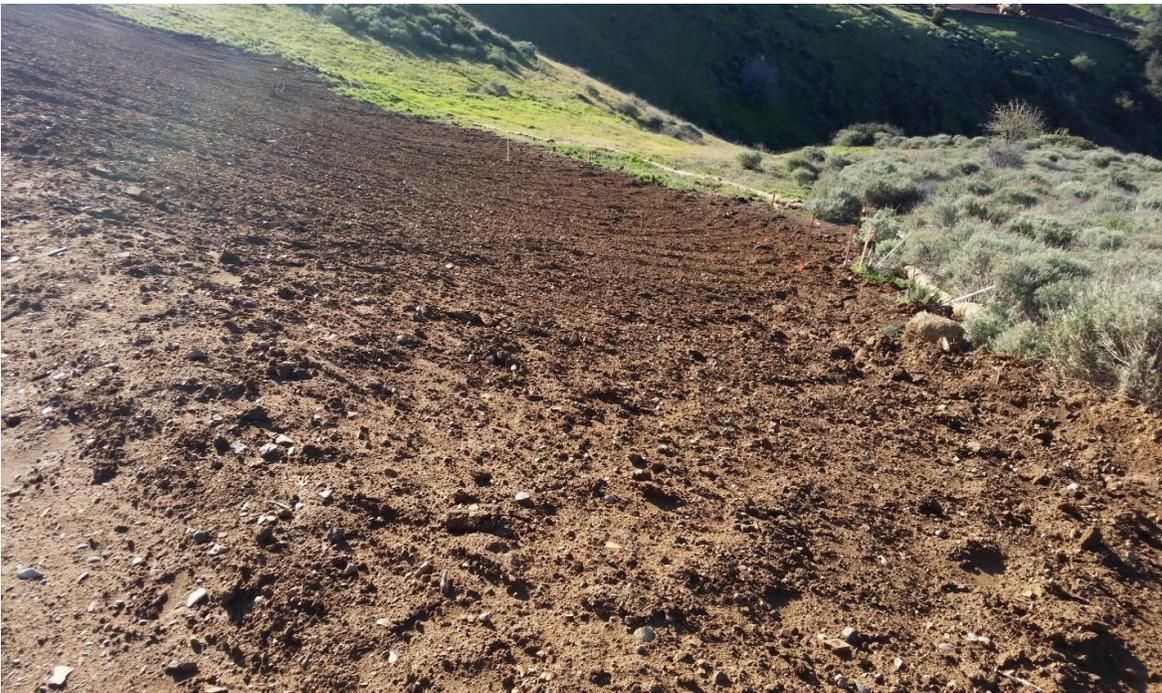
Photo 4: Provide cover for inactive slope and place fiber rolls every 10 ft. and trench in fiber rolls at the Natural Substation, February 23, 2015

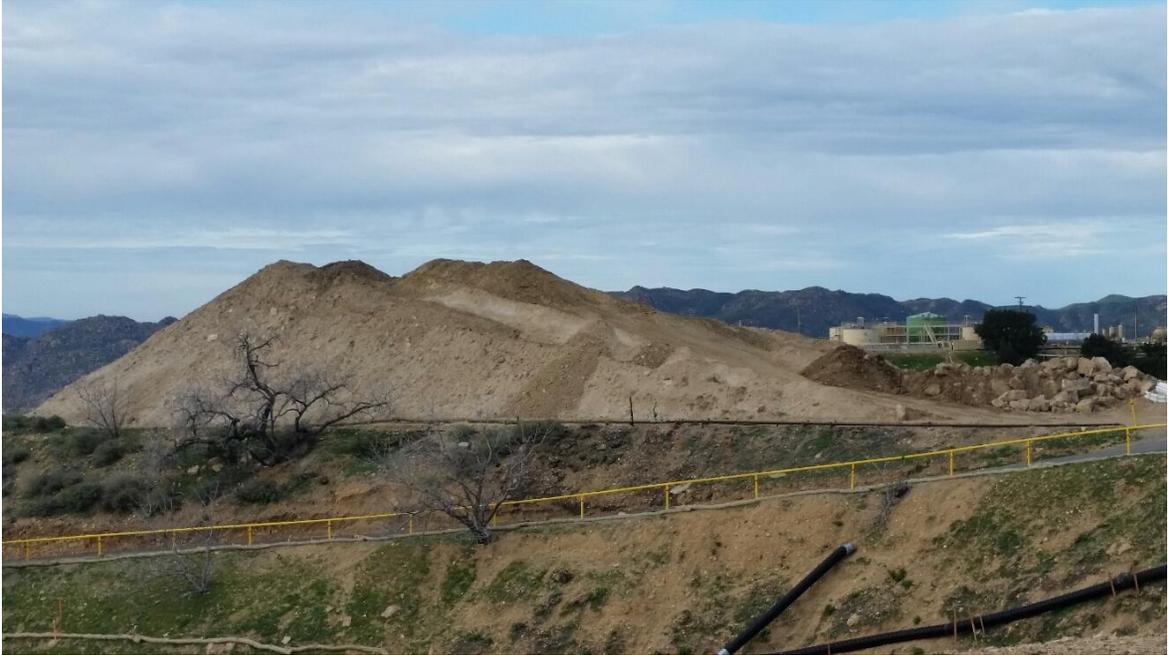
Photo 5: Provide cover for an inactive stockpile at the PS-42 Rock Staging Area, January 26, 2015

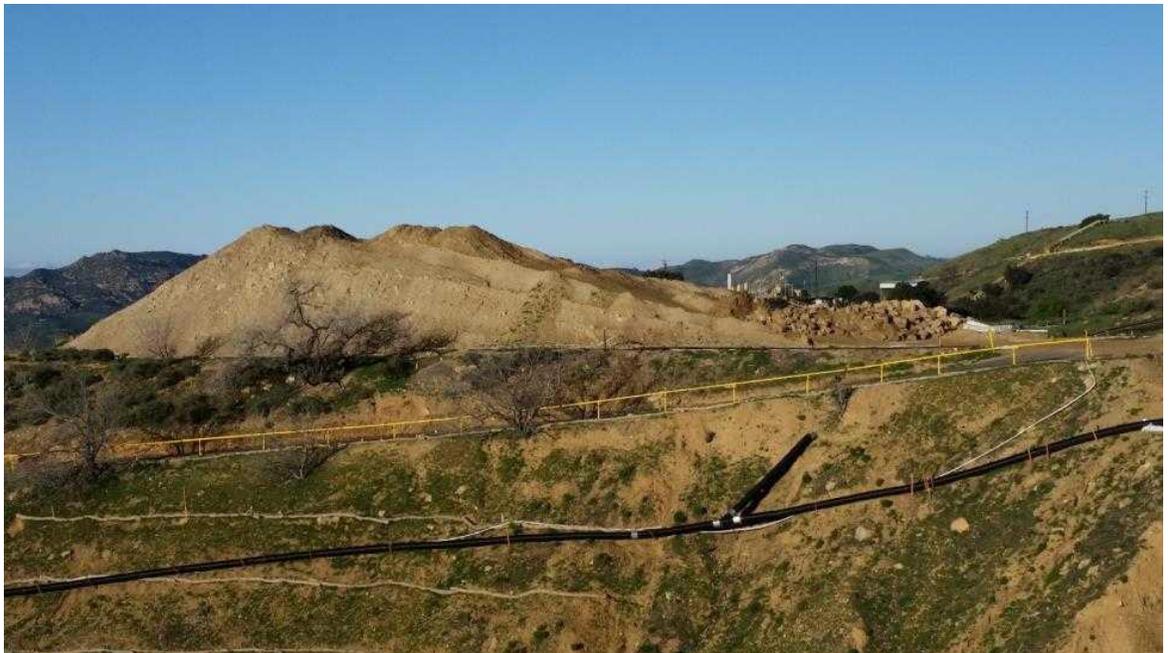
Photo 6: Provide cover for an inactive stockpile at PS-42 Rock Staging Area, February 17, 2015

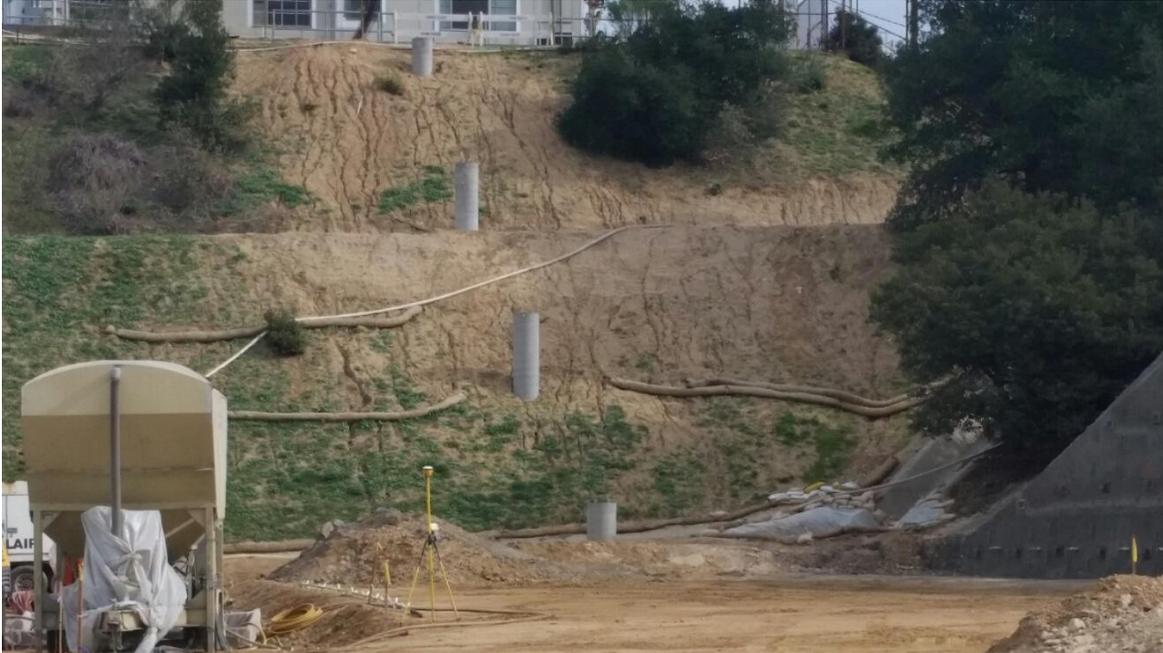
Photo 7: Provide either chemical or mechanical cover for inactive slopes at the Central Compressor Station, January 26, 2015

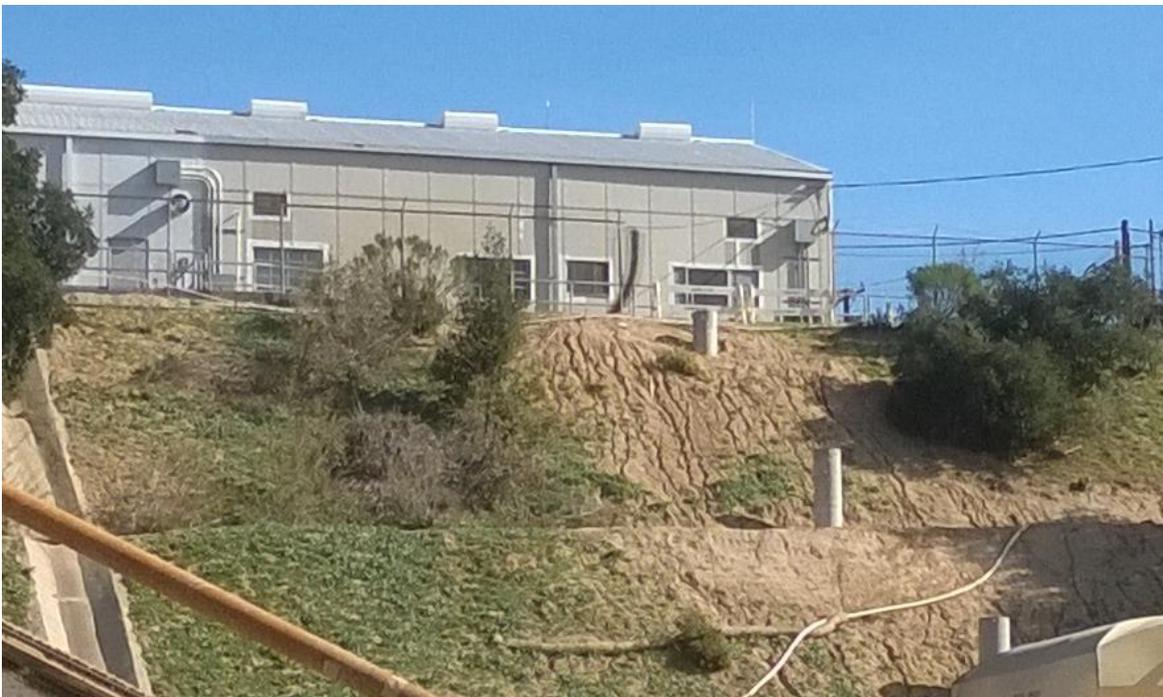
Photo 8: Provide either chemical or mechanical cover for inactive slopes at the Central Compressor Station, February 3, 2015
