Re: Monthly Report Summary #15 for the Mesa 500-kV Substation Project

CPUC Site Inspection Reports
December 4, 11, and 18, 2018

Mesa 500–kV Substation Project CPUC Site Inspection Form

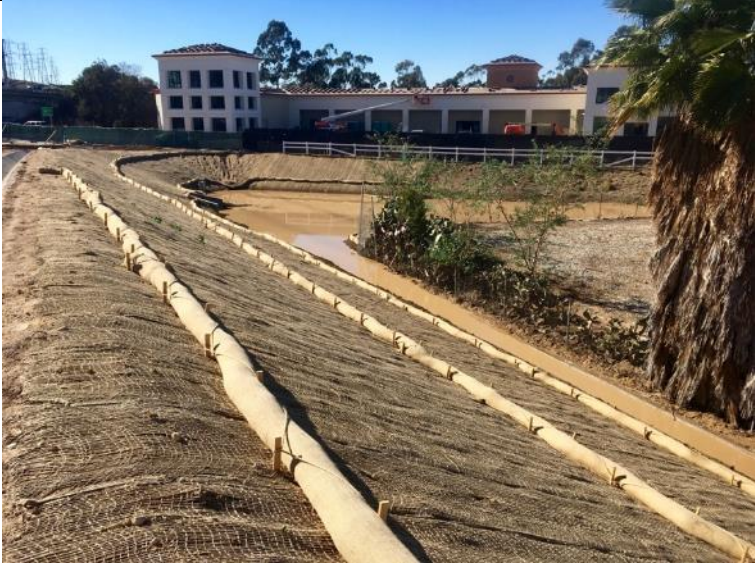
Photo 4 – Some ponding of water in the detention basin. Photo facing southwest
12/4/18	Mesa substation

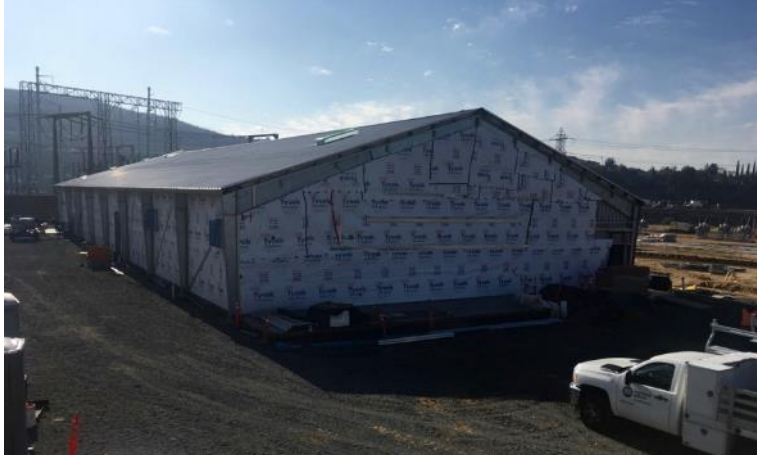
Photo 1 – Senior MEER building construction. Photo facing south
12/11/18	Mesa substation

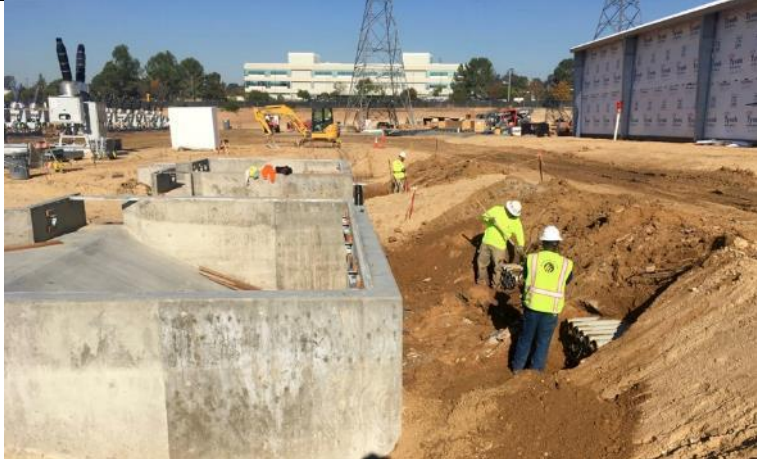
Photo 2 – Crews cleaning mud from around the conduit – pulling pits near the Senior MEER building. Photo facing east
12/11/18	Mesa substation

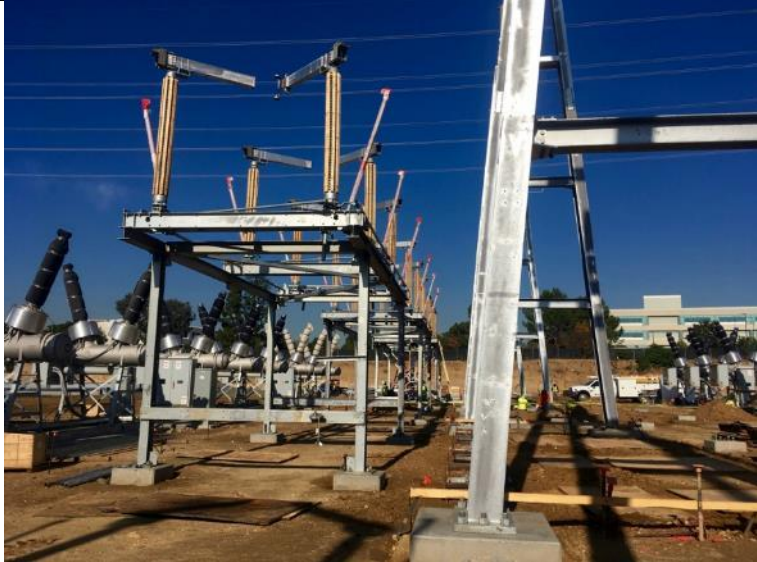
Photo 3 – Foundation installation work and installation of the “disconnect” structures continue within the 220-kV rack area. Photo facing north

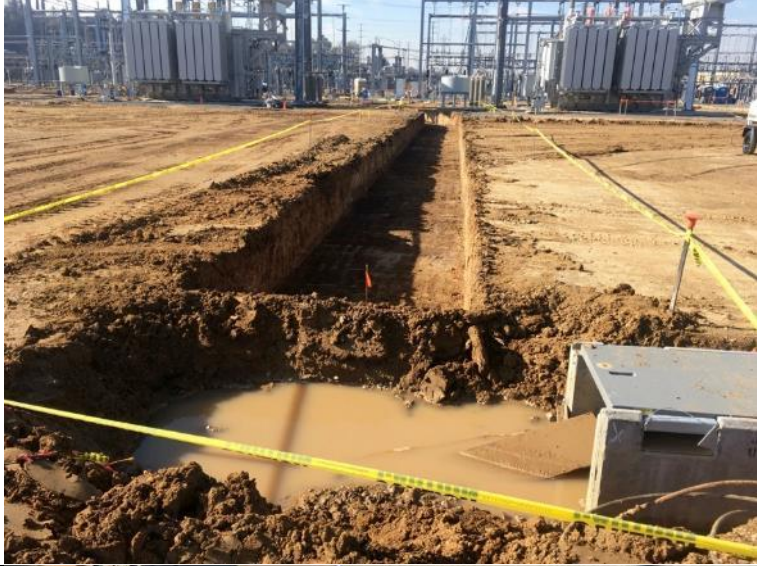
Photo 4 – Some trenching work being done. Photo facing west
12/11/18	Mesa substation

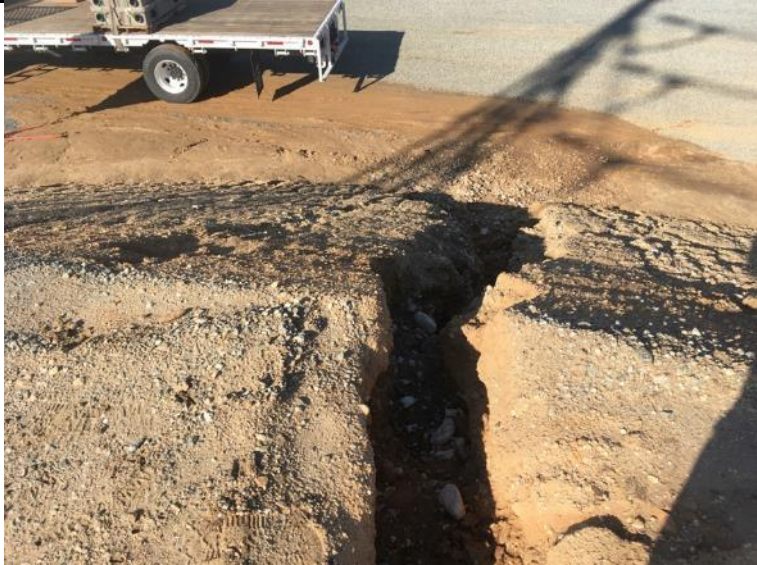
There had been substantial rainwater runoff during the recent storm event, as indicated by the erosion riles created by water flowing off the existing substation site – Photo 5, and the water filled excavations observed throughout the project site – Photo 6.

Photo 5 – Erosion rille generated by stormwater runoff leaving the Mesa Substation Site.
12/11/18	Mesa substation

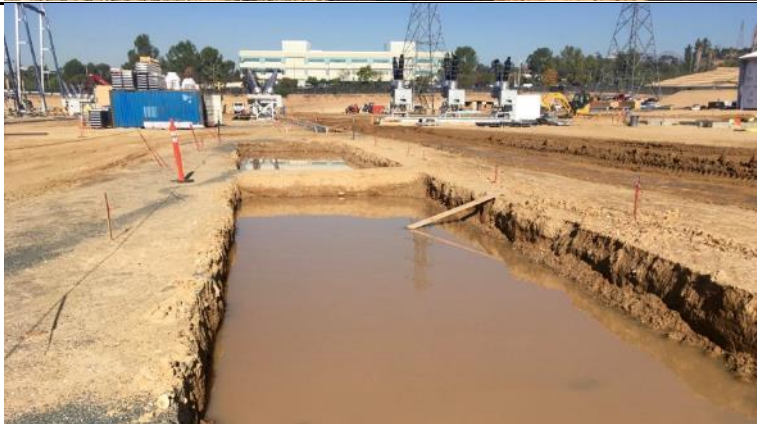
Photo 6 – Rack foundation excavations filled with stormwater runoff. Photo facing north

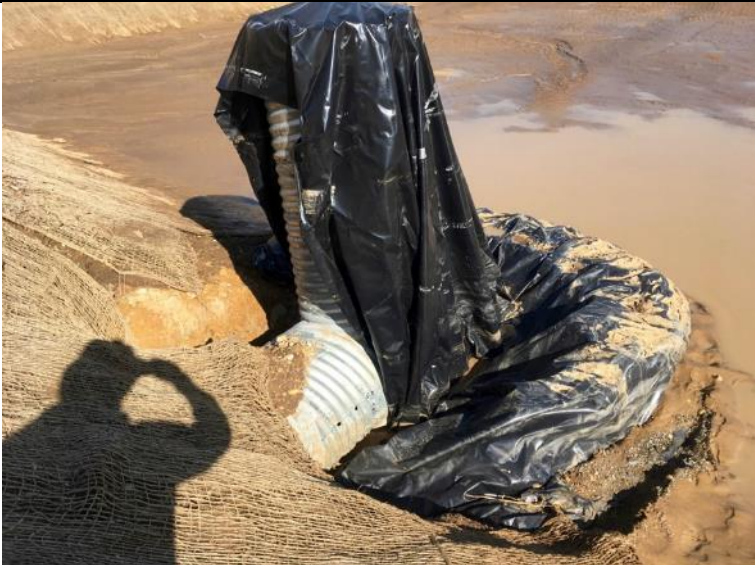
Sheet flow across the project site was primarily directed into the detention basin. Large erosion riles developed where the water entered the basin at the northeast – Photo 7, and southeast corners of the detention basin – Photo 8. The water in the detention basin appeared to have reached a maximum depth of approximately 6 feet, as indicated by the sediment line on the bank by the standpipe – Photo 9. The gravel bags and Visqueen plastic that had covered the holes in the standpipe failed – Photo 10, allowing the sediment-laden stormwater runoff to drain offsite.

Photo 10 – Significant quantities of sediment-laden water drained out of the detention basin at the base of the standpipe, entering the stormdrain system.
12/11/18	Mesa substation	 	Photo 11 – Rainwater runoff captured in the smaller triangular detention basin. Photo facing west
12/11/18	Mesa substation	 	Photo 12 – Erosion along the banks of the triangular detention basin. Photo facing east

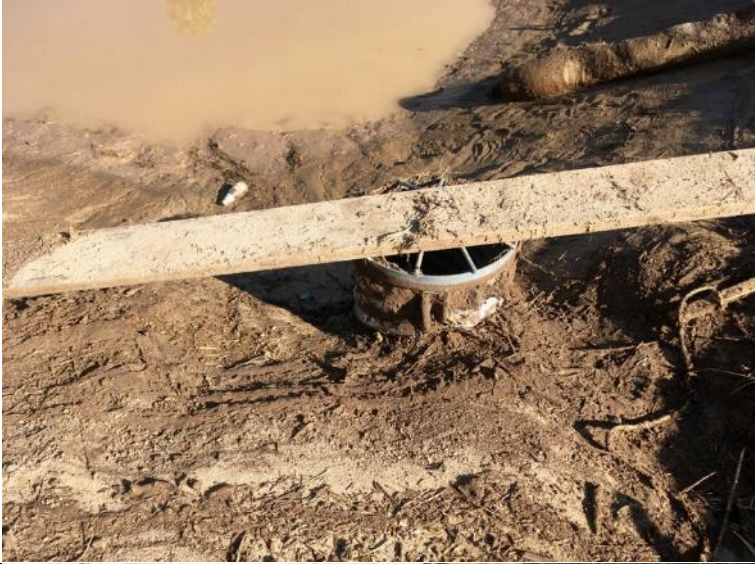
Photo 13 – Standpipe in the triangular detention basin.
12/11/18	Mesa substation

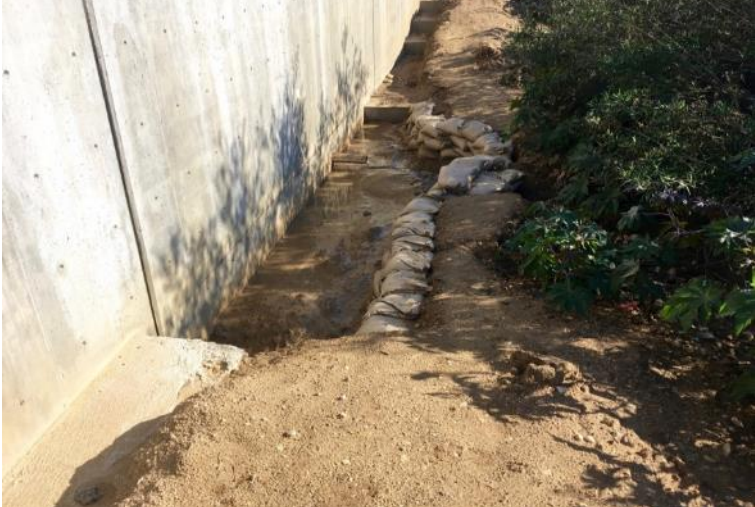
Photo 14 – Gravel bags placed along the outside of the southern boundary fence where stormwater had previously escaped the Mesa Substation Site.
12/11/18	Mesa substation

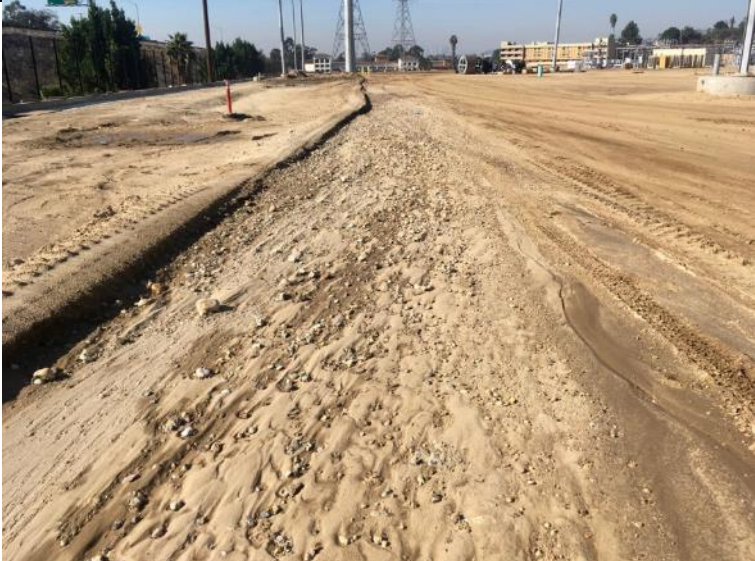
Photo 15 – Evidence of large amounts of stormwater runoff running along the southern portion of the project site. Photo facing west

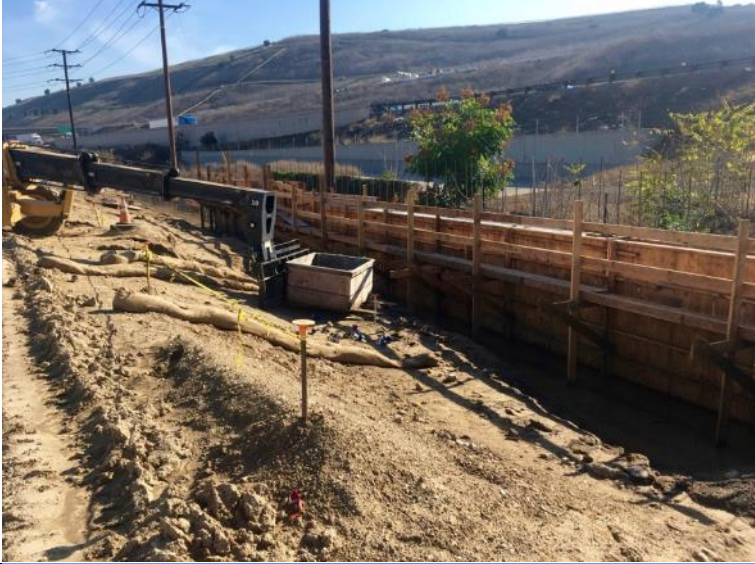
Photo 16 - Wall work along the southern boundary of the project area. Photo facing southeast
12/11/18	Mesa substation

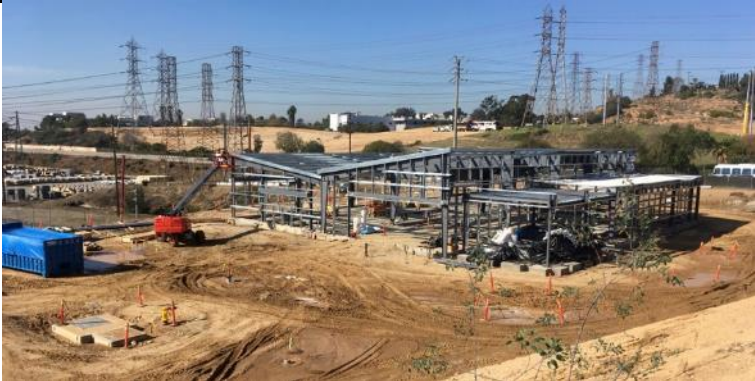
Work on the Mesa Operations Building continues, though conditions are very muddy – Photo 17.

Photo 17 – Work on the Mesa Operations Building. Photo facing northwest
12/11/18	Mesa substation

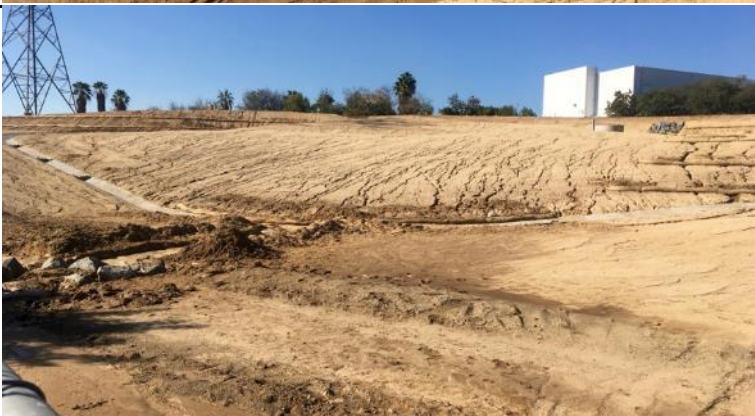
The telecommunications corridor north of Potrero Grande Drive was being cleaned up after rainwater overwhelmed most of the BMPs during the most recent rain event. Crews were working on cleaning out the “V” ditches, reestablishing the straw wattles, and potentially hydromulching the whole area. SWPPP inspector Lucy Cortez-Johnson had indicated that most hydroseeding crews were currently booked conducting repairs following wildfires elsewhere in the state.

Photo 18 – BMP repairs within the telecommunications corridor North of Potrero Grande. Photo facing north

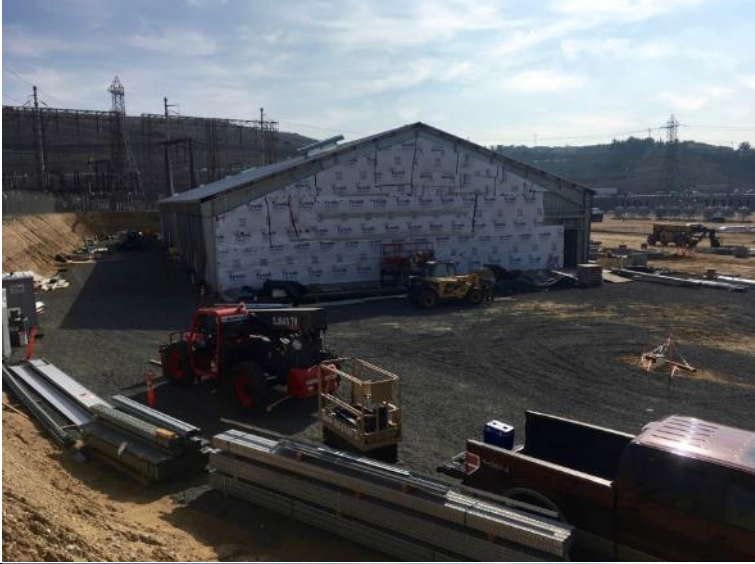
Photo 1 – Senior MEER building construction. Photo facing south
12/18/18	Mesa substation

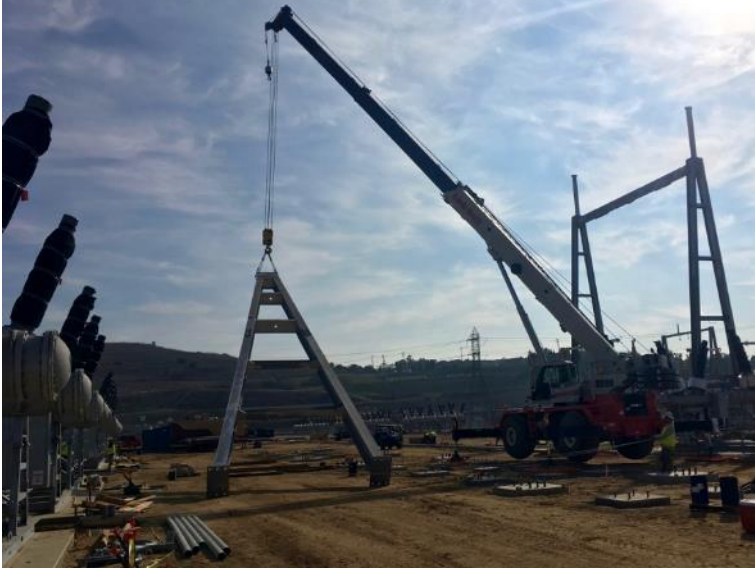
Photo 2 – Erection of structural supports within the 220-kV rack area. Photo facing south

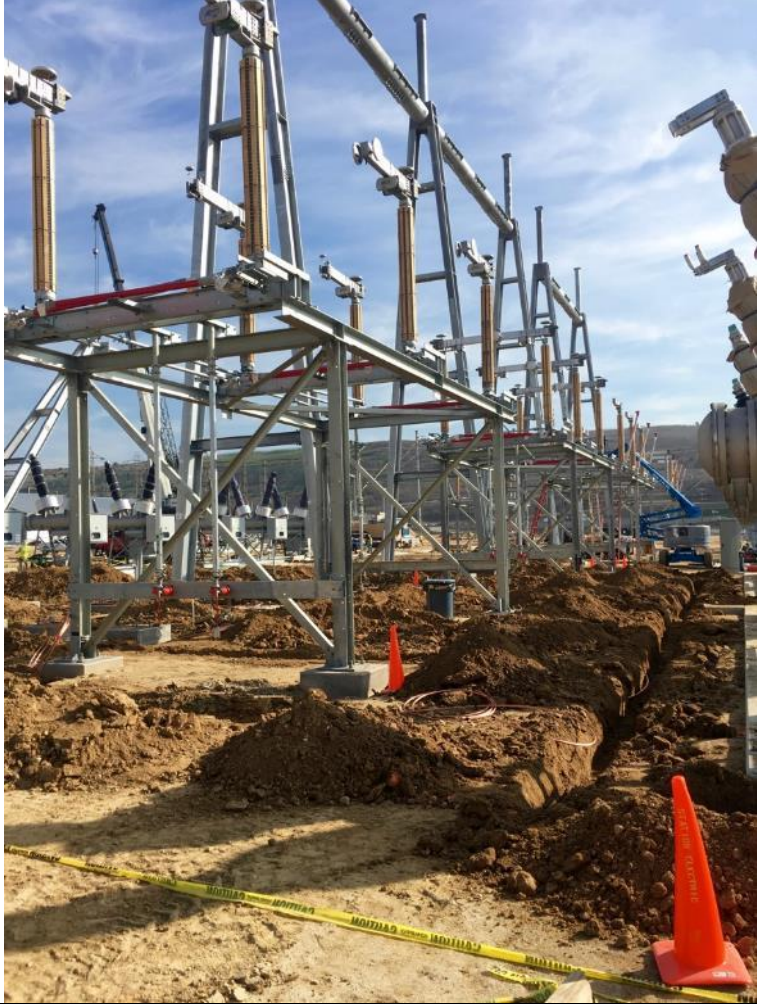
Photo 3 – Trenching for the grounding wire within the disconnect structures. Photo facing south
12/18/18	Mesa substation

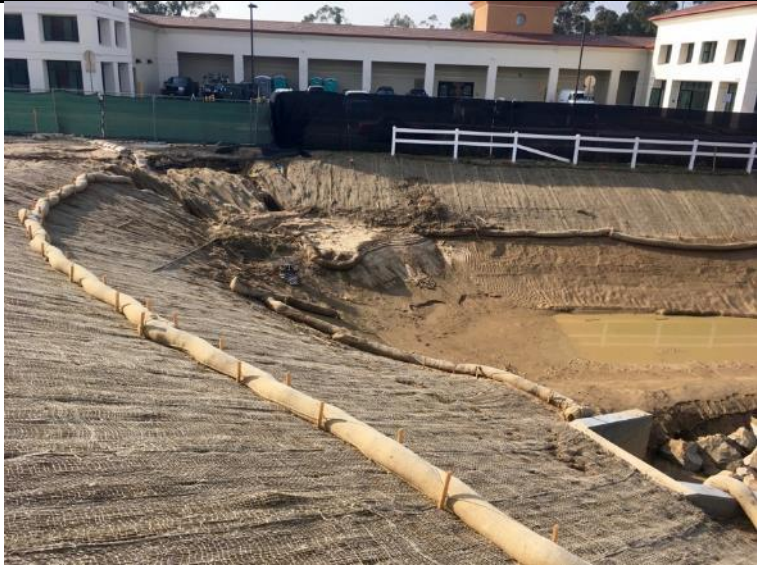
Photo 4 – Small triangular detention basin. Photo facing west

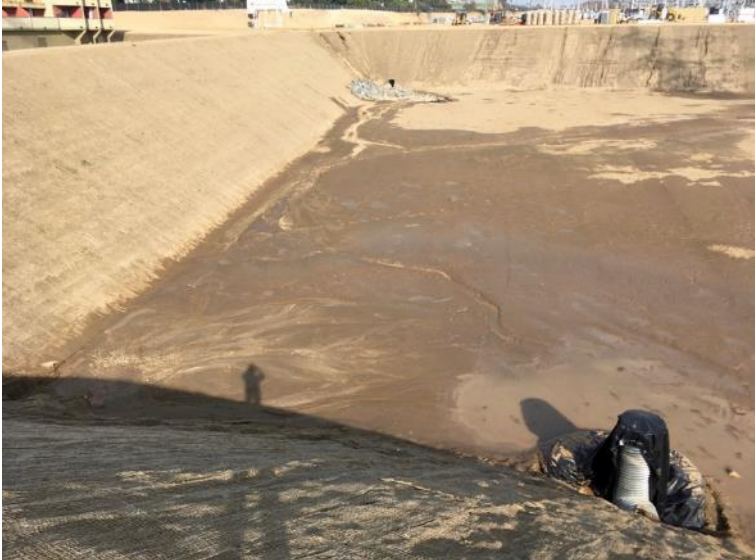
Photo 5 – Large detention basin. Note the overwhelmed visqueen plastic around the standpipe. Photo facing east
12/18/18	Mesa substation

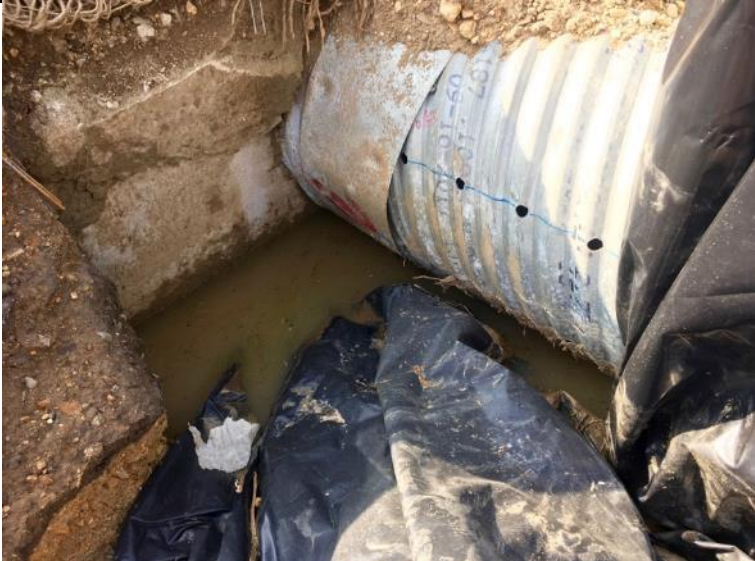
Photo 6 – Close-up of the standpipe drainage system in the detention basin. Note the holes along the bottom of the standpipe that allow sediment-laden water to quickly exit the detention basin via the stormdrain system.
12/18/18	Mesa substation

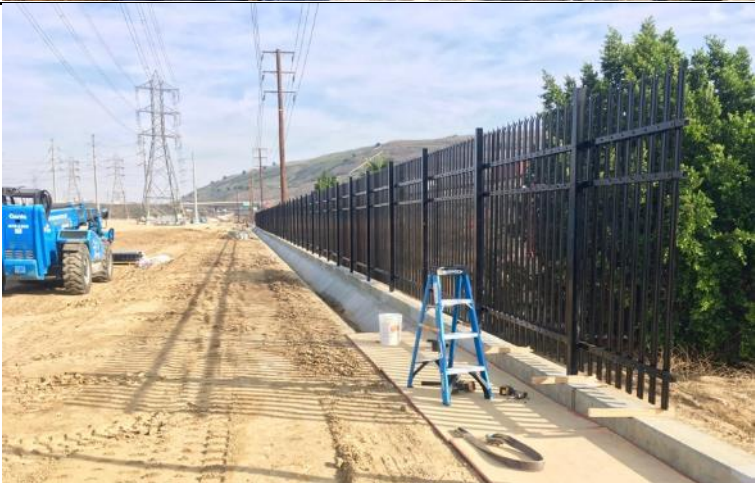
Crews continue work on the southern boundary combo wall. Activities include both foundation work – Photo 8, and fencing installation on top of the wall – Photo 7.

Photo 7 – Fence installation along the southern boundary of the Mesa Substation Site. Photo facing east

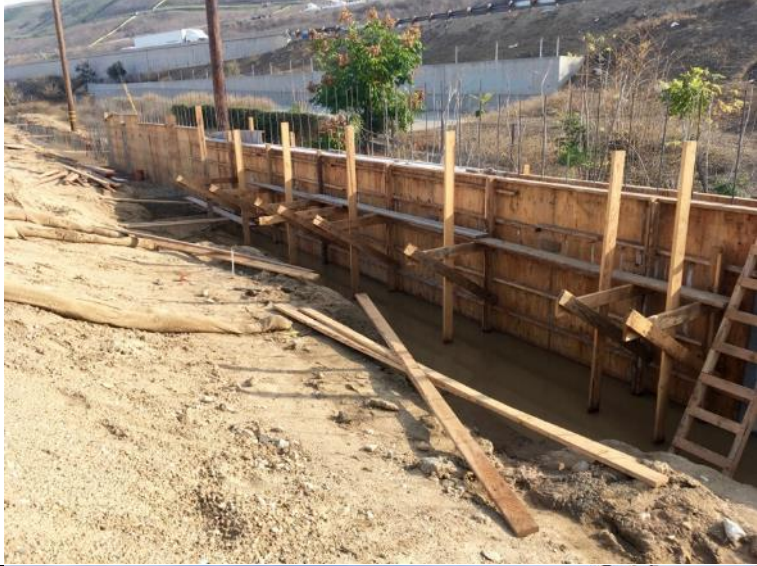
Photo 8 – Foundation wall work along the southern boundary of the Mesa Substation Site. Photo facing southeast
12/18/18	Mesa substation

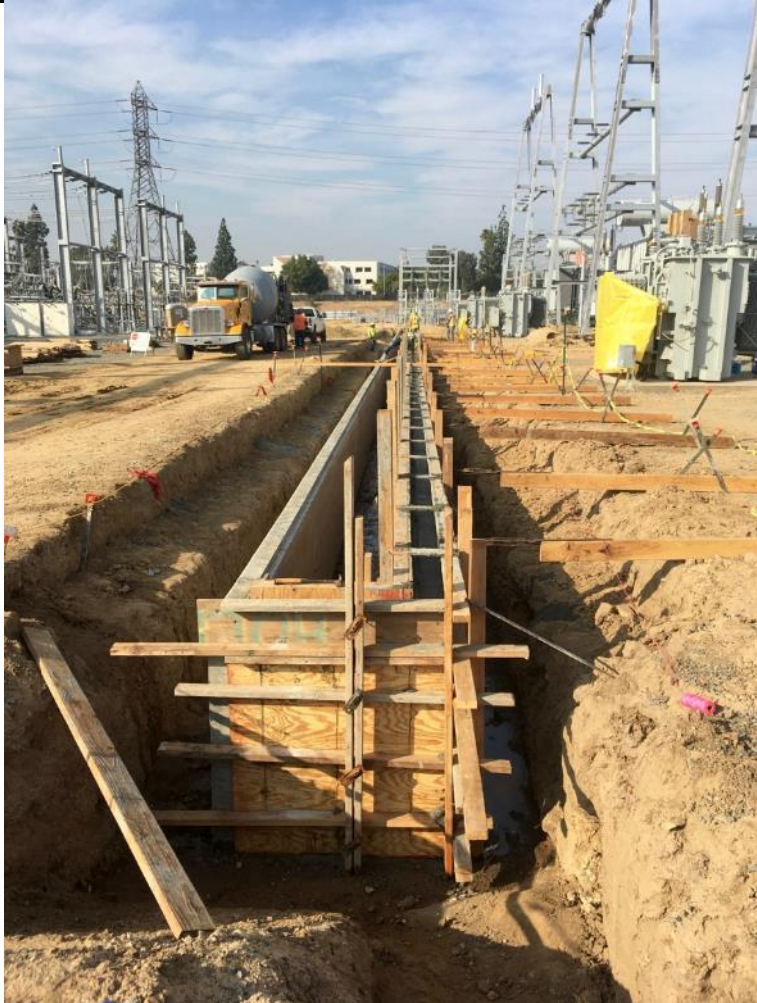
Photo 9 – Concrete slurry in a conduit trench. Photo facing north

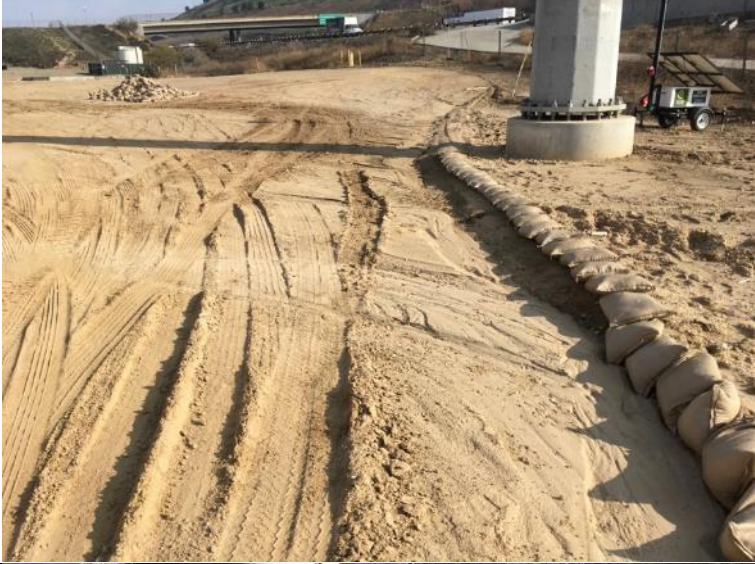
I observed multiple locations where additional BMP installation/maintenance might help site conditions. Sheet flow through the southern portion of the project reaches a small berm lined with gravel bags – Photo 10; this berm should be made larger to accommodate heavy flows. Additionally, it appeared that rainwater runoff from Highway 60 had bypassed the grouted riprap entry site and spilled into the project area – Photo 11; installation of additional gravel bags would help manage this onsite flow. At the end of my site visit I spoke with Lucy Cortez-Johnson (QSP), who said she would talk to the contractor about improving BMPs at these locations.

Photo 10 – Small berm redirecting large amounts of stormwater runoff. Photo facing southeast
12/18/18	Mesa substation

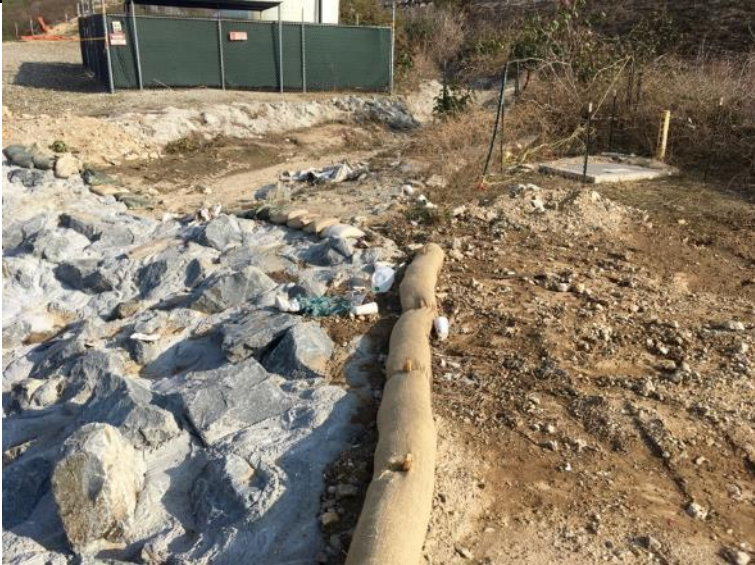
Photo 11 – Rainwater runoff coming off of Highway 60 appears to have bypassed the onsite drainage system due to inadequate BMPs. Photo facing south
12/18/18	Mesa substation

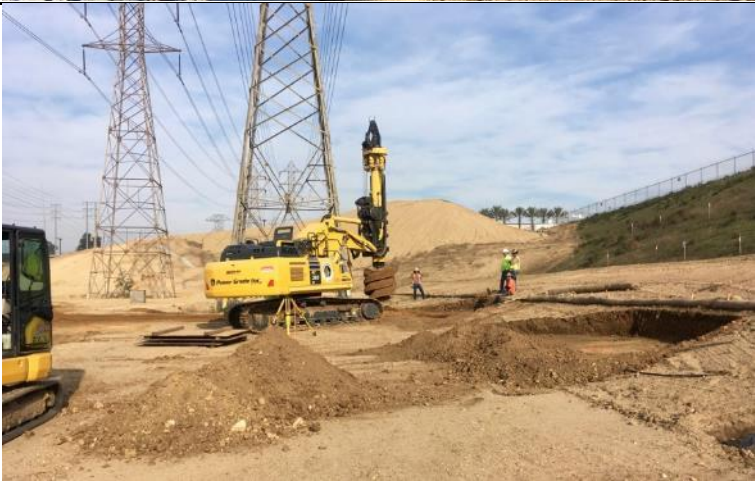
A drilling rig is operating in the southeast corner of the project site drilling foundation holes for four new TSPs to be installed – Photo 12. Linette Davenport (biological monitor, Coastal California Gnatcatcher biologist, Borrego Biological) is monitoring activities in this area, because it is near Coastal California Gnatcatcher habitat. An archaeological monitor is also observing activities in this area.

Photo 12 – Drilling work near Coastal California Gnatcatcher habitat. This work is being monitored by a Coastal California Gnatcatcher biologist. Photo facing east

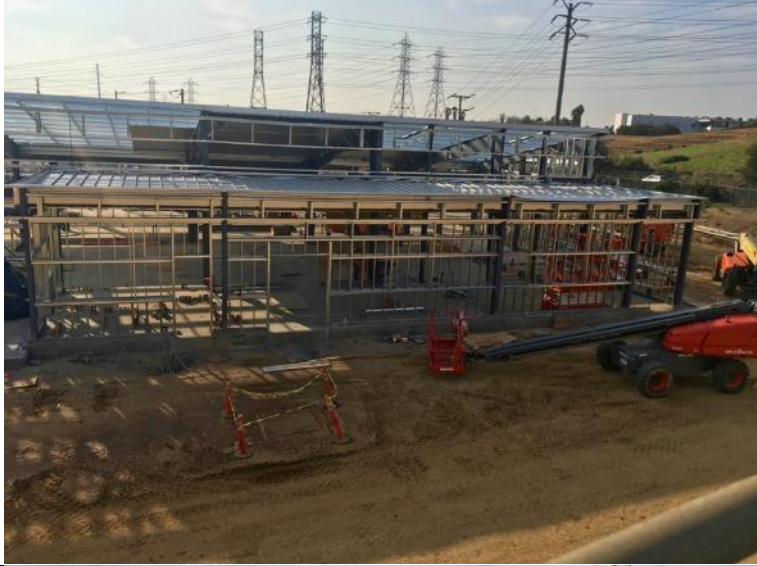
Photo 13 – Work on the Mesa Operations Building continues. Photo facing west
12/18/18	Mesa substation

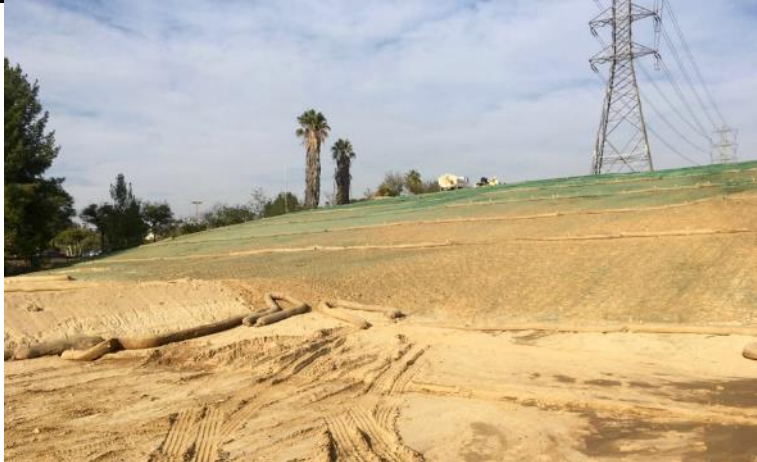
Photo 14 – BMP repairs and hydroseeding north of Potrero Grande Drive within the telecommunications corridor. Photo facing north
