November 14, 2018

Re: Monthly Report Summary #12 for the Mesa 500-kV Substation Project

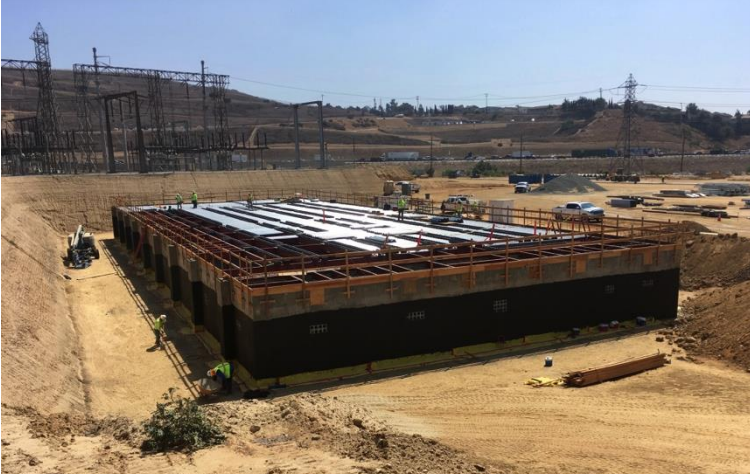
Photo 1 – The Sr. MEER first floor installation. Photo facing south
9/05/18	Mesa substation

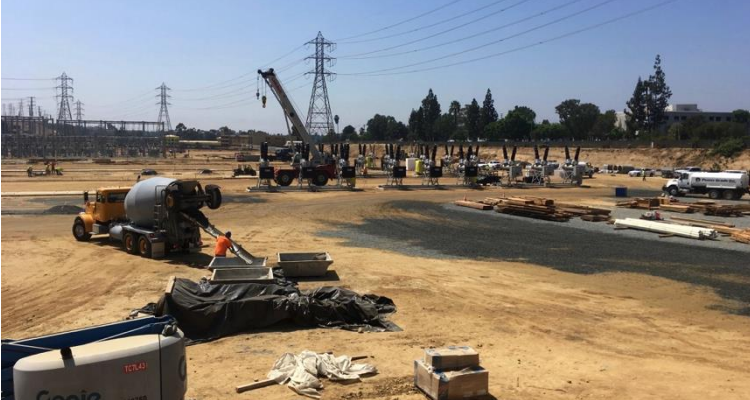
Photo 2 – Concrete trucks washing out in approved bins. Photo facing west
9/05/18	Mesa substation

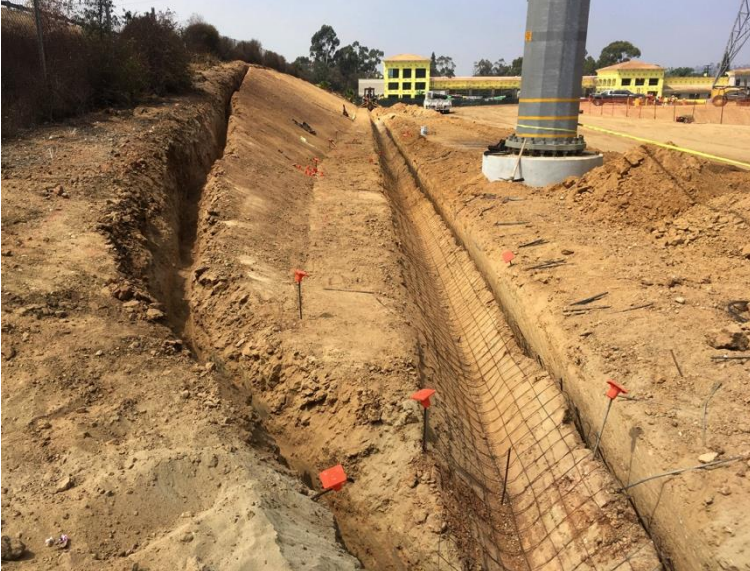
Photo 3 – Excavation for a “V” ditches along the southern border of the project. Photo facing west

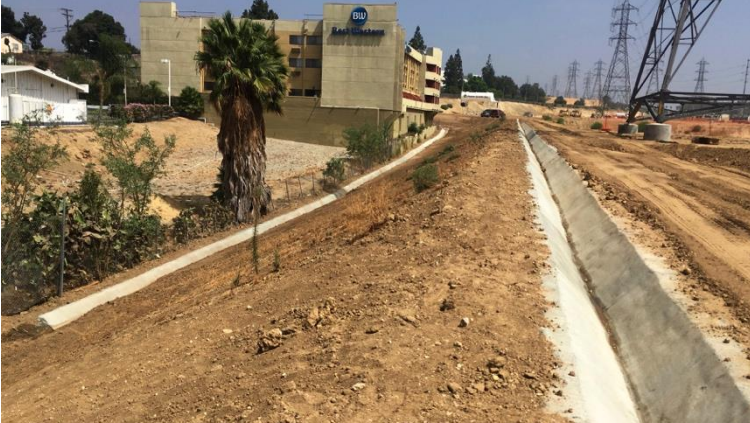
Photo 4 – Newly poured “V” ditches along the northern border of the project site. Photo facing east
9/05/18	Mesa substation

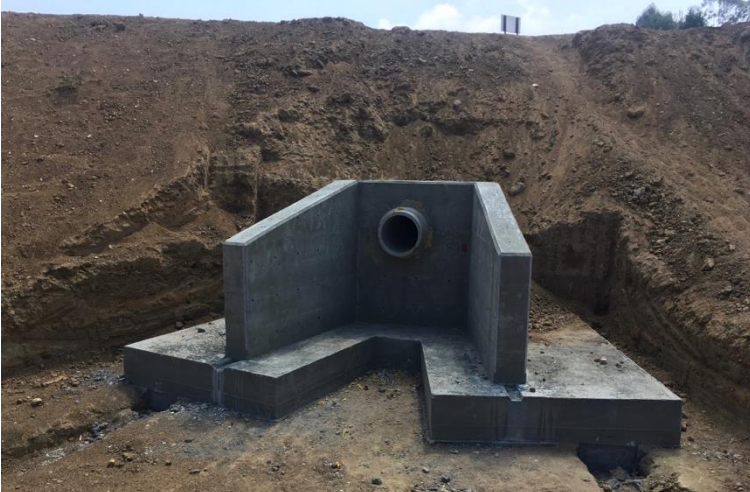
Photo 5 – Concrete drain inlet for the Markland storm drain lateral line.
9/05/18	Mesa substation

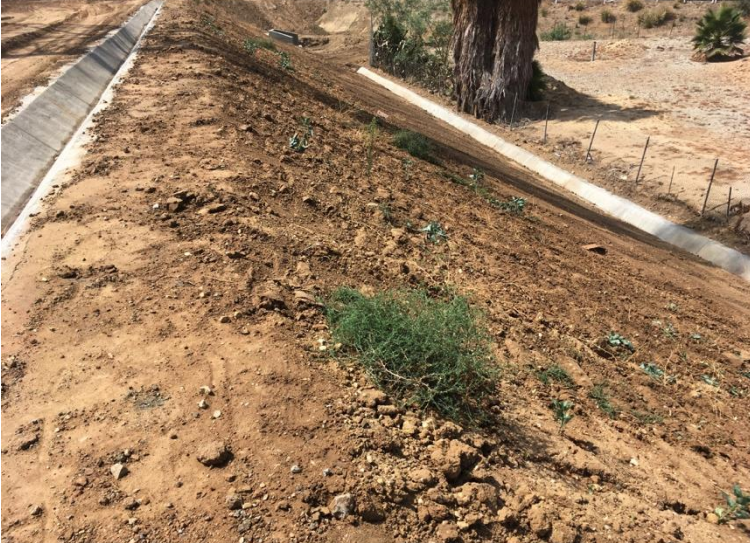
Photo 6 – Weedy vegetation track rolled into the slope. Photo facing west

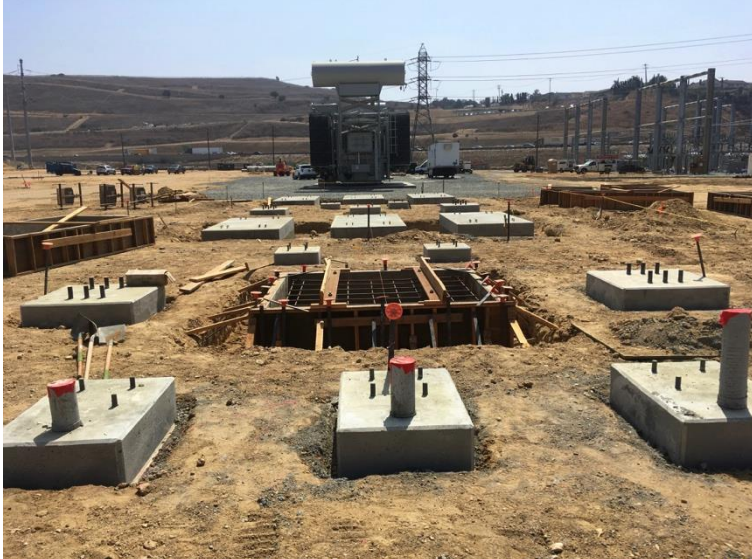
At the 66-kV and 220-kV racks, foundations continued to be dug, formed, and poured– Photos 7 & 9. Aboveground installation work continued within the 66Kv rack area – Photo 10.

Photo 7 – Foundations continue to be excavated, formed and poured. Photo facing south
9/05/18	Mesa Substation

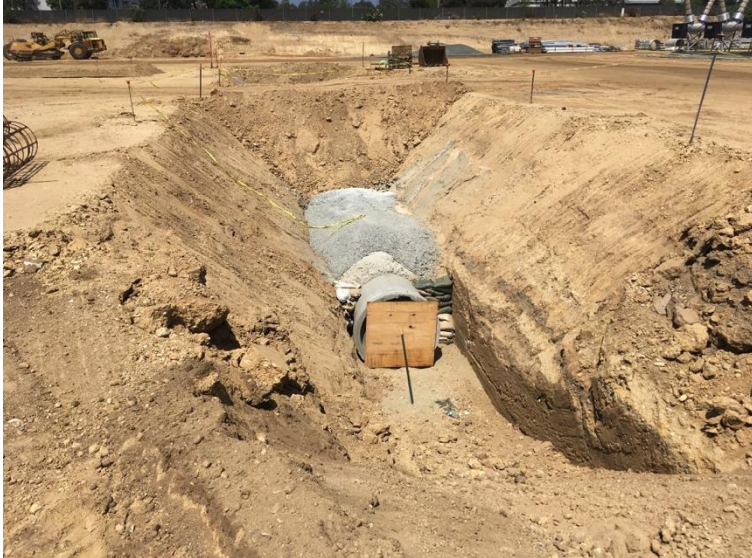
Photo 8 – Various locations of the storm drain system remain open.
9/05/18	Mesa Substation

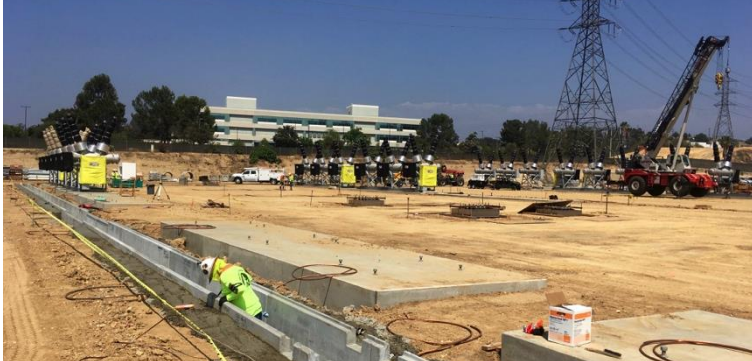
Photo 9 – 220Kv rack area. Photo facing north

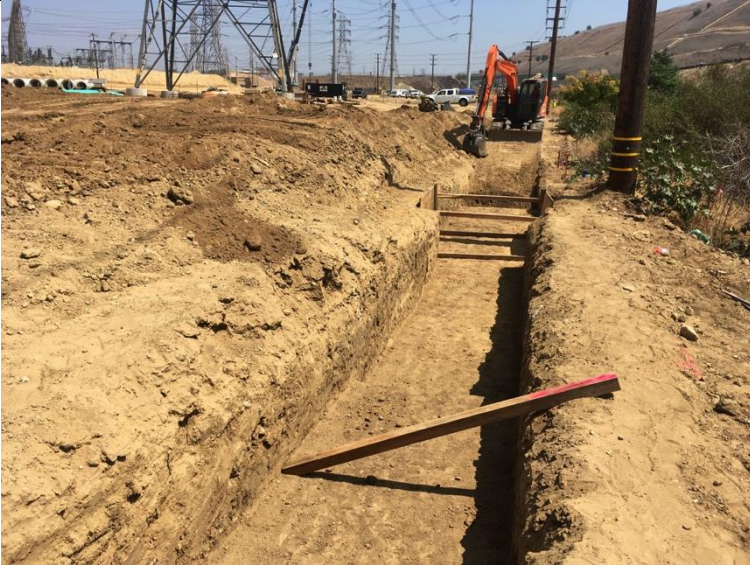
Excavation for the border wall foundation was underway. The wall will be extended along the southern edge of the project site – Photo 11. Escape ramps had been placed in the excavation (MM BR-10).

Photo 11 – Trench for border wall foundation being dug. Photo facing north
9/05/18	Mesa Substation

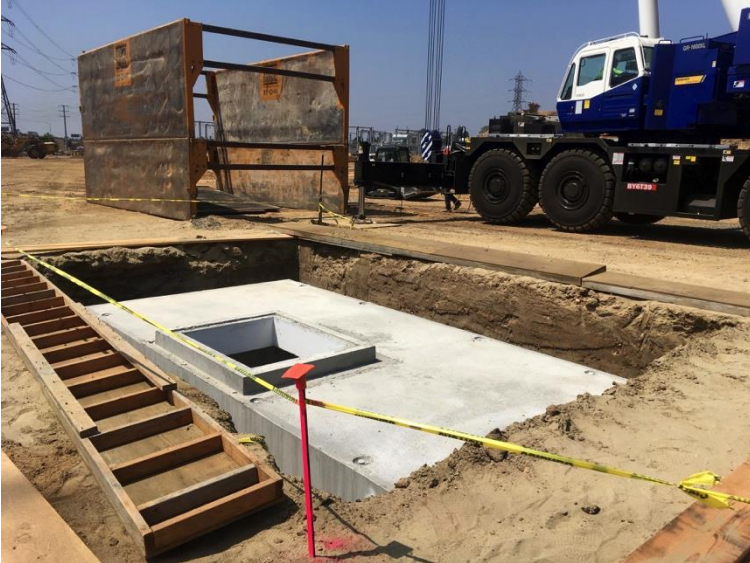
Photo 12 – Newly installed conduit vault with the shoring removed.

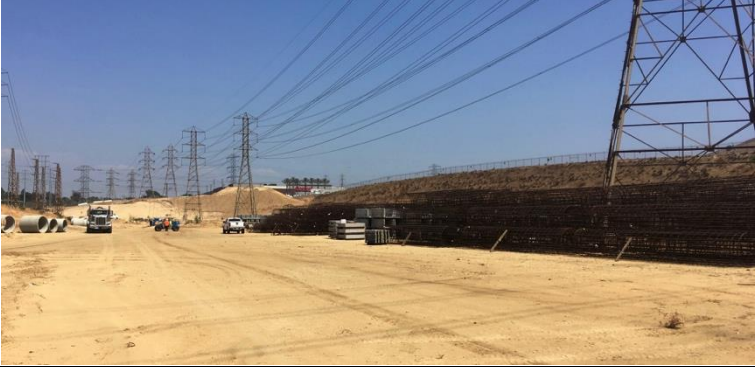
<p>Photo 13 – Numerous rebar cages stockpiled onsite near the southeast corner of the project site. Photo facing east</p>
9/05/18	Mesa substation

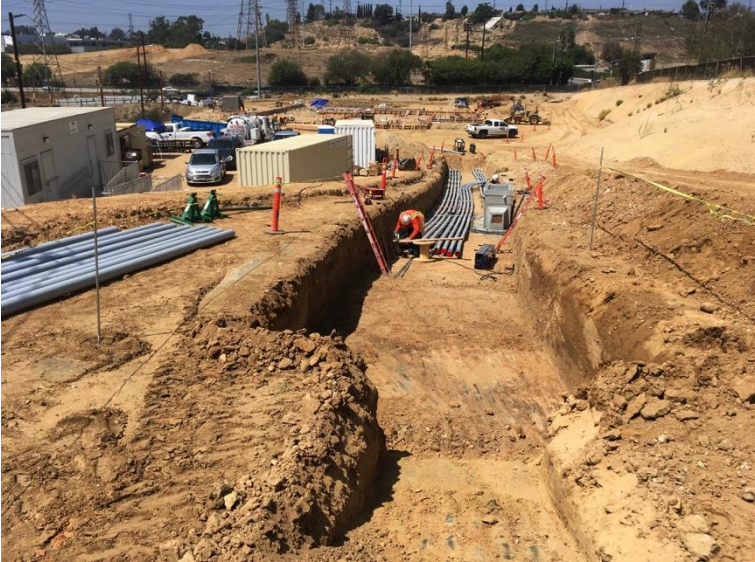
<p>Photo 14 – Conduit work continues within the Mesa Operation Building area. Photo facing north</p>
9/05/18	Mesa substation

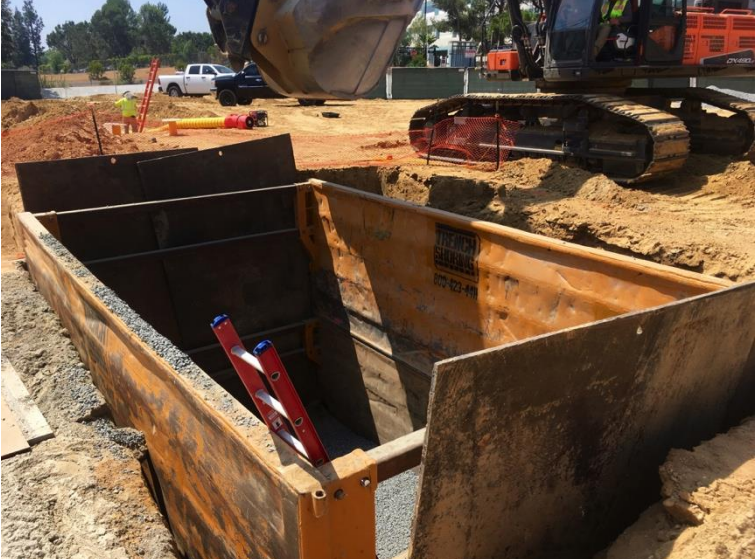
<p>Photo 15 – Conduit vault excavation continues north of Potrero Grande. Photo facing west</p>

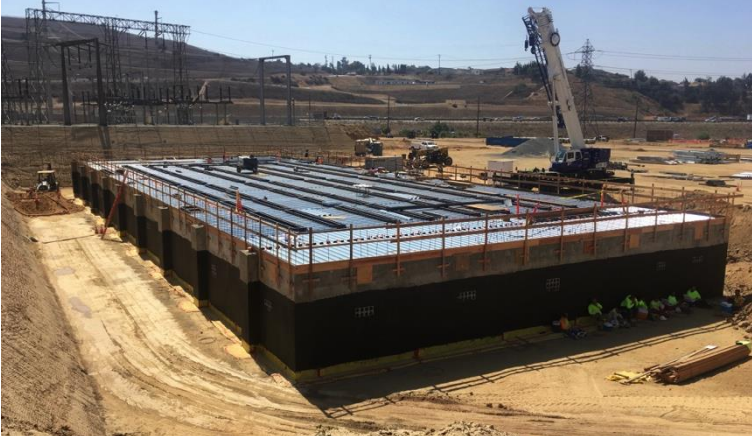
Photo 1 – The Sr. MEER first floor installation. Photo facing south
9/12/18	Mesa substation

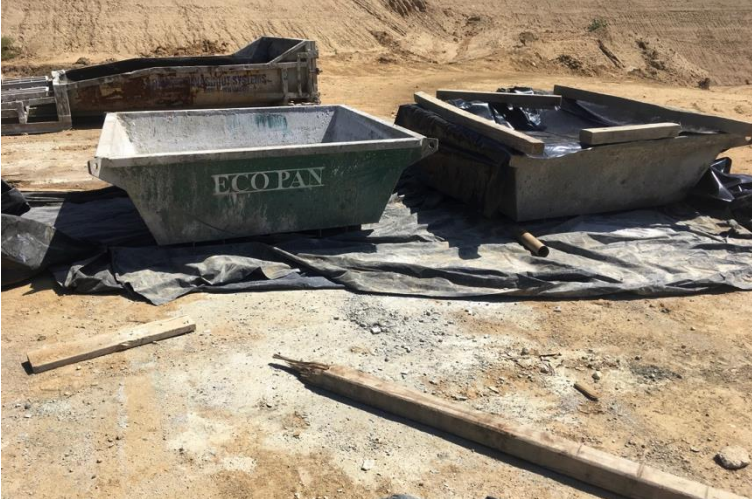
Photo 2 – Concrete trucks mostly washing out in approved bins. Photo facing west

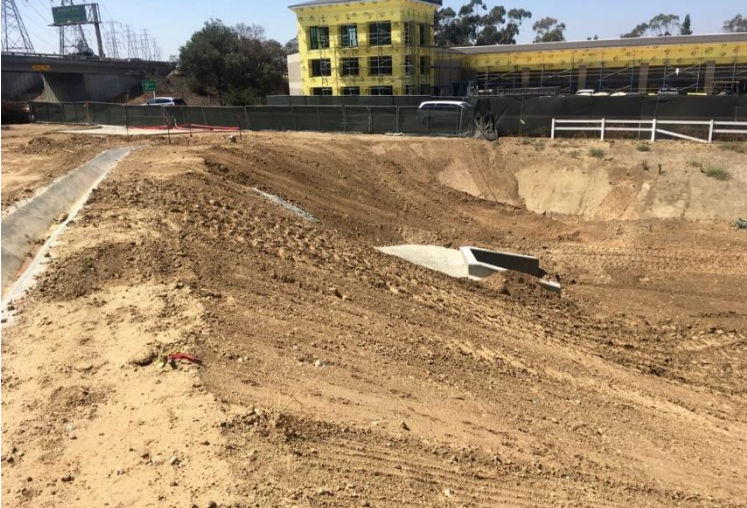
Photo 5 – Concrete drain inlet for the Markland storm drain lateral line has been backfilled. Photo facing west
9/12/18	Mesa substation

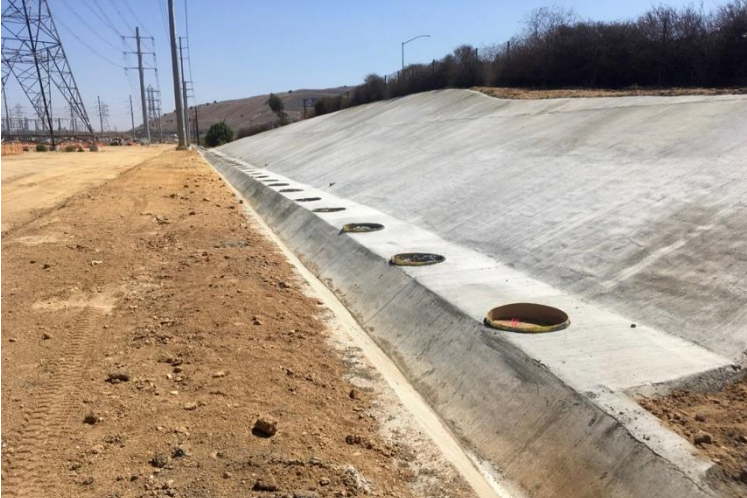
Photo 6 – Concrete slurry poured on a short steep slope near the southwestern portion of the project site. Photo facing east
9/12/18	Mesa substation

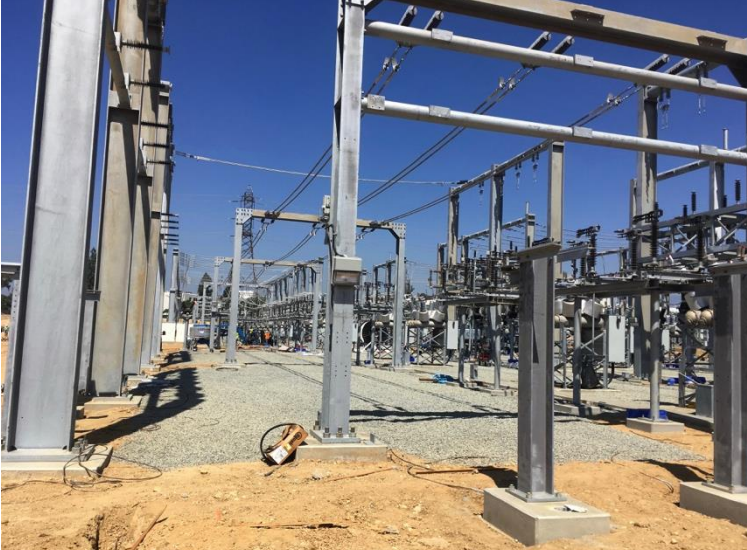
Photo 7 – Work within the 66 and 220Kv rack areas. Photo facing north

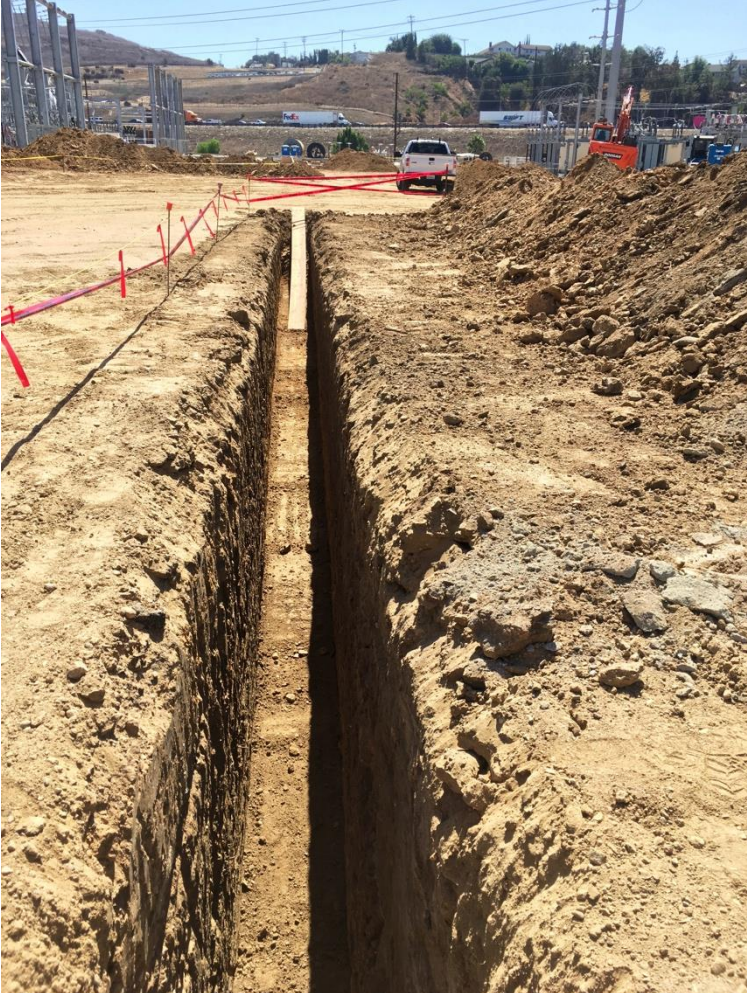
Photo 4 – Conduit trench near the 66Kv rack area. Photo facing south
9/19/18	Mesa substation

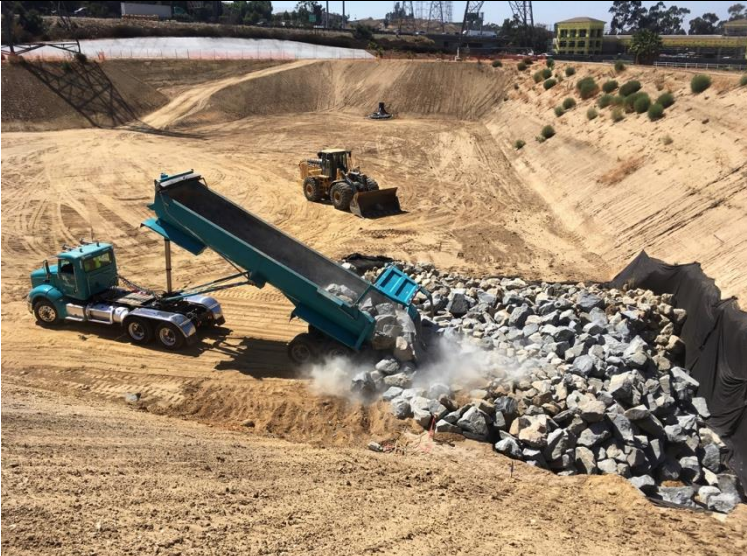
Photo 5 – Riprap being brought into the detention basin. Photo facing west

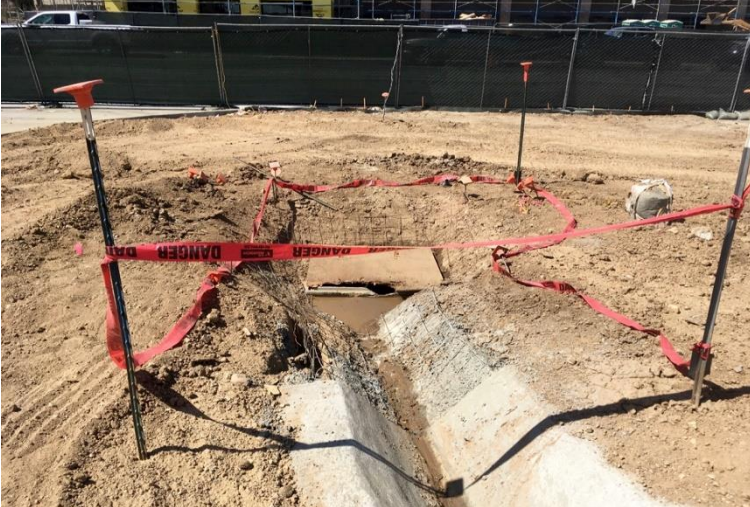
Photo 6 – “V” ditch work near the Markland road area. Photo facing west
9/19/18	Mesa substation

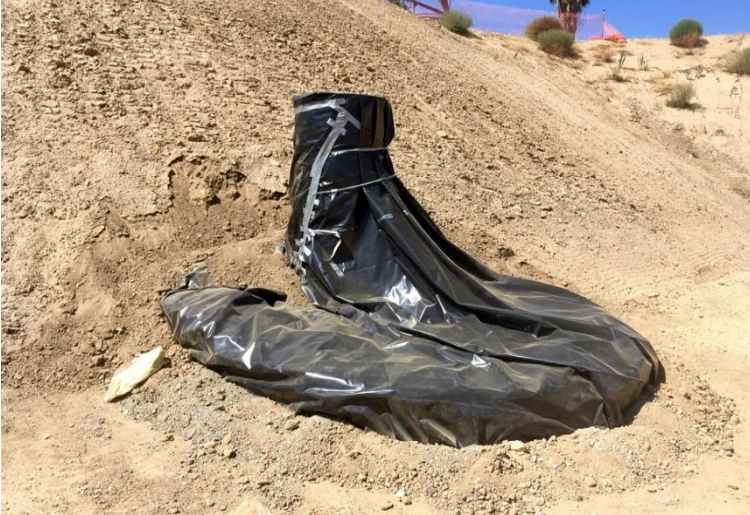
Photo 7 – Detention basin standpipe wrapped in plastic.
9/19/18	Mesa Substation

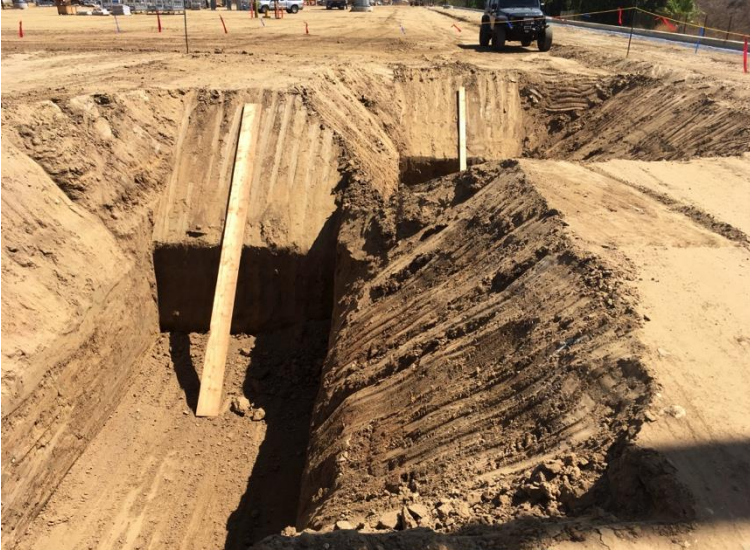
Matt Daniele and I observed the vault excavations, which had escape ramps installed – Photo 8. He said he noticed a rabbit in one of the vault excavations early one morning recently, but it was able to escape easily upon his approach. We discussed the variety of wooden escape ramps throughout the site and the need for the escape ramps to be more effective than some we were observing – Photo 10. Conduit vaults were being poured at several locations – Photo 11.

Photo 8 – Vault excavations with escape ramps. Photo facing east

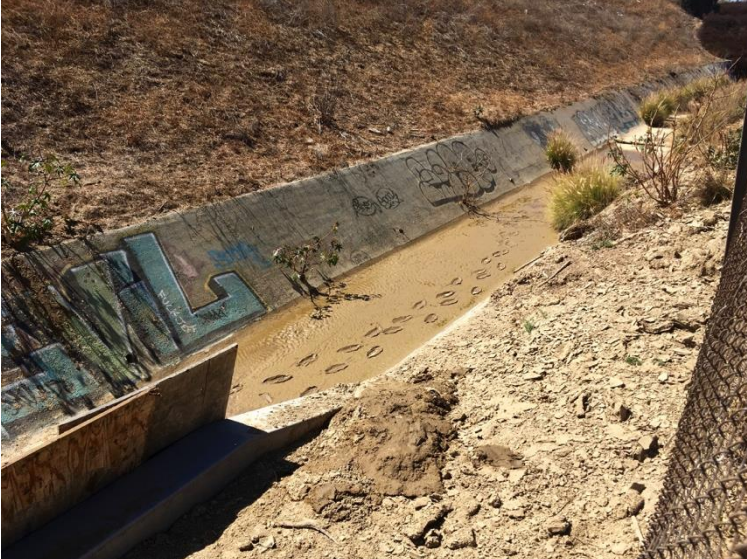
Matt and I observed the sediment deposited in the offsite drainage culvert – Photo 9. This came from the ponded area around the Marketplace outlet. The water was pumped into the new storm drain system that drains into the offsite culvert. Matt said they would ensure the sediment is removed. Work had begun on connecting the offsite inflow with the new storm drain system, which would eliminate future accumulation of sediment – Photos 15 & 16.

Photo 9 – Muddy sediment captured in the offsite drainage channel. Photo facing west
9/19/18	Mesa Substation

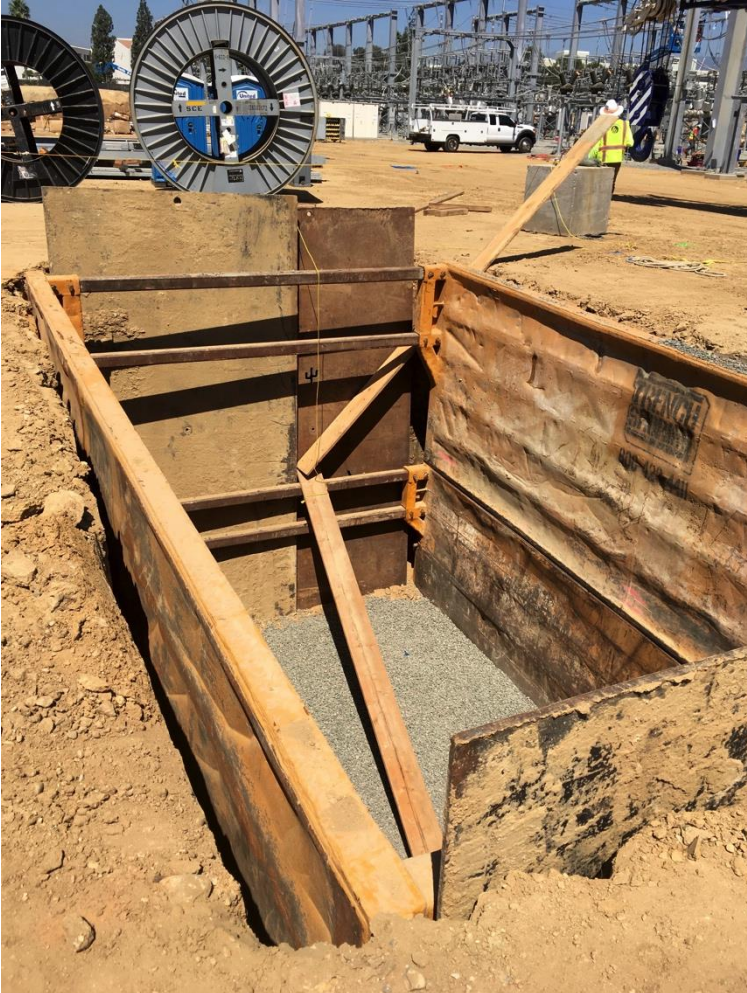
Photo 10 – Vault holes with shoring and a form of escape ramp. Photo facing north

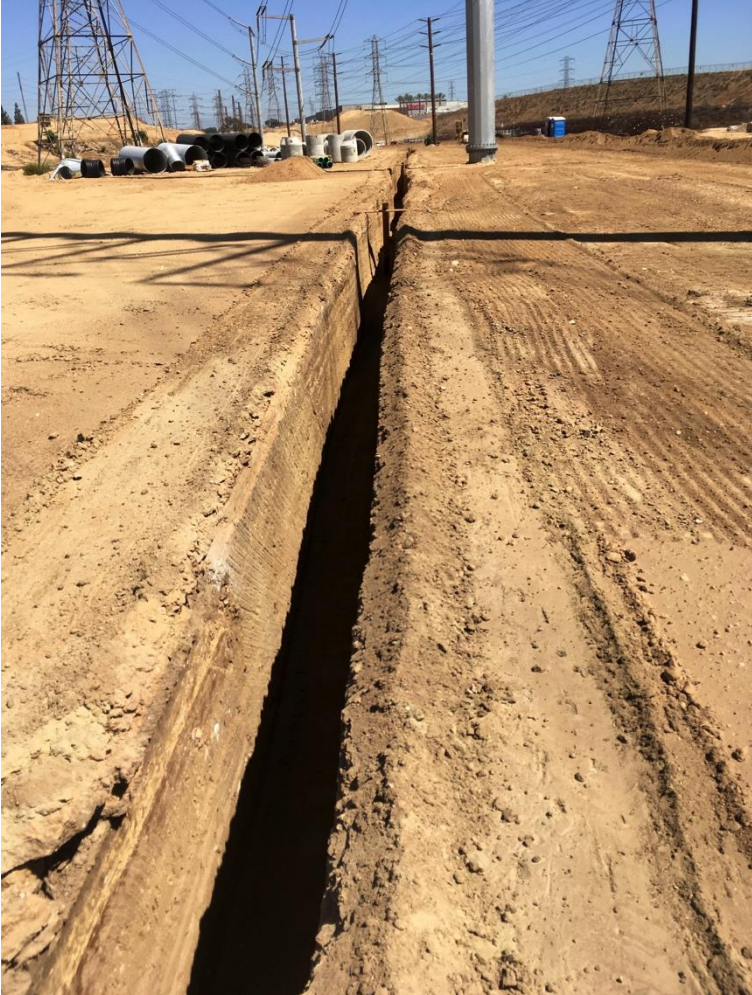
Photo 14 – Conduit trench with climbing boards. Photo facing east
9/19/18	Mesa Substation

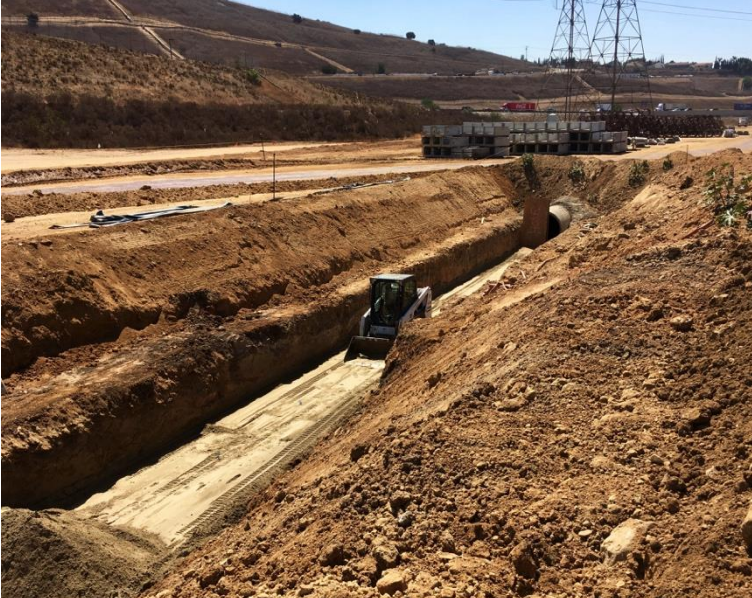
Photo 15 – Storm drain work near the southeast portion of the project. Photo facing southwest

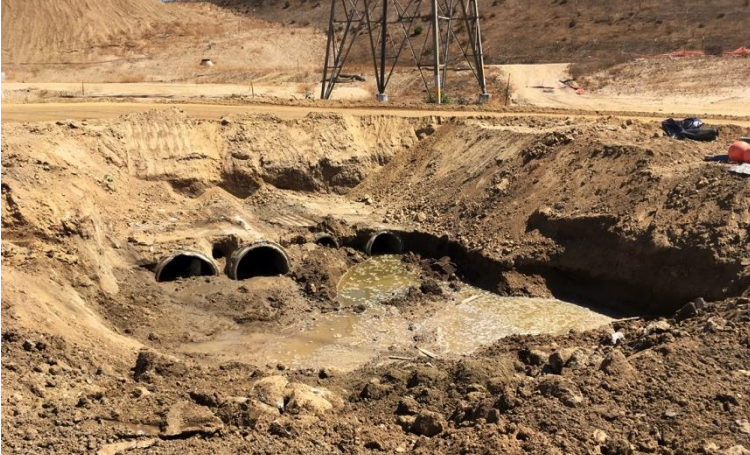
Photo 16 – Marketplace drain outlets.
9/19/18	Mesa Substation

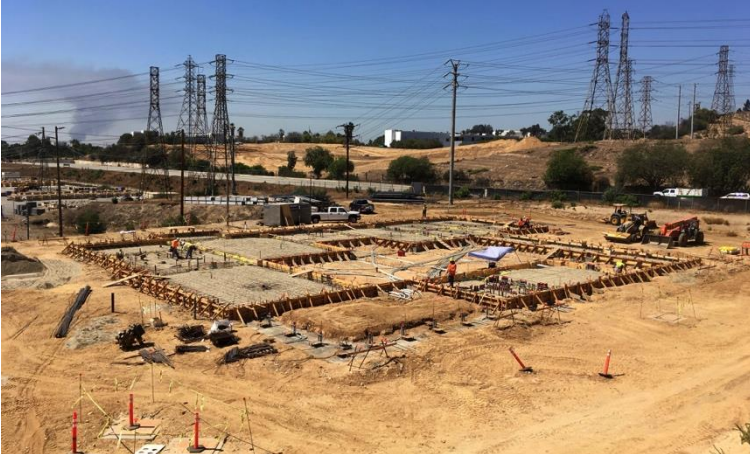
Photo 17 – Mesa Operations Building work. Photo facing northwest
9/19/18	Mesa Substation

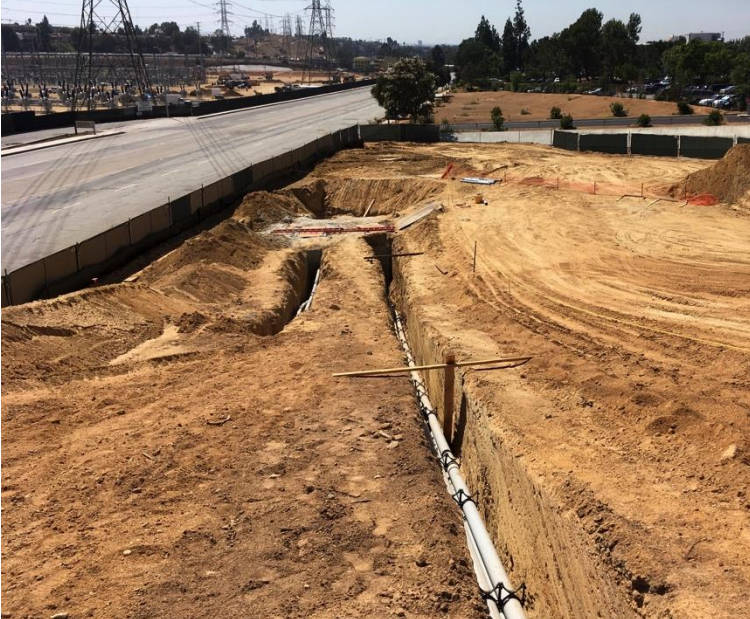
Photo 18 – Conduit installation north of Potrero Grande. Photo facing southwest

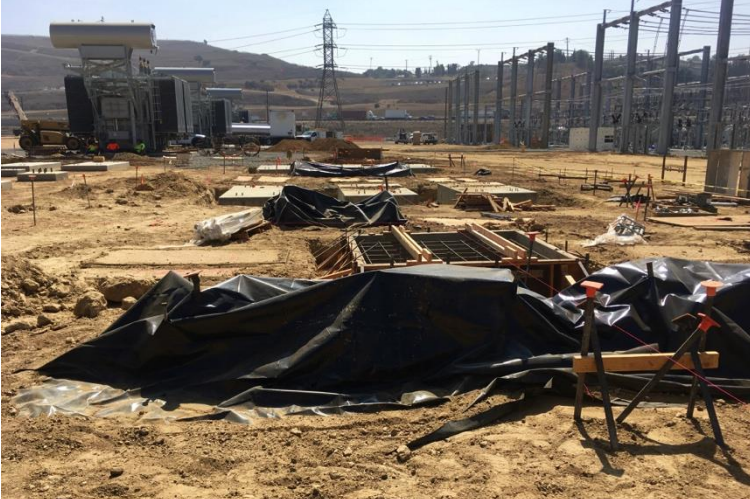
Photo 3 – Excavations for foundations continues. Photo facing south
9/26/18	Mesa substation

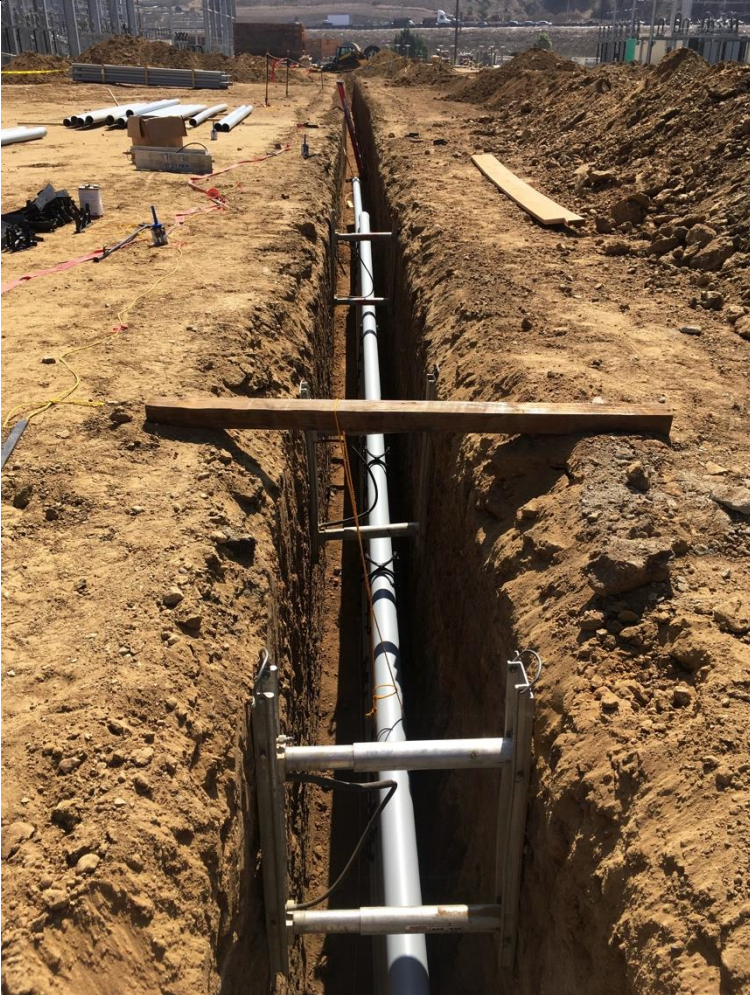
Photo 4 – Conduit trench near the 66Kv rack area. Photo facing south

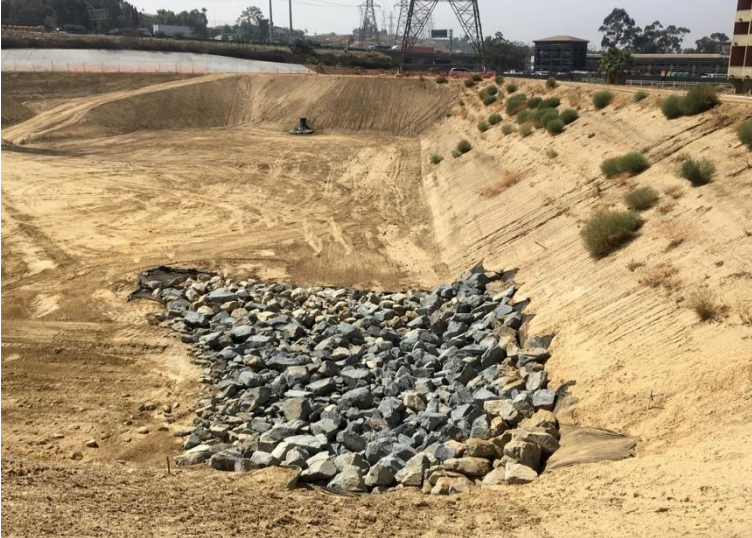
Photo 5 – Riprap work looks to be done in the detention basin. Photo facing west
9/26/18	Mesa substation

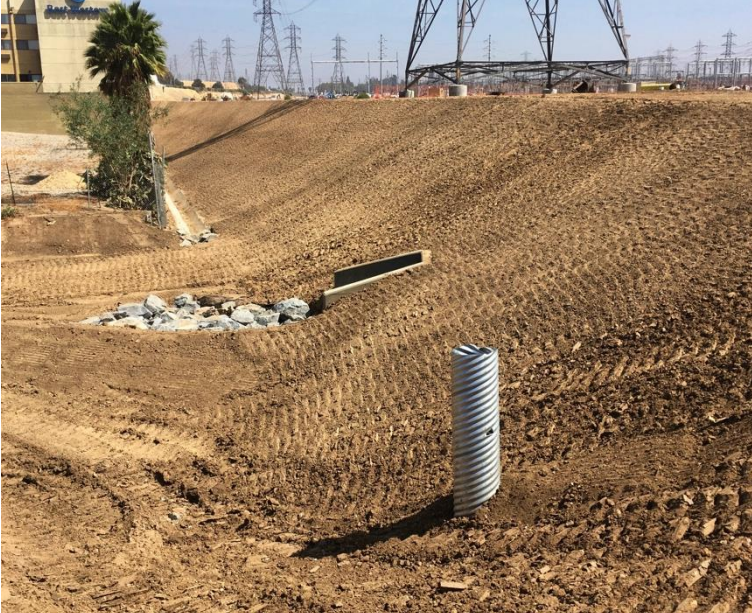
Photo 6 – Drainage system work near the Markland road area. Photo facing east
9/26/18	Mesa substation

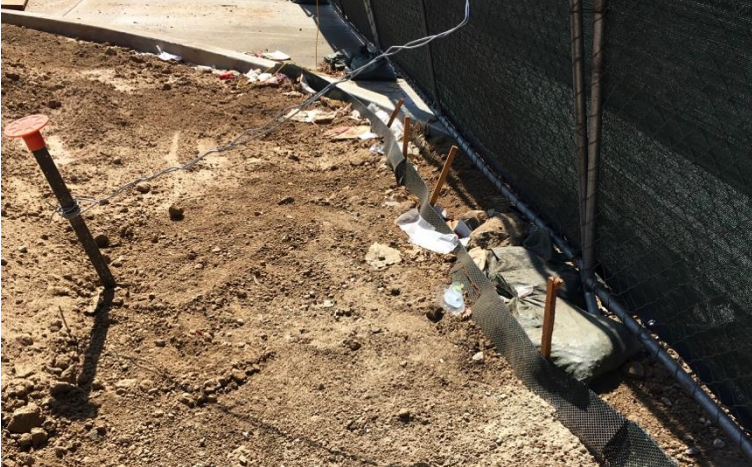
Photo 7 – BMPs and trash along the Markland road border fence.

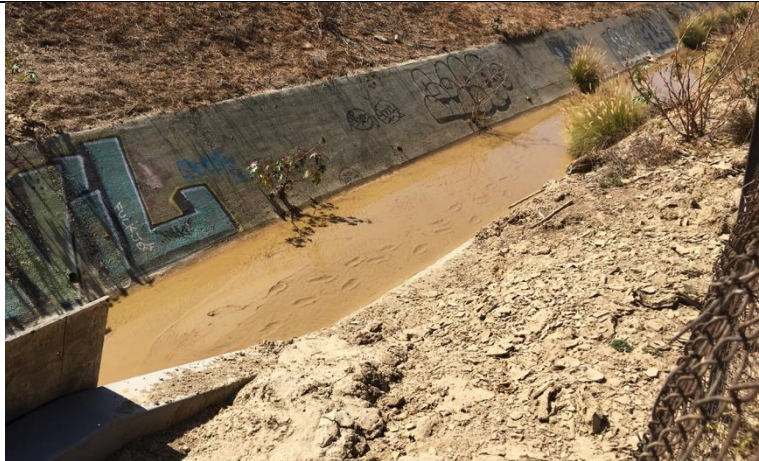
The sediment was still present in the offsite drainage culvert and water had continued to be pumped into the system – Photo 8. Power Grade crews were installing the drainpipe to connect the onsite system to the pipe extending from the offsite Marketplace development – Photos 14 & 15. I recommended to foreman Willie Clark (Power Grade) that sediment-laden water should not be released into the storm drain system.

Photo 8 – Muddy sediment remains in the offsite drainage channel.
9/26/18	Mesa Substation

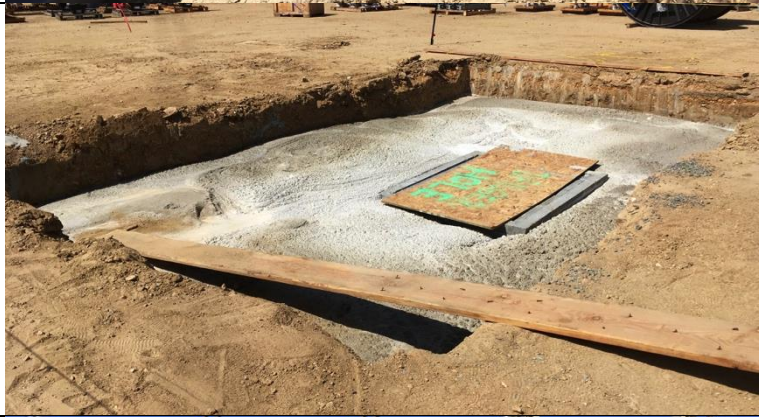
Photo 9 – Conduit vaults recently poured.
9/26/18	Mesa Substation

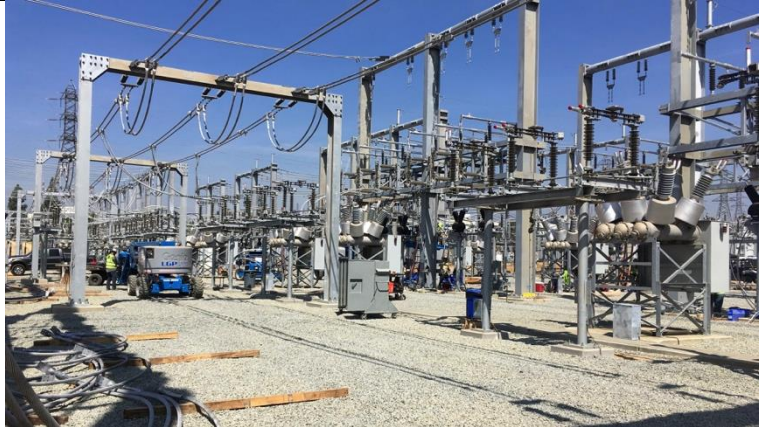
Photo 10 – Installation activity within the 66Kv rack area. Photo facing north

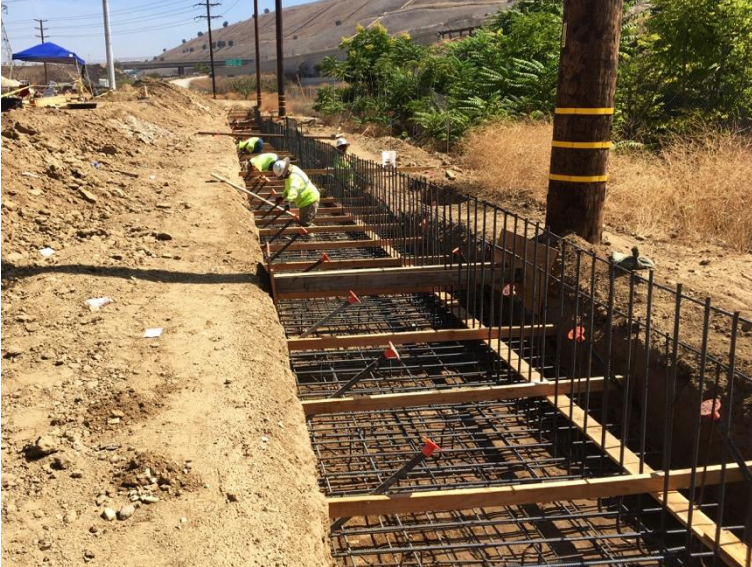
<p>Photo 11 – Rebar installation for the “Combo” wall foundation continues along the southern property boundary. Photo facing east</p>
9/26/18	Mesa Substation

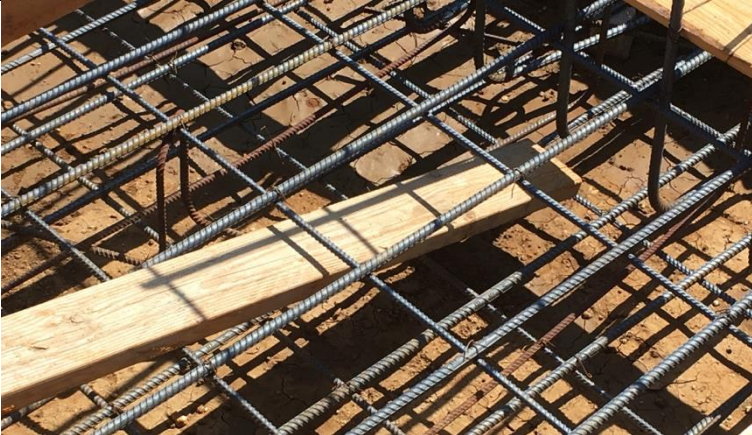
Rebar installation continued in the “combo wall” foundation excavation along the southern border of the project site – Photo 11. Some of the wooden escape ramps were not installed correctly. The wood must reach the ground for animals to be able to climb up and out – Photo 12. I discussed this issue, and the sediment in the storm drain, with lead biological monitor Matt Daniele (ICF). I also asked whether there was a paleontological monitor onsite, and he confirmed that one was (Bobby Ebelhar, PaleoSolutions). Bobby was spot-checking the excavation work at the western end of the old substation – Photo 13.

<p>Photo 12 – Poorly installed wooden escape ramps – they need to reach the ground.</p>
9/26/18	Mesa substation

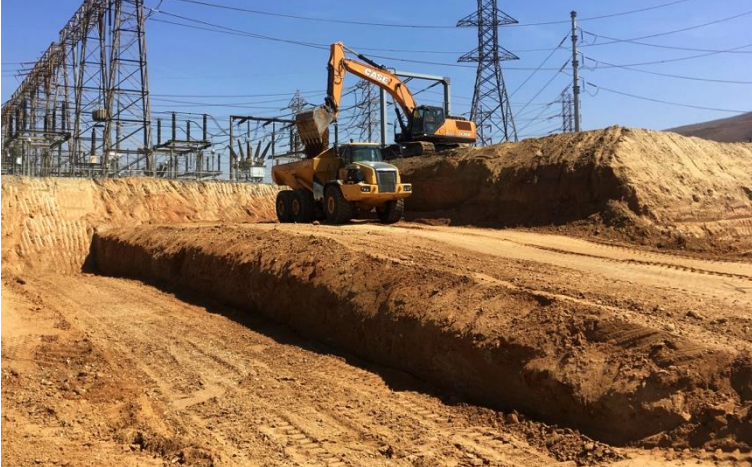
<p>Photo 13 – Excavator removing dirt from west of the old substation. Photo facing east</p>

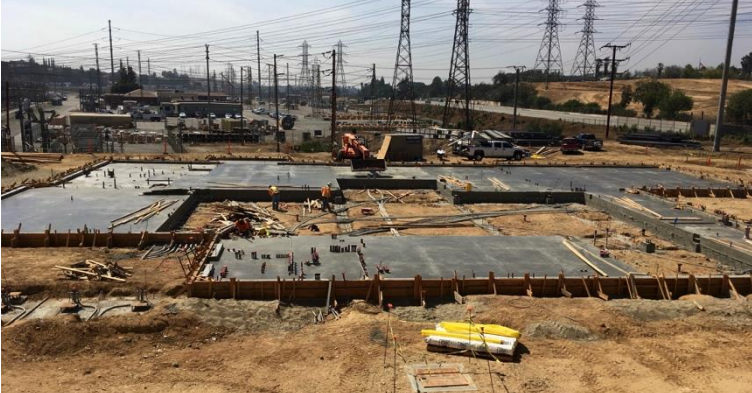
A concrete washout bin located along the eastern access was full and leaking – Photo 16, likely because the Mesa Operations Building floors had recently been poured – Photo 17.

Photo 17 – Mesa Operations Building work. Photo facing west
9/26/18	Mesa Substation

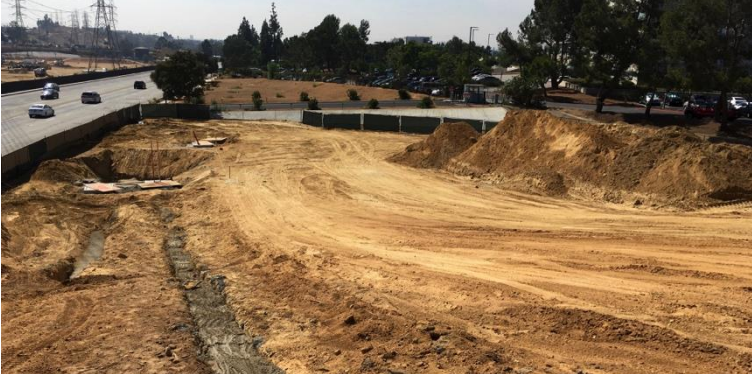
Photo 18 – Conduit and conduit vault installation north of Potrero Grande. Photo facing west
