Re: Monthly Report Summary #23 for the Mesa 500-kV Substation Project

This report provides a summary of the compliance monitoring activities that occurred during the period from **August 1 to 31, 2019**, for the Mesa 500-kilovolt (kV) Substation (Mesa Substation) Project in Los Angeles County, California. Compliance monitoring was performed to ensure that all project-related activities conducted by Southern California Edison (SCE) and their contractors comply with the requirements of the Final Environmental Impact Report (Final EIR) for the Mesa Substation Project, as adopted by the California Public Utilities Commission (CPUC) on February 9, 2017.

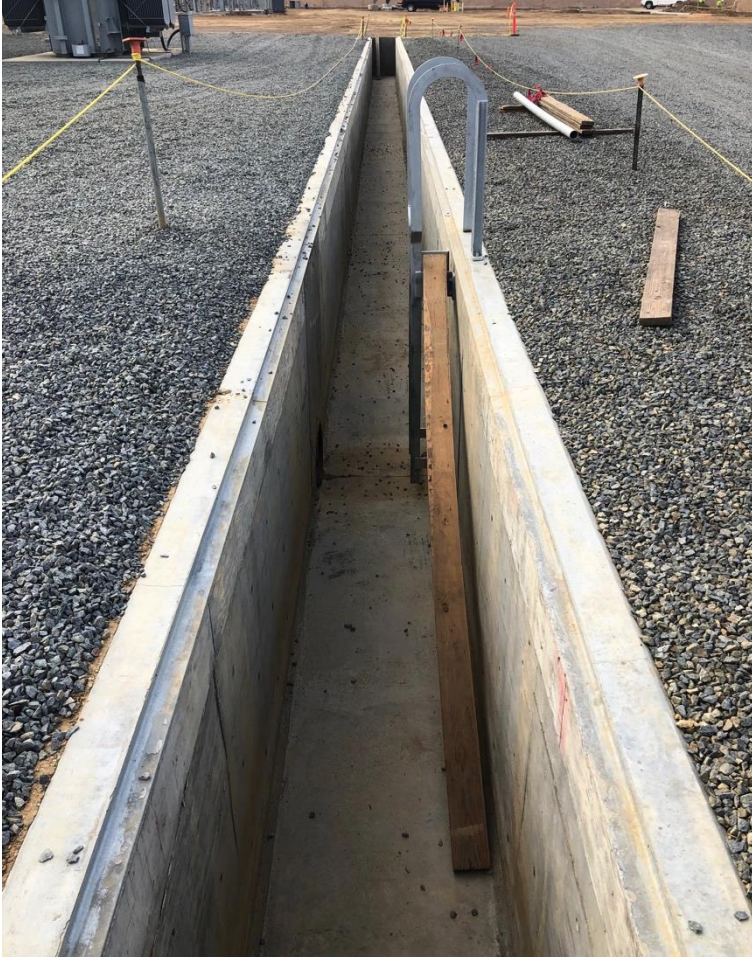
Long cable channels were open at the switchrack areas; all had climbing structures inside and are inspected every morning for entrapped animals – Photo 8. The extra containment system remained in place within the 16-kV switchrack and appeared to be in good condition – Photo 9.

Photo 8 – Concrete lined cable trench – note the climbing structures. Photo facing south.

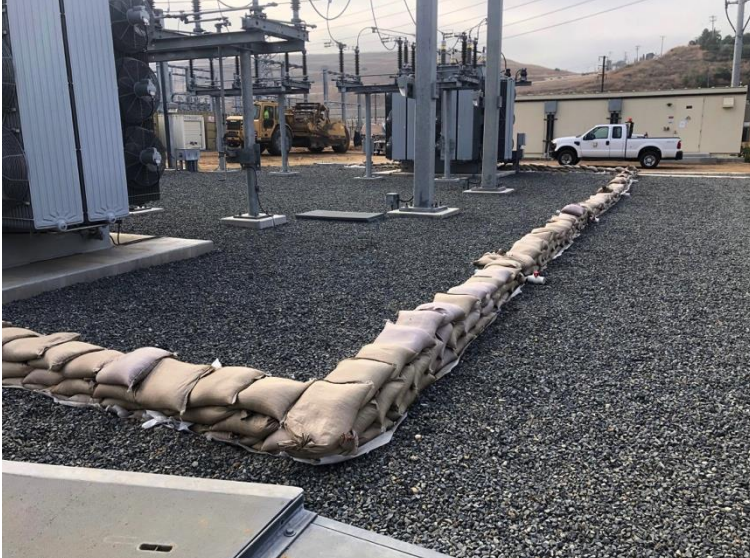
Photo 9 – Containment berm within the 16-kV switchrack area. Photo facing south.
8/07/19	Mesa Substation

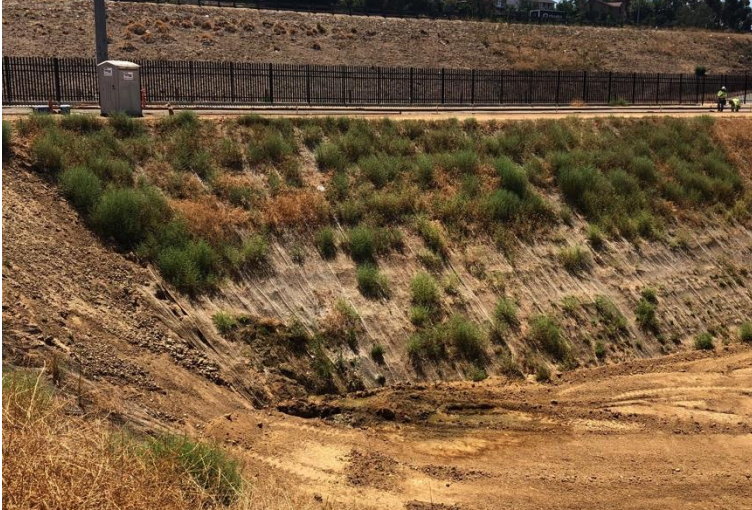
- On August 7, 15, 2019, the CPUC Compliance Monitor noted Russian thistle growing on both walls and at the bottom of the large detention basin and ponded water at the base of a slope in the detention basin. The CPUC Compliance Monitor recommended removing the Weeds prior to the rainy season and removing the ponded water to eliminate potential vector issues.
- On August 22, 2019, the CPUC Compliance Monitor noted a significant amount of settled sediment near the standpipe inlet at the small triangular retention basin. The CPUC Compliance Monitor recommended removing the sediment prior to the next rainy season.
- On August 27, 2019, the CPUC Compliance Monitor noted several old, broken drip pans throughout the project site. Replacing the broken drip pans was recommended.

Photo 5 – Northeast corner of the detention basin, note Russian thistle and a wet area at the base of the slope. Photo facing south.
8/15/19	Mesa Substation

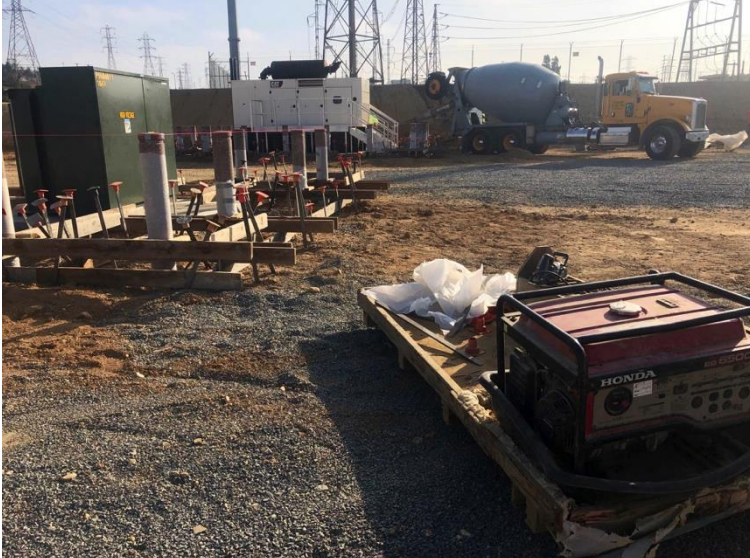
<p>Photo 1 – Concrete pour around protection barriers was being completed near the Senior MEER – note the gas generator is well contained. Photo facing east.</p>
8/22/19	Mesa Substation

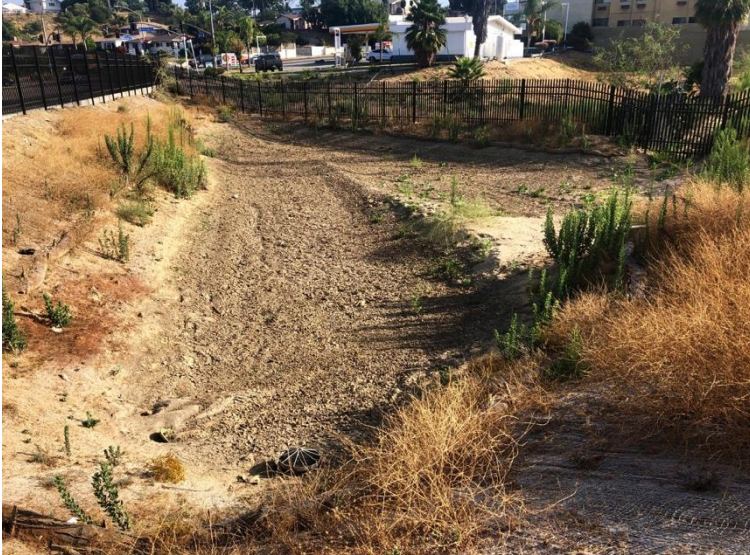
I traveled to the small triangular retention basin located at the western end of the project site and I noted that the captured sediment had filled up the basin very close to the standpipe inlet – Photo 6. This material needed to be dug out of this basin before the next rainy season.

Photo 6 – Triangular retention basin was nearly filled with sediment. Photo facing north.

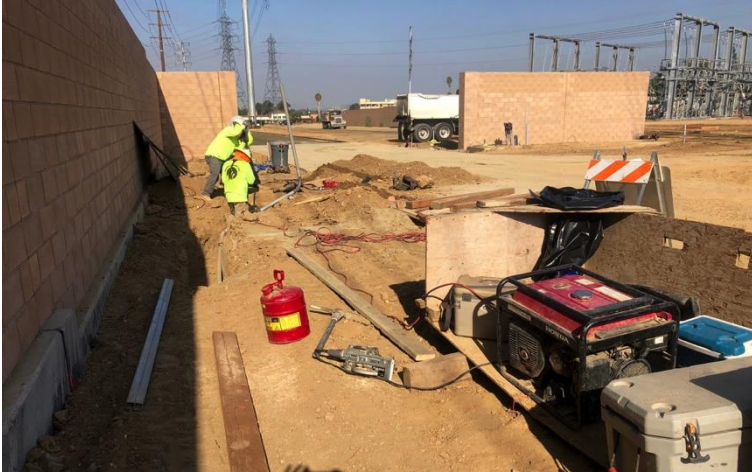
<p>Photo 10 – Crew working along the southern boundary wall without a drip pan under the gas generator. The gas can is also not contained. Photo facing west.</p>
8/22/19	Mesa Substation

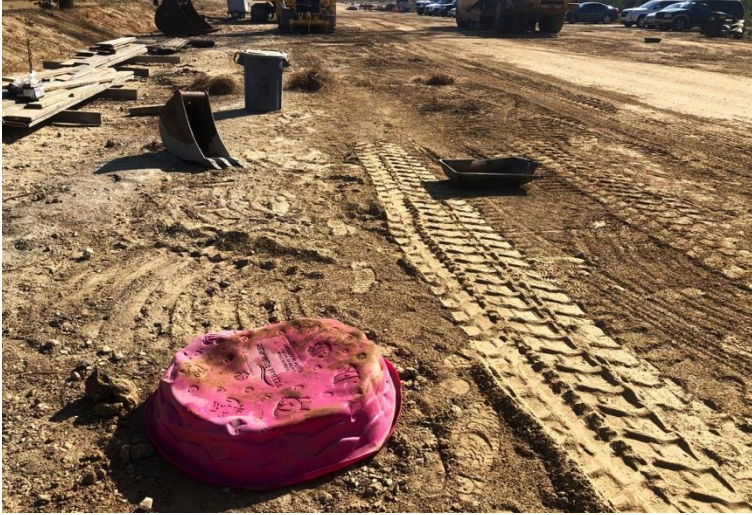
I walked through the equipment parking area and noted the following broken and flipped over drip pans – Photo 11; spilled oil from drip pans – Photo 12; and parked equipment without any drip pans – Photo 13. As I was inspecting this area, safety lead Craig Pernot from Power Grade, arrived to clean the oil spill. I spoke to Project Coordinator Pete Lubich (ULM Services, Inc.) and biological monitor Matt Daniele (ICF) about the drip pan issues throughout the project site.

<p>Photo 11 – Broken and overturned drip pans. Photo facing east.</p>

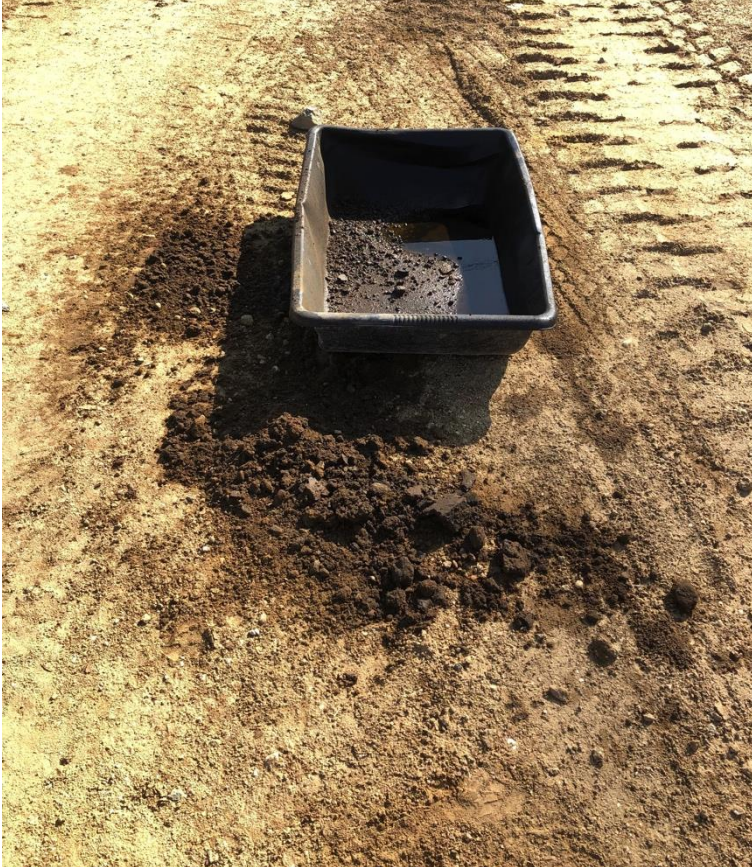
A black plastic drip pan is shown on a dirt surface. The pan contains a dark, thick, spilled substance, likely oil or hydraulic fluid. The surrounding ground is dry and dusty, with some tire tracks visible.	Photo 12 – Spilled drip pan.
8/22/19	Mesa Substation

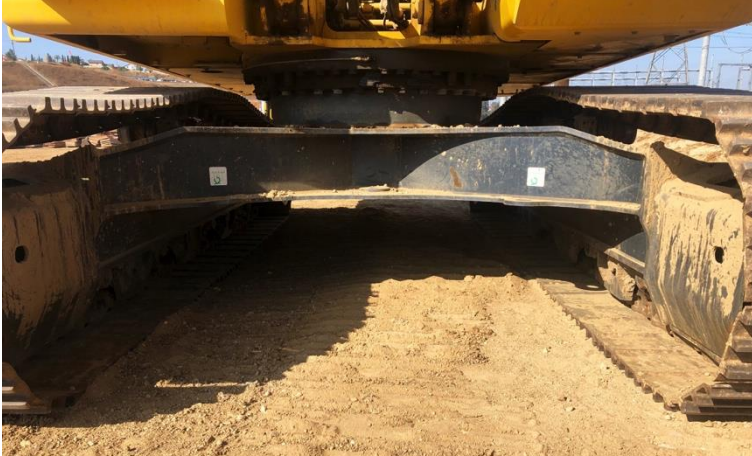
A view from underneath a piece of yellow tracked equipment. The equipment's undercarriage and tracks are visible. There is no drip pan or collection tray present under the equipment.	Photo 13 – No drip pan under this equipment. Photo facing west.

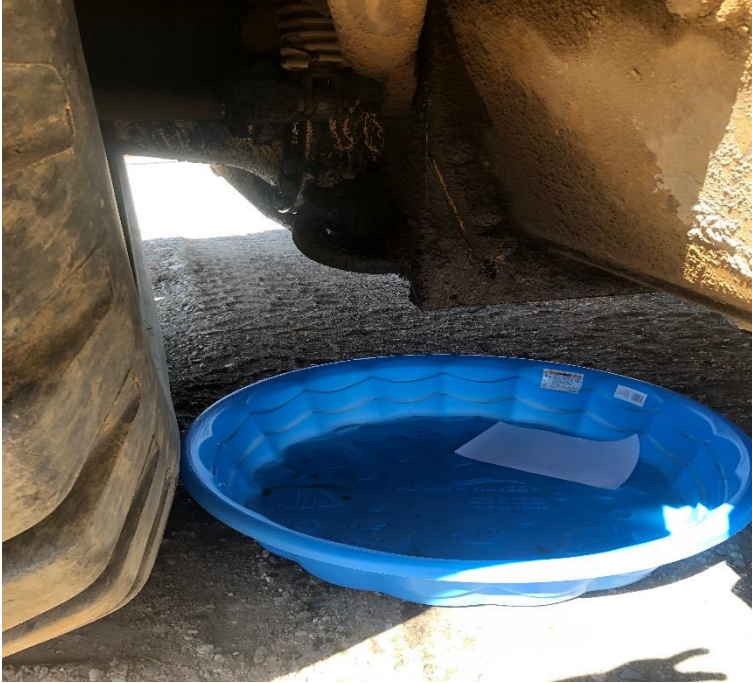
New drip pans (i.e., “kiddie” pools) were placed underneath the parked equipment – Photo 5. Old and damaged drip pans were still noted throughout the project site.

Photo 5 – New kiddie pool drip pans installed under some of the parked heavy equipment.

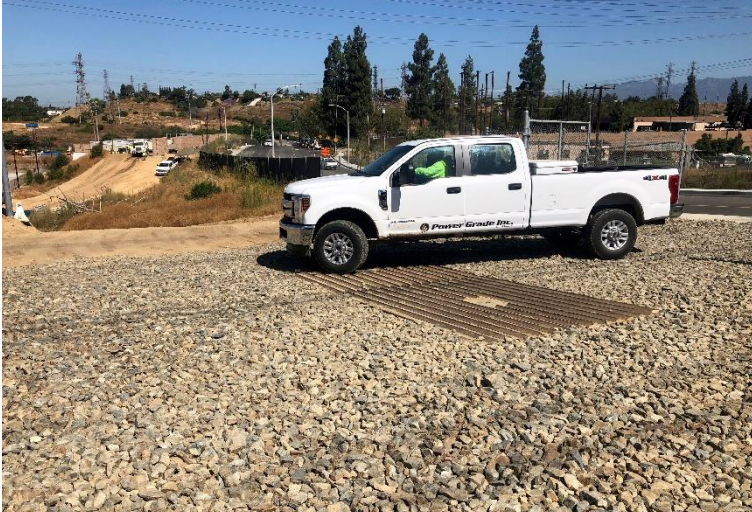
<p>Photo 6 – The Marketplace Drive entry/exit needs more rock past the rumble plate, where project vehicles turn north to enter the project site. Photo facing north.</p>
