ecology and environment, inc.

May 25, 2018

Re: Monthly Report Summary #7 for the Mesa 500-kV Substation Project

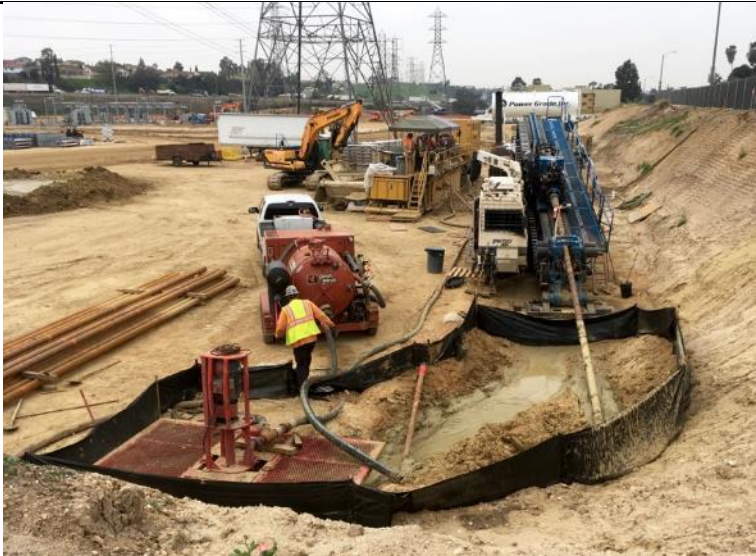
I observed horizontal directional drilling (HDD) work being conducted (Photo 3). One of the lines had been pulled and the pipe was capped (Photo 4).

Photo 3 – HDD operation. Photo facing west

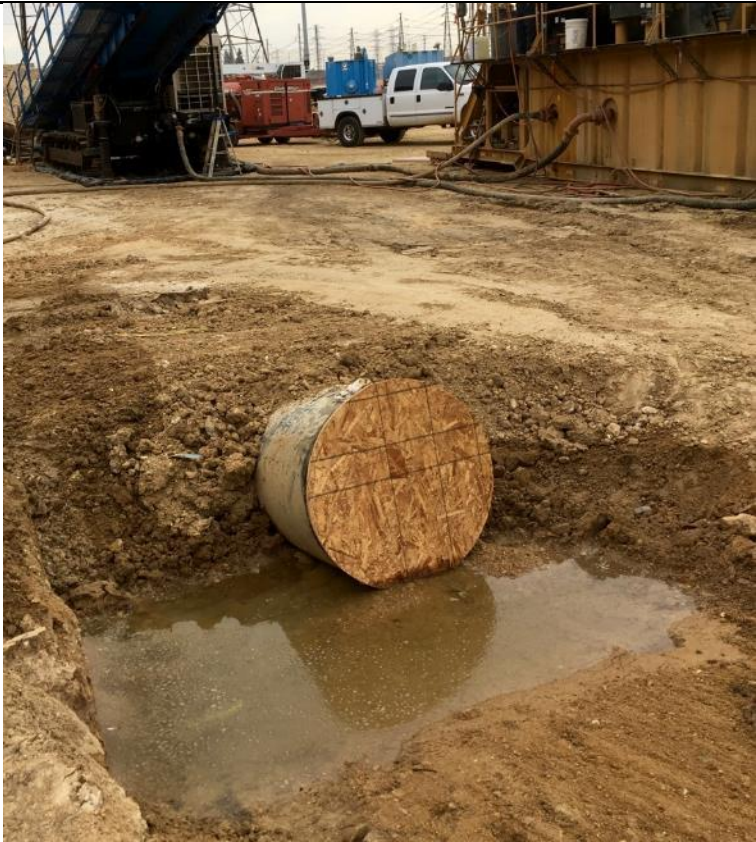
Photo 4 – HDD pipe pulled through and sealed.
4/3/18	Mesa Substation

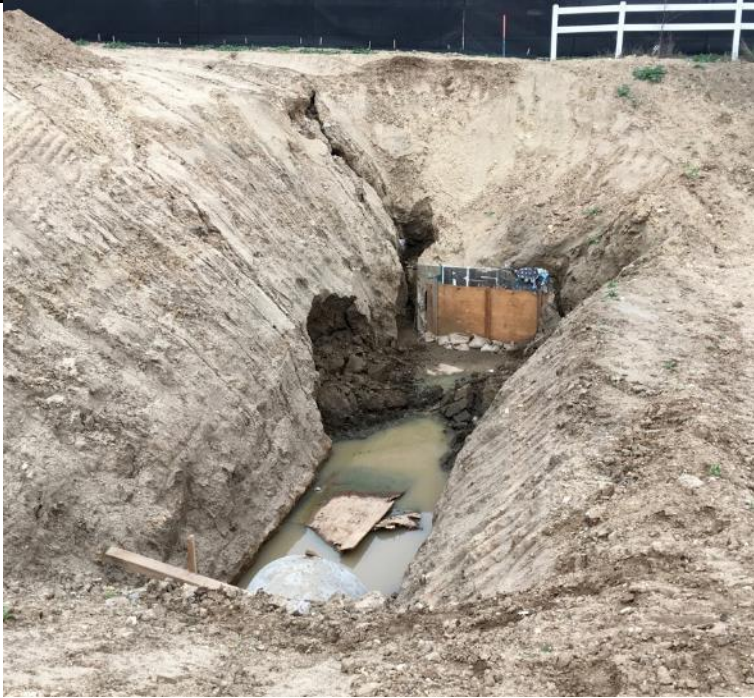
Photo 7 – Connection point to the existing offsite drainage pipe.
4/3/18	Mesa Substation

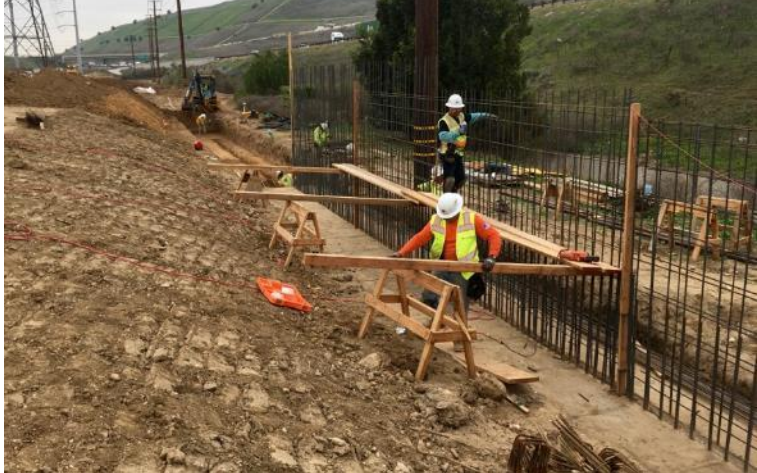
A crew was working on the southern perimeter wall. The crew was installing rebar and setting the concrete forms (Photo 11). Generators were contained and located on the inside of the new perimeter wall. Mud was being removed from the foundation trench and being deposited next to the offsite drainage channel. None of this mud was entering the channel.

Photo 11 – Work on the perimeter wall. Photo facing southeast.

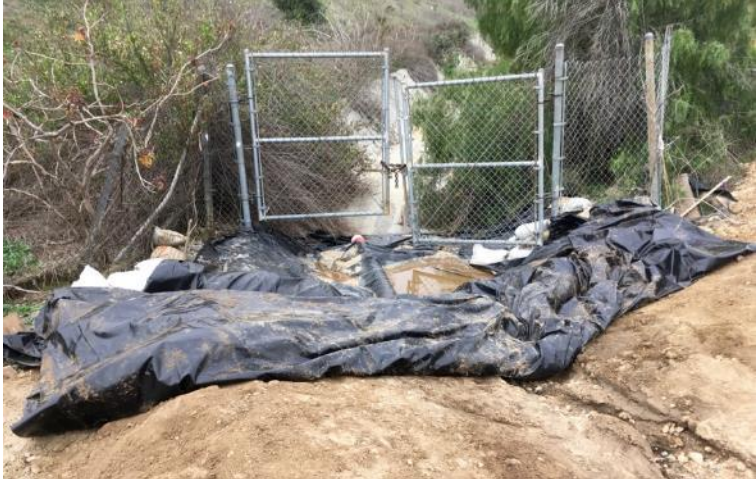
All of the visqueen-lined rainwater runoff diversion system had been removed, with the exception of a small amount of plastic near the offsite drainage channel (Photo 12). If weather conditions continued to stay dry, the crews planned to finish installing the new underground rainwater drainage system (MM HY-3).

Photo 12 – Remnants of the plastic-lined channel transporting offsite storm water runoff through the Mesa Substation site.
4/3/18	Mesa Substation

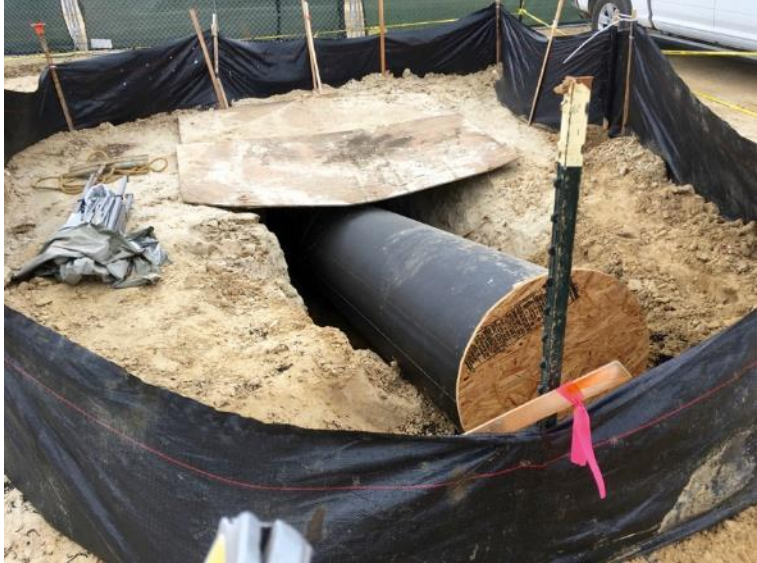
Photo 21 – Pipe pulled through the drilled hole; note the capped pipe and the silt fencing.
4/3/18	Mesa Substation North of Potrero Grande Drive

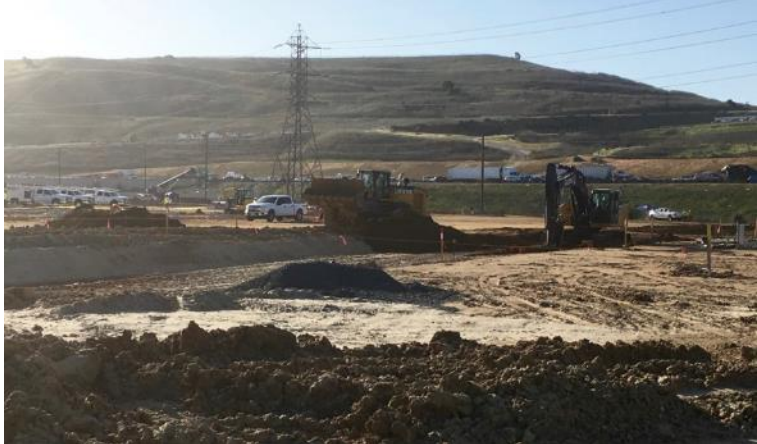
Photo 4 – Trenching work taking place near a pair of killdeer nesting in the pile of gravel in the middle of the photo. Photo facing south.
4/11/18	Mesa Substation

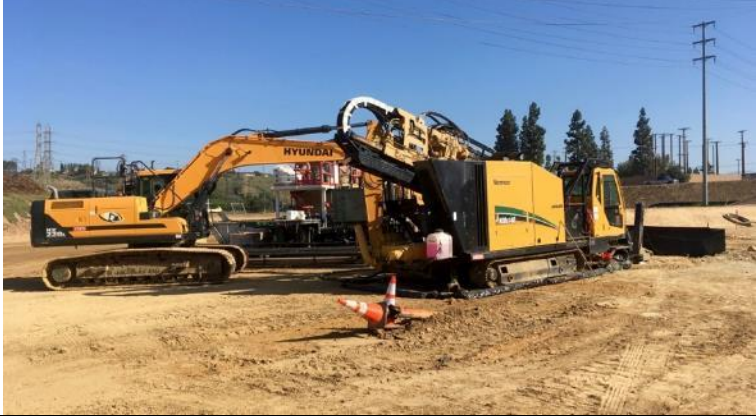
The equipment used for the HDD MarketPlace bore was out of service and being repaired (Photo 12).

Photo 12 – Market Place HDD work is temporarily discontinued for equipment repairs.
4/11/18	Mesa Substation

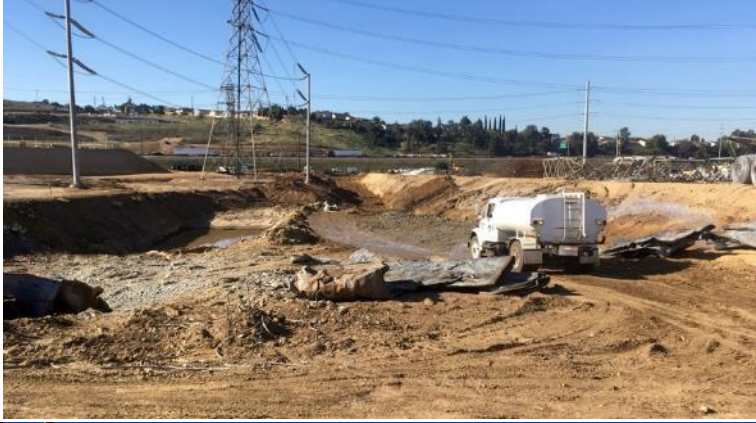
Within the Mesa Substation site, materials that had been salvaged from the old water line were still being processed and transported off site (Photo 1). Other portions of the old water line were stockpiled near the southern border of the Mesa Substation site and were being broken apart by a large excavator (Photo 10).

Photo 1 – Demolished water line materials are being transported offsite. Photo facing southwest
4/18/18	Mesa Substation

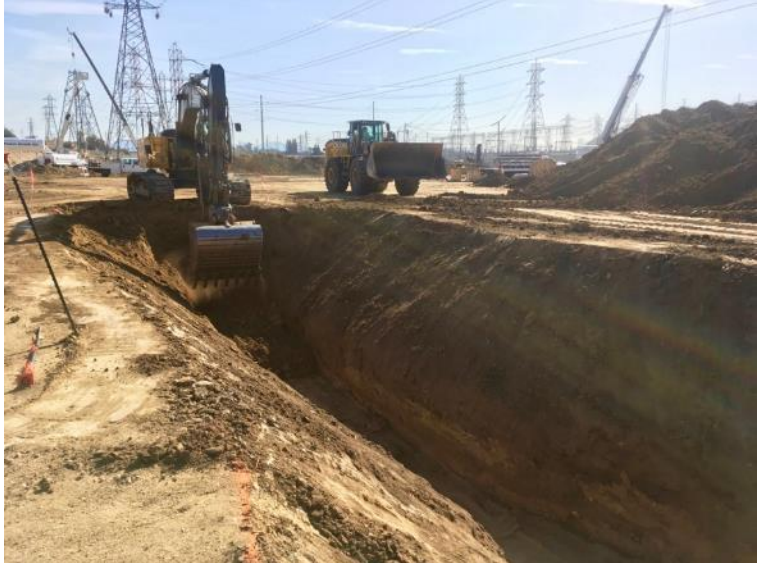
Trenching for the new storm water runoff drainage system was ongoing during my site visit (Photo 3). The killdeer chicks (noted during my prior week's visit) in a nest located near the trenching operation had fledged (killdeer chicks leave the nest within days of hatching); therefore, crews were working in the area. The chicks in the nest under the lattice steel tower also had hatched. Two killdeer chicks were seen in the detention basin area. Only some small puddles of water remained, and the chicks were foraging around this water. I spoke with ICF biological monitor Kristen Kleinfelter who was checking on the chicks in the detention basin. We both observed a Coopers hawk in the area just north of the Mesa Substation site. Noreas biological monitor Bob Huttar was also onsite.

Photo 3 – Trenching for the storm drain system. Photo facing east
4/18/18	Mesa Substation

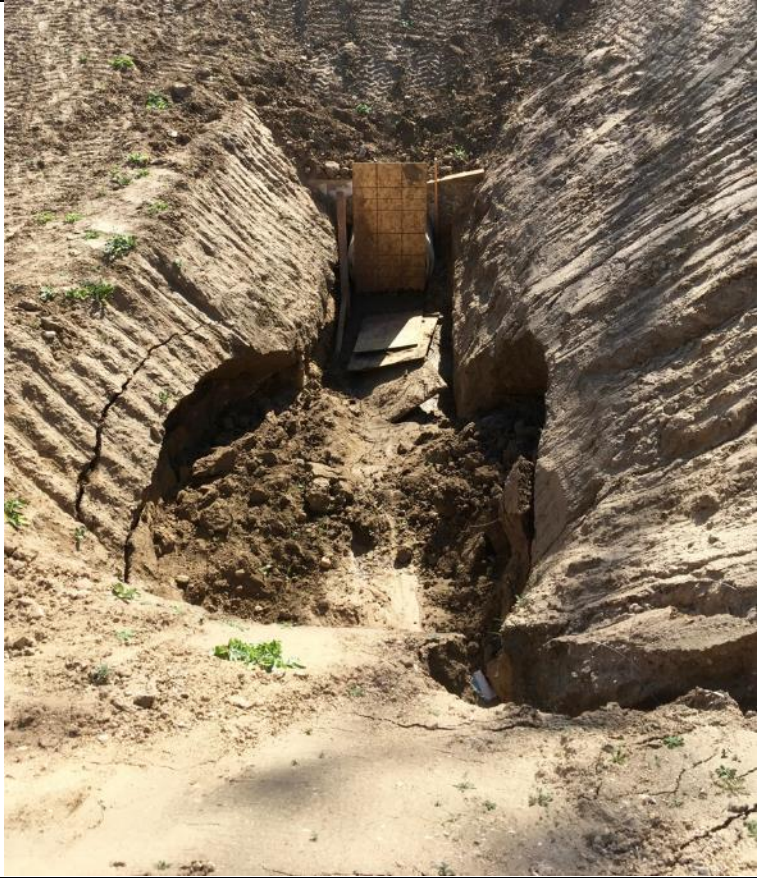
Photo 4 – Storm drain pipe outlet, an escape ramp is needed.

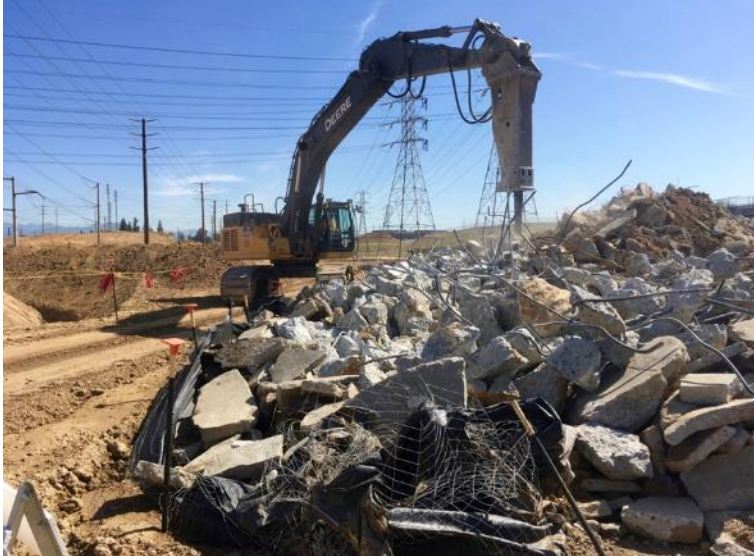
Photo 10 – Crews using equipment to break up the old water line. Photo facing east.

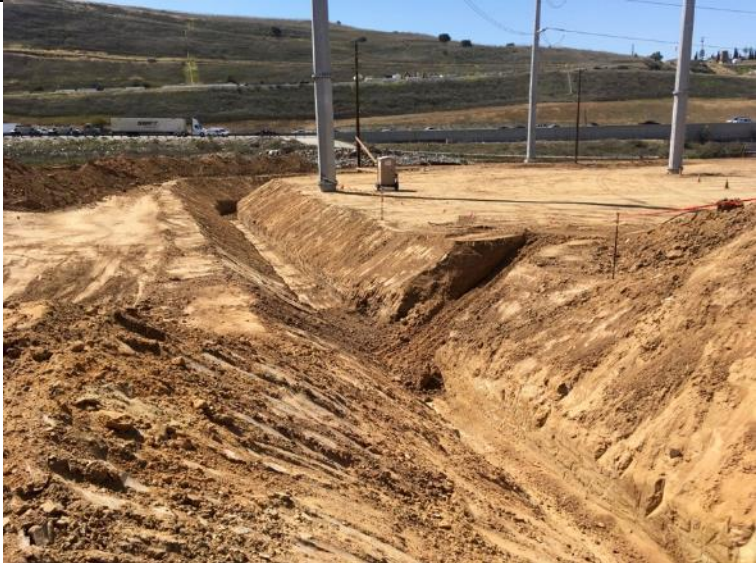
Photo 12 – Storm drain pipe trench with escape ramps installed. Photo facing south.
4/18/18	Mesa Substation

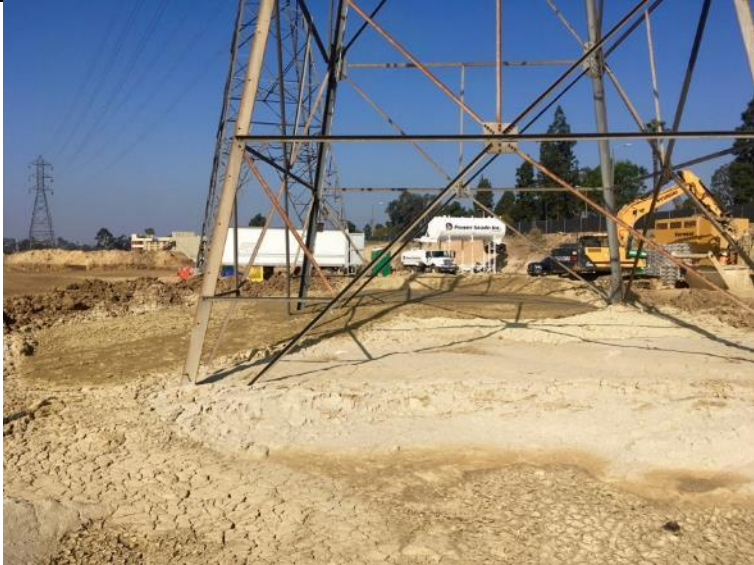
Photo 5 – HDD mud and tailings were deposited in a bermed basin under a nearby tower.
4/25/18	Mesa Substation

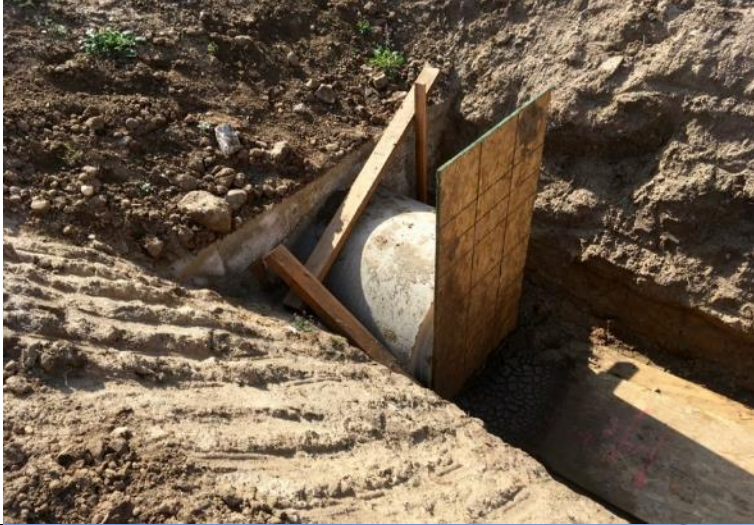
Photo 10 – Inadequate escape ramp in the trench.
4/25/18	Mesa Substation

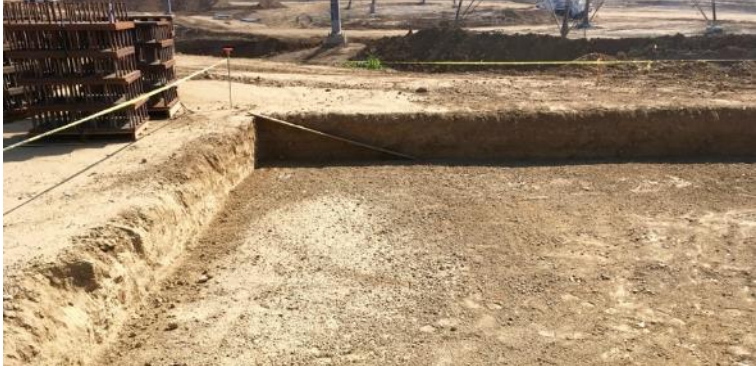
Photo 14 – Shallow but straight-walled foundation excavation with a small wooden escape ramp.
4/25/18	Mesa Substation	 	Photo 15 – Backfilling the old water line trench. Photo facing northeast.
