PUBLIC UTILITIES COMMISSION

Incident Date:	June 12, 2020	Report No.:	NCR-006
Date Submitted:	September 17, 2020	Location:	Old Mesa Substation footprint
Level:	Level 2 Non-Compliance	Relevant Plan/Measure:	MM HZ-4
Current Land Use:	Mesa Substation	Sensitive Resources:	N/A

NCR-006 Incident Photograph and Figure

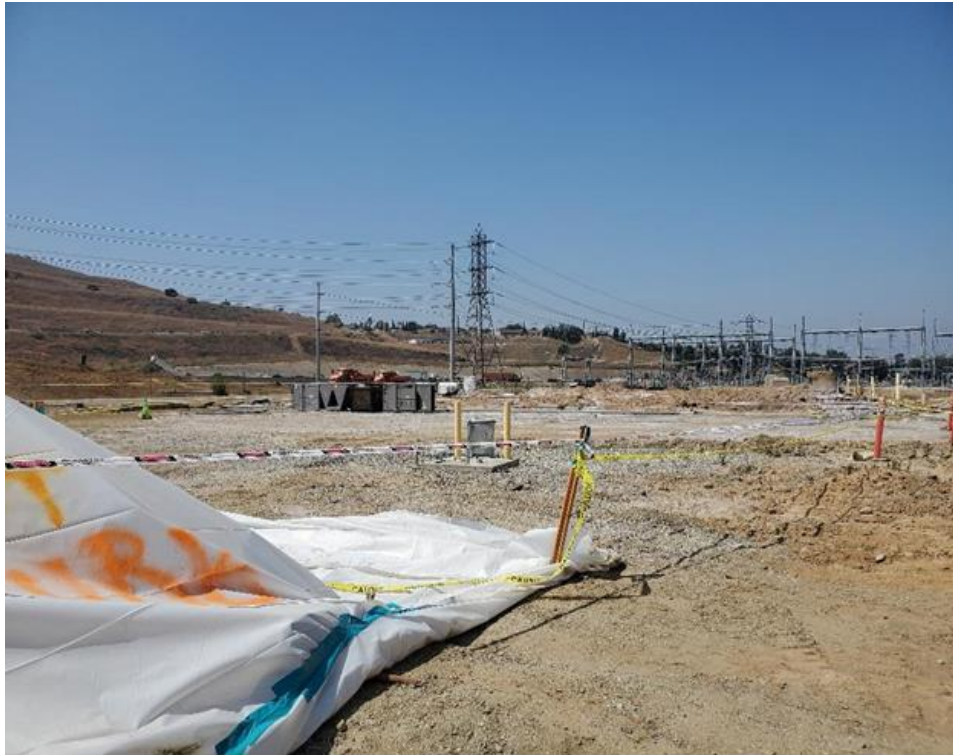
Between June 12 and June 13, 2020, while excavating and removing foundations in the 220-kV area of Old Mesa Substation, PGI uncovered transite pipe. Subsequent to the discovery, PGI moved portions of the transite pipe out of the immediate area and staged the material on plastic approximately 40 feet to the east. PGI is not approved as an abatement contractor and not allowed to handle or excavate asbestos containing materials (ACM). Additionally, moving the transite contained in excavated material would conflict with MM HZ-4 with respect to handling contaminated soils, and procedures for appropriate disposal and/or treatment.

Photo 1: Exclusionary zone -asbestos containing construction material covered and roped off at the old Mesa Substation footprint area, June 12, 2020.

- SCE applied water to the area twice a day to limit exposure of airborne asbestos particles. Additionally, a soil binding treatment is being applied in the area to further limit potential airborne particles containing asbestos. Asbestos air quality sampling is being completed once a day to ensure there is no asbestos air borne particle readings. Moving forward, SCE continued to utilize drawings to locate underground conduits.
