<p><b>California Public Utilities Commission</b> <b><i>Mitigation Monitoring, Compliance, and Reporting Program</i></b></p>
	<p><b>East County (ECO) Substation Project</b></p> <p><b>Compliance Status Report: 045</b></p> <p><b>December 21, 2014</b></p>

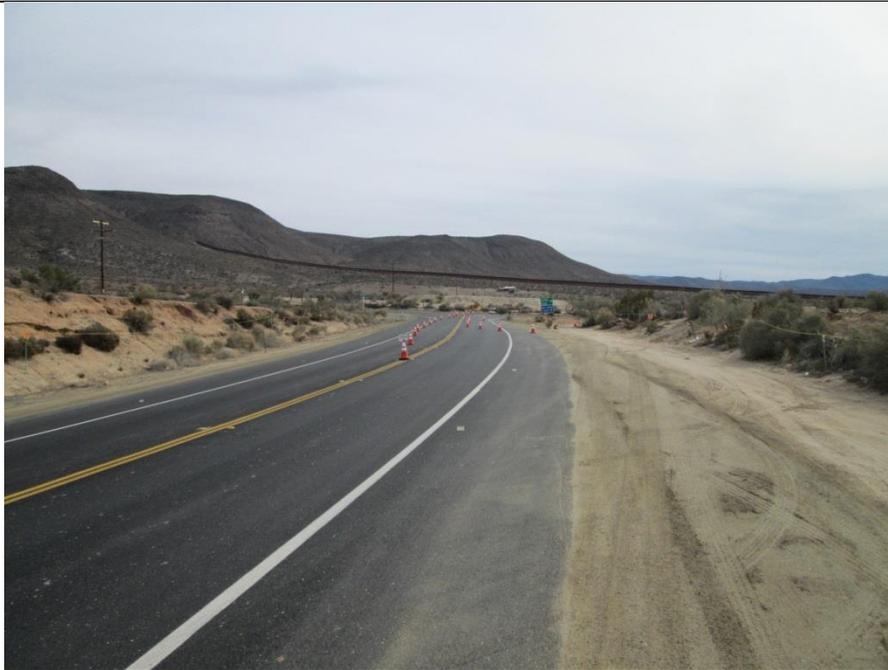
Traffic safety measures observed being implemented included the use of traffic cones to direct motorists along Carrizo Gorge Road in accordance with MM-TRA-1 (see Attachment A – Photo 1). Hydroseeding crews were observed applying hydroseed along the right-of-way between the Boulevard Rebuild Substation and the 138 kV overhead alignment (see Attachment A – Photo 2). The temporary work areas were decompacted prior to the seed application in accordance with MM-BIO-1D. Restoration activities were also observed being performed under the direction of a habitat restoration specialist in accordance with MM-BIO-1D.

**Photo 1:** Traffic control measures consisting of traffic cones were observed being utilized to direct motorists along Carrizo Gorge Road in accordance with MM-TRA-1.

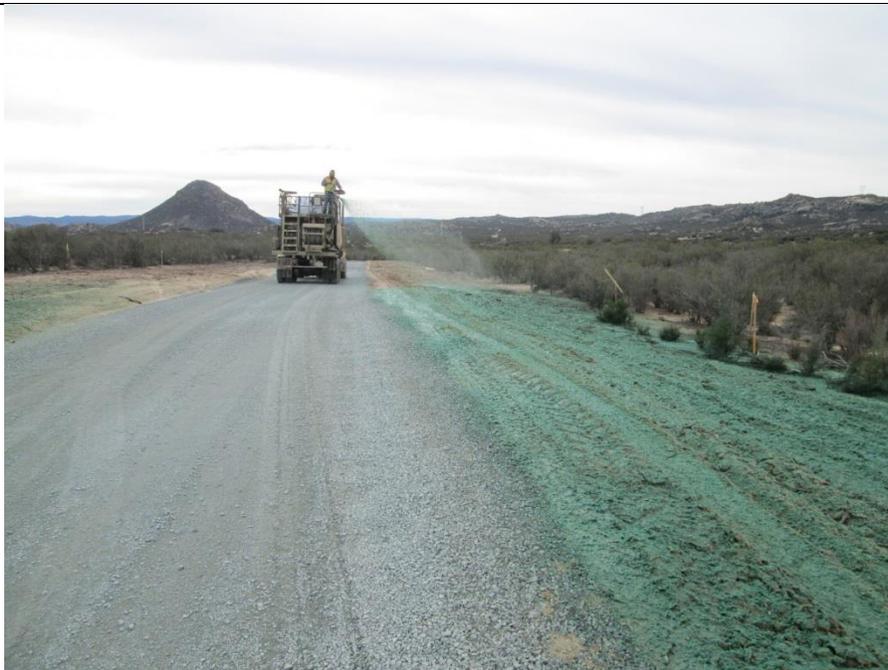
**Photo 2:** Restoration activities consisting of applying hydroseed occurred during this reporting period along the 138 kV underground alignment between the Boulevard Substation Rebuild and 138 kV overhead transmission line.

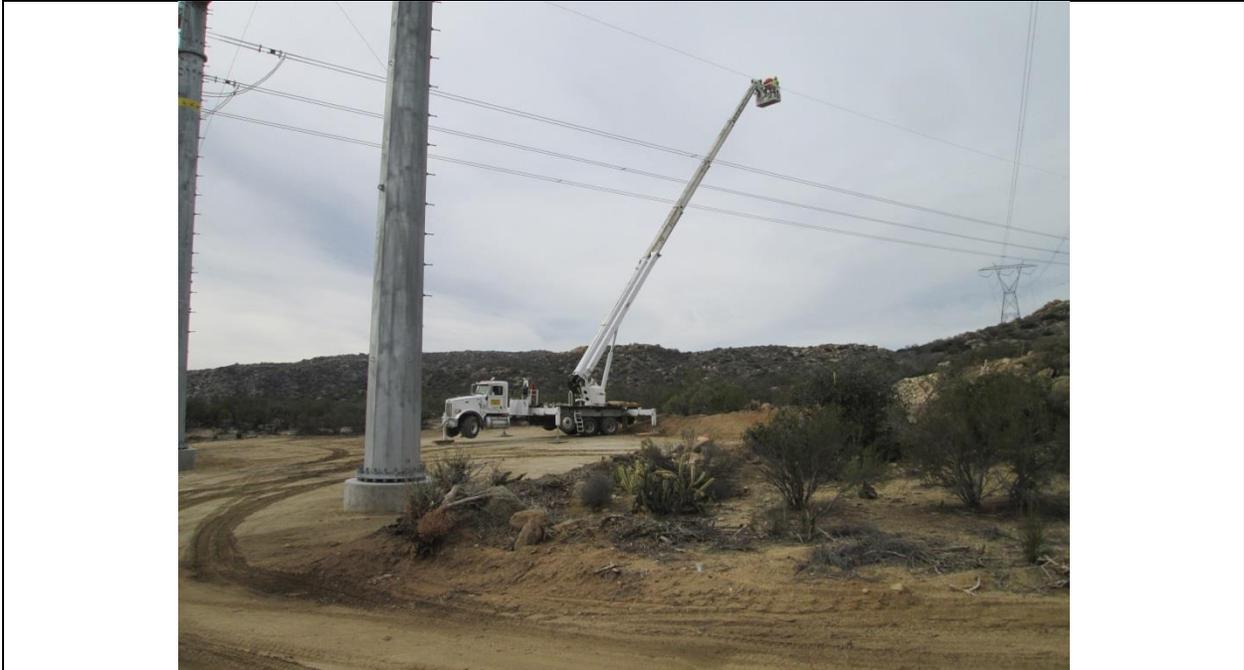
FAA marker balls have been installed at locations along the 138 kV overhead transmission alignment in accordance with FAA regulations and MM-TRA-3 (see Attachment A – Photo 3). In accordance with MM-HAZ-1A, spill prevention countermeasures were observed in place, consisting of containment bins below temporary generators (see Attachment A – Photo 4). Temporary impact areas along access roads and adjacent to pad sites are undergoing restoration efforts in accordance with MM-BIO-1D.

**Photo 3:** FAA marker balls were observed being attached to the 138 kV line at select locations to meet FAA requirements and MM-TRA-3.

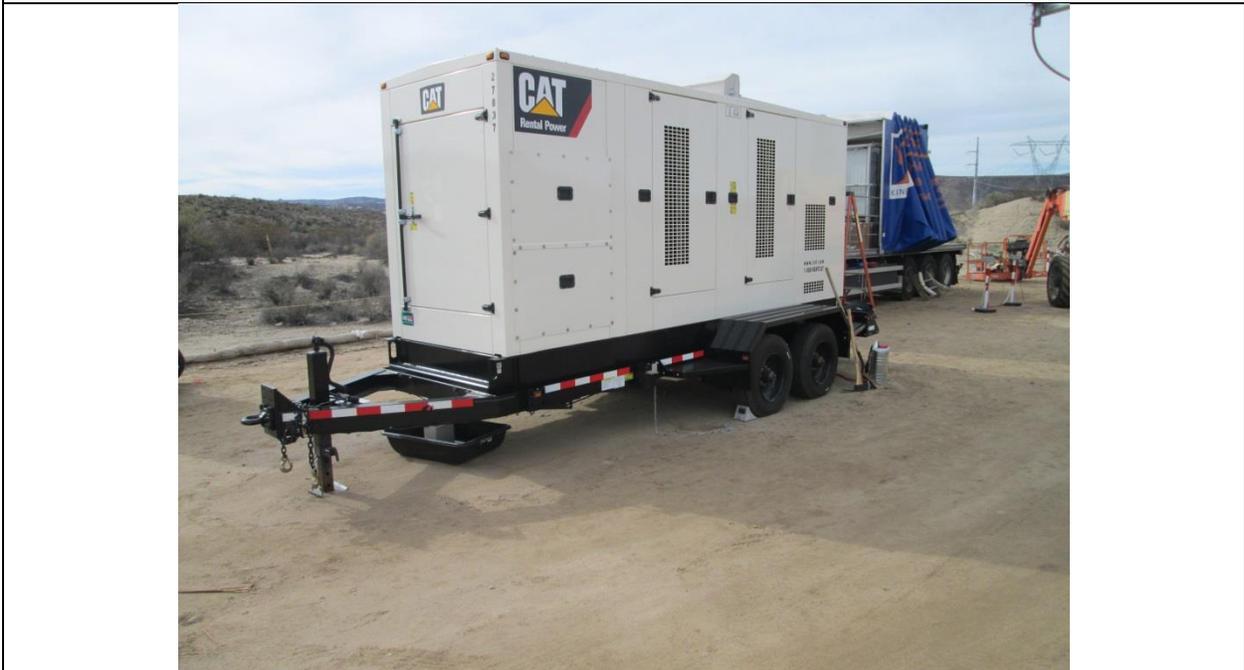
**Photo 4:** In accordance with MM-HAZ-1a, spill prevention countermeasures were observed in place, consisting of containment bins below temporary generators.

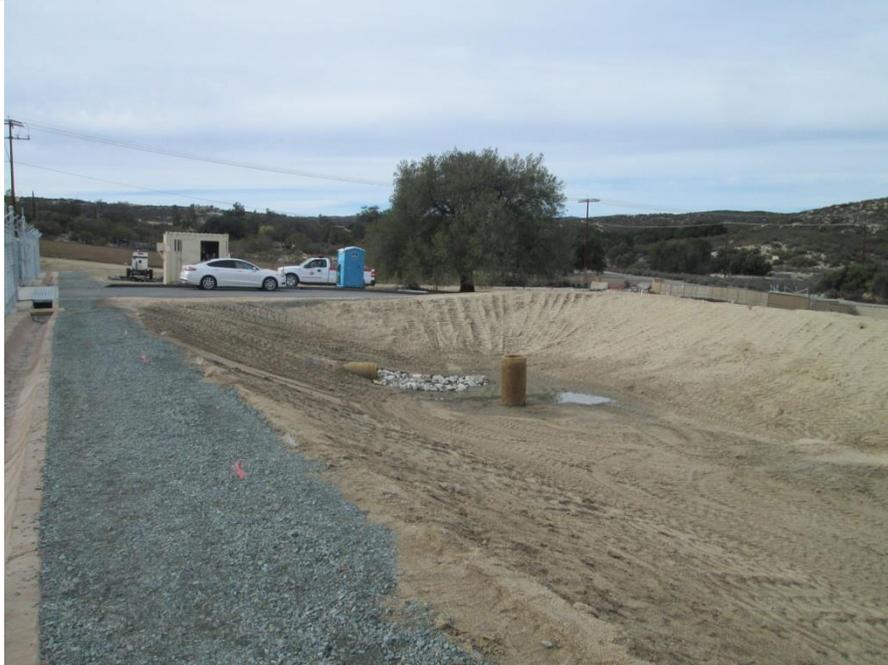
Crews were observed preparing the site for installation of landscaping materials in accordance with the Landscaping Plan (APM-ECO-AES-2). All work was observed being completed within the approved work limits under the supervision of a biological monitor in accordance with MM-BIO-1C. Crews recently completed the construction of a detention basin that will be utilized to dissipate stormwater flows during a storm event (see Attachment A – Photo 5).

**Photo 5:** A detention basin has been constructed at the Boulevard Substation Rebuild to dissipate stormwater flows during a rain event.

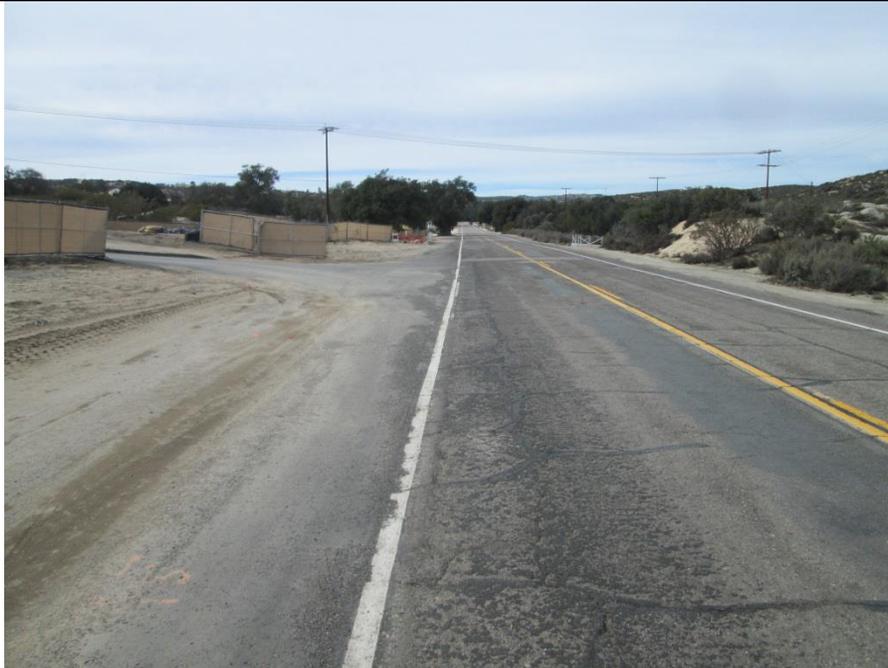
Dust control measures consisting of watering down areas of active construction and sweeping the adjacent roadway (Old Highway 80) at the point of ingress/egress to minimize trac-out were being implemented (MM-BIO-4A) (see Attachment A – Photo 6).

**Photo 6:** Old Highway 80 was observed being swept on a regular basis in accordance with MM-BIO-4a.
