<p><b>California Public Utilities Commission</b>  <b><i>Mitigation Monitoring, Compliance, and Reporting Program</i></b></p>
	<p><b>East County (ECO) Substation Project</b></p>
	<p><b>Compliance Status Report: 047</b></p> <p><b>January 18, 2015</b></p>

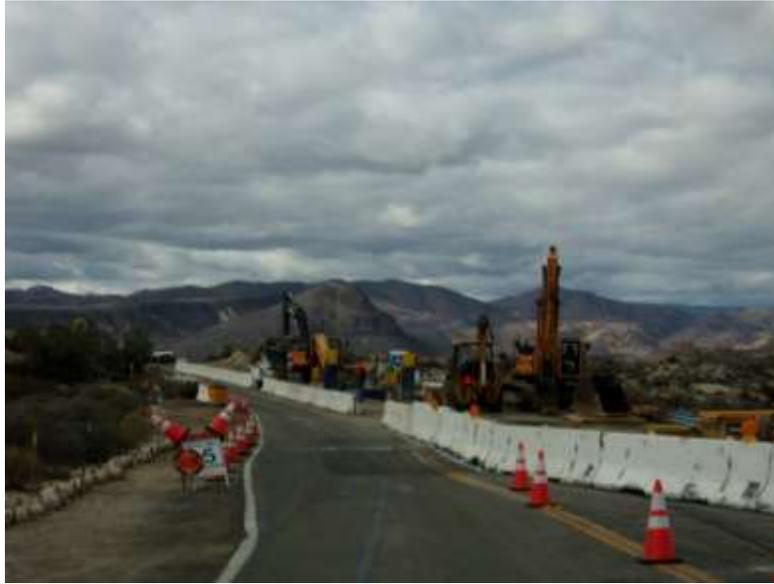
Roads were kept free of track out and signage was posted notifying construction workers of the project speed limit in accordance with MM-BIO-4a and MM-AQ-1 (see Attachment A – Photo 1). Traffic control measures consisting of use of a flagger and signage was observed being implemented along Old Highway 80 as required by MM-TRA-1. Work limits along Section 3 right-of-way were clearly delineated with flagging in accordance with MM-BIO-1A and a biological monitor was present per MM-BIO-1C.

**Photo 1:** Roads were kept free of track out and speed limits of 15mph were posted and maintained by all project personnel in accordance with MM-BIO-4a and MM-AQ-1.

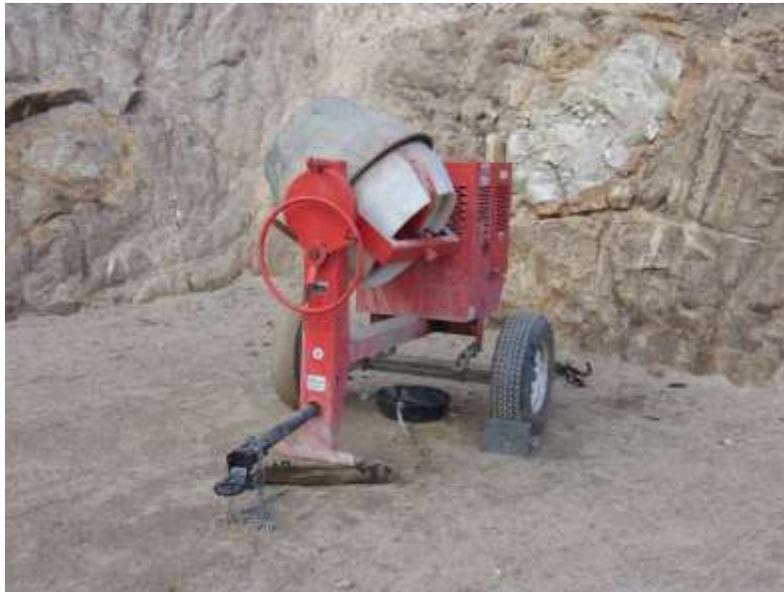
During installation of pole erosion protection at SP42, required fire response tools were present in accordance with MM-FF-1. Drip pan containment was also observed being placed under equipment as stipulated by MM-HAZ-1a (see Attachment A – Photo 2).

**Photo 2:** During installation of pole erosion protection at SP42, drip pan containment was observed placed beneath equipment as stipulated by MM-HAZ-1a.

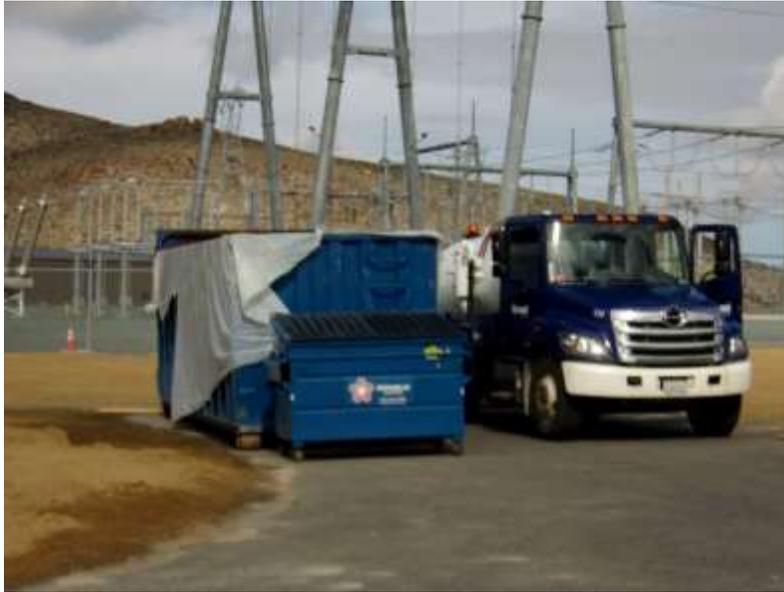
Waste containers staged at the substation were observed covered in accordance with the project Waste Management Plan and MM-HAZ-1c (see Attachment A – Photo 3). As stipulated by the Project SWPPP and MM-HYD-1, erosion control devices in the form of straw wattles, hydromulched slopes, and rock drainages were observed stabilized and in good condition throughout the substation (see Attachment A – Photo 4).

**Photo 3:** Waste containers staged at the ECO substation were observed covered in accordance with the project Waste Management Plan and MM-HAZ-1c.

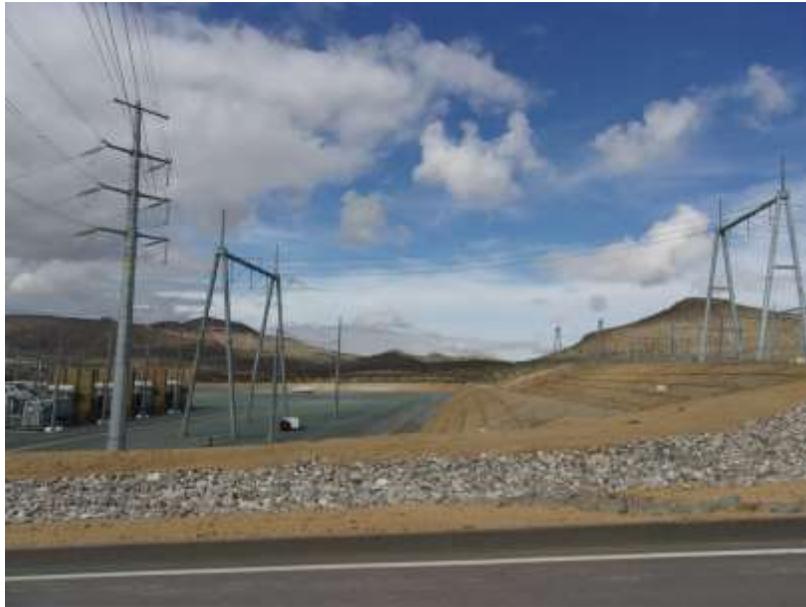
**Photo 4:** As stipulated by the Project SWPPP and MM-HYD-1, erosion control devices in the form of straw wattles, hydromulched slopes, and rock drainages were observed stabilized and in good condition.
