Phase I Environmental Site Assessment of  
360 Acres of Vacant Land in Support of the  
Energía Sierra Juárez Project, Near Old Highway  
80, Unincorporated San Diego County,  
California

AECOM, Inc.  
April 2009  
Document Number: 02450-063-100

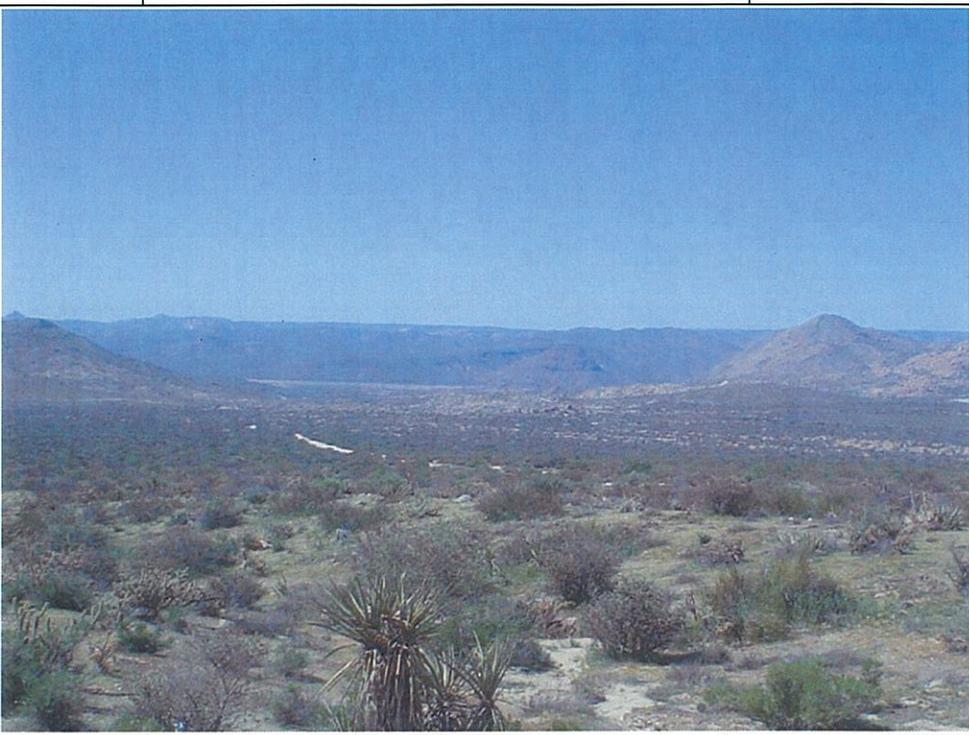
View of the western portion of the subject property.

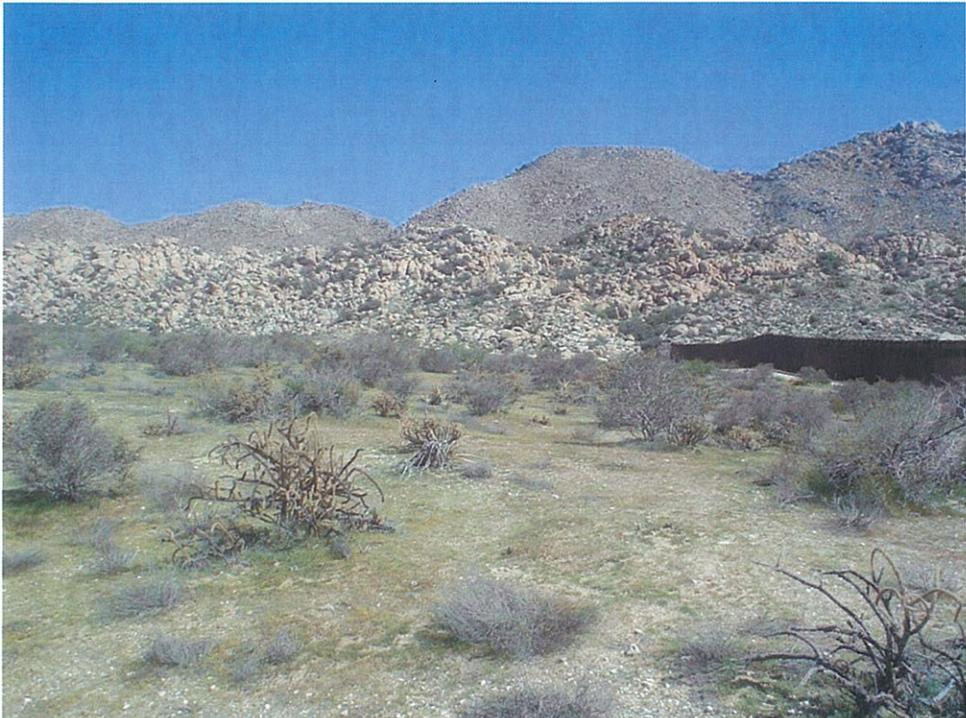
<b>Photo No.</b> 3	<b>Date:</b> 03/16/09

<b>Direction Photo Taken:</b>  East		
<b>Description:</b>  View of the rugged hills that make up the majority of the eastern portion of the subject property.

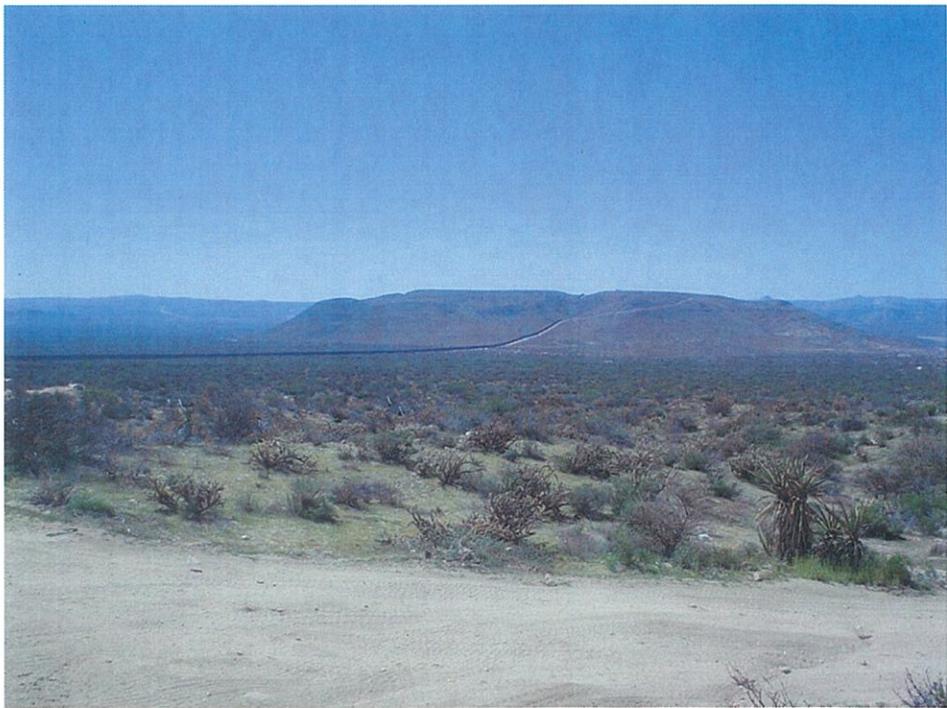
<b>Photo No.</b> 4	<b>Date:</b> 03/16/09

<b>Direction Photo Taken:</b>  West		
<b>Description:</b>  View of the western half of the subject property. The U.S./Mexico fence/border can be seen along the left hand side of the photograph.

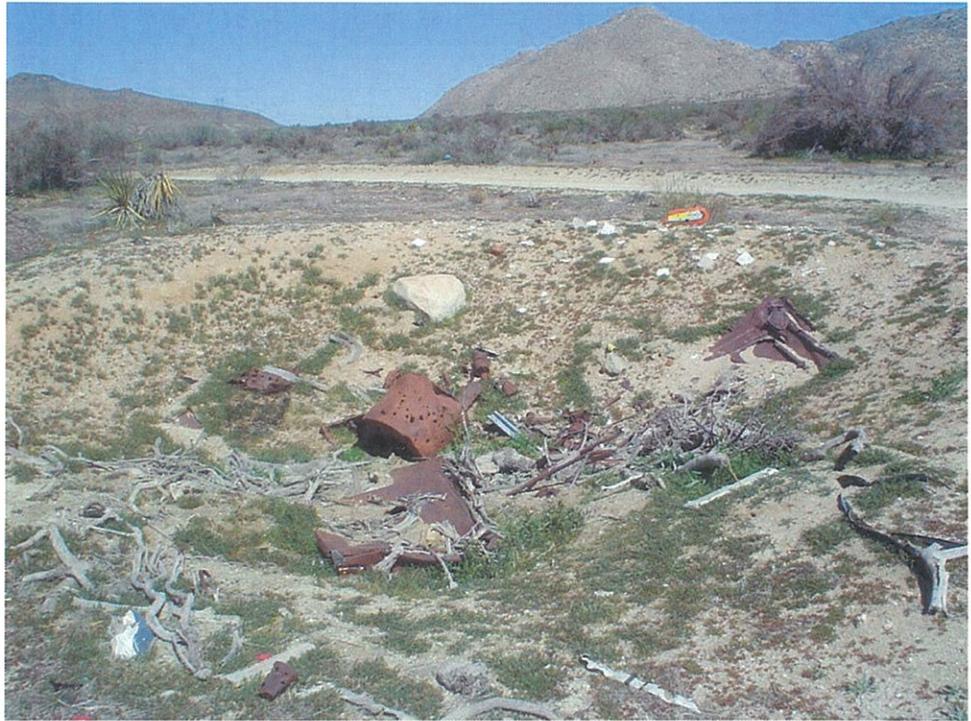
View of trash and debris that was observed to the west of the subject property.

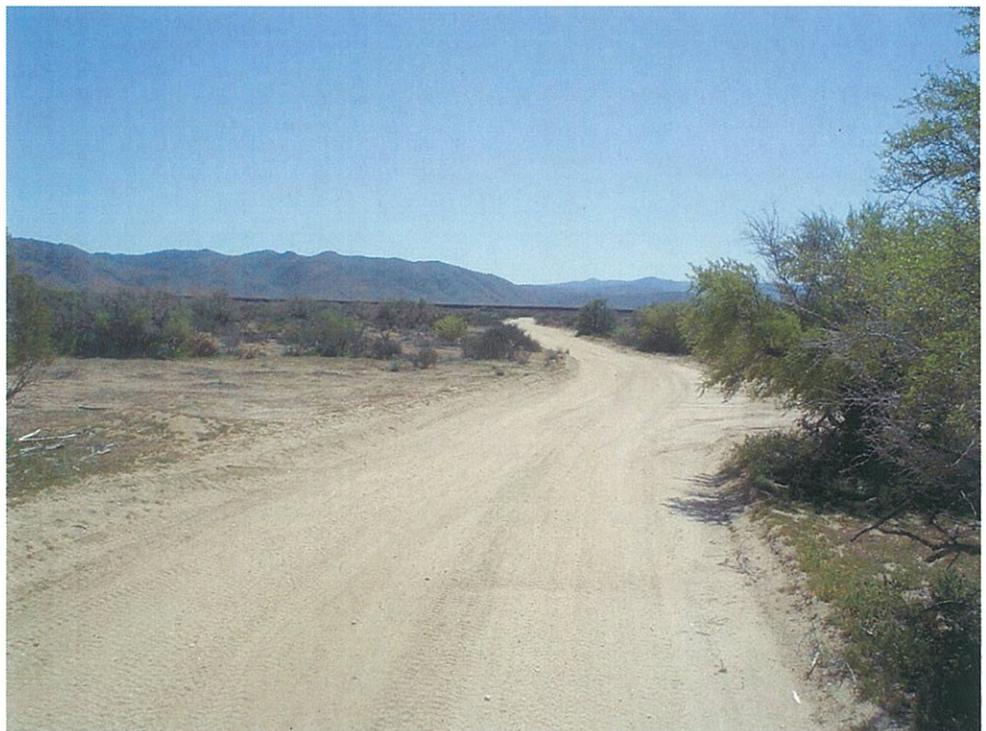
View of a dirt road that borders the western property boundary.

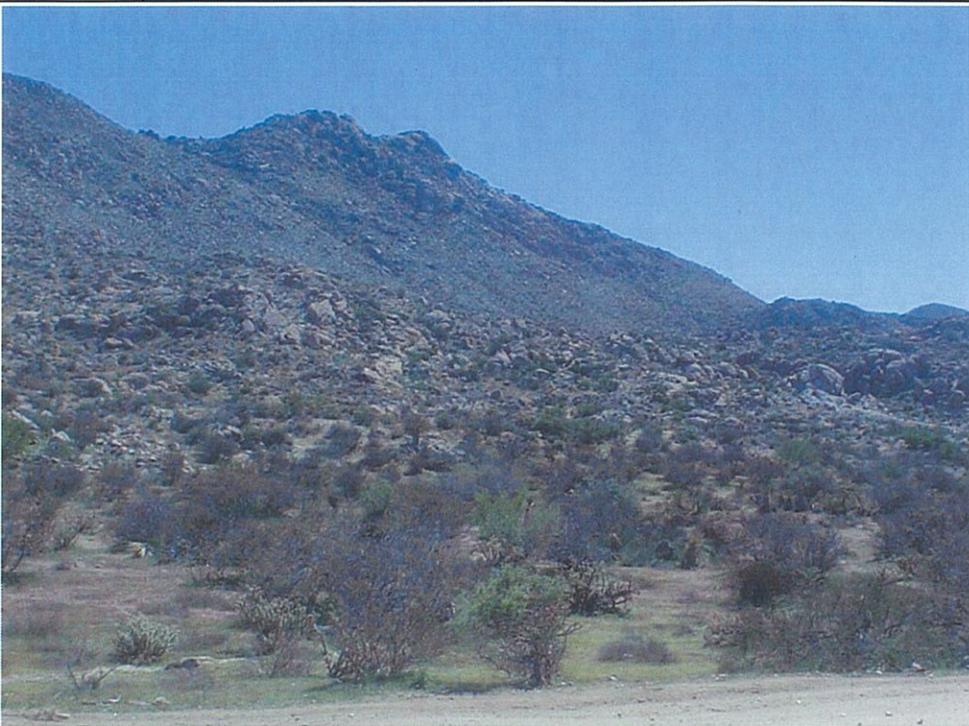
<b>Photo No.</b> 7	<b>Date:</b> 03/16/09

<b>Direction Photo Taken:</b>  Southeast		
<b>Description:</b>  View of the rugged hills that comprise the eastern portion of the subject property.

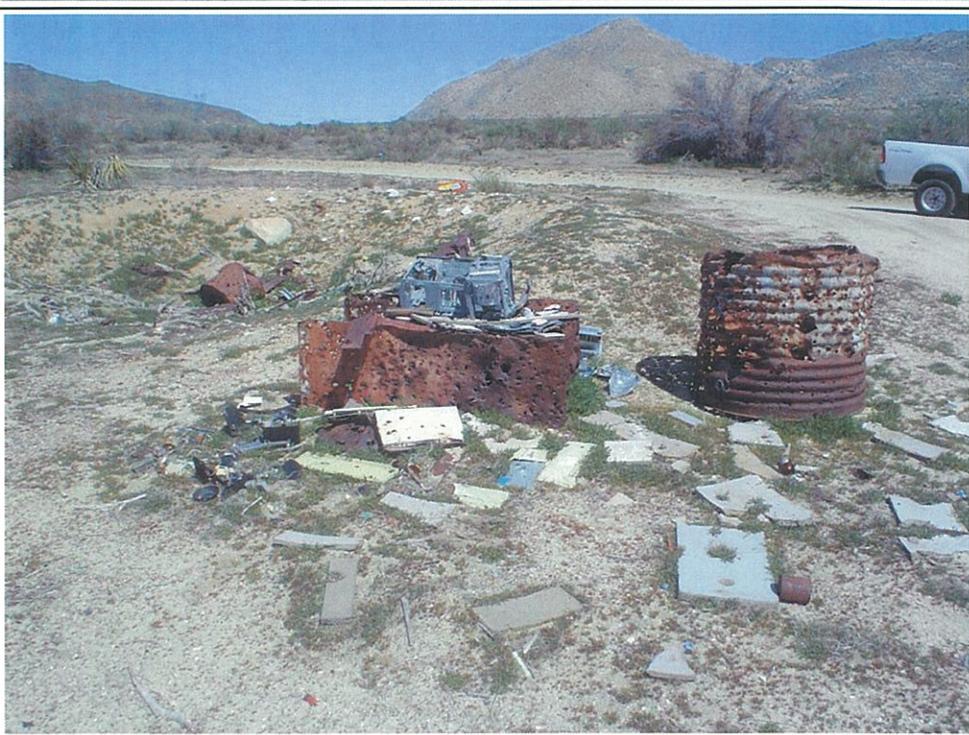
<b>Photo No.</b> 8	<b>Date:</b> 03/16/09

The southeast portion of the subject property along the hillside is reportedly used occasionally as an unofficial firing range. In addition to shotgun and bullet casings, AECOM observed miscellaneous trash and debris in this area. Limited trash and debris consisting of plastic bags and paper trash was observed scattered throughout the remaining portion of the subject property, the majority of which appeared to be wind-blown. No staining or visual evidence of hazardous materials release was observed during the site visit.

<b>Direction Photo Taken:</b>  Northeast		
<b>Description:</b>  View of trash, debris and bullet fragments that were observed along the eastern portion of the subject property near the hillside.

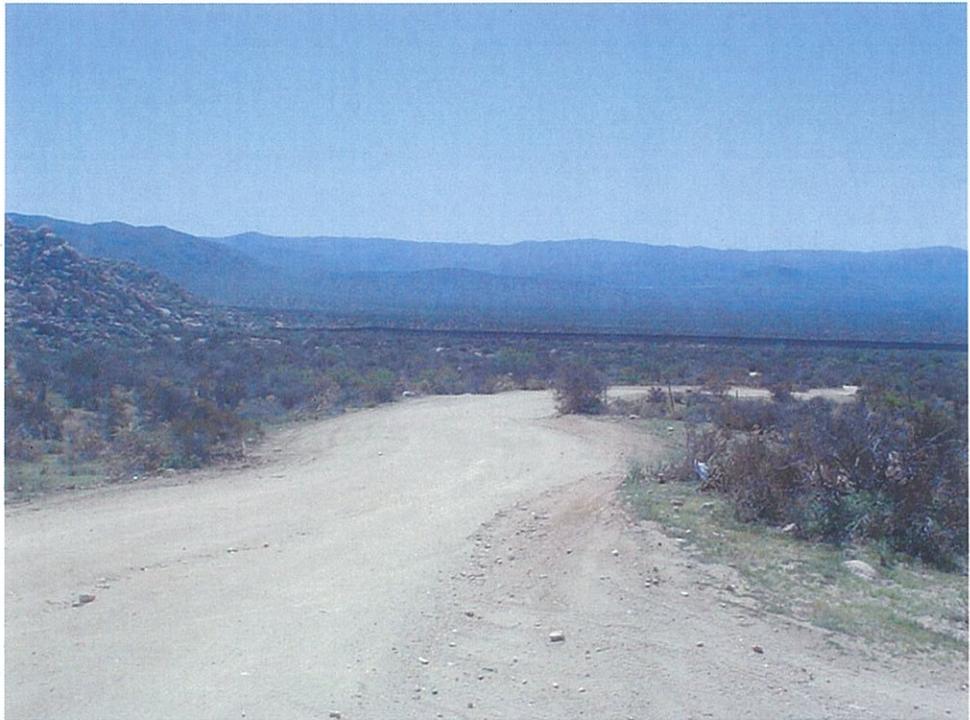
View of the subject property looking towards the U.S./Mexico border.

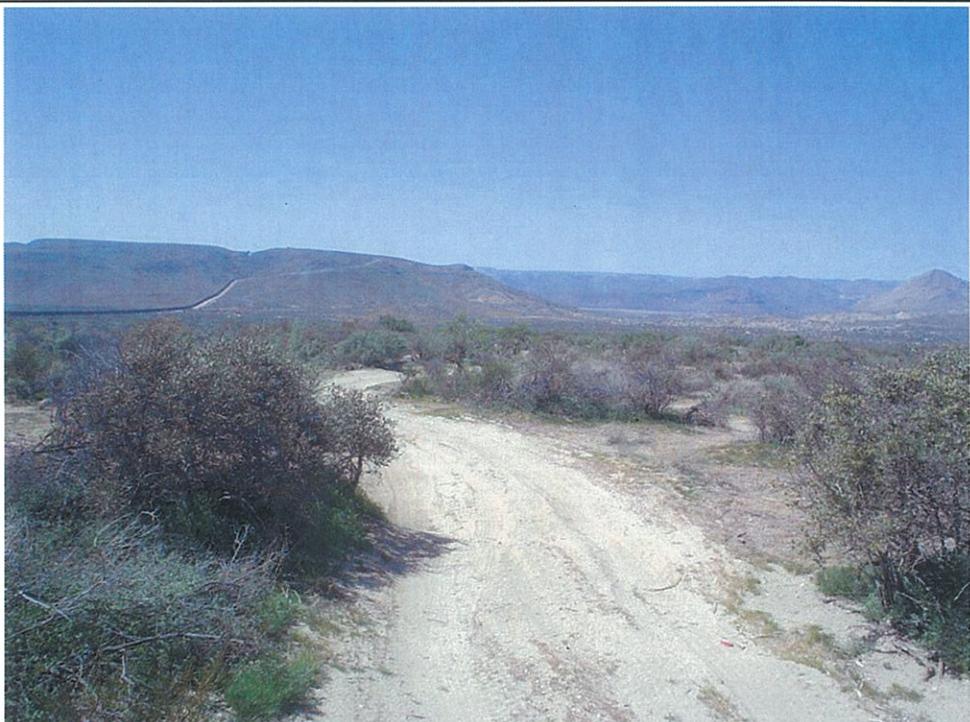
View of the northern most dry desert wash that is located on the subject property.
