<p>California Public Utilities Commission <i>Mitigation Monitoring, Compliance, and Reporting Program</i></p>
	<p>East County (ECO) Substation Project</p> <p>Compliance Status Report: 032</p> <p>June 22, 2014</p>

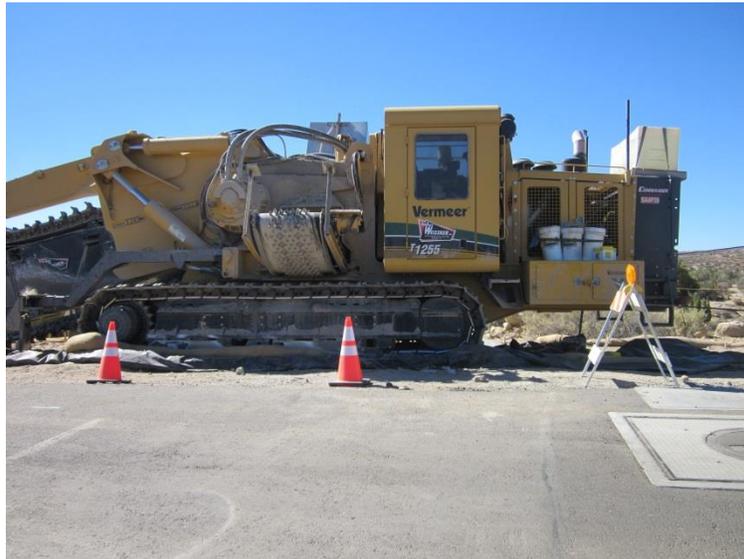
Photo 1: Staged equipment featured containment as required by MM-HAZ-1a.

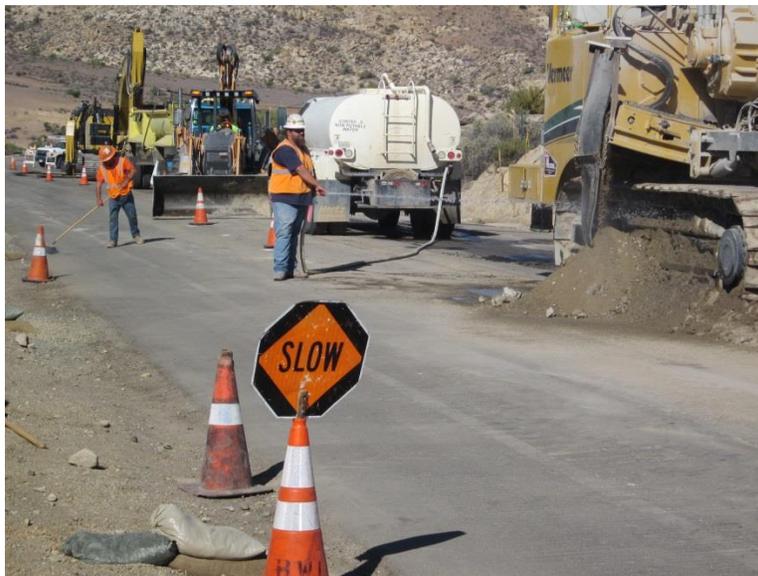
Dust control measures in accordance with MM-AQ-1 and MM-BIO-4a, including watering of active construction were implemented. Track-out measures consisting of rumble plates and rock aprons were in place and maintained, and traffic control crews were observed manually sweeping up project related track out throughout and at the end of the day (See Photo 2 - Attachment A).

Photo 2: Construction workers were observed sweeping roadways to minimize trac-out in accordance with BIO4a and AQ-1.

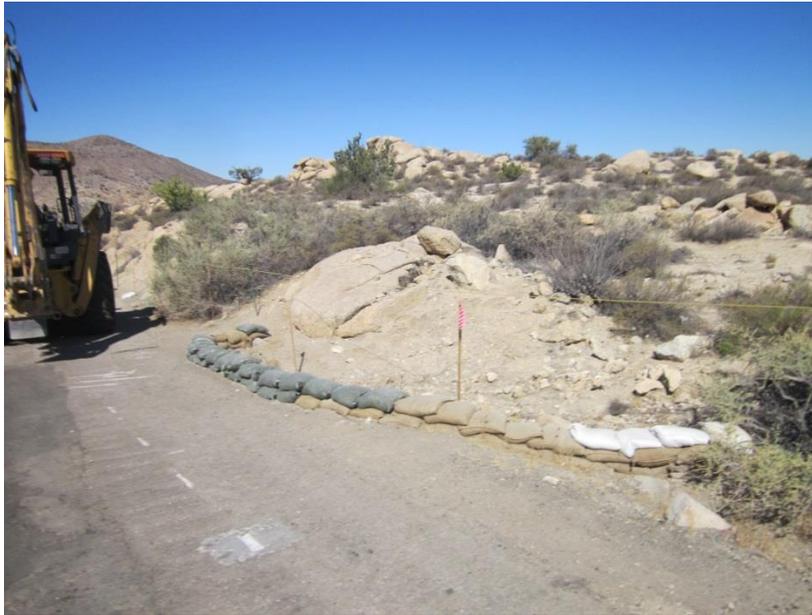
Erosion control measures consisting of straw wattles, silt fence and gravel bags are being maintained along the ROW in accordance with the SWPPP and MM-HYD-1 (See Photo 3 - Attachment A). Staged and active stationary equipment featured containment as required by MM-HAZ-1a. Jurisdictional waterways were marked off with blue flagging to highlight their location for avoidance. ESA's were marked, including special species flagging for plants as stipulated by BIO-5b.

Photo 3: Erosion control measures consisting of straw wattles, silt fence and gravel bags are being maintained in accordance with the SWPPP and MM-HYD-1.

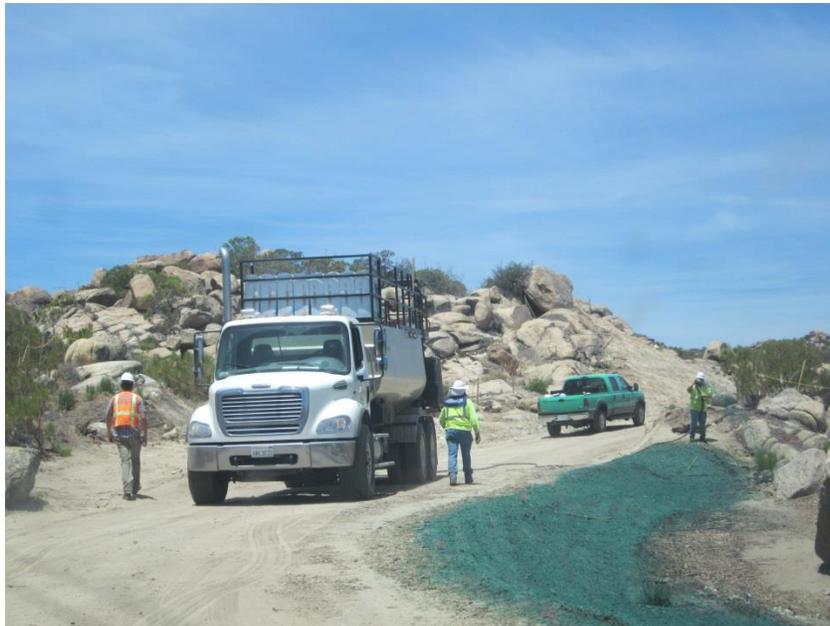
In accordance with the BIO1-d and the Habitat Restoration Plan, pad fill slopes were covered with hydro mulch in an effort to reduce soil erosion during precipitation events (See Photo 4 - Attachment A). In accordance with the Project's Noxious Weed and Invasive Species Control Plan, mulch used was weed-free straw and applied with an SDGE approved tackifier.

Photo 4: In accordance with the BIO1-d and the Habitat Restoration Plan, pad fill slopes are sprayed with hydro mulch in an effort to reduce soil erosion.

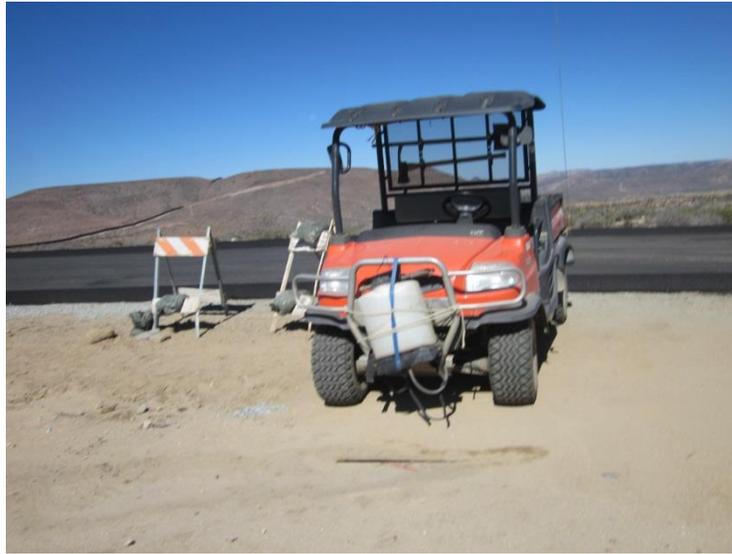
A fire patrol was on site and actively checking all entering personnel for SWEAP training stickers and required Pulaski's, shovel, and 5-gallon water supply in accordance with MM-FF-1. Throughout the substation, fire tools were set out at individual areas of work and attached to equipment for easy access in case of an emergency and in accordance with the Construction Fire Plan and MM-FF-1 (See Photo 5 - Attachment A).

Photo 5: Fire tools were set out at individual areas of work and attached to equipment for easy access in case of an emergency and in accordance with the Construction Fire Plan and MM-FF-1.

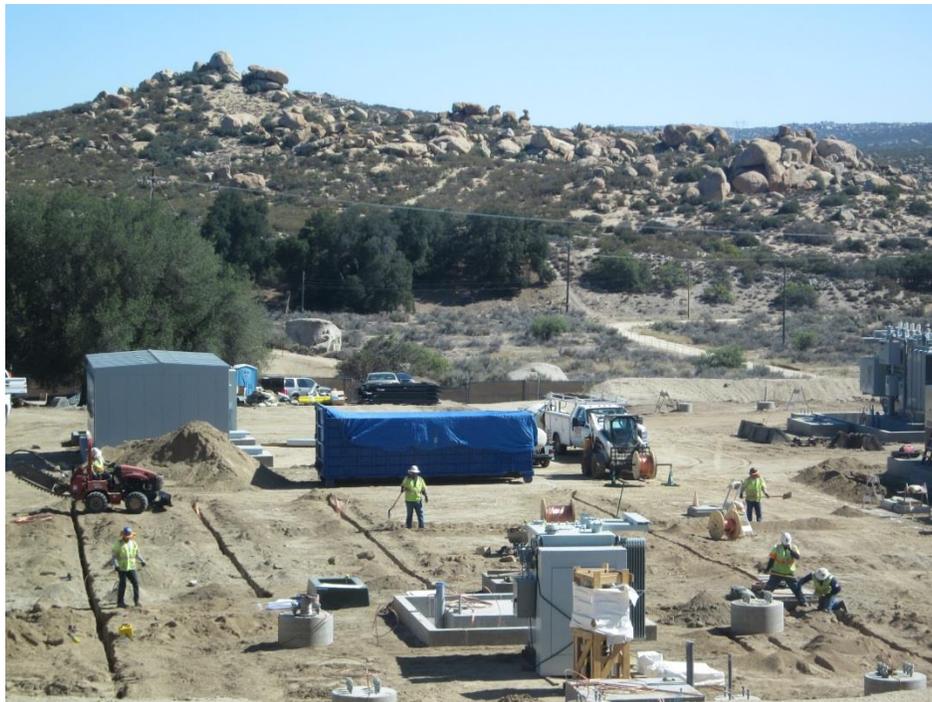
Construction equipment and staged materials throughout the substation were equipped with drip pan containment as stipulated by MM-HAZ-1a. Hazardous materials stored onsite were labeled and staged in proper containment bins per MM-HAZ-1a. As required by MM-HAZ1-c, trash storage bins were equipped with covers to avoid dispersal due to weather or wildlife (See Photo 6 - Attachment A).

Photo 6: As required by MM-HAZ1-c, trash storage bins were equipped with covers to avoid dispersal due to weather or wildlife.
