Appendix F

ANALYSIS FROM AVAILABLE TECHNICAL INFORMATION ON PIPELINE RUPTURE

By Dr. Robert E. Nickell

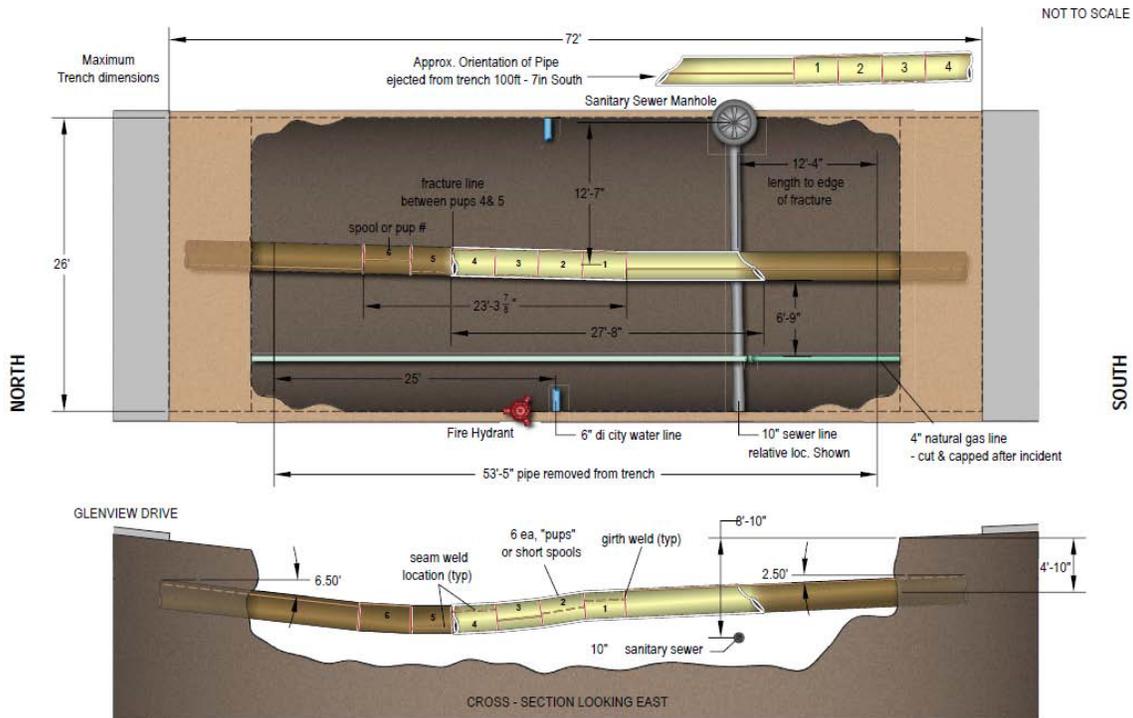
Two observations come to mind from the figure. First, the decision to place such a circumferential-weld-connected system of short piping runs together in a ravine fill section would normally trigger concerns about threats due to earth movement and possibly to the effects of water pressure during heavy rains. This concern would be amplified by knowledge about the location and orientation of the pipeline relative to seismic activity along the Daly City-Serramonte-San Bruno axis, with potential for lateral motion and soil liquefaction. Second, knowing the location of PUP 1 relative to the lateral crossing of the San Bruno city sewer lateral,

even if the seam weld defect was not known, should have triggered a significant concern during any excavation and related disturbances during the sewer replacement project in June 2008.

Figure F-1 Schematic of the failed pipeline segment in both plan and elevation view¹

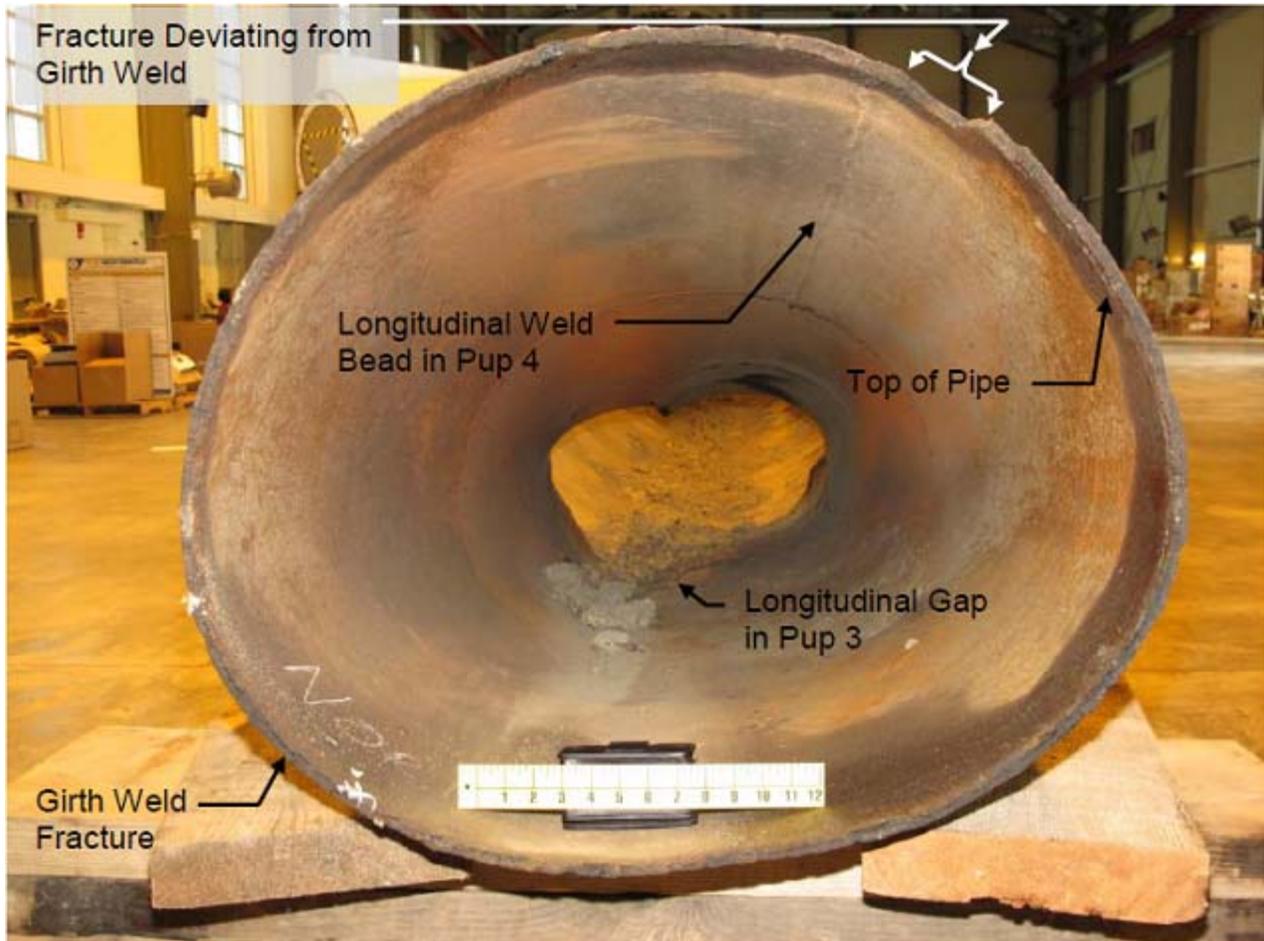
A good check on the longitudinal seam orientations is provided by Figure F2 from Report 10-119, which shows the longitudinal seam weld in PUP 4 looking South. The 15.25-inch clockwise measurement given in the table (about 58 degrees from the top of the pipe) can be directly compared to the angular location of the longitudinal weld bead shown in Figure F2, which appears to be a little more than 45 degrees counterclockwise (looking South) from the top of the pipe.

Figure F-2: Fracture Through the Girth Weld Between PUP 4 and PUP 5 at the North End of the Center Section. The View is Looking South. PUP 3 and PUP 2 are Also Visible.

From the table and the figure, two features can be observed: (1) some attempt was made during installation to offset longitudinal weld seams from one piping segment to the next; and (2) most, but not all, of the longitudinal weld seams were located in the top portion of the pipe segments. With particular regard to the PUP 1 and PUP 2 segments, the location of the longitudinal weld seams are both fairly close to 90 degrees from the top of the pipe segments on the east side of the pipe run. This implies large, unbalanced pressure loads on the east side of the pipe run, such as could be caused by completely backfilling the east side after excavation, without corresponding backfill on the west side, would cause “flattening” on that side of both segments, placing the inside of the pipe segments at those locations (and the deepest portions of any internal defects) in tension.

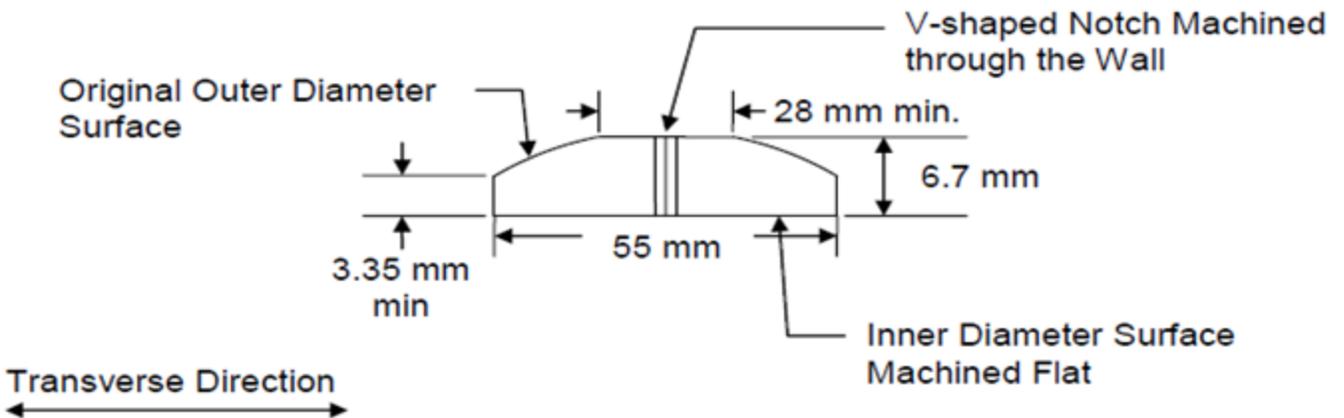
**Figure F3: Schematic of Charpy Impact Test Specimens Taken from Each Piece of Pipe
The Longitudinal Axis of the Pipe Runs In and Out of the Page**

Note LS and LN denote data for the south and north long pipe segments attached to PUP 6 and PUP 1, respectively. P1 through P6 denote data for the PUP piping sections. All of the specimens were taken from base metal and none of the data are for weld or heat-affected zone material. The impact data for PUP 1 (P1) show a variation from 6.0 to 9.0 ft-lb. The specimens are only slightly sub-size, since the full 10 mm dimension was available along the pipe axis, and 6.7 mm out of 10 mm was available through the pipe wall thickness (see Figure 3 from NTSB 11-005).

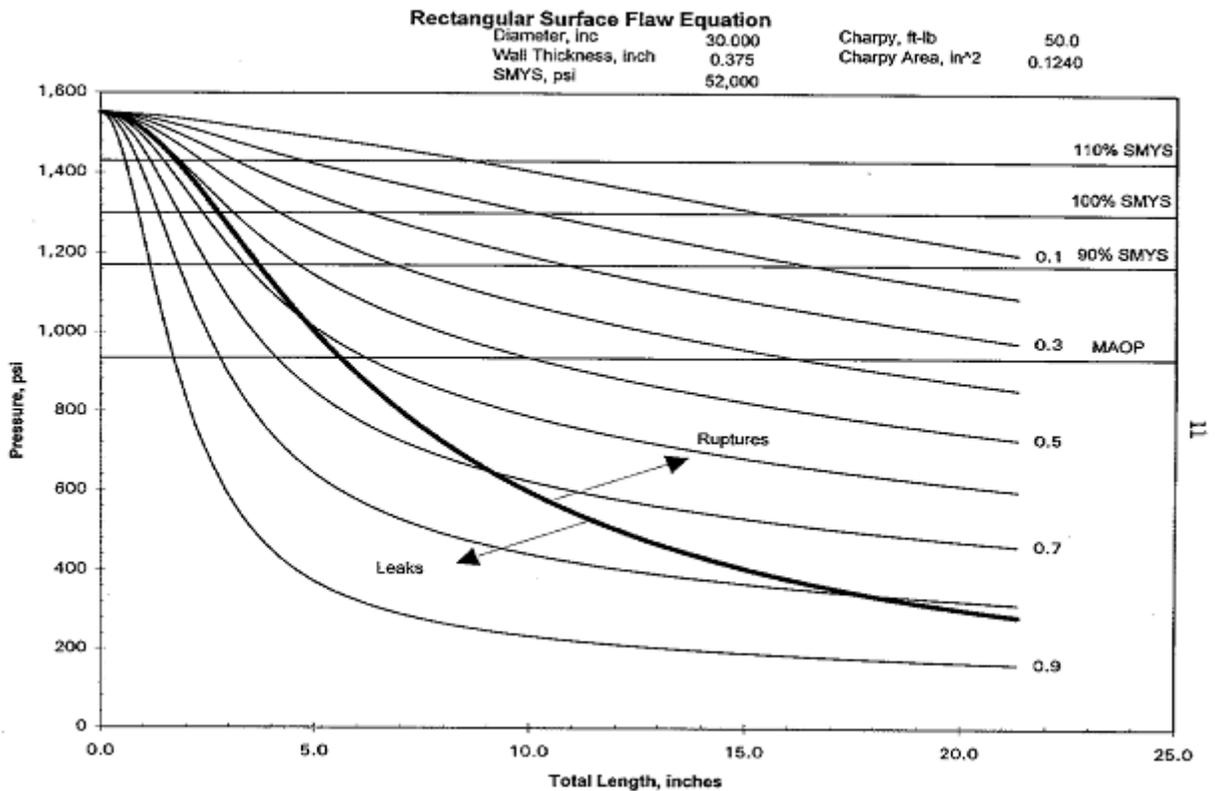
In order to assess the stability of this initial manufacturing defect, Figure F4 (see below) from the paper by Kiefner and Maxey (The Benefits and Limitations of Hydrostatic Testing, by John F. Kiefner and Willard A. Maxey) is used for an initial evaluation. Note the graph has been prepared for a 30-inch-diameter, 0.375-inch-thick-walled pipe, with a yield strength of 52,000 psi and a Charpy impact energy of 50 ft-lb. Note also both the yield strength and the Charpy impact energy are far too high for the PUP 1 segment. Using these unrealistically high values, the figure shows that, for an operating pressure of 400 psi, even with a defect 50 to 55% across the wall and infinitely long, no leakage or rupture will occur.

Even with more realistic material property assumptions, an infinitely-long axial defect on the inner surface of the pipe that extends of the order of 50% across the wall can be shown to be stable. With an approximation to the Mode I fracture toughness established at around 45 ksi $\sqrt{\text{in}}$, or even slightly lower for weld metal and heat-affected zone material, that stability can be demonstrated, by using the stress intensity factor solutions in Annex C of API 579 (API 579-1/ASME FFS-1, Fitness-For-Service, Second Edition, American Petroleum Institute, July 2007), with an internal pressure of 400 psi. For an infinitely-long 40% through-wall defect, the applied stress intensity was calculated to be about 22 ksi $\sqrt{\text{in}}$; for an infinitely-long, 60% through-wall defect, the applied stress intensity was calculated to be about 50 ksi $\sqrt{\text{in}}$. In other words, for an infinitely-long internal surface defect, instability would be expected with a defect depth of the order of 60% of the wall thickness. Therefore, an initial longitudinal seam weld defect in PUP 1 that extended the full length of that piping segment (about 44 inches) and which extended through the wall on the order of 50 to 55% would have been marginally stable and have survived fifty or more years of service operating at MAOP.

Figure F4: Impact of Test Pressure Levels on Margin of Safety

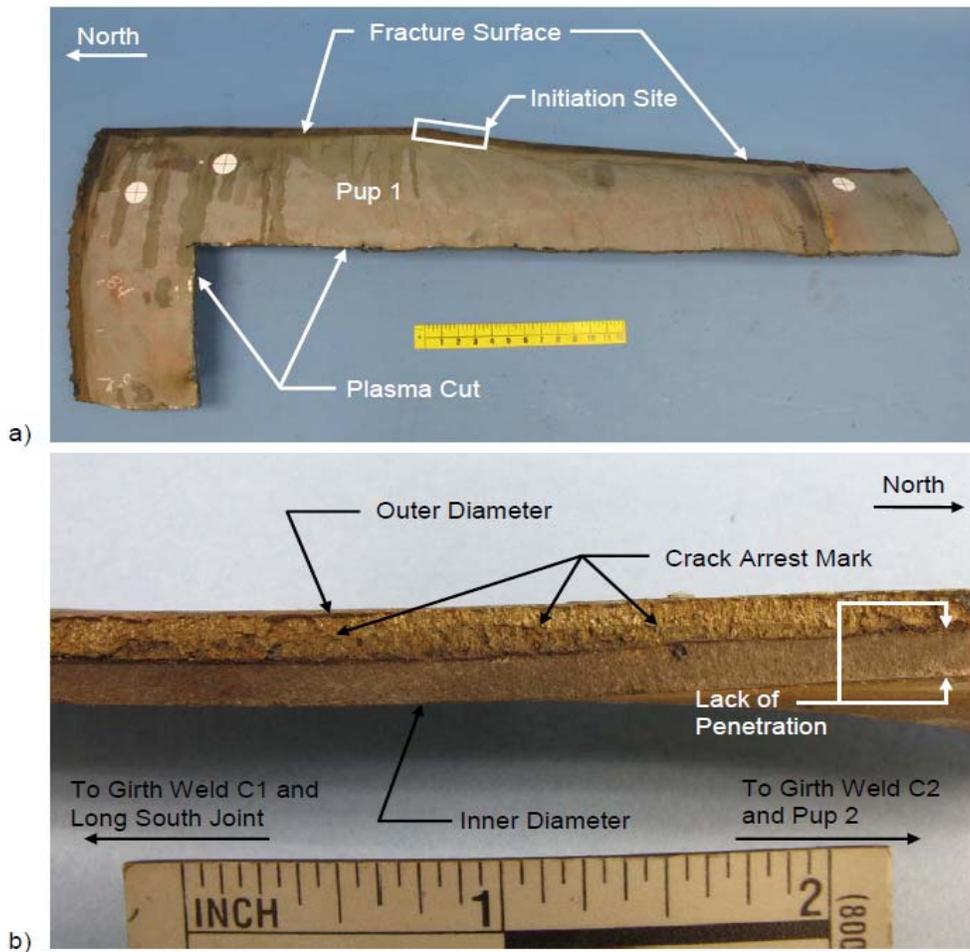
Figure F6

As a point of discussion of this effect, in the NTSB metallurgical Report No. 10-119, the longitudinal weld seam on the relatively long run south of PUP 1 is readily visible and would have been readily visible during the excavation for the sewer replacement project. That particular longitudinal seam was located near the top of the pipe segment (see Table 1), while the longitudinal weld seam for PUP 1, which probably would not have been visible, was located at about 70° from the top of the pipe on the east side of the piping run. NTSB Report No. 10-119 fixed the initiation point for the failure at the PUP 1 longitudinal seam roughly half way between the connections to the south end long run and PUP 2 (see Figures 33a and 33b from NTSB Report No. 10-119, shown below in Figure F6).

Figure 33: a) Counterclockwise half of pup 1 longitudinal fracture with the location of the crack initiation site indicated; b) cross section view of the longitudinal seam at the initiation site.

Note Figure 33b of the longitudinal weld cross section at the initiation site shows the initial 50 to 55% lack of weld penetration through-wall defect, with no clear evidence of cyclic crack growth extension of that defect. Also shown in the figure, without much explanation, are what are referred to as fairly localized “crack arrest marks” near the initiation site. These marks could be interpreted as stable extension of the initial defect, caused by a single event, out to somewhere in the neighborhood of 75 to 80% of the wall thickness.
