Brake Issues on North County Transit District's (NCTD) "Sprinter" Light Rail Vehicles

Paul King
Deputy Director, Office of Rail Safety
Safety and Enforcement Division

March 21, 2013

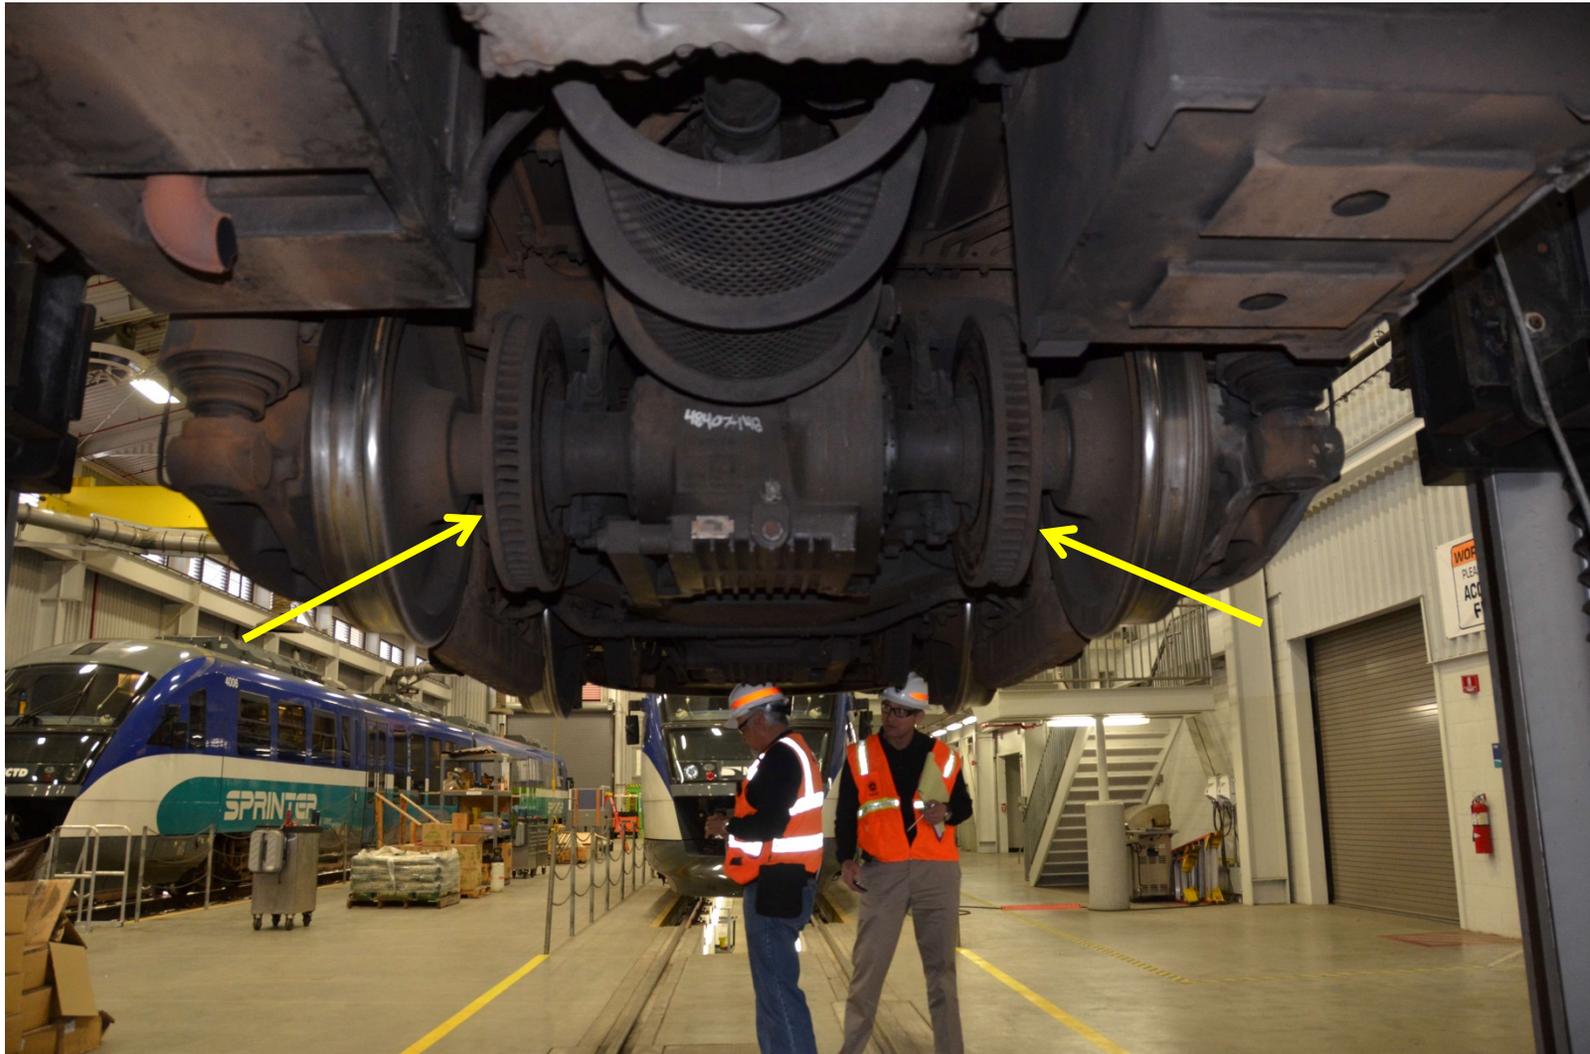
Front powered truck axle, showing brake rotors

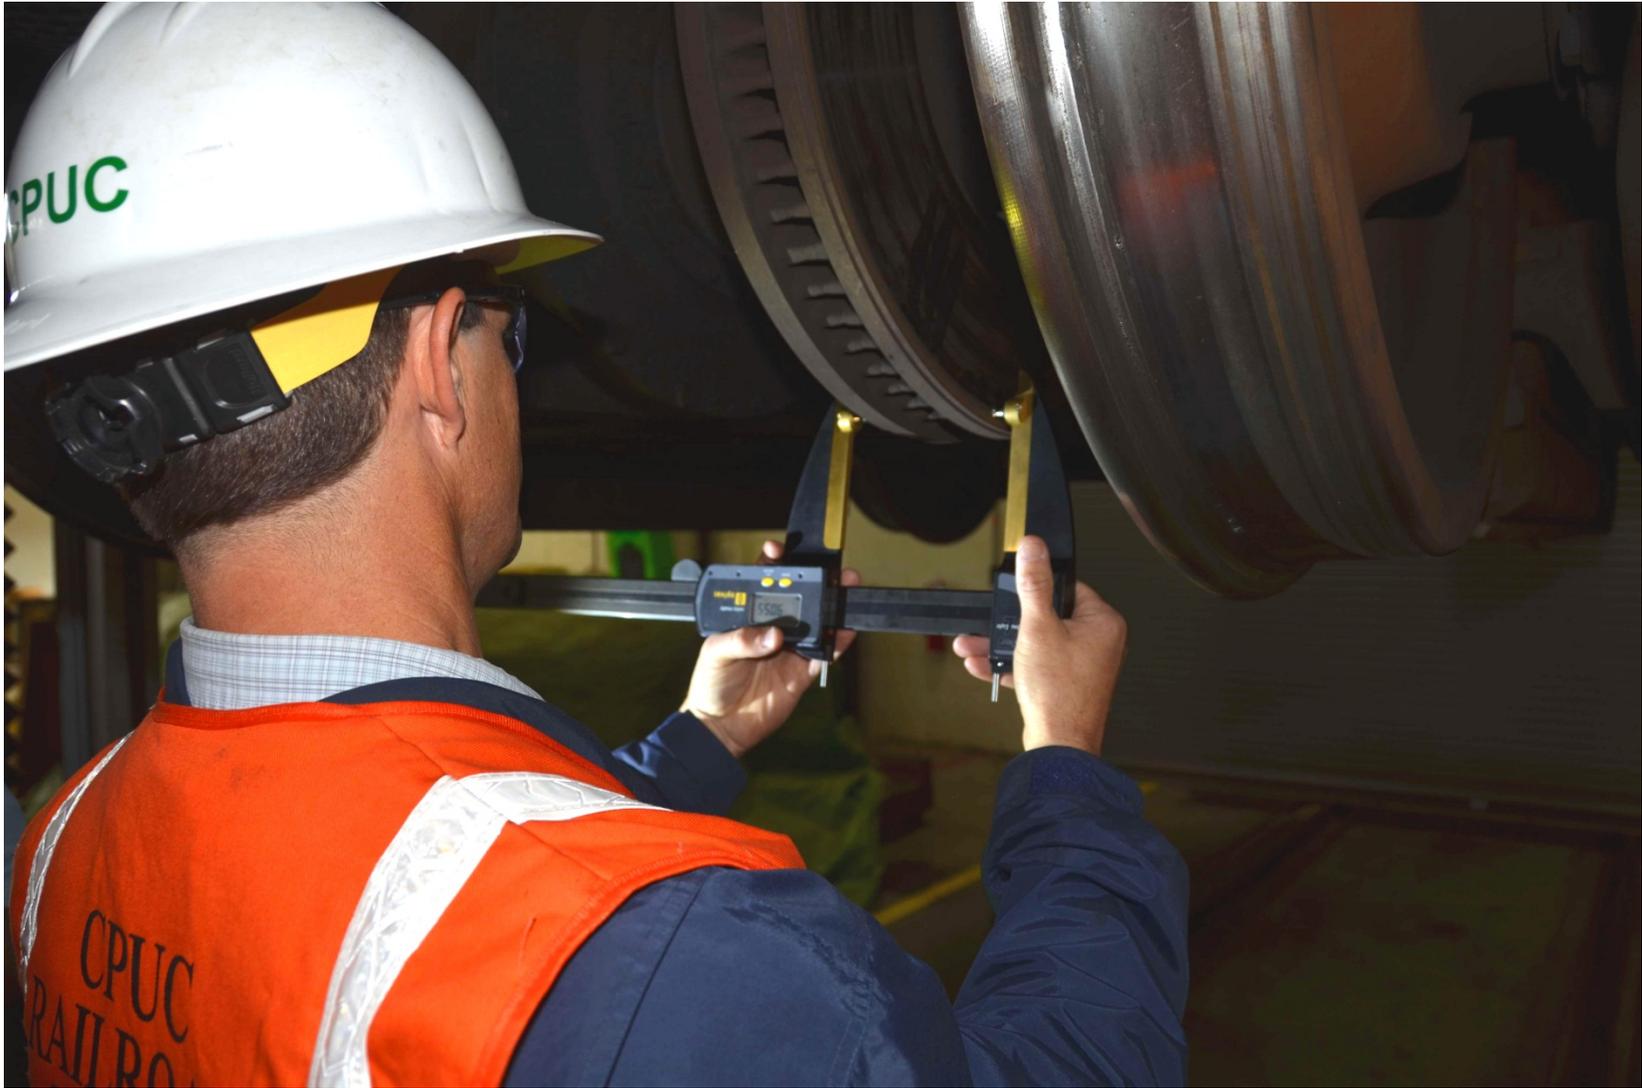
SED inspector measuring powered truck axle rotor wear

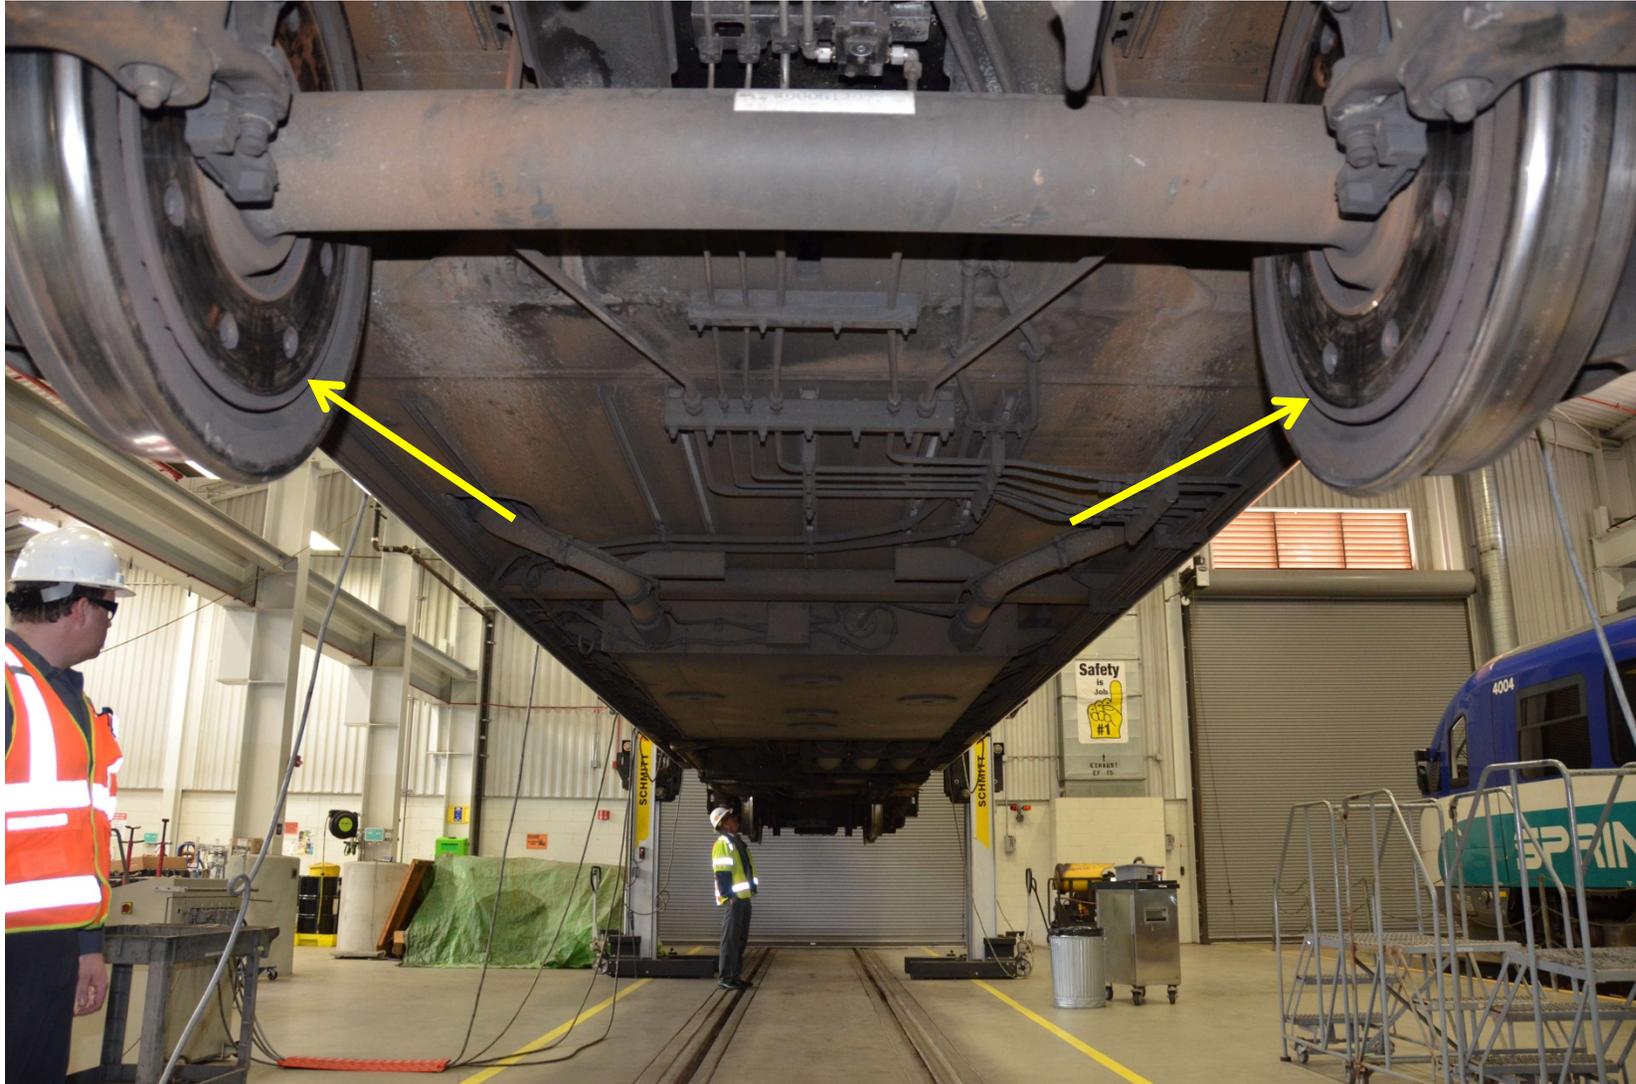
Center non-powered truck axle, showing brake rotors

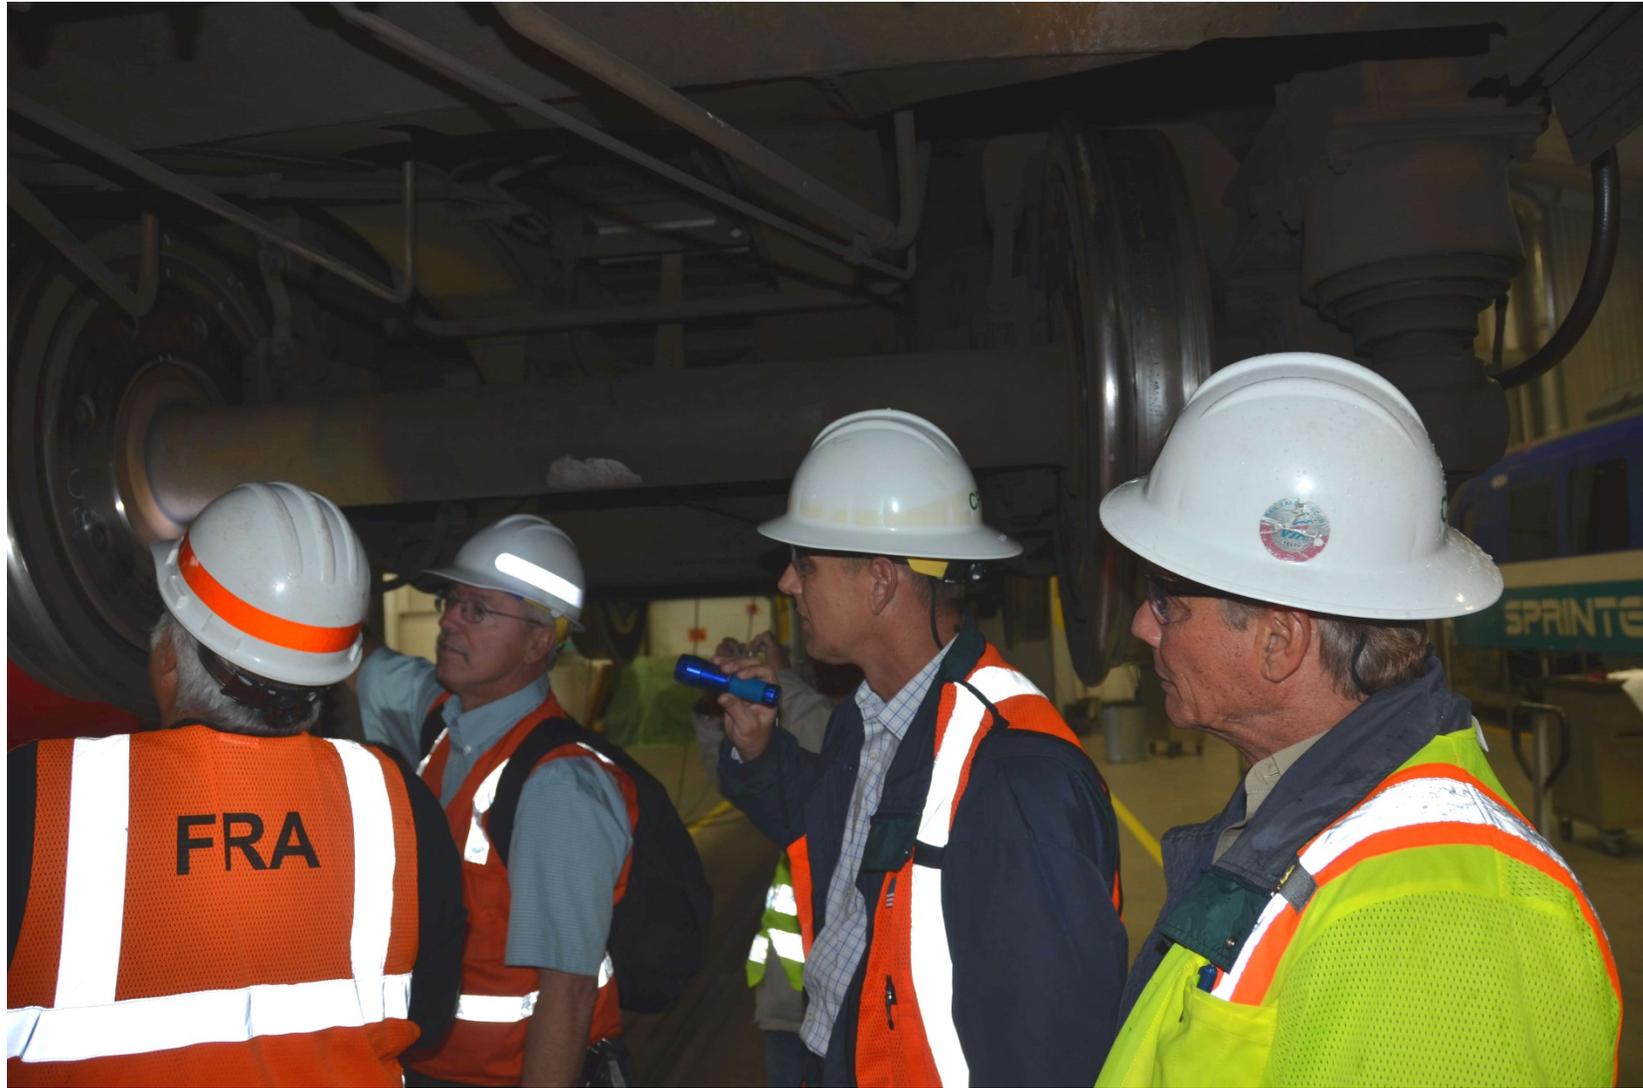
SED inspectors showing FRA inspector excess wear rotors

- March 7, 2013, SED letter to NCTD:
 - Rotors must be replaced immediately.
 - Continued operation with rotors beyond wear limit:
 - Unsafe by manufacturer's standards.
 - Violation of CPUC General Order 143-B.
 - Subject to penalties under PU Code sections.

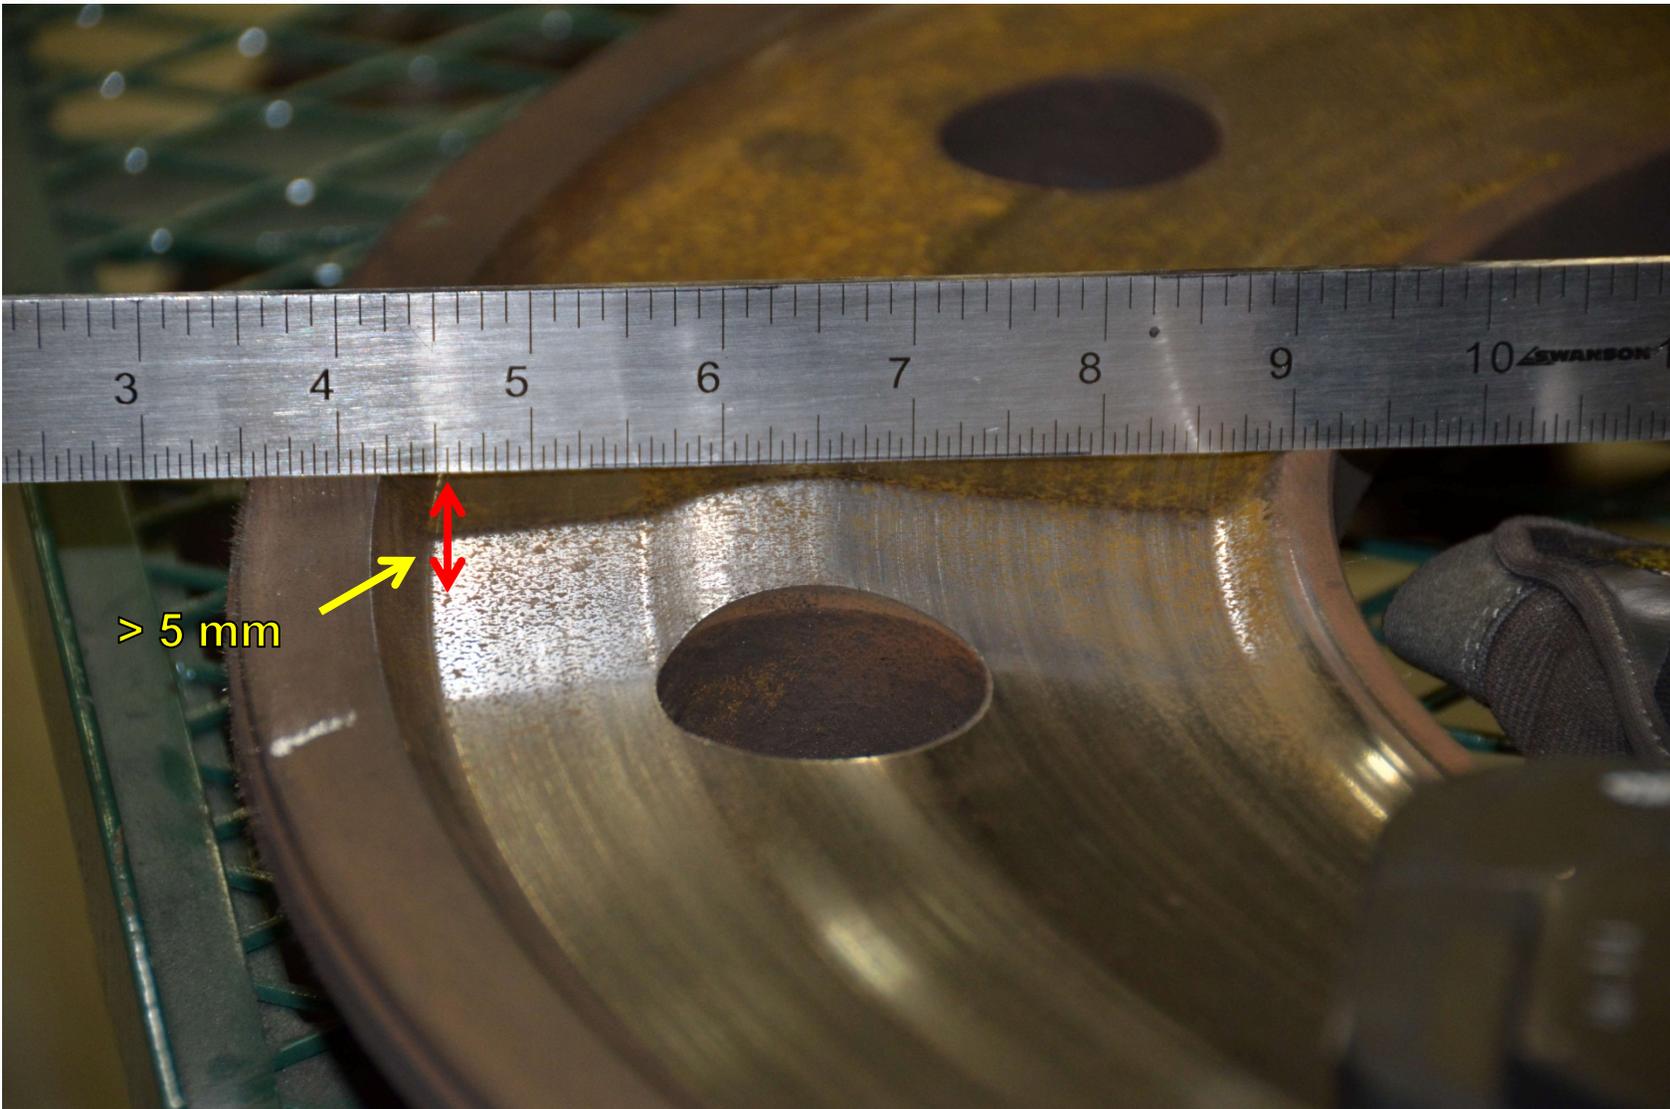
Center-truck brake rotor wear, greater than 5 mm

- “The maximum admissible wear per wheel-mounted brake disc is 5 mm.”
- “The deepest point of the hollow wear or scoring must not exceed the lower deviation of the operating limit dimension.”

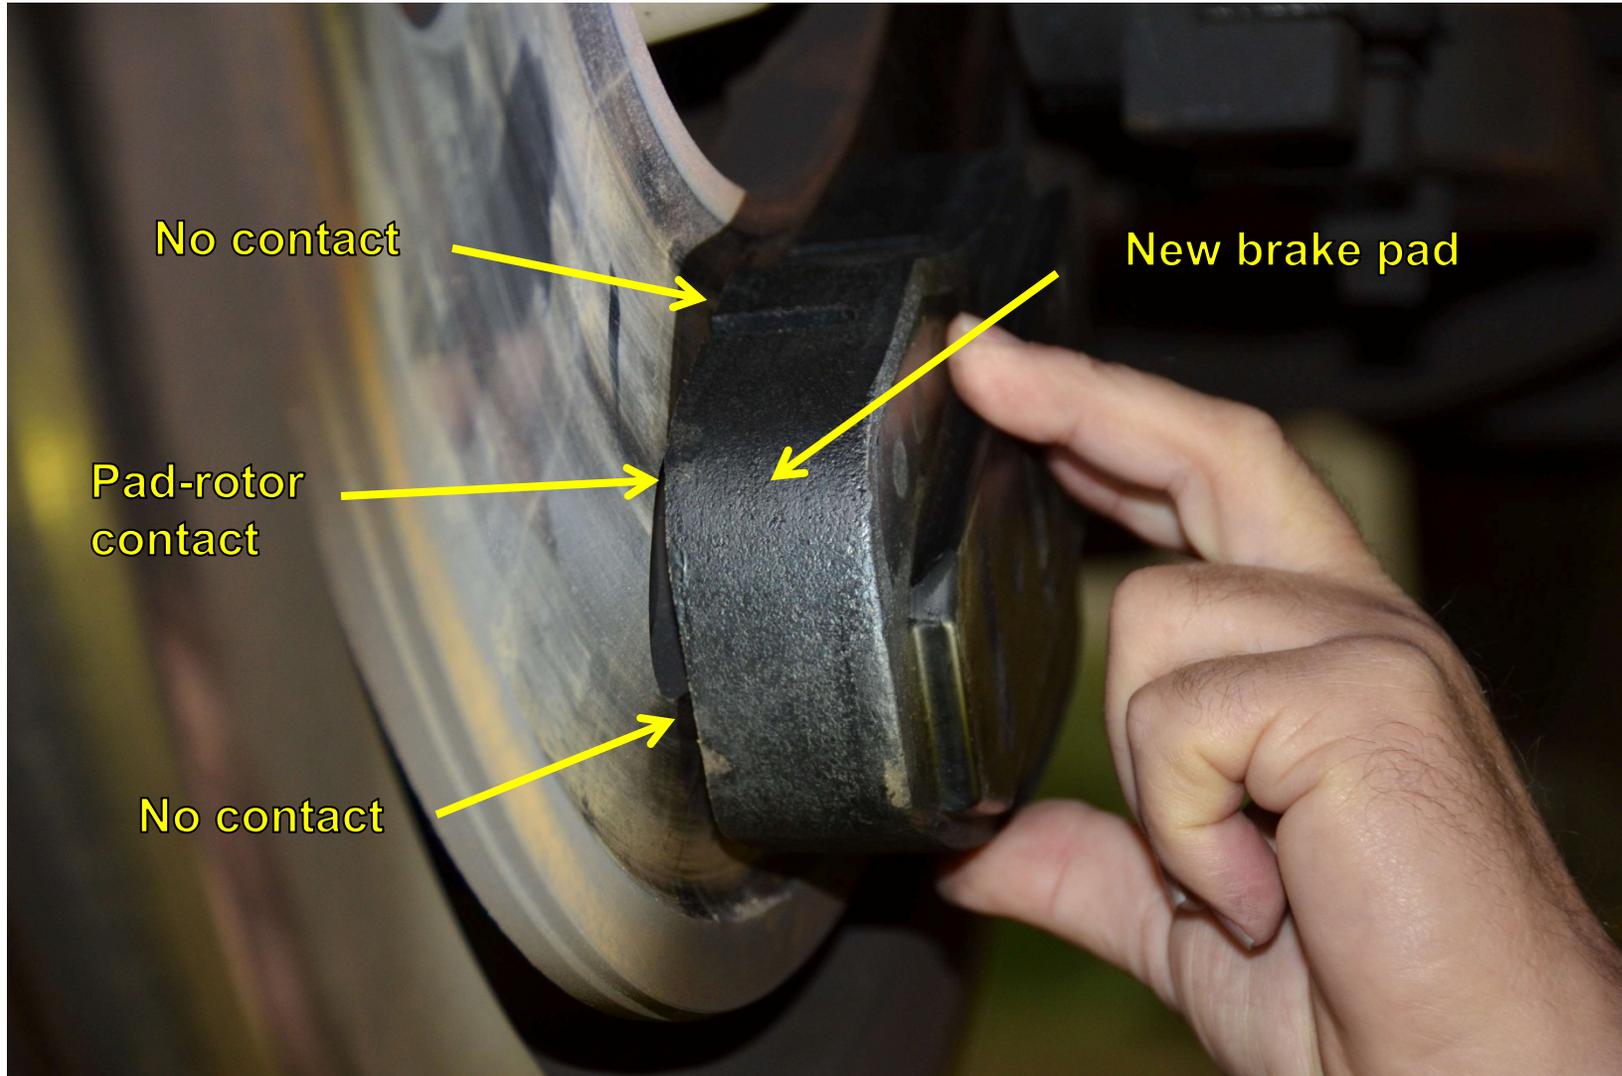
Illustration of minimal pad-rotor contact with new pad

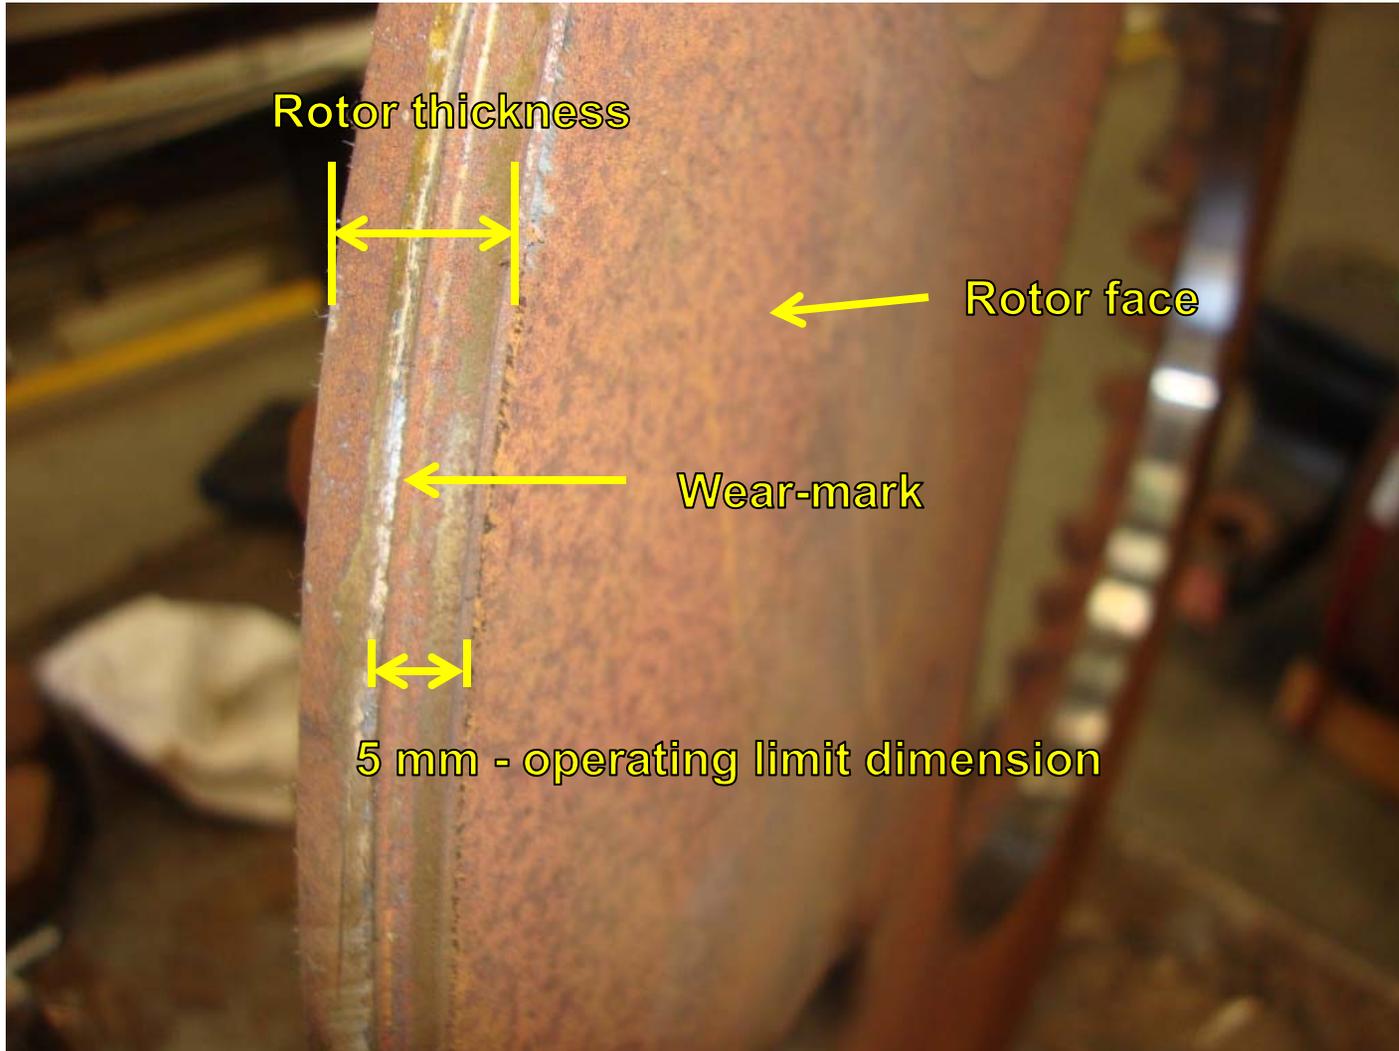
Edge of new rotor showing thickness, wear limit mark

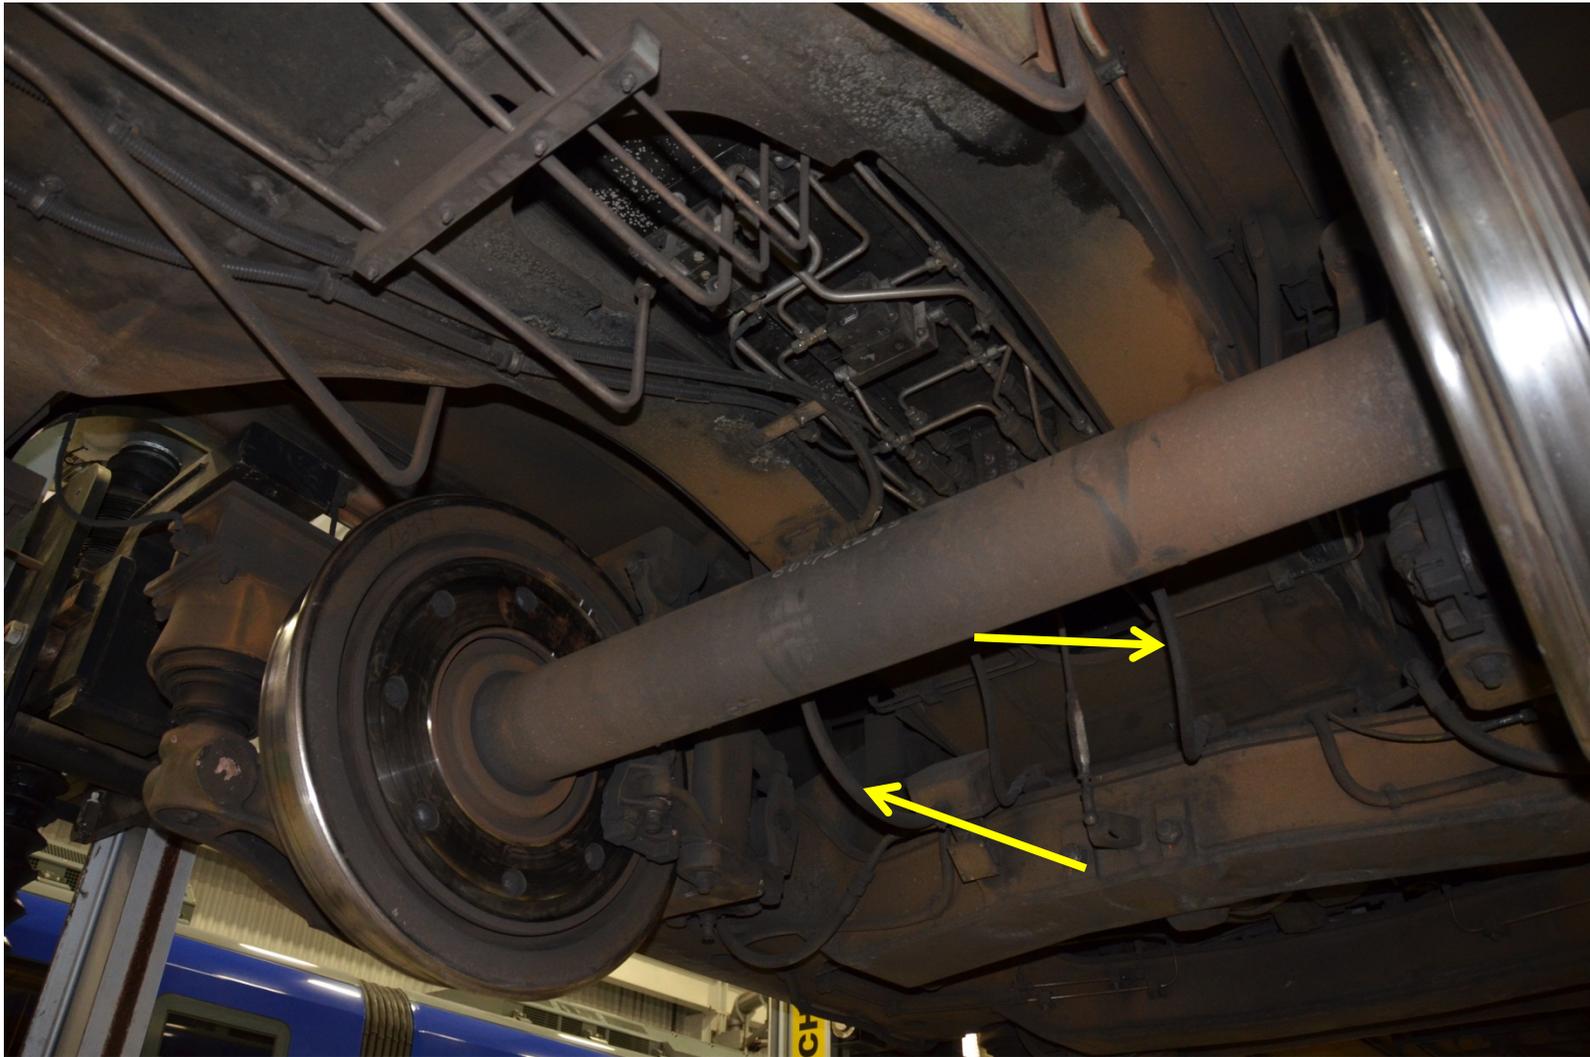
Proximity of primary air lines for brakes – fails to safe

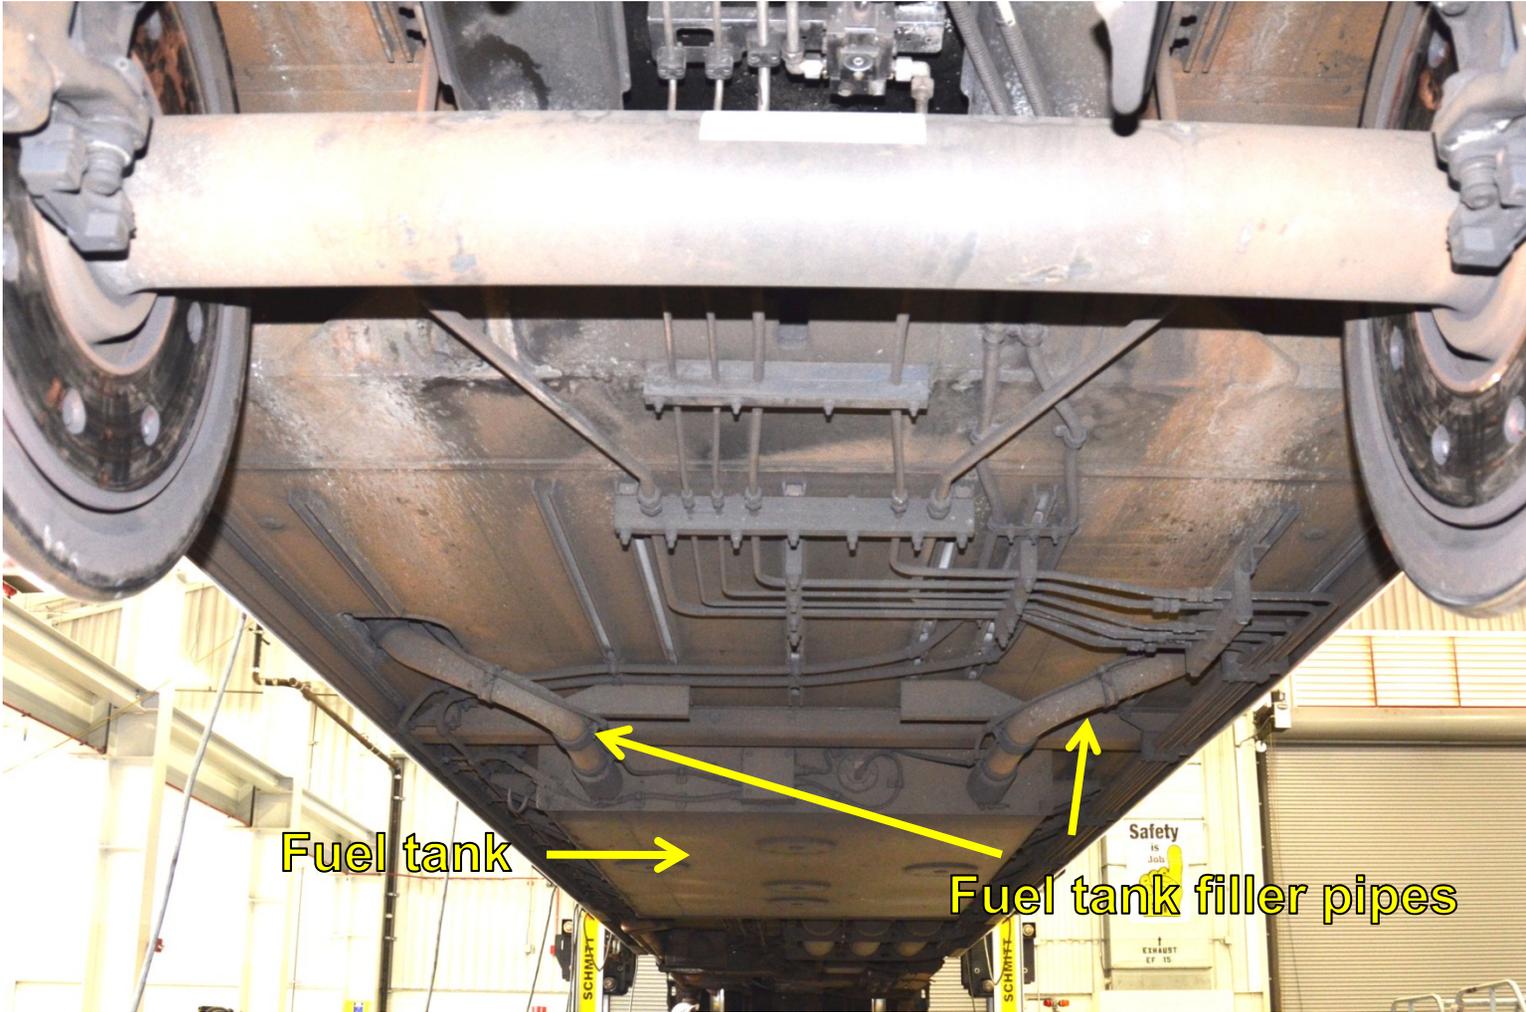
Proximity of rotors to diesel fuel tank, filler pipes
