# LA Metro Safety Issues at the Blue Line-Expo Line Rail Junction

**Daren Gilbert**

***Program Manager, Rail Transit and Crossings Branch***

September 13, 2012

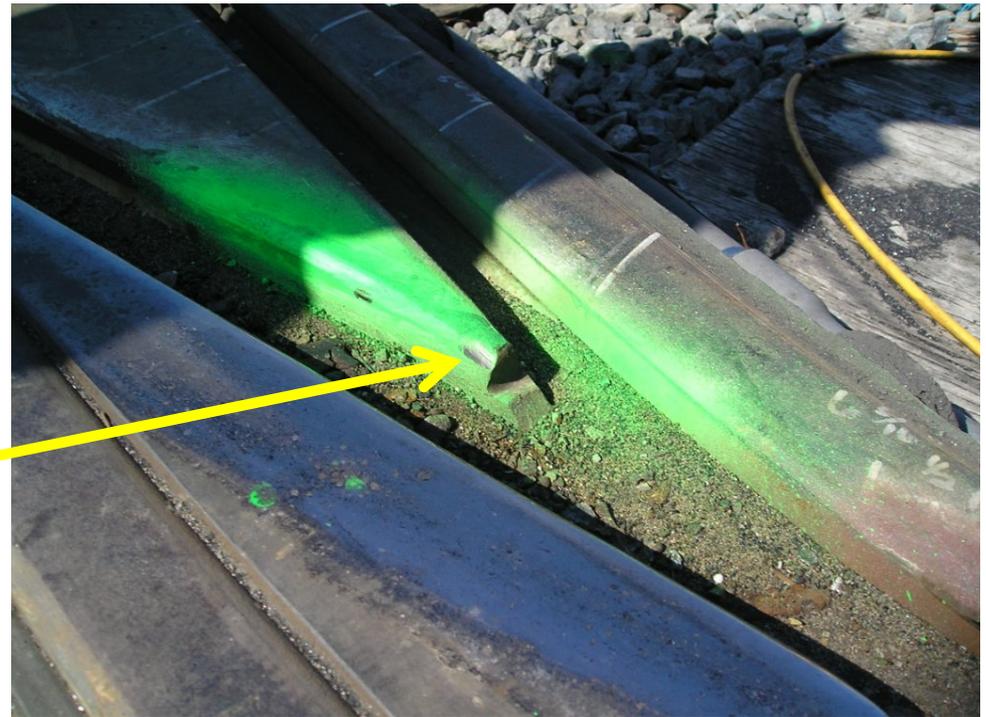
- Frog point close-up.
- Evidence of wheel-flange contact.

- LRVs' eastside wheels strike and damage the eastside frog point.
- Uncorrected continuing damage would increase the potential for derailment through:
  - Wheels climbing over the frog.
  - LRV wheel and brake gear damage.
- Expo's modification pushes the eastside wheels over far enough to avoid hitting the frog point.

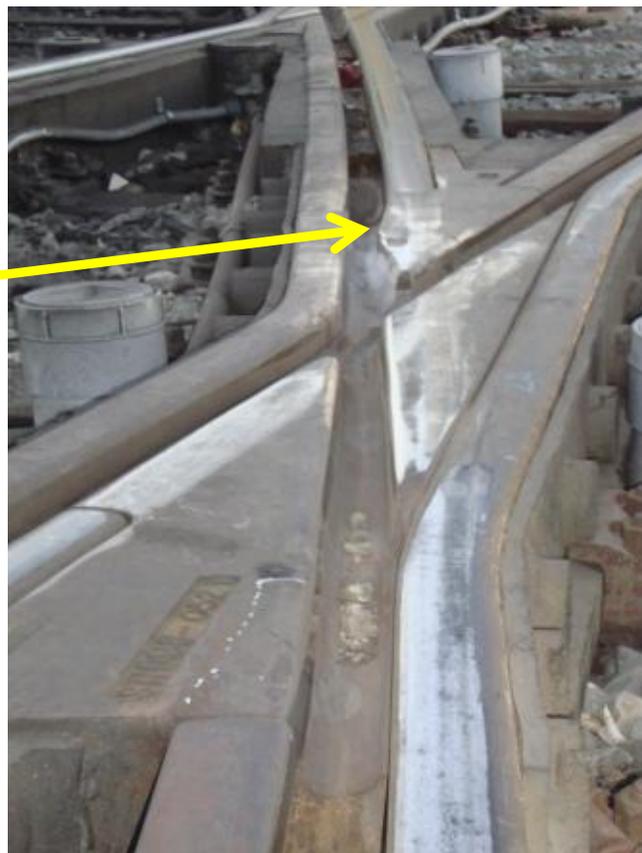
- The modification was a large build-up of metal (welded) on the inside of the rail within the frog's flange-way.
- The build-up shifts the LRV trucks laterally to avoid hitting the opposite frog point.

- The modification was developed by the EXPO Authority.
- The modification is not supported by any standard practice in the U.S.
- The manufacturer of the frog opposed this modification.

- Staff is aware of two occasions when the frog weld build-up chipped and fractured.
- On March 23, 2012, and June 29, 2012, ultra sonic testing identified weld fractures.
- The internal fractures became exposed.
- The fractures caused chipping and cracking within the first layers of the weld, resulting in visible defects.
- These fractures resulted in the modification being re-welded.

- Interim Safety Measures
  - 5 mph speed restriction for LRVs traversing the diamond.
  - Two additional visual inspections per week of the frog and modifications, plus other already-required inspections.
  - Monthly ultrasonic inspections of the welds.
  - Detailed maintenance procedures for the modification, including wear and condemning limits.
  - Immediate notification of CPUC staff of any defect or anomaly detected, or any incident at the location.
  - Advance notice to CPUC staff of inspections and ultrasonic testing.

- Path Forward
  - CPSD staff has recommended that LACMTA/EXPO replace this diamond.
  - CPSD Director, General Hagan, issued a directive to replace the diamond in a July 13, 2012, letter.
  - LA Metro, Expo, and CPSD staff subsequently met and agreed to have an independent track expert evaluate and recommend correction.
  - CPSD staff, LA Metro, and EXPO interviewed and selected track experts who could assess the junction and provide corrective actions.
  - The track experts reviewed the site last week.
  - Staff awaits a report of the findings and recommendations.

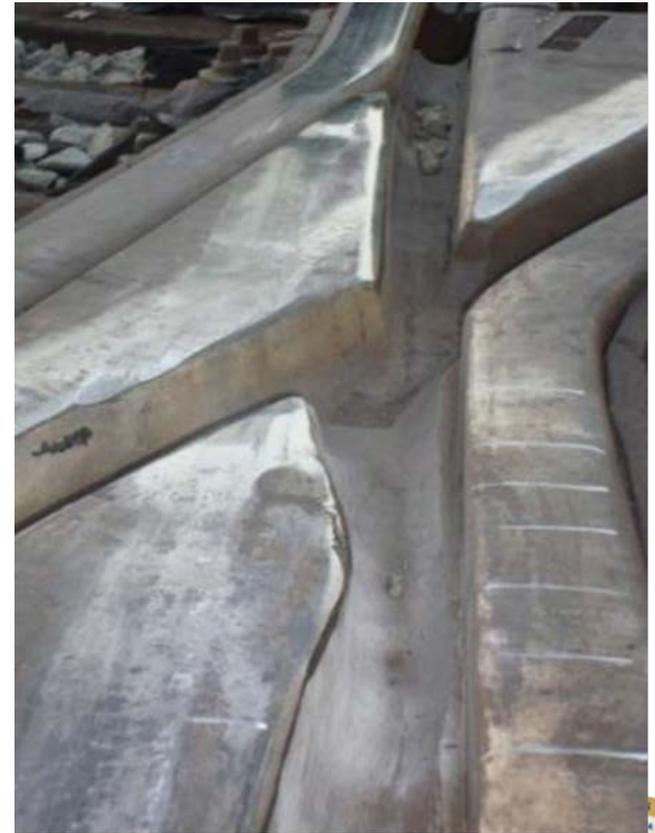
- Non-standard modification.
- Ongoing inspection and maintenance.
- Undetected failure compromising safety.
- Long-term harm to LRV fleet.
- Failure or maintenance disrupting service.
- Derailment of LRV at frog point.
