# CASF Public Housing Account Site Visit Report

January 25, 2023

Tenderloin Neighborhood Development Corporation

- 939 Eddy St. SF, CA.
- 951 Eddy St. SF, CA.

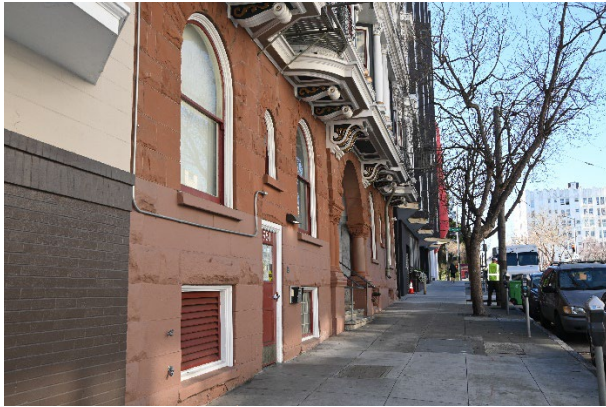
The two sites were a relatively historical architecture multi-story brick building situated near downtown San Francisco in the Tenderloin community (*Figure 1*). The Main Distribution Frame (MDF) for the network system serving the site was securely located in an accessible and well-maintained communication room located on the first floor of the building (*Figure 2*). This MDF served both the 939 Eddy St. and 951 Eddy St. TNDC projects.

Figure 1: 951 Eddy St. TNDC property SF, CA

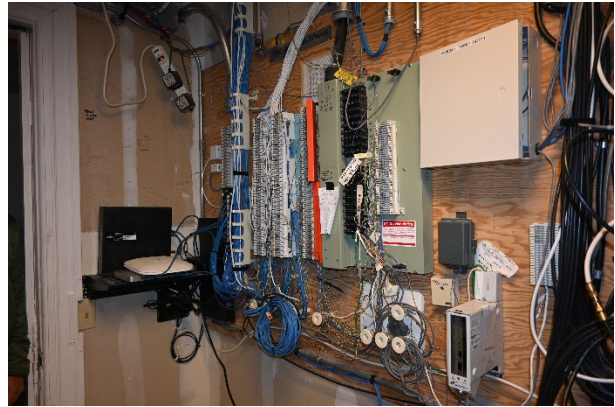
Figure 2: 951 & 939 Eddy St. MDF Room

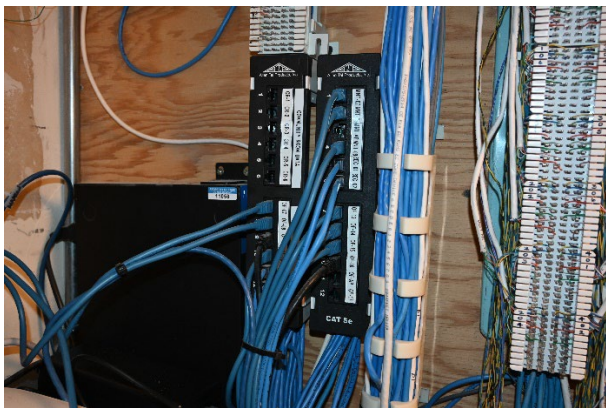
Staff found the equipment installation of the MDF to be adequate with proper securing and anchoring of the network devices to the equipment tray and to the wall and proper cable management via the use of tie-wraps and routing of cables through an organized array of backboard mounted cable raceways to the distribution patch panels with clearly labeled network port assignments for the system switch and interfaced wireless access points being distributed throughout the building (*Figure 3*).<sup>7</sup>

Figure 3: MDF Room cable management and labels

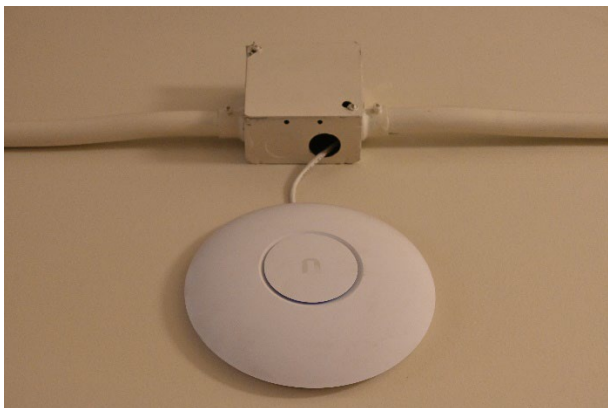
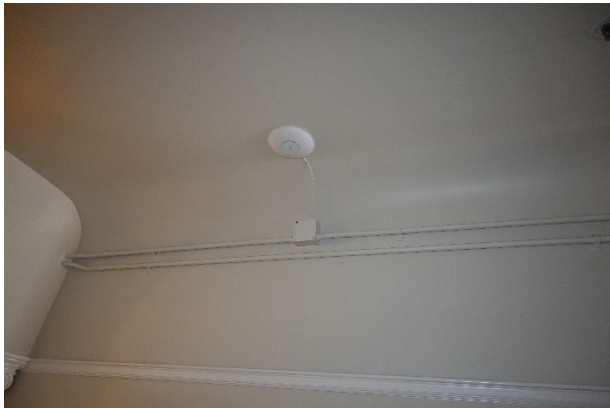
Figure 4: 939 Eddy St. WAP

Site installations *Figure 4* through *Figure 8*, captured by Staff during the site walk, found that the grantee's network vendor followed the required standards during the deployment on both the sites. Staff also found that the grantee had its own network staff to provide assistance for the residents and perform network operations and maintenance (O&M) post-deployment and has been maintaining both sites well.

**Figure 5: 939 Eddy St. WAP**

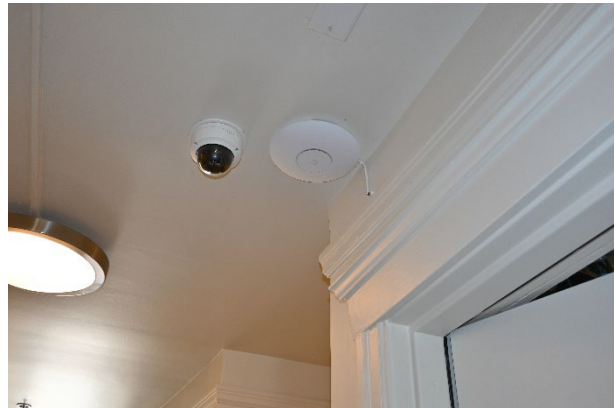
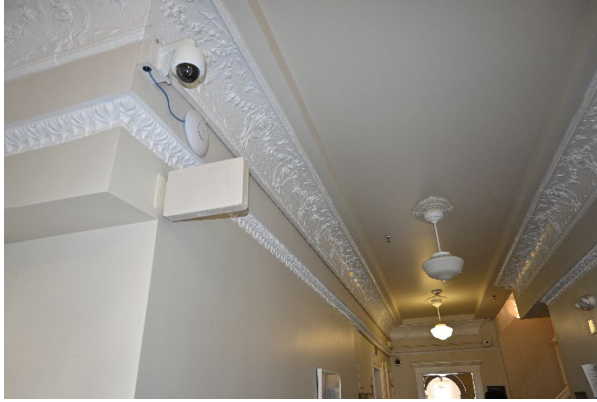
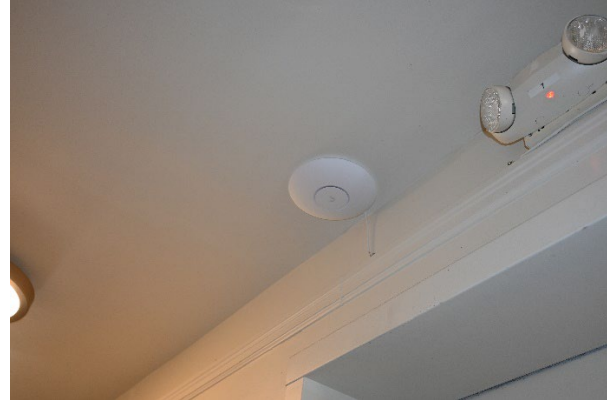
**Figure 6: 951 Eddy St. WAP**

Figure 7: 951 Eddy St. WAP

Figure 8: 951 Eddy St. WAP
