Application of Pacific Gas and Electric Company (U 39 M) for Authority, Among Other Things, to Increase Rates and Charges for Electric and Gas Service Effective on January 1, 2023.	Application 21-06-021
NOT CONSOLIDATED	
Application of Pacific Gas and Electric Company (U 39 M) to Submit Its 2024 Risk Assessment and Mitigation Phase Report.	Application 24-05-008
NOT CONSOLIDATED	
Application of Pacific Gas and Electric Company (U 39 M) for Authority, Among Other Things, to Increase Rates and Charges for Electric and Gas Service Effective on January 1, 2027.	Application 25-05-009

**COMMENTS OF THE PUBLIC ADVOCATES OFFICE
ON PACIFIC GAS AND ELECTRIC COMPANY'S 2024 RISK
SPENDING ACCOUNTABILITY REPORT**

September 29, 2025

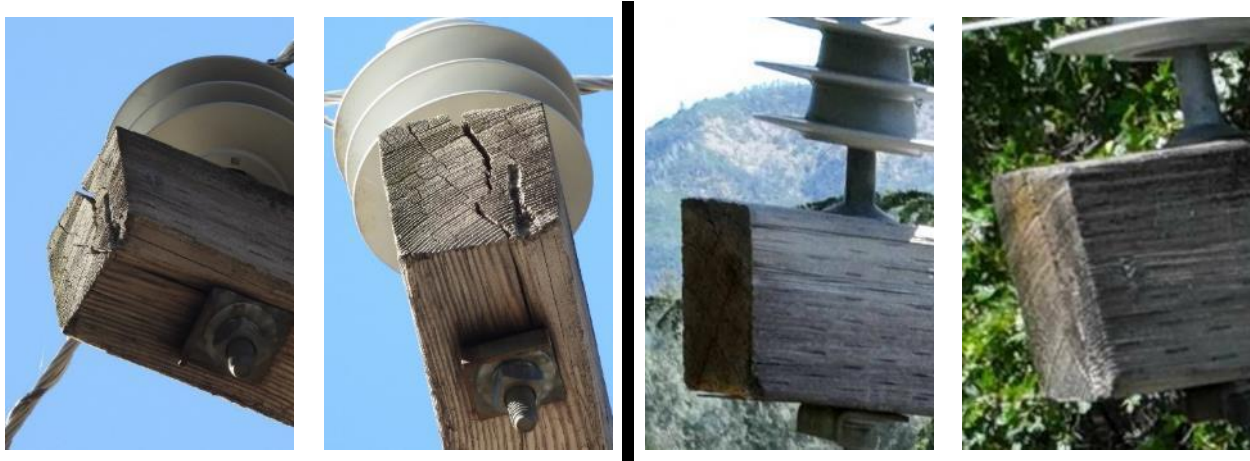
The ISM's crossarm integrity findings observed in 2024 were primarily conditions identified from ground inspections. These findings were often due to the visibility of the defect from the ground that may not have been visible from an aerial photograph or when there were insufficient aerial photographs to see the condition. The following photographs in Figure 16 provide examples of conditions identified by the ISM that were not captured in aerial photographs.

Figure 16: This condition was not identified by PG&E aerial inspections. Left: Photos taken during ground inspections show damage to the crossarm. Right: The crossarm damage is difficult to see from aerial photographs.
