**CALIFORNIA PUBLIC UTILITIES COMMISSION**  
**Safety and Enforcement Division**  
**Wildfire Safety and Enforcement Branch**

**Incident Investigation Report**

**Incident Number:** E20220908-02 (Mosquito Fire)

**Regulated Utility Facilities Involved:** PG&E's Middle Fork #1, Oxbow Tap and Weimar #1 60 kV transmission circuits

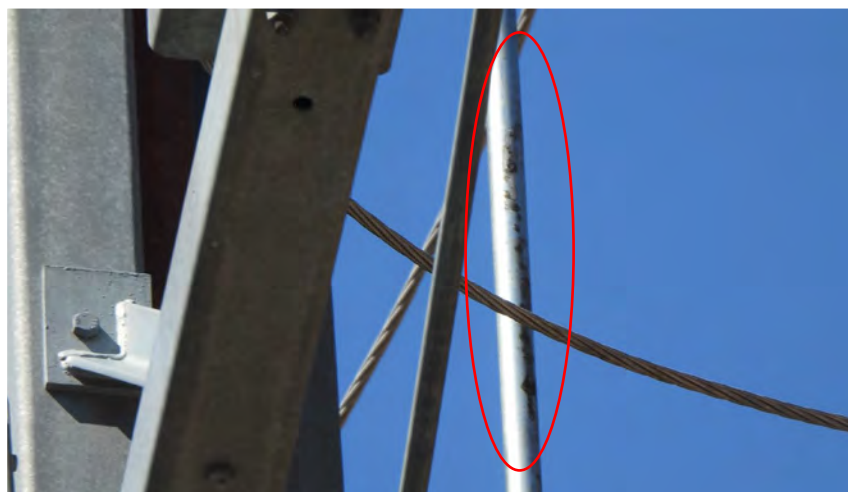
from the pole. PG&E photographs also show the lower jumper contacting or essentially contacting the control rod (Figure 10) and evidence of scorch marks on the rod (Figure 11).

Figure 11: Control rod next to Switch 47 jumper.  
Red indicates damaged section of control rod.<sup>41</sup>

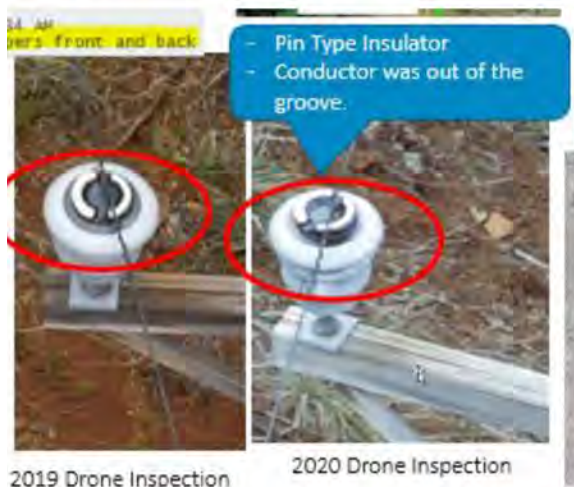
Figure 33: Loose tie wire (left) and resulting pole fire (right)<sup>123</sup>

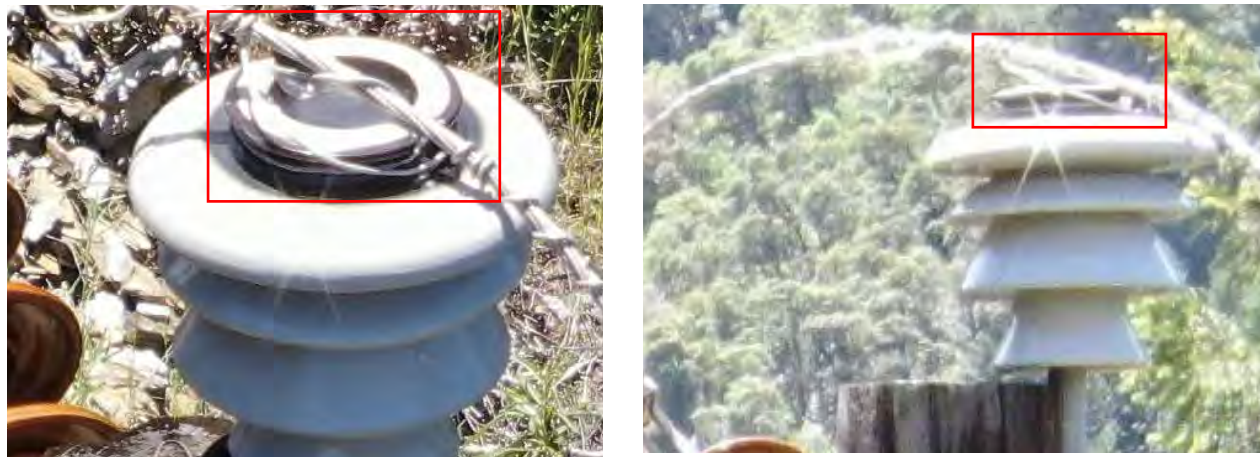
PG&E's June 9, 2022, Transmission notification 123833466 for Pole 14/186 states "LEFT POLE TIE WIRE NOT TO STANDARD."<sup>128</sup> PG&E also refers to the left pole as Pole 14/186(A), and the right pole as Pole 14/186(C).<sup>129</sup> Figure 35 below shows this loose tie wire.

**Figure 35: PG&E photos of loose tie wire, Pole 014/186(A), May 26, 2022<sup>130</sup>  
(SED outlined in red the loose tie wires)**

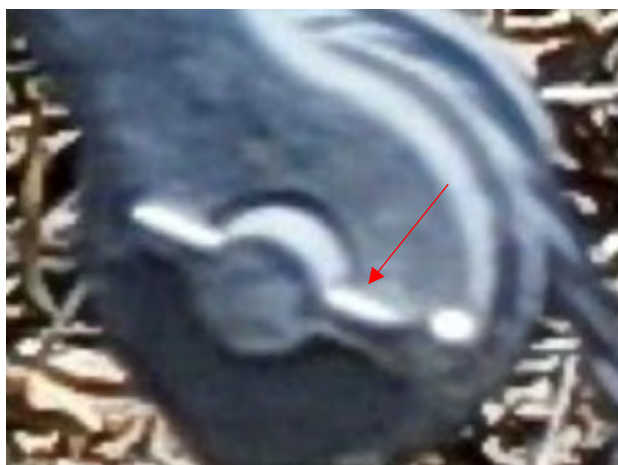
Figure 42: Partially seated cotter key at Pole 009/131 on May 26, 2022<sup>187</sup>  
(red arrow shows unseated section)
