CALIFORNIA PUBLIC UTILITIES COMMISSION
Safety and Enforcement Division
Wildfire Safety and Enforcement Branch

Incident Investigation Report

Incident Number: E20220905-03 (Fairview Fire)

Regulated Utility Involved: Southern California Edison Company (SCE)

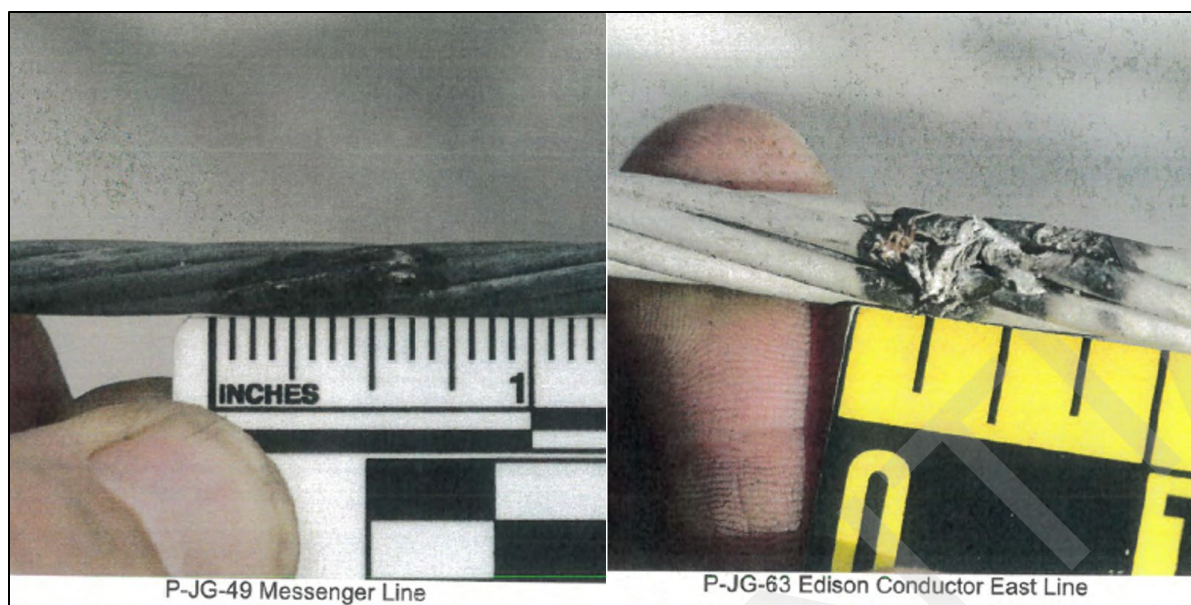
SED obtained the CAL FIRE report from SCE on December 1, 2023. The CAL FIRE report found SCE in violation of the California Penal Code, California Public Resources Code, California Health and Safety Code, and GO 95, Rule 31.1. CAL FIRE determined the cause of the fire was the East electrical line¹⁶ at the Incident Span contacting the Frontier Communications messenger cable, which arc and caused sparks to fall and ignite the vegetation below.¹⁷ CAL FIRE observed the conductor and messenger line showing signs of damage and molten metal, indicating that the two lines made contact, as shown in Figure 2 below.

Figure 2: Photographs from CAL FIRE's report of the Frontier Communications messenger cable and SCE's East phase conductor.¹⁸

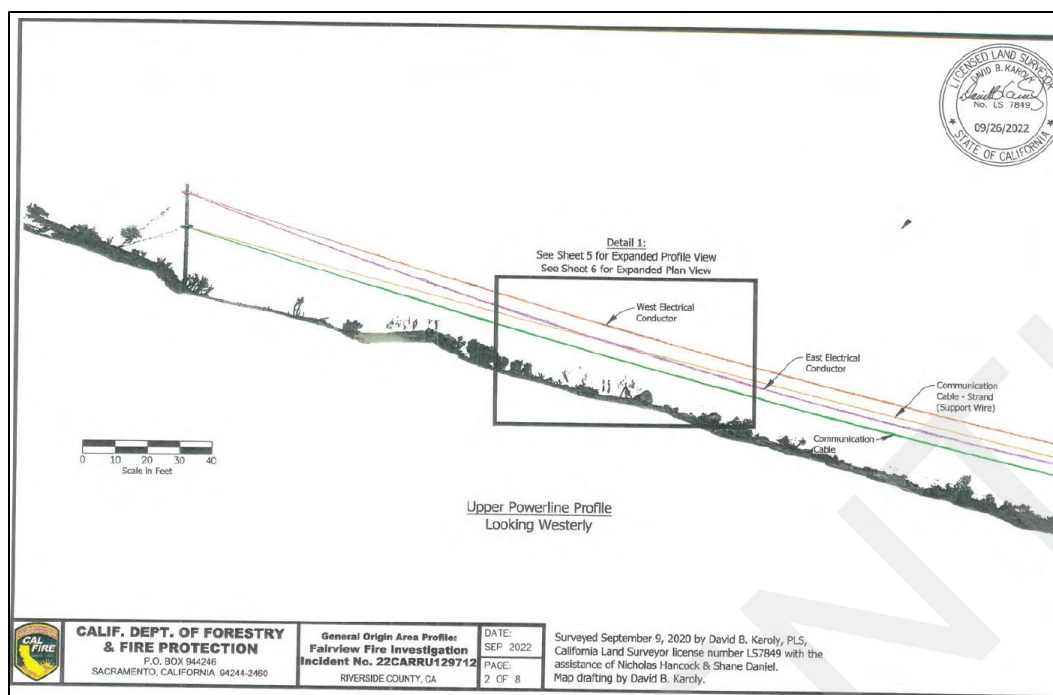
Figure 3: CAL FIRE LiDAR scan of the Incident Span.¹⁹

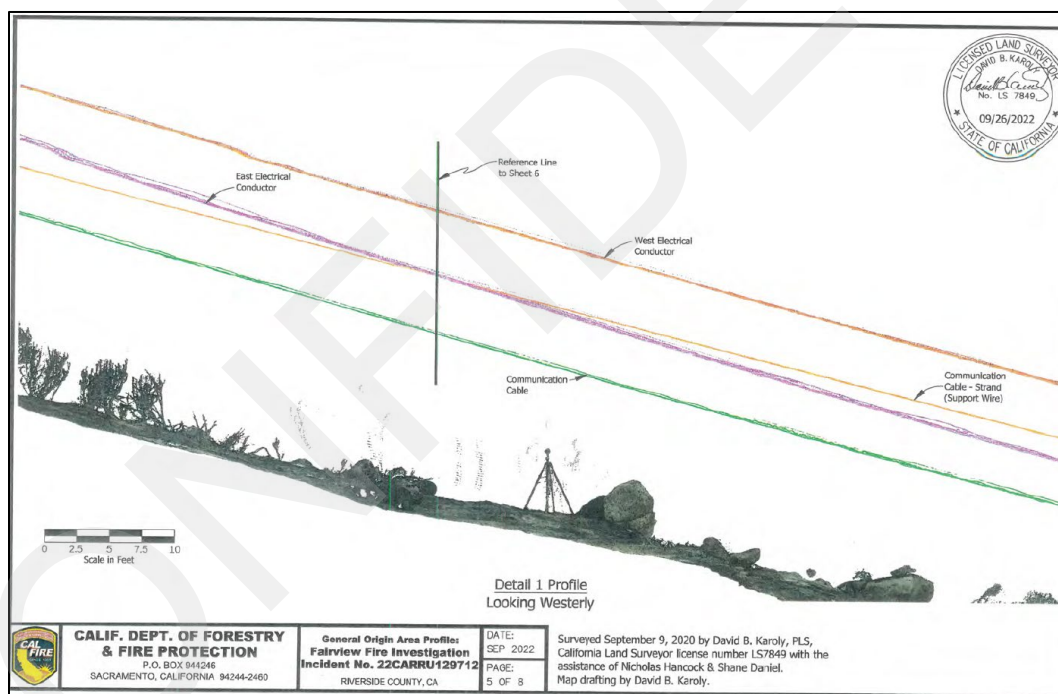
Figure 4: Detailed view of CAL FIRE LiDAR scan of the Incident Span.²⁰

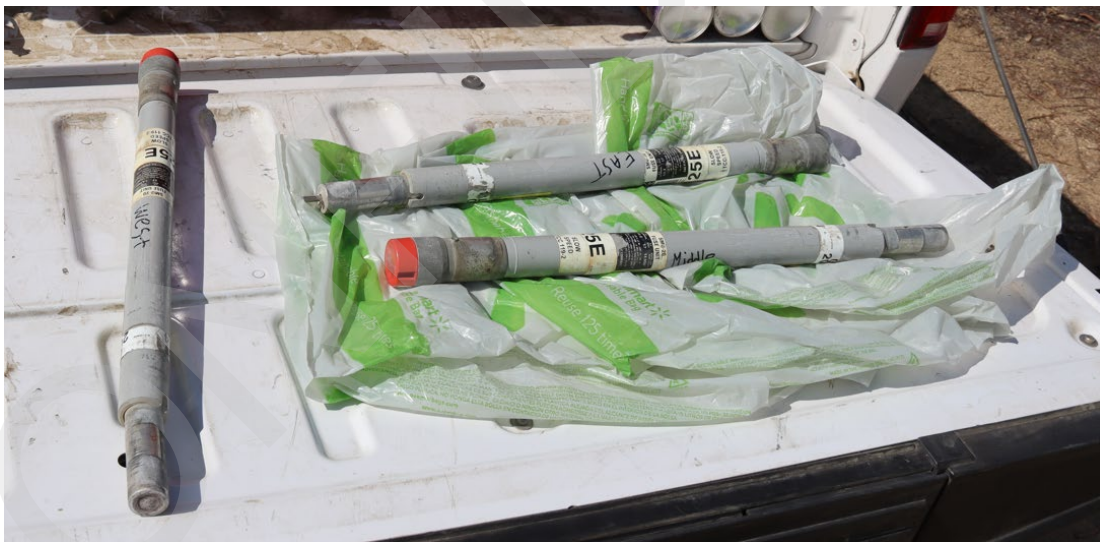
SCE staff stated that the only evidence SCE collected were three “power fuses” which SCE removed from Pole 4905500E. SCE staff explained that power fuses are used in HFTDs because they are non-expulsive and do not result in blowing out flames or creating sparks when they activate. SCE staff did not know what caused the East phase fuse to activate. The three fuses are shown in Figure 10 below.

Figure 10: East, Middle, and West phase fuses collected by SCE from Pole 4905500E.

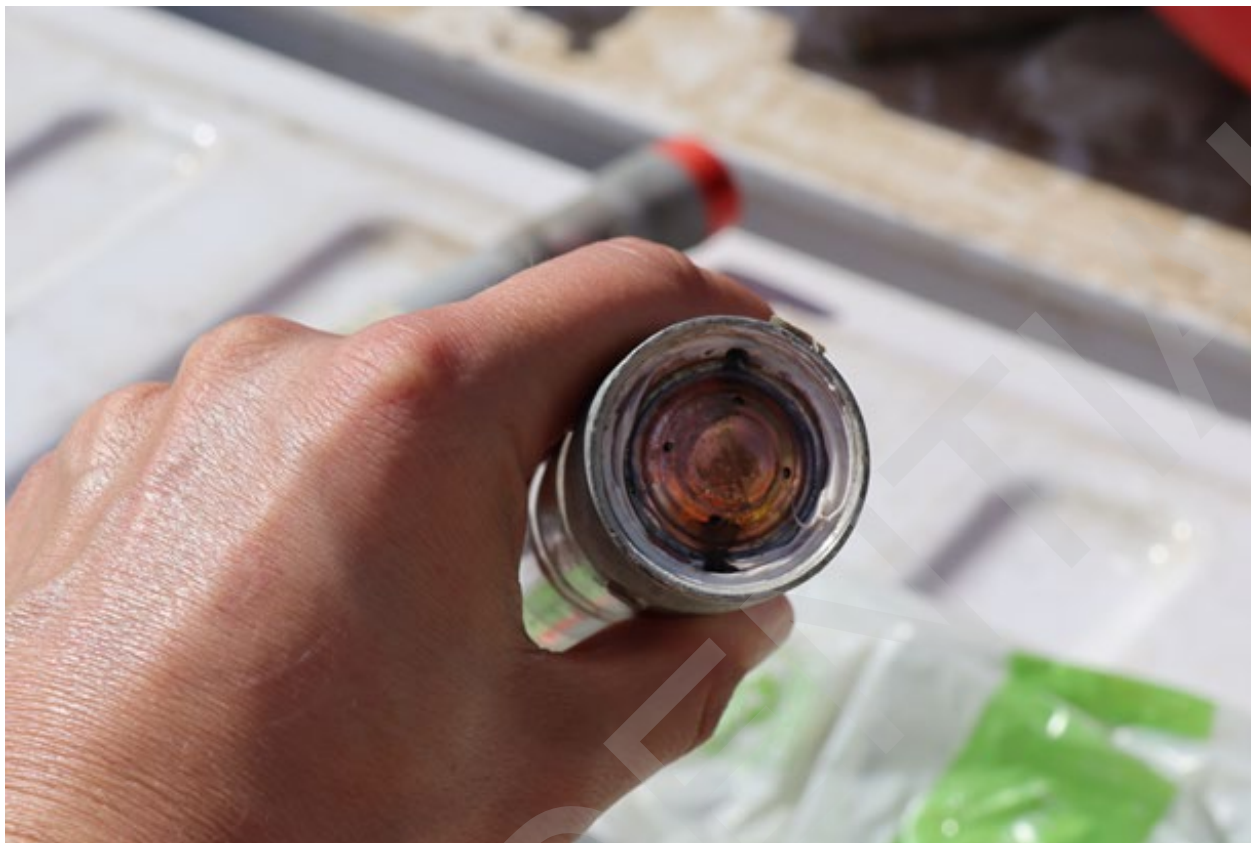
Figure 11: The East phase fuse is missing the red cap, indicating that the fuse activated and opened the circuit.

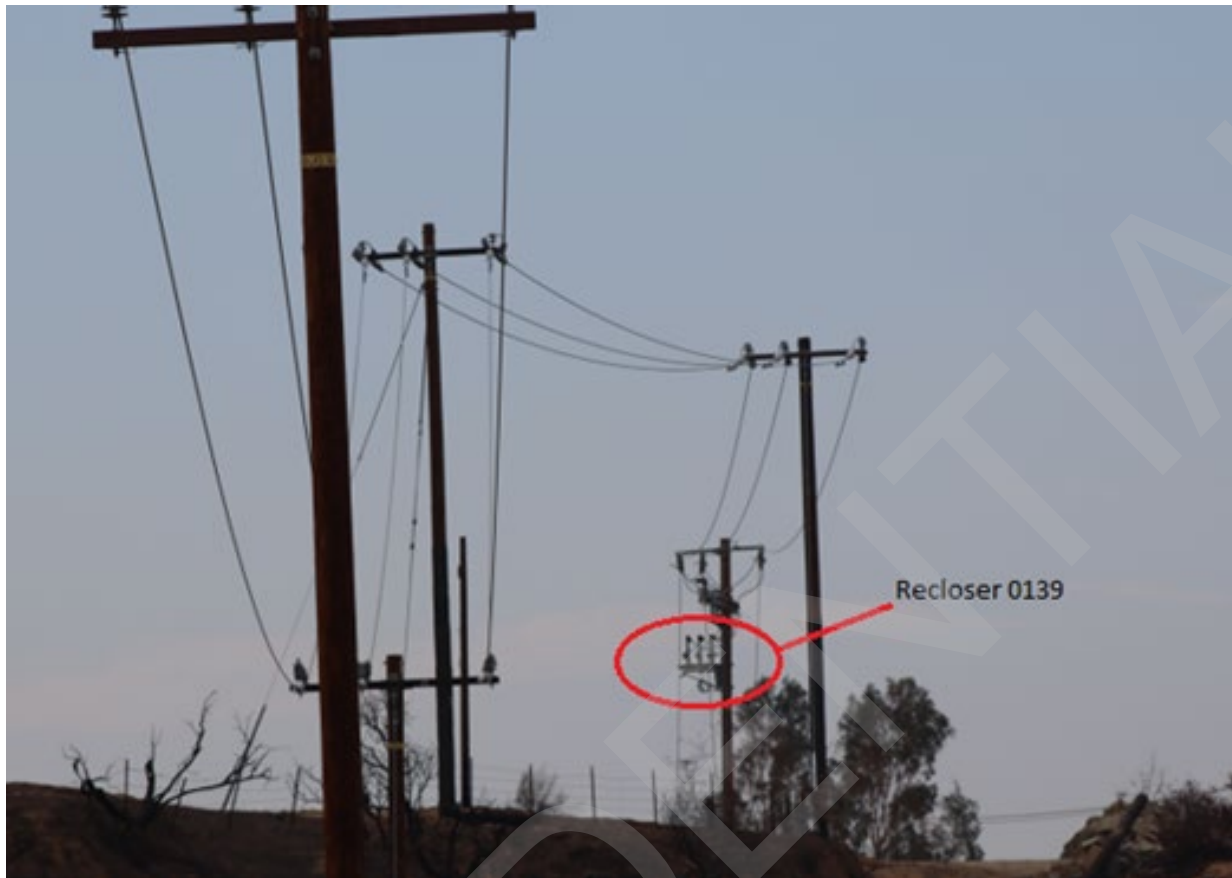
Figure 15: Pole with RAR 0139 which relayed open on September 5, 2022, at 1529 hours.

SCE stated in the 20-day report that the RAR 0139 operated at 1529 hours and relayed which caused a lock-out of the Subject Distribution Circuit and a fuse to blow on Pole No. 4905500E.²⁵ The Fairview Fire ignition was reported at approximately 1537 hours, eight minutes after RAR 0139 relayed.

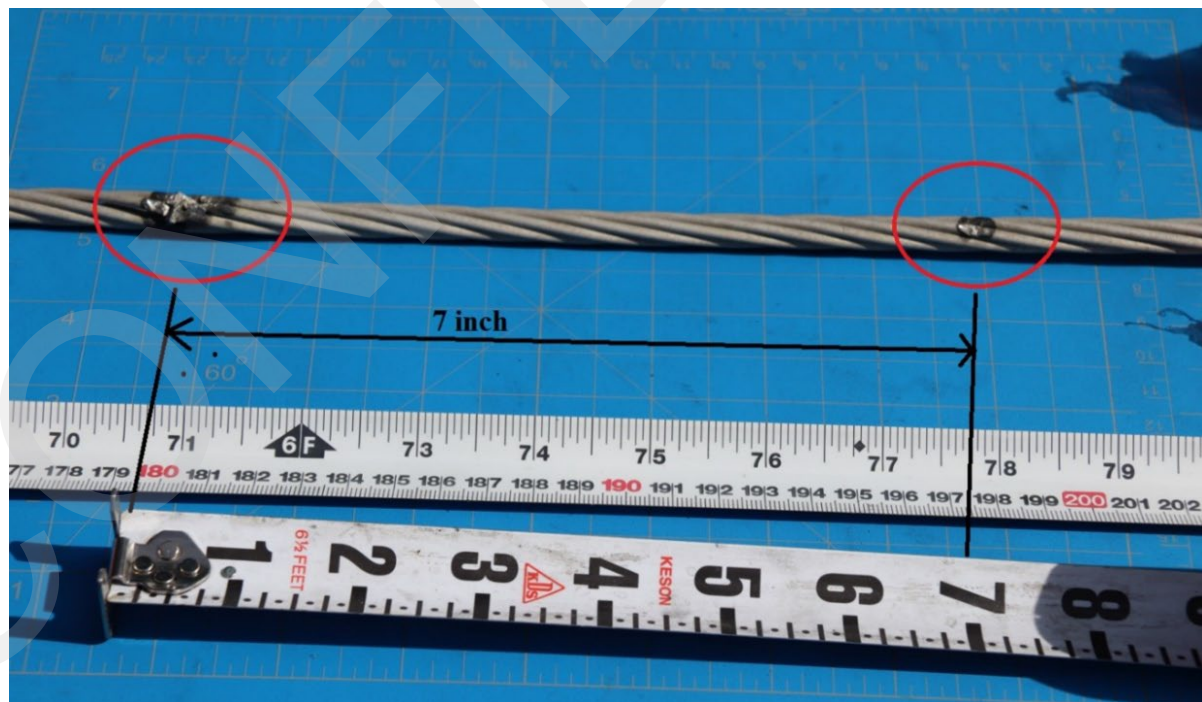
SED investigators observed CAL FIRE staff unwrap the areas of interest for all parties to inspect and photograph. As shown in Figure 17 below, SCE's East phase conductor displayed two distinctive scorch marks consistent with arcing and/or electrical damage spaced approximately seven inches apart.

Figure 17: SCE's East phase conductor with two scorch marks.

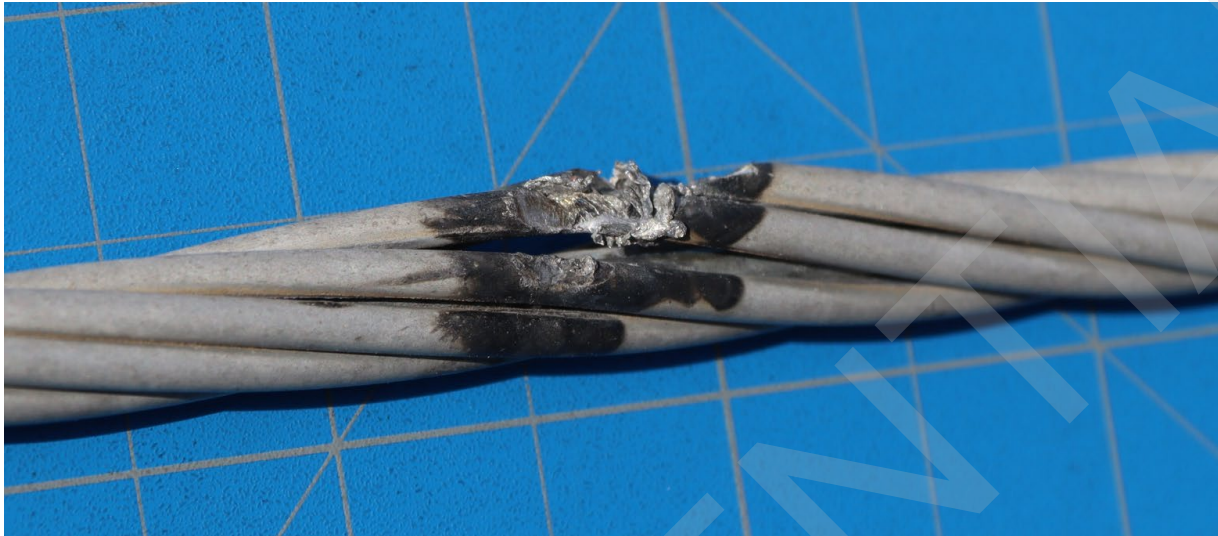
Figure 18 below shows a close-up of the damaged area on SCE's East phase conductor. In this photo, metal from the woven conductor strands appears to have melted off and dark discoloration consistent with arcing appears all around the area.

Figure 18: Detailed view of one of the scorch marks on SCE's East phase conductor showing missing metal.

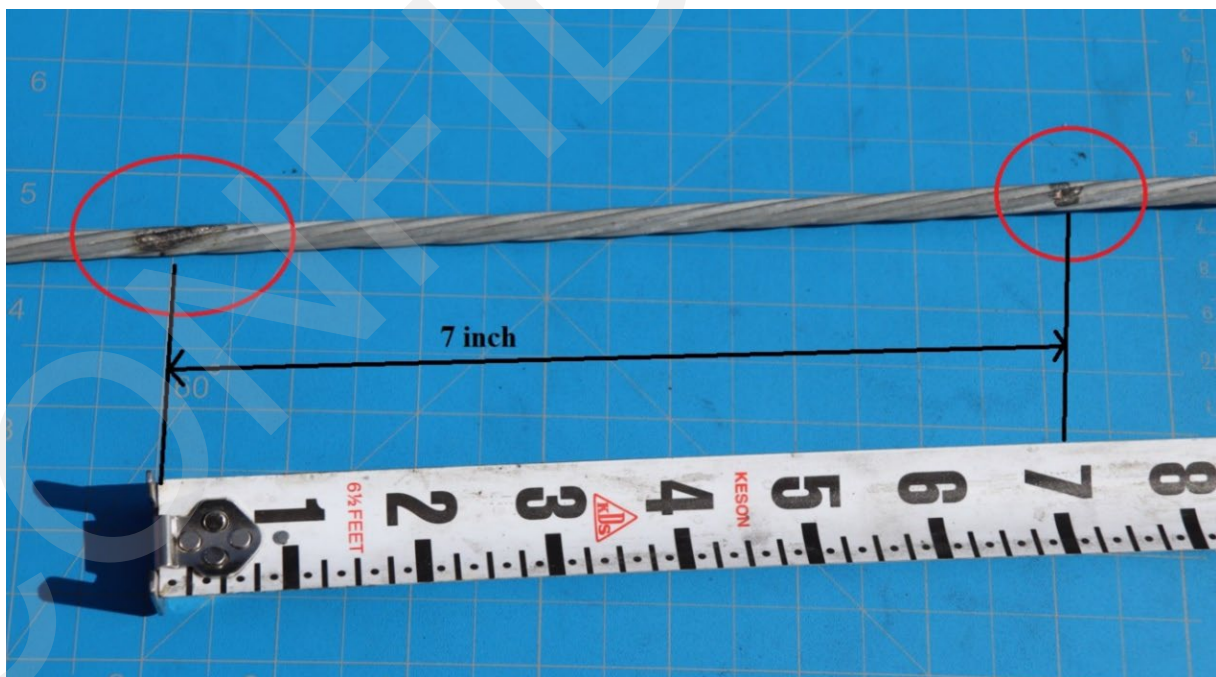
SED investigators observed similar black marks on the Frontier Communications messenger cable, as shown below in Figure 19 below. The black marks on the messenger cable were also spaced seven inches apart just like the black scorch marks seen on SCE's East phase conductor.

Figure 19: Frontier Communications' messenger cable exhibiting two distinct scorch marks.

The scorch marks and visible damage seen on both SCE's East phase conductor and Frontier Communications' messenger cable are consistent with electrical arcing damage.

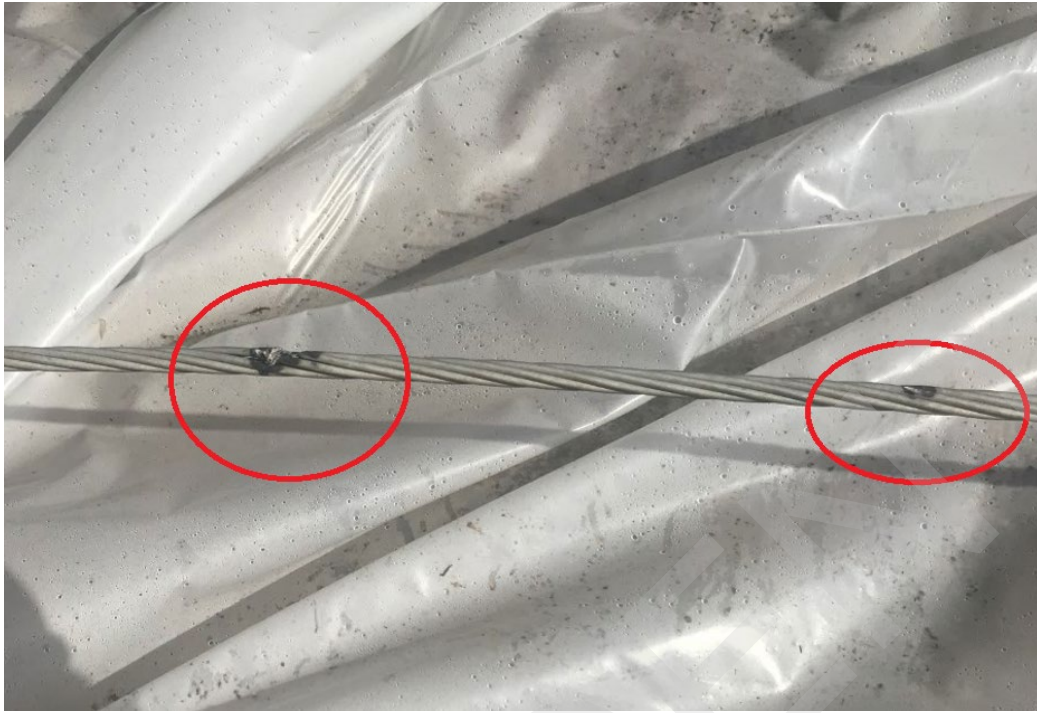
Figures 21 and 22 below both show photos of SCE's phase 1B conductor. Both sets of photos show a similar black scorch mark damage and location (circled red) on the phase 1B conductor. SCE provided the photo shown in Figure 21 but did identify and label the conductor. SED

Figure 21: SCE provided a photo of the phase 1B conductor showing damaged areas.

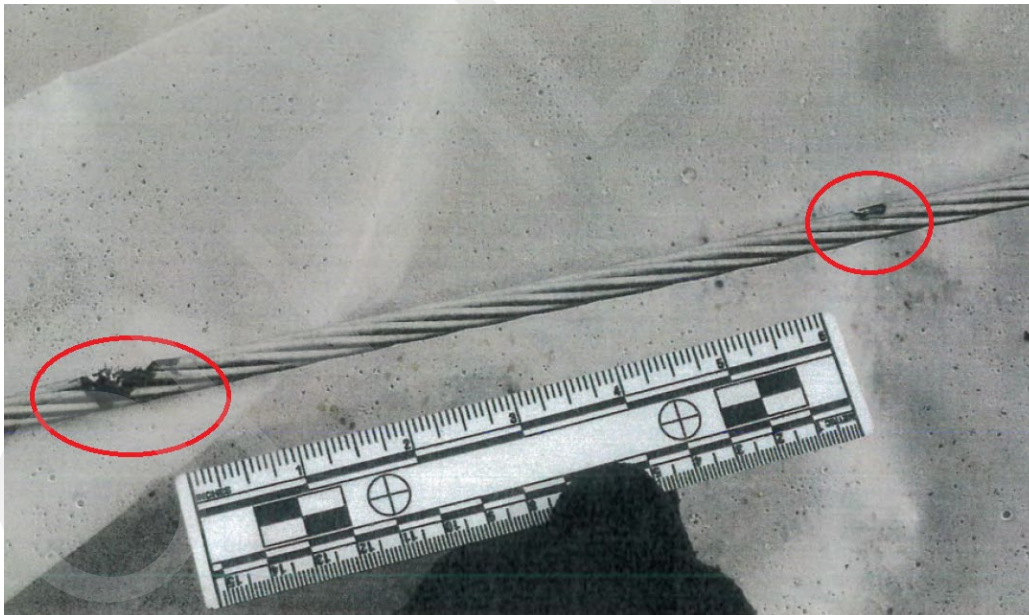
identified a similar photo (See Figure 22) in the CAL FIRE investigation report that shows the same damage area and location on SCE's phase 1B conductor.

Figure 22: CAL FIRE's photo of SCE's phase 1B conductor showing damaged areas.⁴⁰

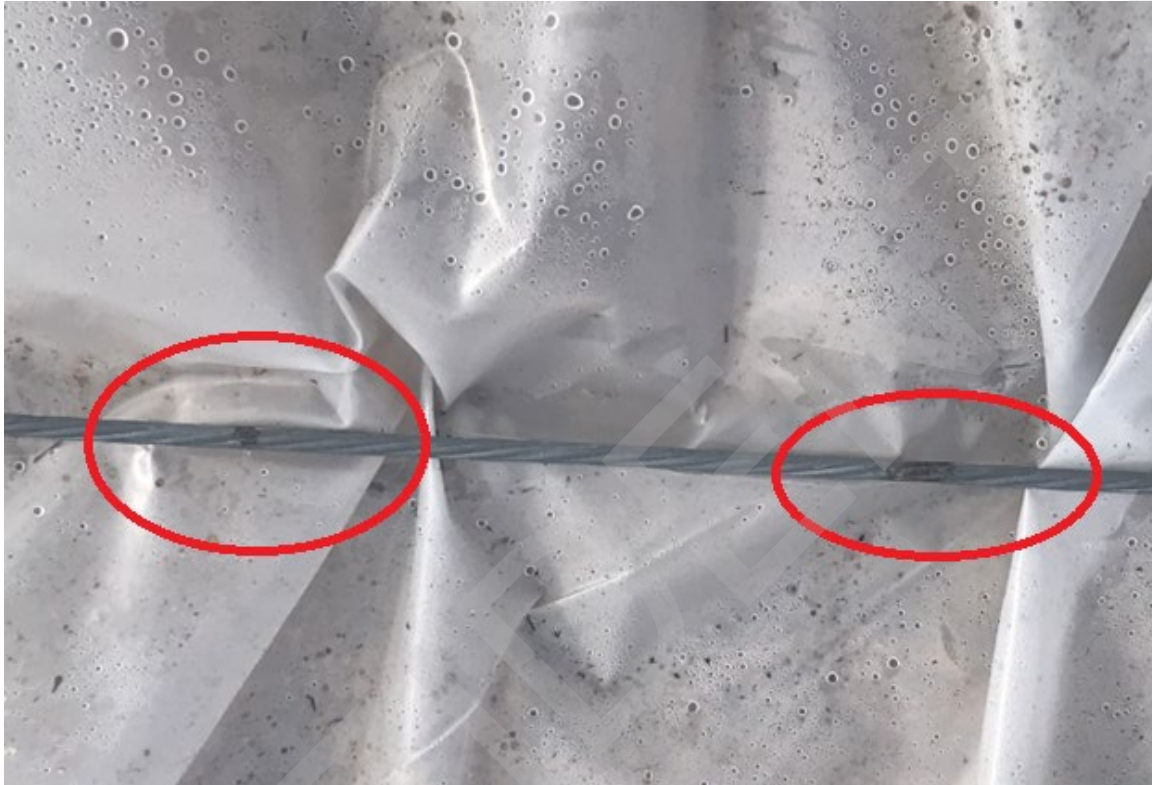
Additionally, SCE provided photos of the Frontier Communications messenger cable, which SED analyzed and matched with a similar photo seen in the CAL FIRE investigation report. Both photos (See Figures 23 and 24) show the same damage and location where SCE's phase 1B conductor most likely struck the Frontier Communications messenger cable. The red circled areas in the photos show the Frontier Communications messenger cable and signs of damage consistent with electrical arcing.

Figure 23: SCE provided a photo of the Frontier Communications messenger cable showing damage.⁴¹

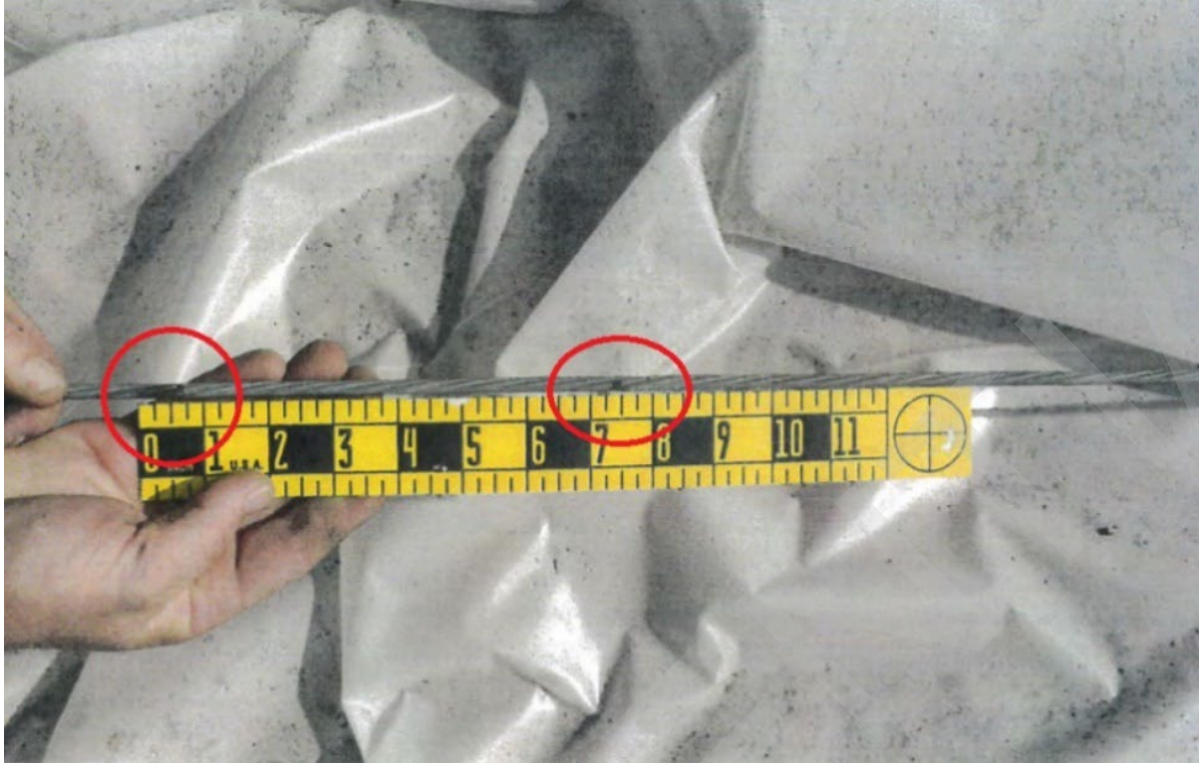
Figure 24: CAL FIRE's photo of the Frontier Communications messenger cable showing damage.⁴²

The black scorch mark damage seen on both the phase 1B conductor and the Frontier Communications messenger cable, the phase to ground fault detected by RAR 0139 at the time of the Fairview Fire ignition, and the post-fire LiDAR scan measurements that showed a reduced conductor to messenger cable clearance are all evidence of the phase 1B conductor striking the Frontier Communications messenger cable.

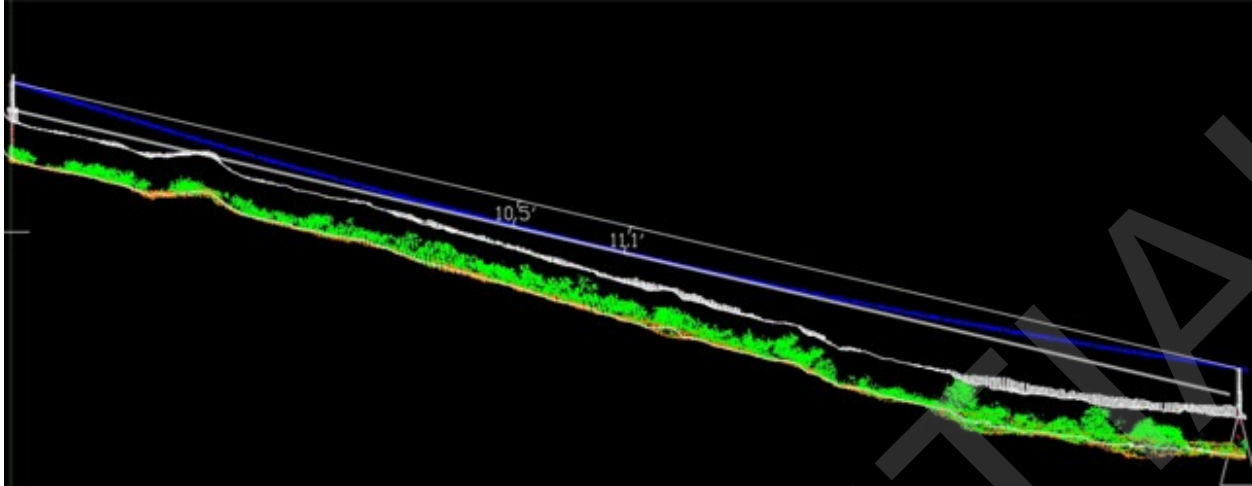
Figure 26: Profile drawing of the Incident Span based on SCE's June 2, 2020, LiDAR scan with sag measurements of the Incident Span conductors.

Between the sag measurement taken on June 2, 2020, and the post-fire sag measurements taken on September 8, 2022, the sag on the Incident Span conductors increased dramatically and SCE did not identify a reason or provide an explanation for the increased sag between the specified time period. SCE also provided photos of the Incident Span taken on September 7, 2022. Figure 27 below shows the Incident Span viewed from the top of the hill towards the bottom of the hill. In the photo, the phase 1B conductor significantly sags compared to the phase 1A conductor.⁵¹

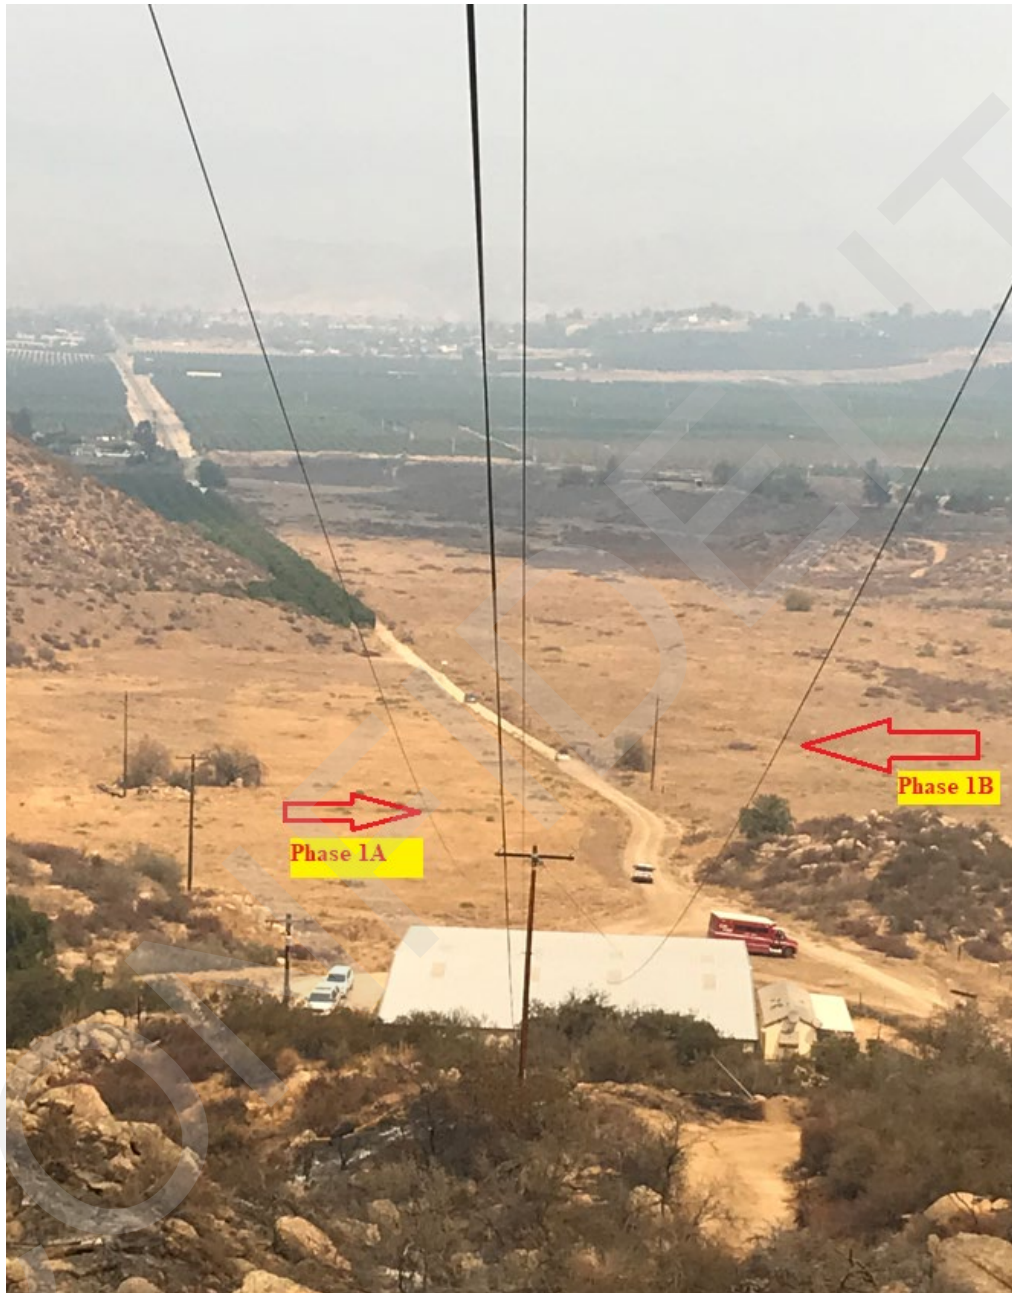
Figure 27: View of the Incident Span from the top of the hill taken by SCE on September 7, 2022.

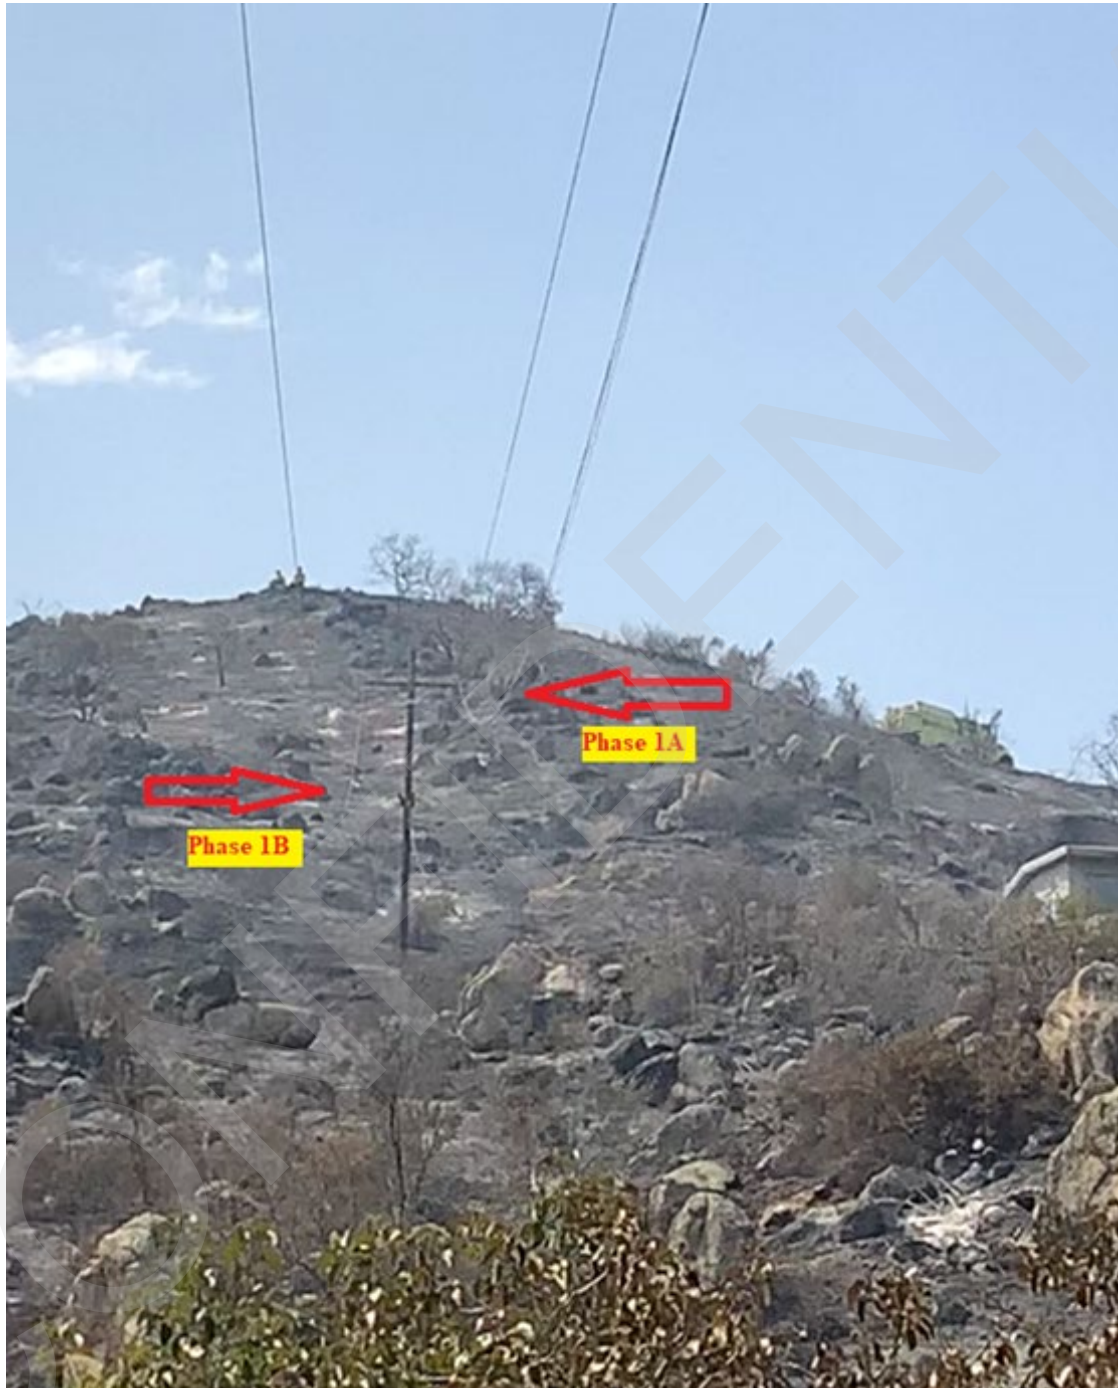
SCE provided a short video clip of the Incident Span viewed from the bottom of the hill near Pole 220028S looking up towards Incident Pole 220029S at the top of the hill. As shown in a frame from that video clip in Figure 28 below, SCE's phase 1B conductor appears to significantly sag lower than the phase 1A conductor.

Figure 28: Southern view of the Incident Span taken by SCE on September 7, 2022.⁵²

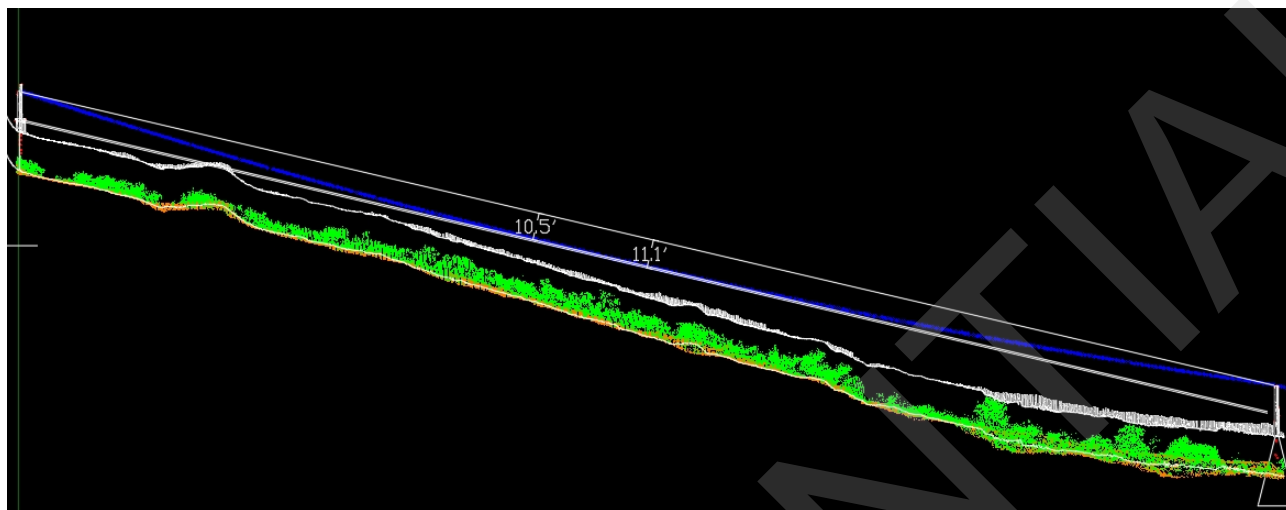
- ii. See below diagram. Dimensions for Wire 2 (Phase 1B) is 11.1 feet of sag. This information was captured on June 2, 2020.

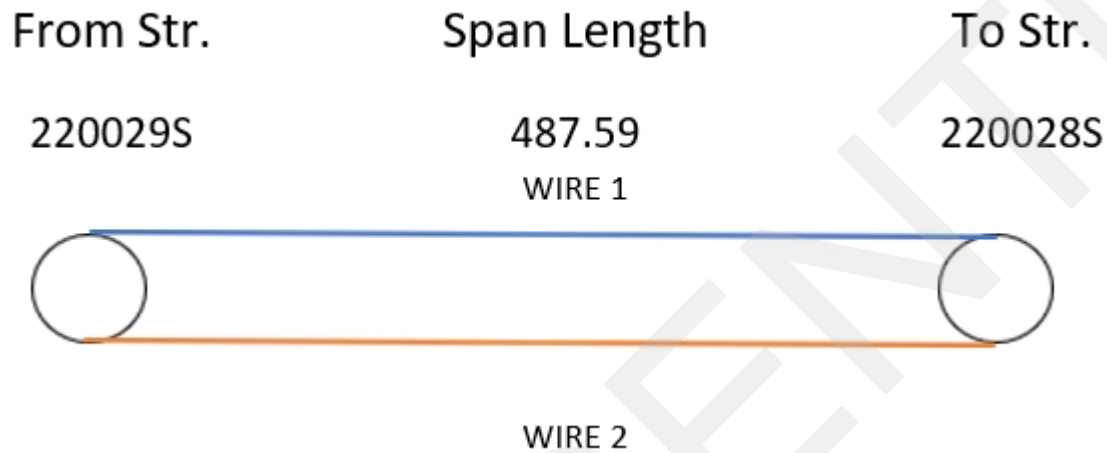
- a. Reference Diagram 8.1 above. The approximate minimum distance to ground (K) for each phase is:
 - a. Wire 1: 18.1'
 - b. Wire 2: 19.4'
- b. Reference Diagram 8.2 above. The approximate maximum sag is 10.5'.
- c. Reference Diagram 8.1 above. The approximate minimum radial distance between phases is 8.8'.
