Incident Number: 24CAAEU0018665

PACIFIC GAS AND ELECTRIC COMPANY
PG&E Reference Number: EI240706A
Electric Incident - 20 Day Report

PACIFIC GAS AND ELECTRIC COMPANY
PG&E Ref. DRU14826-Electric Incident-EI240706A-Placerville-Property Damage-
2024 Pay Fire
Data Request CPUC ESRB-SED
Requester DR No. SED-02-PAY FIRE

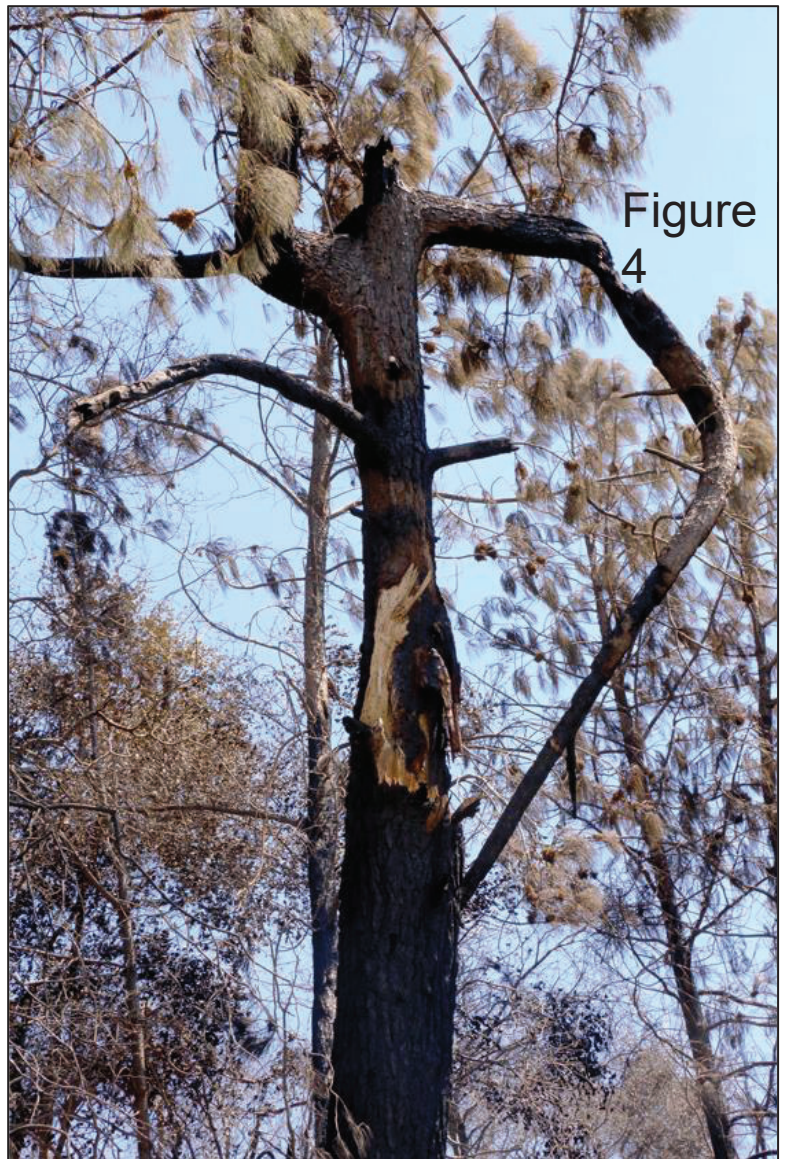
The failure occurred at 26 feet above the ground, just below center in Figure 4. The north trunk was left standing, and the south trunk failed to the ground in a southerly direction, Figure 5.

Near the top of Figure 4 and 17 feet above the July 6 failure, the north trunk of the tree failed 25-40 years ago, and the limb to the south, left, turned upward and has since then served as the top of the north half of the tree. That half now extends to a height of 86 feet.

Given that the failure occurred at 26 feet, the height of the south trunk prior to failure was 26 plus 72, or 98 feet, twelve feet taller than the height of the remaining half of the tree.

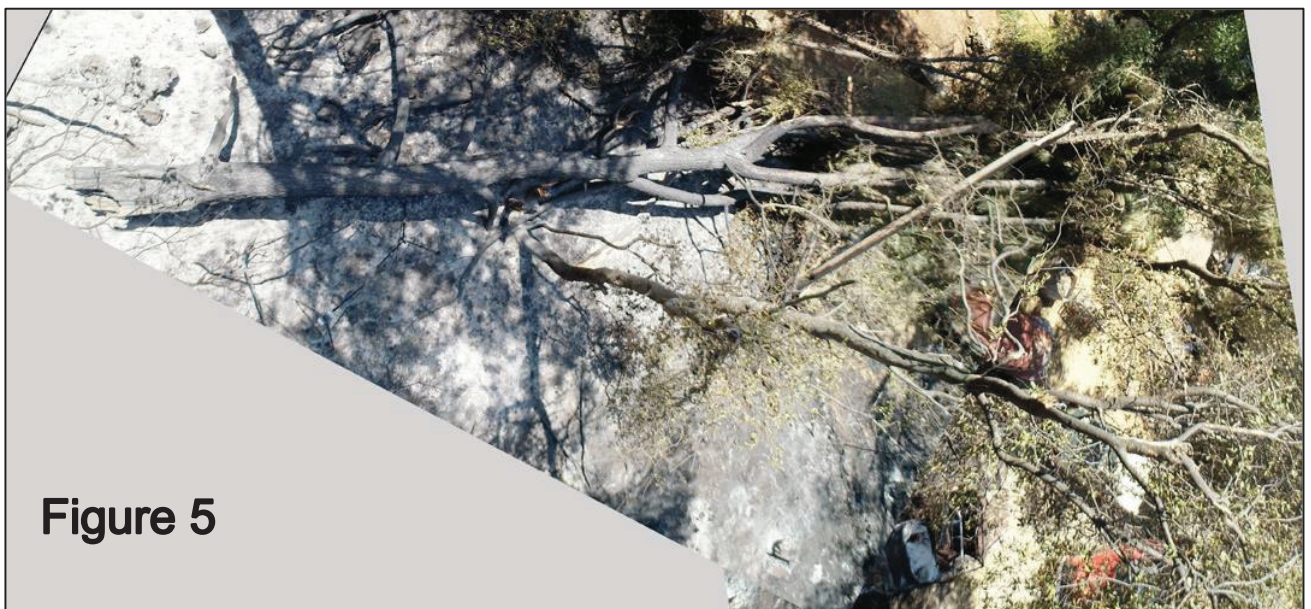
The failed top seen in Figure 5 is prone on the ground. It is 72 feet long. The left half of the photograph shows burned and gray soil. The right half did not burn.

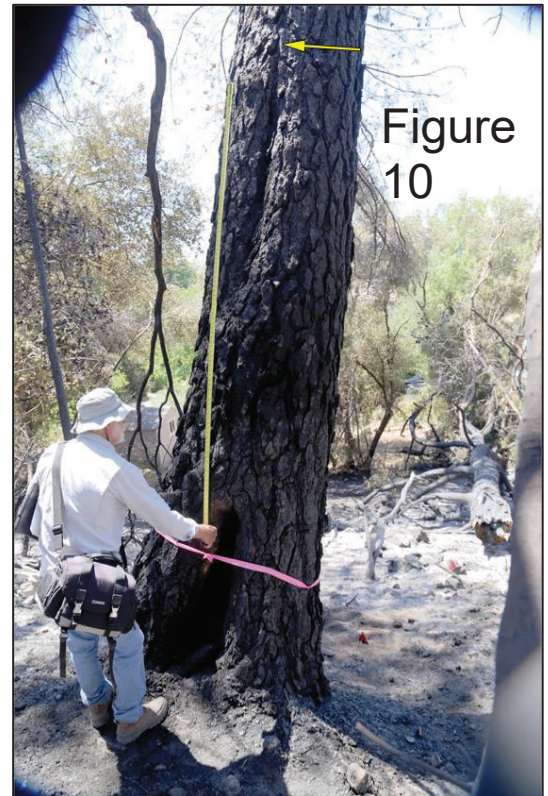
closed by thick woundwood³, but is still seven inches wide by 36 inches high. This is the result of a decades-old wounding event, likely an old fire.

Figure 10, to the right, illustrates a seam, an infolding of the bark to a height of eleven feet, at the yellow arrow. This is an extension of the injury seen in the open cavity in Figure 9.

The center of the tree may or may not be decayed, but as noted previously, the woundwood that lines this old wound is stronger than wood forming on an uninjured tree. Further, most load is carried in the outer portion of the stem⁴, which is largely intact and is buttressed by the nature of the woundwood.

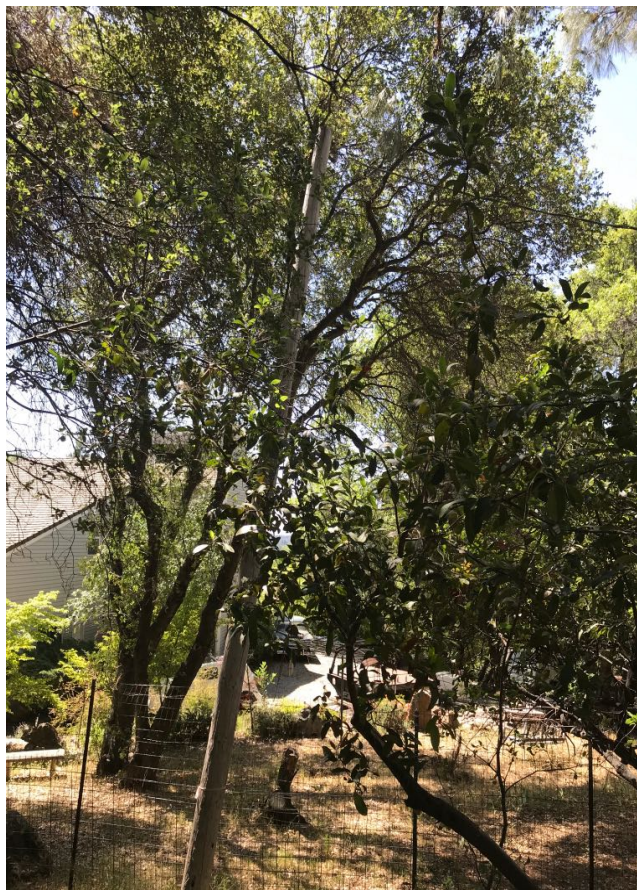
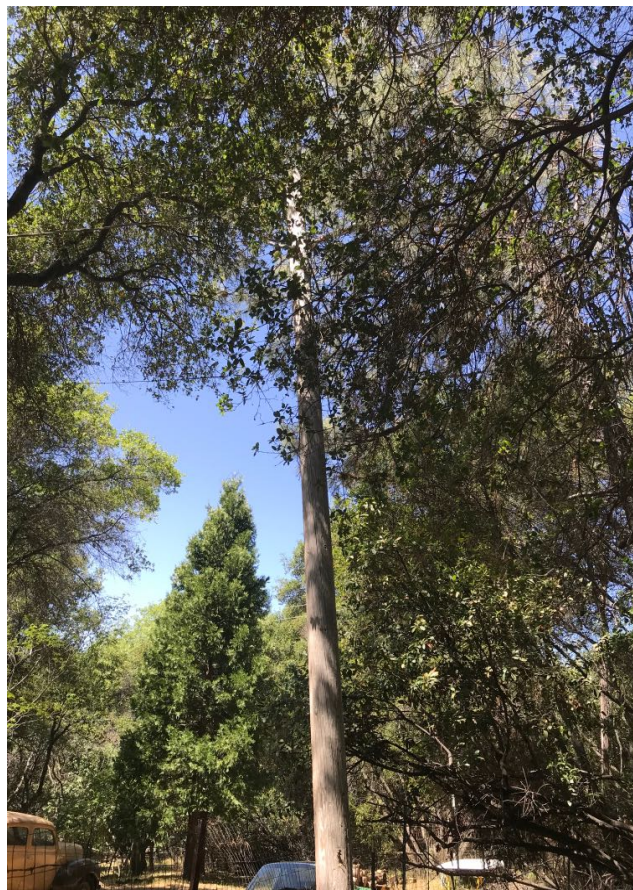
Attach 2 Photos of the entire pole from 2 locations

Select type of structure	Distribution Pole
Structure (Distribution Pole)	• Pole leaning or out of plumb by more than 10% of its height above the ground

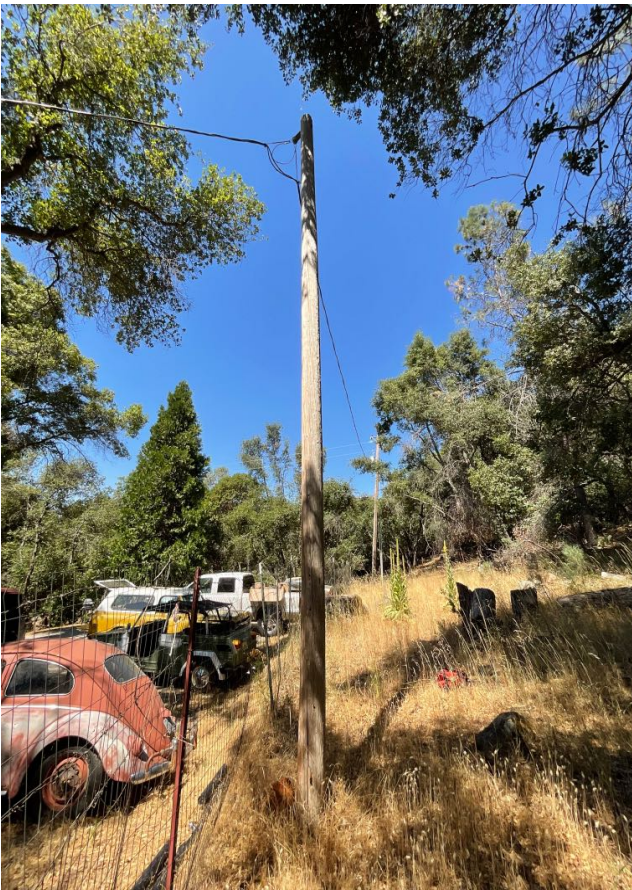
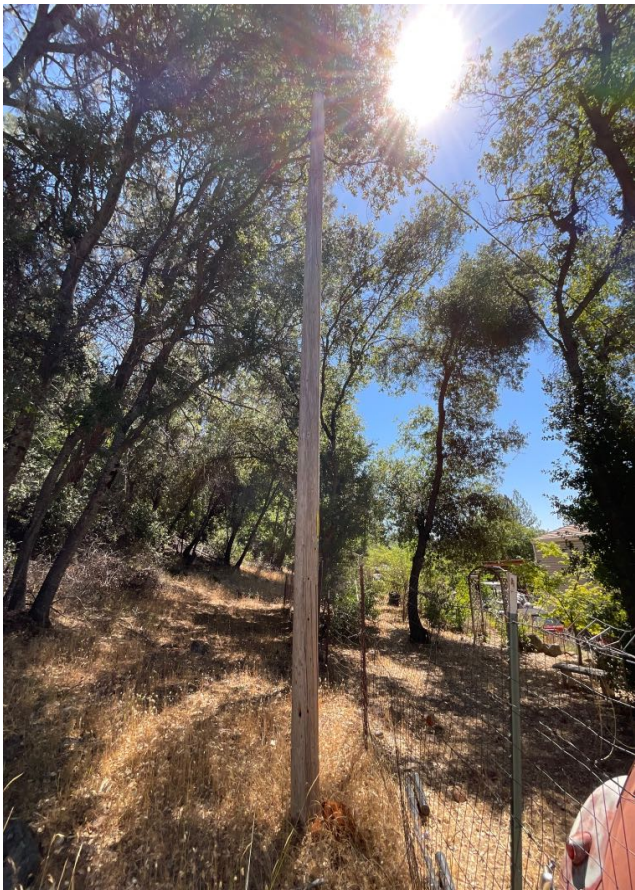
Attach 2 photos of the entire pole from 2 locations

Structure (Distribution Pole)	• No structure damage or compelling abnormal conditions to report
-------------------------------	---
