Bridgeport NAPA Auto Parts Store Explosion 2023 Investigation Report

SAFETY AND ENFORCEMENT DIVISION
GAS SAFETY AND RELIABILITY BRANCH

April 2, 2024 Final Report

Report Date:	January 17, 2025
Investigators:	Mohammad Nouredine
Date incident reported to CPUC	March-02, 2023
Utility:	AmeriGas
Date and Time of the Incident:	March 01, 2023 at 2230 hours
Location of the Incident:	■ Hays St. Bridgeport, CA 93517

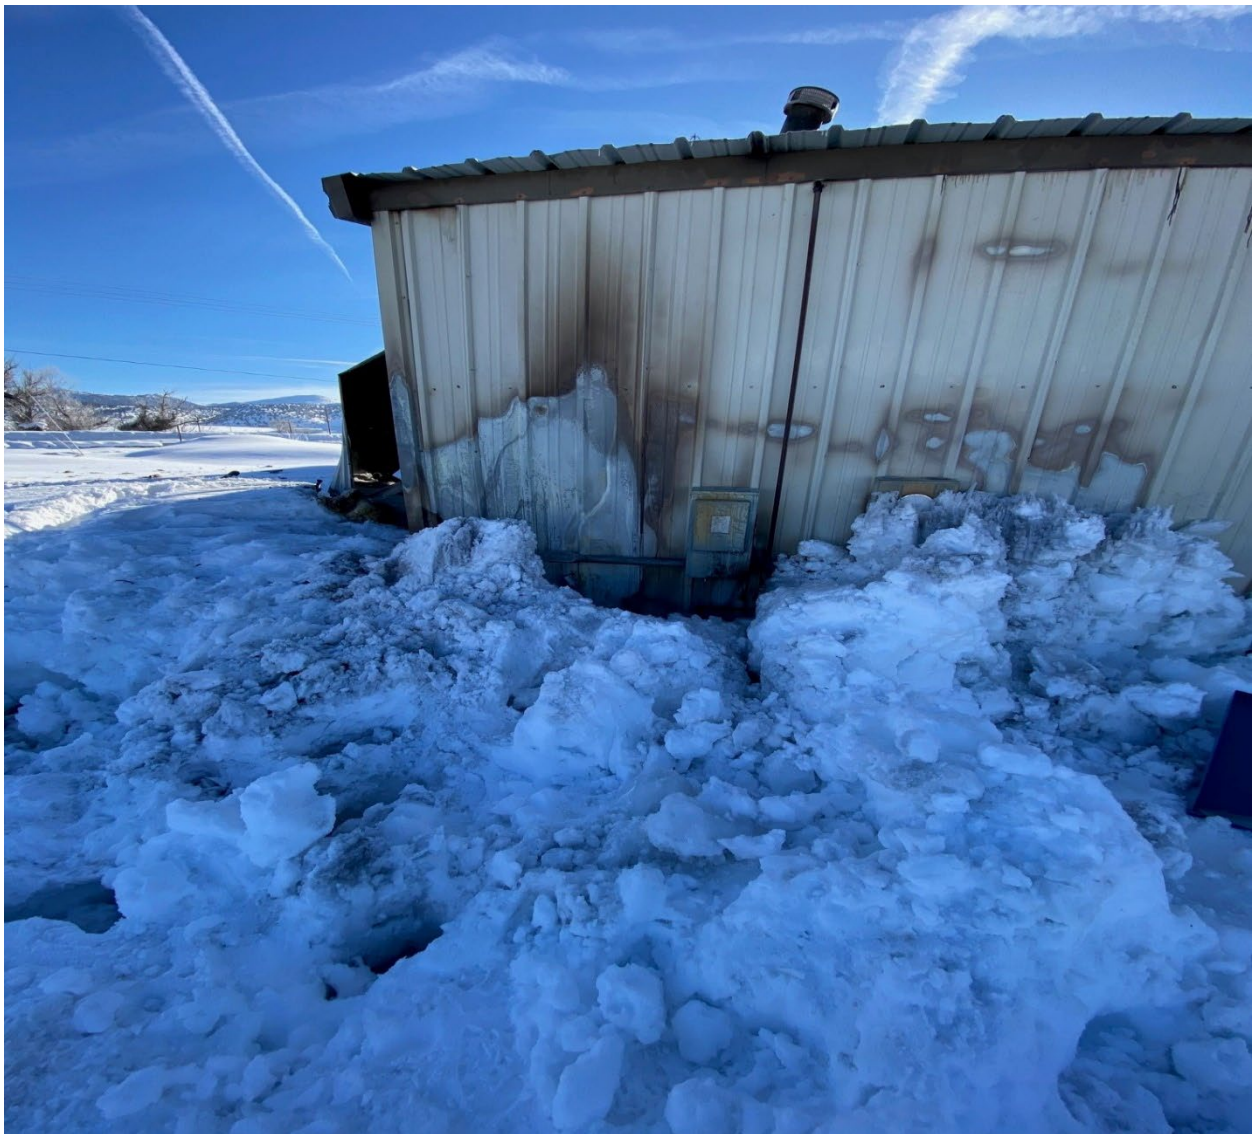
Photograph 1: Fire damage to Bridgeport NAPA Auto Parts Store (photo provided by Bridgeport Fire Department)

Hence according to the totality of the evidence presented, including photos of the fire damage (Photograph 1), failed regulator damage (Photograph 2), the failed regulator’s instructions manual (Fisher R642 HSRL Series Instruction Manual (October 2015)), and the fire departments report (Bridgeport Volunteer Fire Department Incident Report), AmeriGas failed to follow manufacturer’s

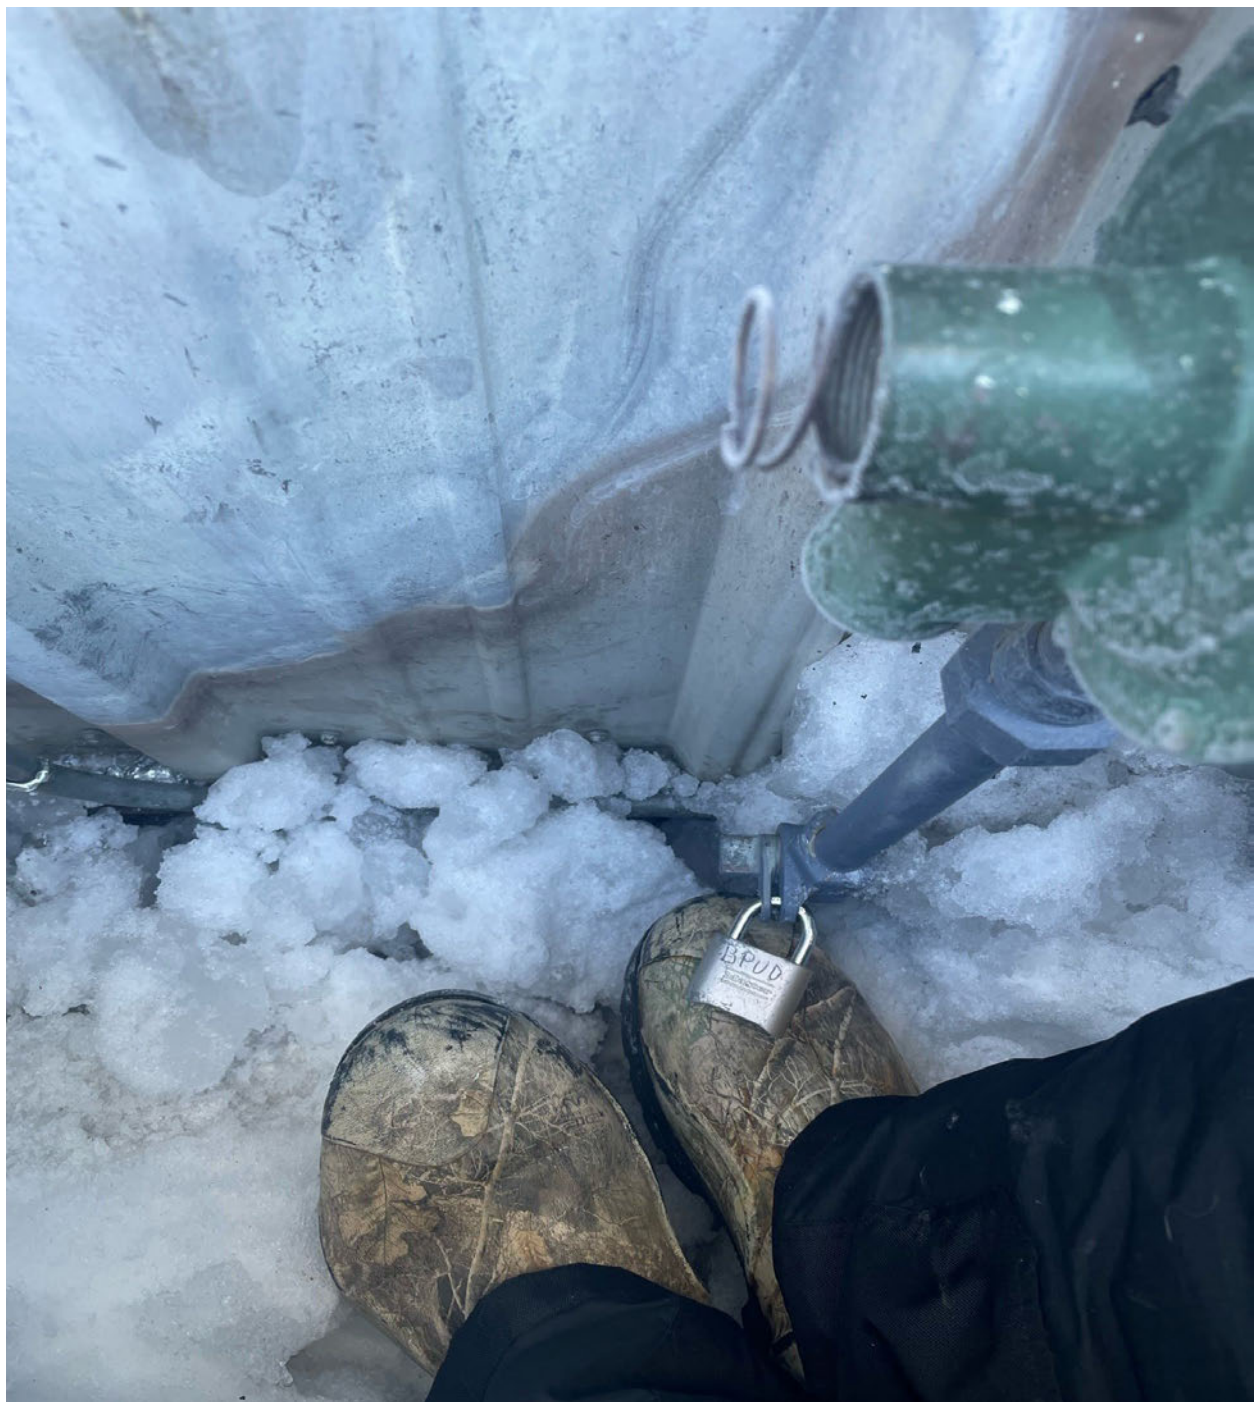
According to the fire department, "it soon became clear to firefighting crews that the fire was fueled and started by the propane gas line going into the building." It took them approximately 2 hours and 18 minutes to extinguish the fire and find the outside shut off valve for the propane due to the snowpack around the building. Once it was found, they were able to shut off the gas valve. The valve was under about 3 feet of snow and ice from the recent storm and had yet to be cleared. During an overhaul of the pipeline by AmeriGas it was found that the regulator located just above the valve had been damaged and the spring was hanging out of it.

AmeriGas failed to protect the regulator ventilation from getting blocked due to snow buildup leading to the failure of the regulator.

Photograph 2: Locked service valve and damaged regulator on Bridgeport NAPA Auto Parts Store gas riser (photo provided by the Bridgeport fire department)

instructions regarding regulator venting which ultimately led to the accident. Based on this evidence, failure to vent the regulator or protect the regulator correctly led to snow building up and covering the entire regulator blocking its vent. This in turn led to pressure building up in the regulator until it failed. Then with nowhere else to go (because of all the snow buildup), the propane found its way into the building and found an ignition source.
