10th St E Palmdale Incident Investigation Report

CPUC - SAFETY AND ENFORCEMENT DIVISION
GAS SAFETY AND RELIABILITY BRANCH

DOT No. 1395201

CPUC SED No. G20240330-3681

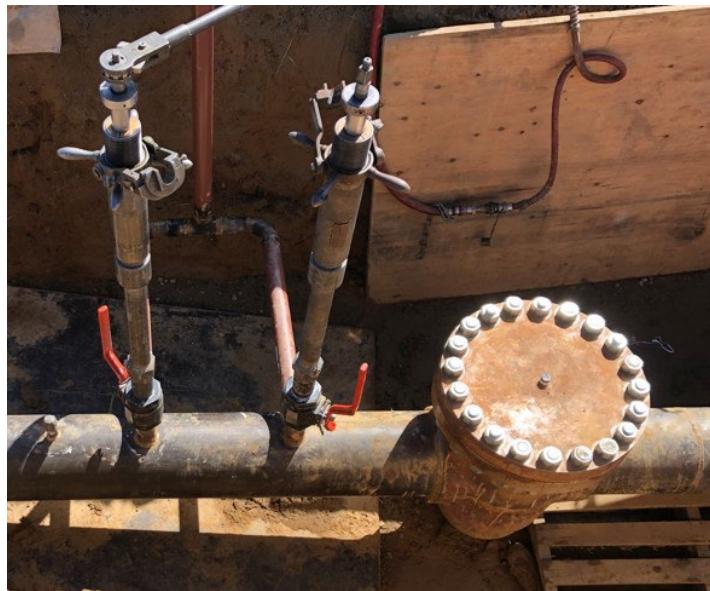
Figure 1. Pressure control fittings and stopper

On March 30, 2024, SoCalGas' crew installed a pressure control fitting and stopper to isolate the damaged section of SoCalGas' 10-inch HPDSM pipe to stop the flow of gas and at approximately 2116 hours the SoCalGas' crews had the gas flow under control. SoCalGas' crews exposed the damaged section of the 10-inch HPDSM pipe and followed SoCalGas' Gas Standards to make a permanent repair by cutting out the damaged section and installing a new section of a 10-inch steel pipe.

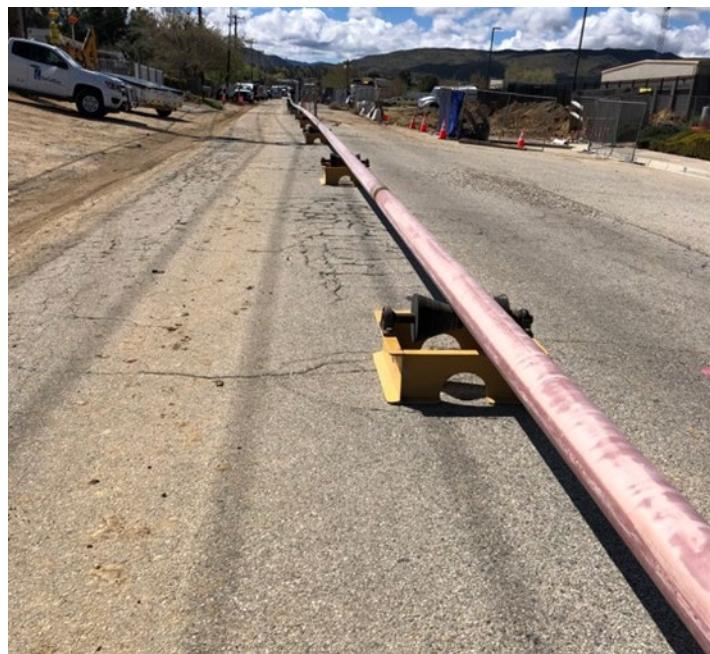
Figure 2. Temporary bypass pipeline

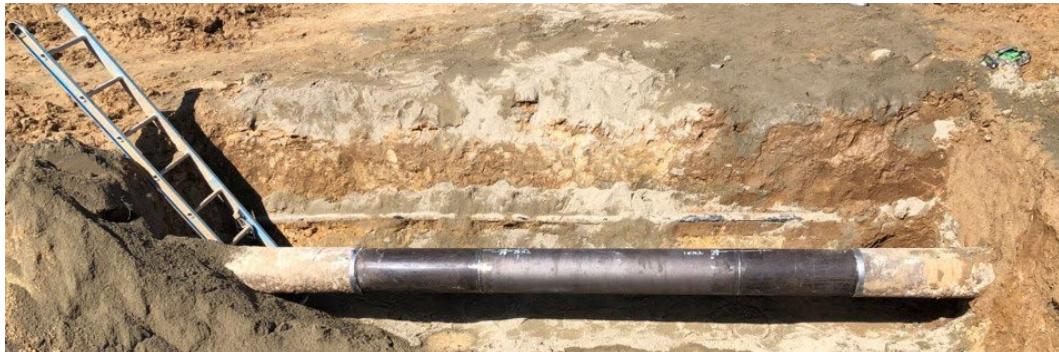
Figure 3. New section of 10-inch HPDSM pipe; replaced steel pipe with permanent repair

On March 30, 2024, at approximately 0845 hours, SoCalGas' crew completed the permeant repair, cleared the stoppers and returned the 10-inch HPDSM pipe back to operating in service (gas flow in the newly installed section).

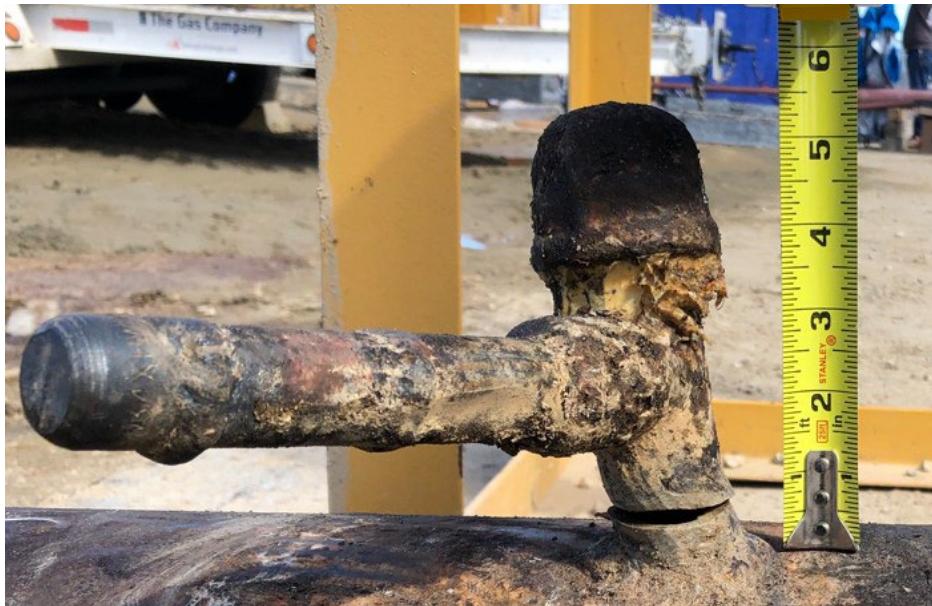
Figure 3. Damaged 1-inch stub "abandoned service tee"

During SED’s field visit to the incident site, investigators observed the damaged 1-inch stub that was struck by Patriot. Investigators measured each part of the 1-inch stub; the cut and capped riser, and the branched and capped “T” (see Figure 3.). SED found that the 1-inch stub had been disconnected from the service line and remained connected to the 10-inch HPDSM pipe until it was struck by Patriot. SED observed that the 1-inch stub had gas in it due to the rupture and release of gas occurring in the section of the stub pipeline.

SED determined that SoCalGas misidentified the 1-inch steel stub “T” subsurface installation as “abandoned” at an unknown prior date and considered it to be a “capped and abandoned T”. **The evidence shows that** the 1-inch stub was not physically disconnected from the source of gas, in this case the 10-inch HPDSM pipe.

1. SoCalGas should take the appropriate steps to address the SED Finding 1. SoCalGas should update its records and procedures to appropriately classify the subsurface installations according to their status of either connection to active subsurface installations and carrying natural gas [inactive subsurface installations] or those that may be classified as “abandoned” according to GO 112F, 49 CFR 192.3 Definitions.
2. SoCalGas should take the appropriate steps to address the SED Finding 2. SoCalGas should incorporate the “inactive subsurface installations” to be shown graphically on its GIS mapping and recording of as-built drawings when disconnecting and abandoned service facilities.
