1373 S State St, San Jacinto Incident Investigation Report

CPUC - SAFETY AND ENFORCEMENT DIVISION
GAS SAFETY AND RELIABILITY BRANCH

DOT No. 1426420

CPUC SED No. G20250320-3827

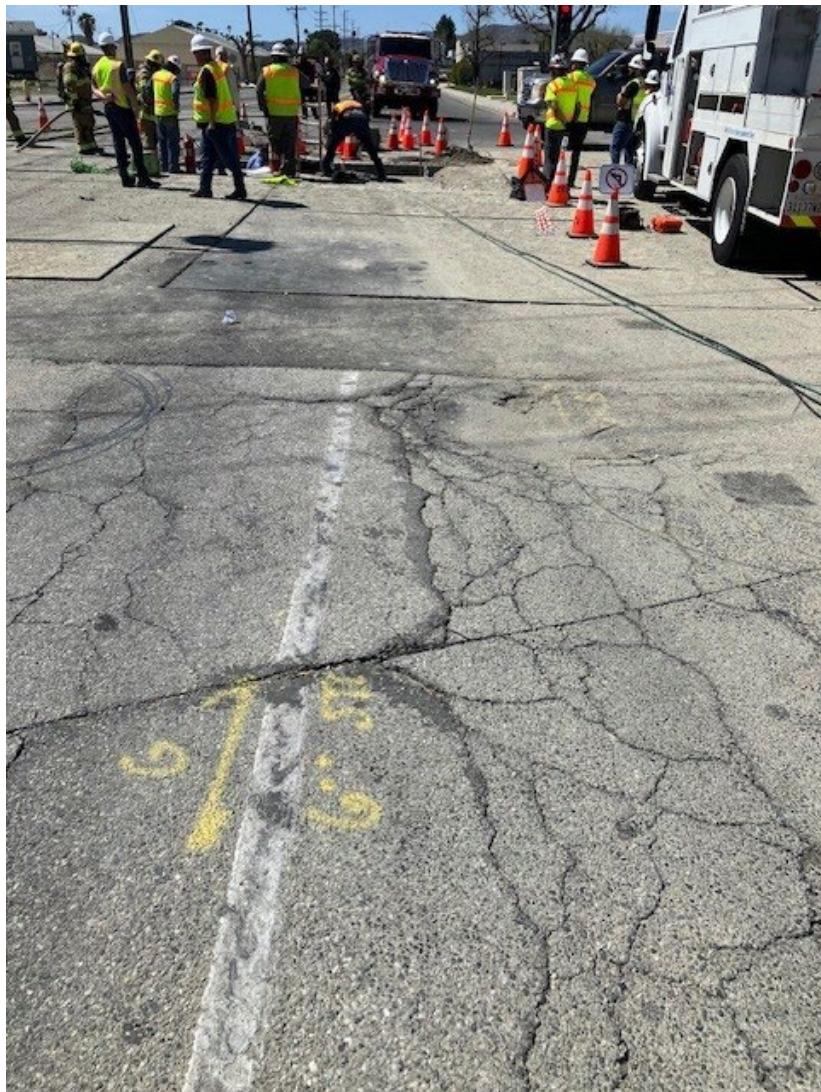
SoCalGas provided USA ticket A243230808. The ticket showed a renew of the ticket on March 11, 2025, 9 days before the incident. The ticket showed a request for re-marks on February 24, 2025, and a expiration date on April 8, 2025. When SED visited the site on March 21, 2025, SED observed SoCalGas' marking of both the MPG& SL41-17.

Figure 1. Line markings observed in the field.

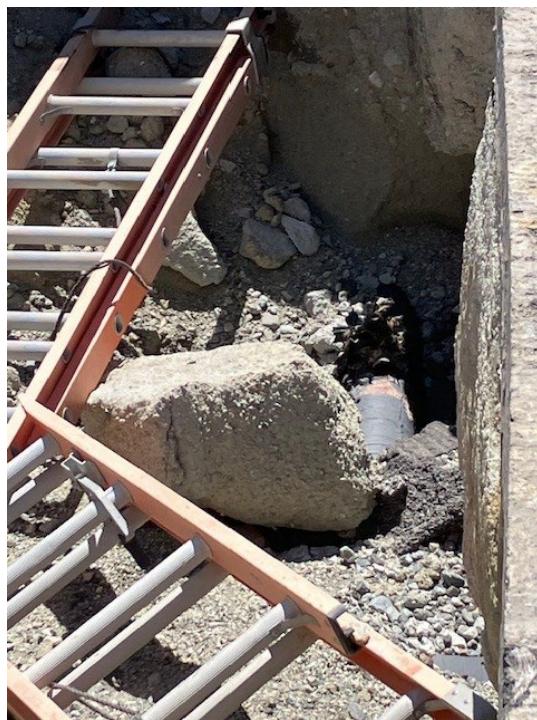
Figure 2. Close-up of the damaged pipe section

south end was controlled by shutting off a valve at a reg station). SoCalGas' crews welded a larger diameter nipple on SL41-17, tested with dye penetrant for gas leak, and found zero gas indication. On March 21, 2025, at 0330 hours, SoCalGas' crews completed restoration of gas service to the affected customers.

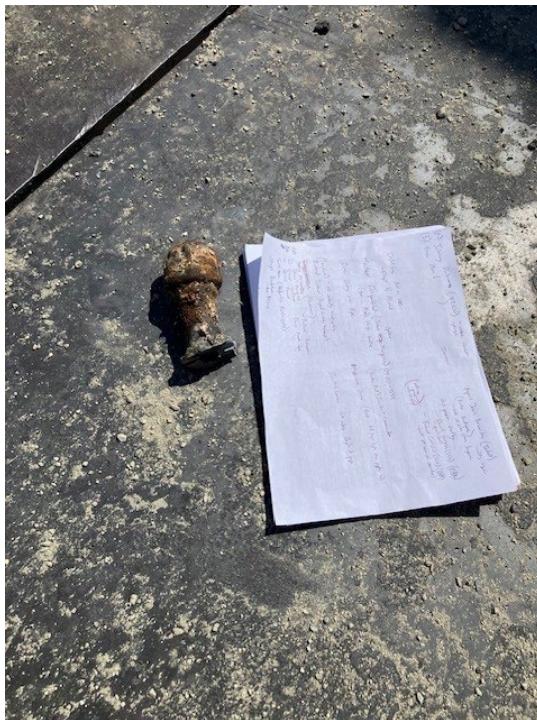
backhoe was being used to help carry out chunks of 2 sac slurry out of the trench. The backhoe ended up going too close and hitting the 1-inch diameter, 3-inch-long nipple on top of the SL41-17.

Figure 3. The damaged 1-inch diameter, 3-inch-long nipple

- a. 13.3 million cubic feet of gas were released during this incident,
- b. The release was categorized as a Mechanical Puncture with an approximate size of 1.5 inches both in axial and circumference.

- h. In addition, SoCalGas stated that the cause of the incident was “*improper excavation practices by the contractor, who failed to use hand tools only and did not maintain adequate distance with the backhoe bucket while excavating over the main.*”

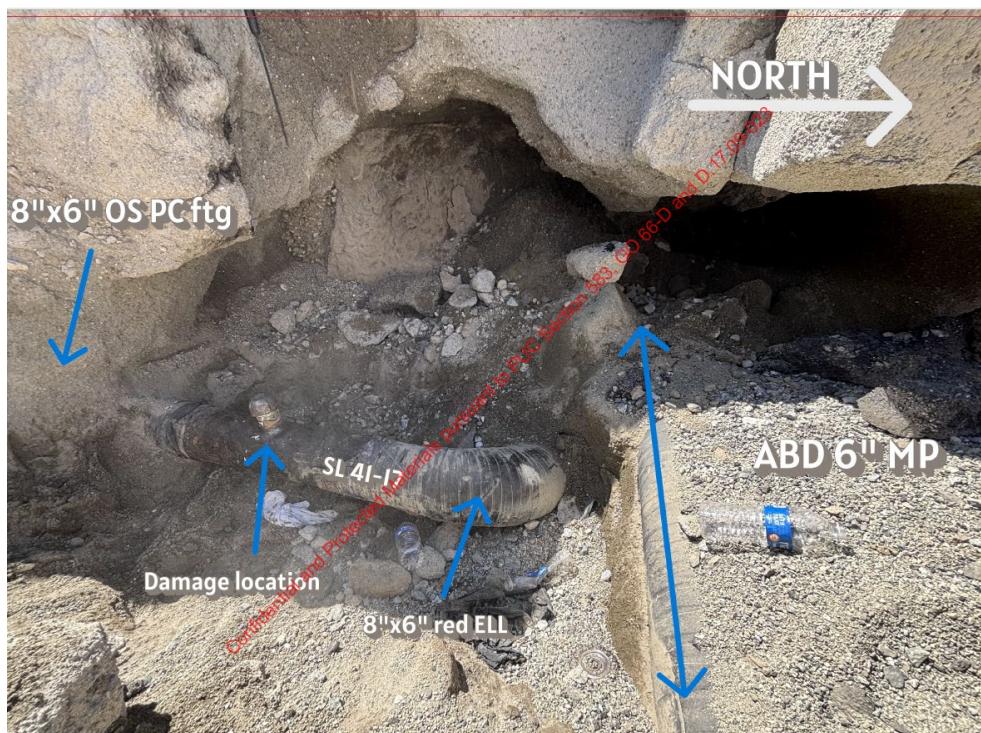
Figure 4. A photo provided by SoCalGas showing the proximity of the MPG and SL41-17 (confidential)

On August 15, 2025, SED received another data request response from SoCalGas. Drawings and photos were provided to show the proximity of the gas lines involved. The 1-inch diameter, 3-inch-long nipple was approximately 18 inches from the 8”x6” oversized pressure control fitting. The clearance between SL41-17 and MPGP at the incident location was approximately 12 inches. In addition, at the intersection, SL41-17 also underwent a 8”x6” reducing elbow, which reduced its

The Stand-by did not provide guidance to expose SL41-17 by hand digging. SL41-17 was at the same depth and 12 inches away from the MPG, which is within 24 inches of the tolerance zone. Therefore, SED finds SoCalGas in violation of G.O. 112-F, Reference Title 49 Code of Federal Regulations (CFR) Part 192.605(a) for failure to provide guidance to hand dig, as required by its GS.
