### **E20201117-01 MOUNTAIN VIEW FIRE SED INCIDENT INVESTIGATION REPORT**

**Incident Investigation Report**

**Incident Number:** E20201117-01 (Mountain View Fire)

**Utility:** Liberty Utilities (Liberty)

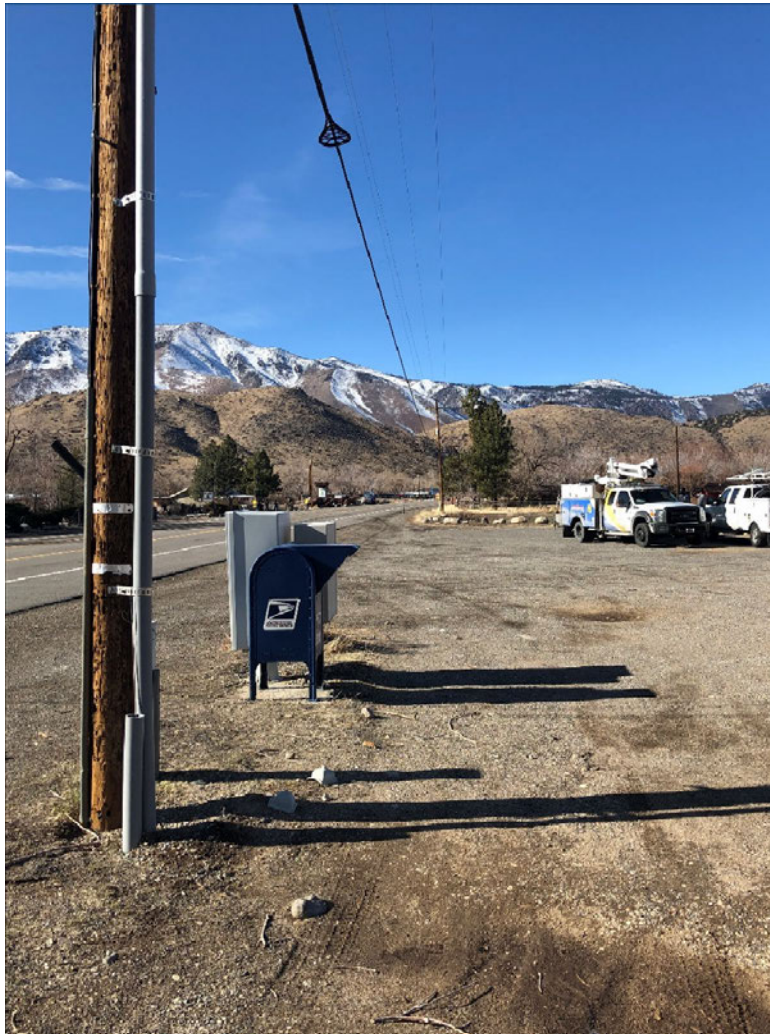
the fire.<sup>5</sup> A section of the repaired span at the incident location can be seen in Figure 3 below.

**Figure 3:** Repaired span at the incident location<sup>6</sup>

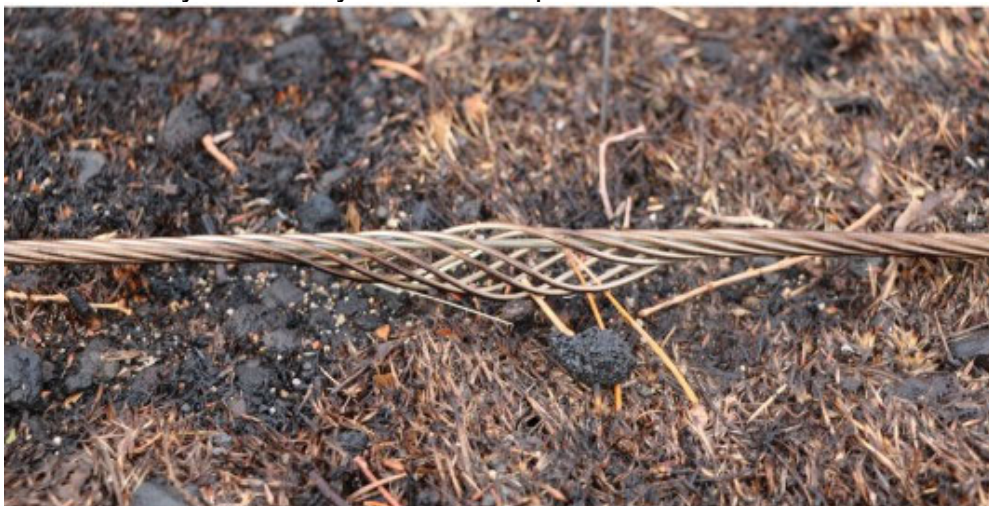
Witness statements indicated that the power line was emitting electrical arcs while downed.<sup>34</sup> CAL FIRE investigator identified no other potential ignition sources at the scene, nor were there any reports of lightning strikes at the time of the incident.<sup>35</sup> The investigator identified birdcaging and burn marks on the wire down. They also identified visible char and melting on one of the aerial conductors.<sup>36</sup> The investigator determined the fire was most likely caused by the downed power line.<sup>37</sup>

**Figure 6: Conductor burned and visible bird-caging.<sup>38</sup>**

Liberty conducted a separate peer-reviewed investigation into the Mountain View Fire using a third-party investigator. The independent investigator acknowledged the broken wire was energized for up to 15 seconds while contacting the ground.<sup>40</sup> Additionally, the investigator agreed with the evidence indicating a wire-to-wire contact on the incident span between the incident poles and that multiple wires were melted and fractured during the wire-to-wire contact.<sup>41</sup> Liberty concedes that the evidence is “consistent with the possibility that electrical facilities caused the Mountain View Fire.”<sup>42</sup> Liberty did not provide any reasonable or probable alternative sources to the fire’s ignition. The electrical conductor, as evidenced by its birdcaging and burn marks, remained to be the most probable cause of the fire.

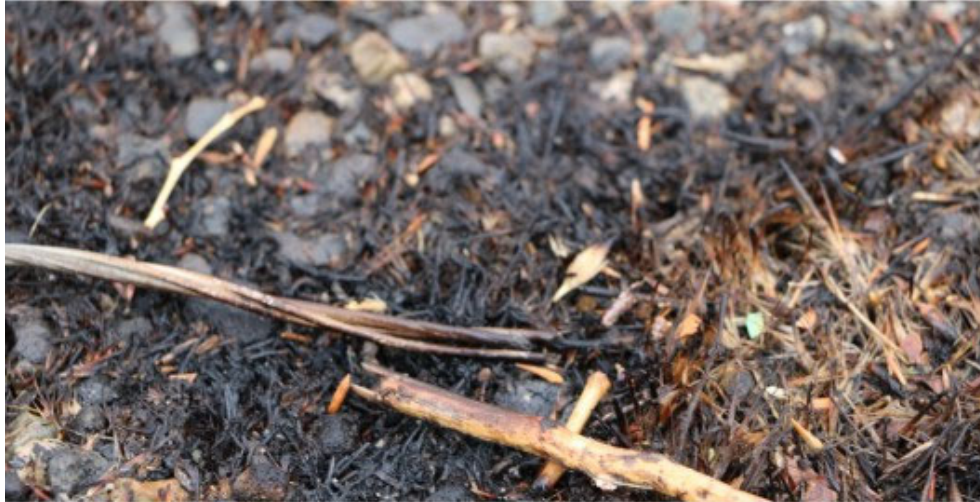
**Figure 7:** Broken conductor with scorched end and signs of beading<sup>39</sup>
