## **APPENDIX E**

### **Liberty Response To Mountain View Fire (NOV)**

**CPUC-ID:** E20201117-01  
**Regarding:** Notice of Violation  
**Location:** Mountain View Fire, Coleville, California

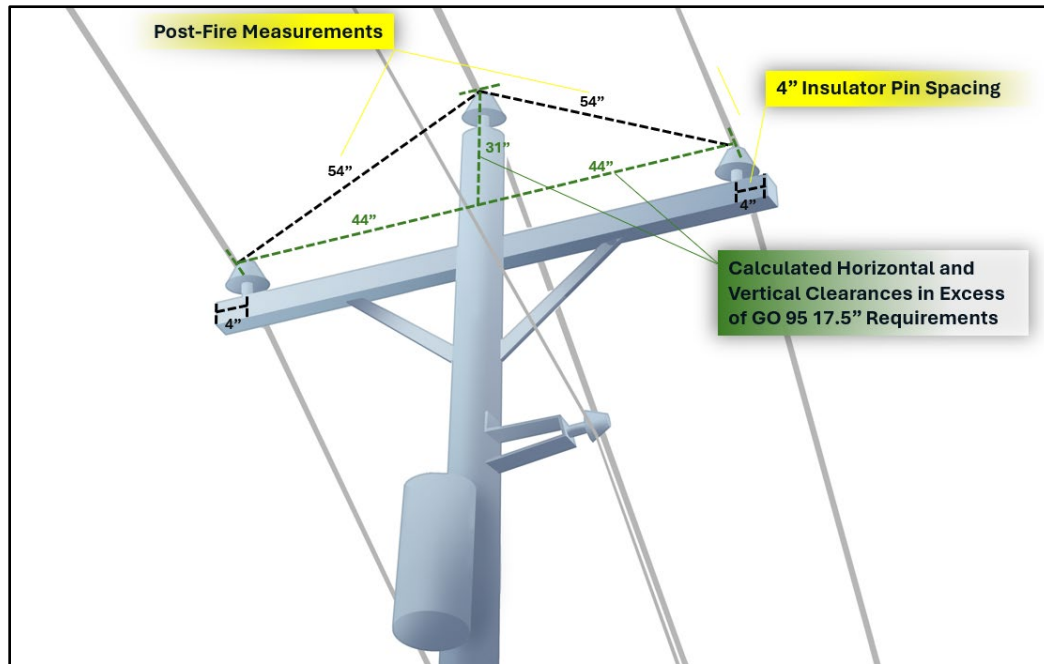
### *Annotated Demonstration of Measured Radial and Calculated Horizontal and Vertical Conductor Clearances*

The existing configuration of the Topaz 1261 Circuit provided enhanced conductor separation. Liberty purchased its utility system from Sierra Pacific, which had constructed the Topaz 1261 Circuit using a triangular crossarm configuration, with increased pin spacing at either end of an 8-foot crossarm and an elevated center phase to provide enhanced clearances between the conductors and mitigate the risk of contact.

This arrangement provided clearances that far exceeded GO 95’s conductor clearance requirements specified in Rule 38 and Table 2. For this type of construction on distribution facilities, GO 95 mandates a minimum horizontal separation of 17.5 inches between conductors, with the elevated center phase having a vertical separation at least equal to the pin spacing for the voltage class (i.e., 17.5 inches). Measurements recorded shortly after the Mountain View Fire identified radial clearances of 54 inches between the center phase and each of the road and field phases at Pole 266731. Based on these dimensions and configuration, 44 inches of horizontal clearance and 31 inches of vertical clearance were present on the Topaz 1261 Circuit. Thus, the Topaz 1261 Circuit incorporated the specific type of “extra measures” contemplated by GO 95, Table 2, Footnote (zz) for addressing known local conditions in high-wind areas—increased pin spacing beyond GO 95’s minimum requirements.<sup>1</sup>

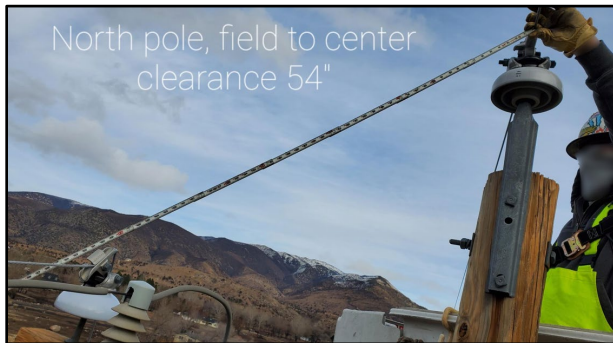
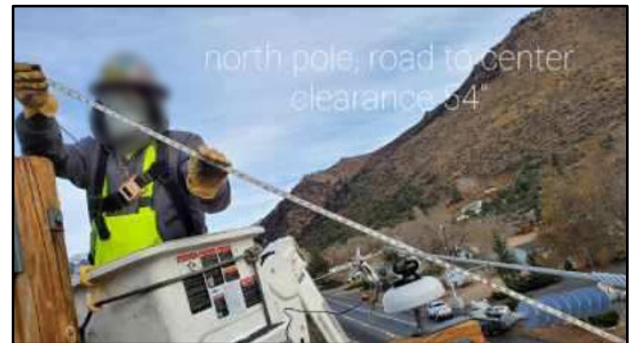
### ***Post-Fire Conductor Radial Clearance Measurements at Pole 266731<sup>2</sup>***

<sup>2</sup> Distance of 54 inches between the center and road phase conductors (left photograph) and between center and field phase conductors (right photograph).
