PUBLIC UTILITIES COMMISSION

SA2019-852

SUBJECT: Substation Audit of PacifiCorp's Klamath Falls-CA and Yreka Districts

AUDIT FINDINGS

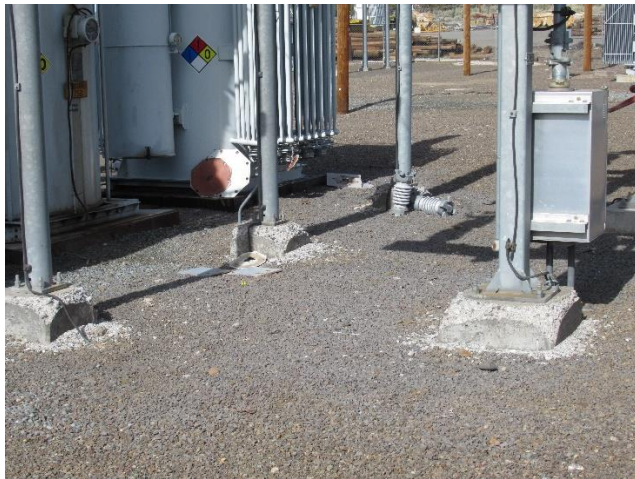
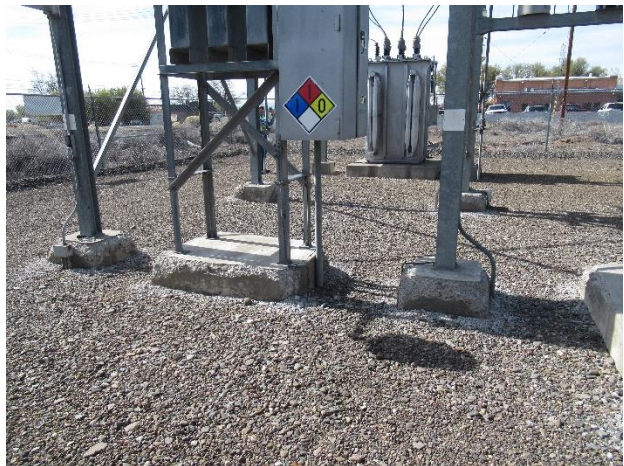
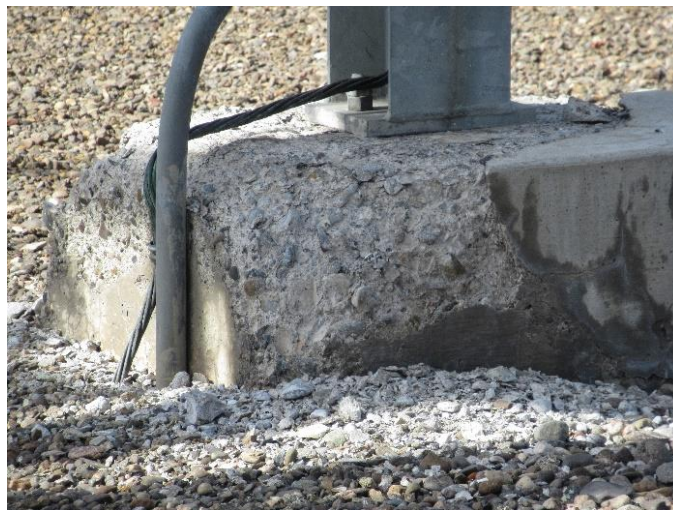
1.1. Multiple concrete foundations that support the substation equipment structures show evidence of deterioration.

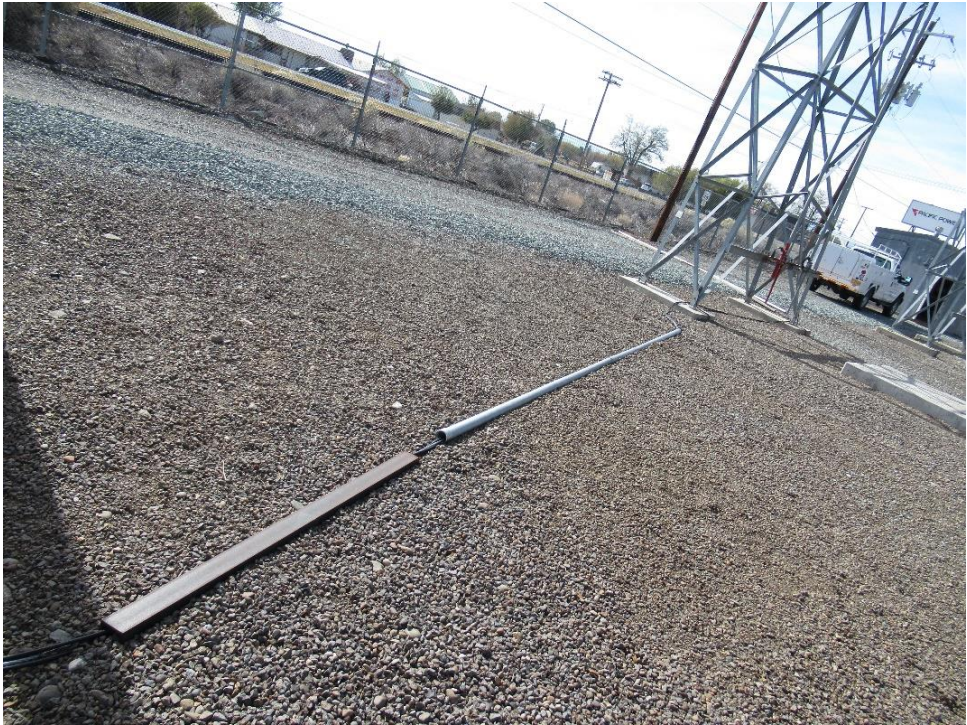
1.2. There is an exposed 120V/240V service conductor bundle lying across the substation yard.

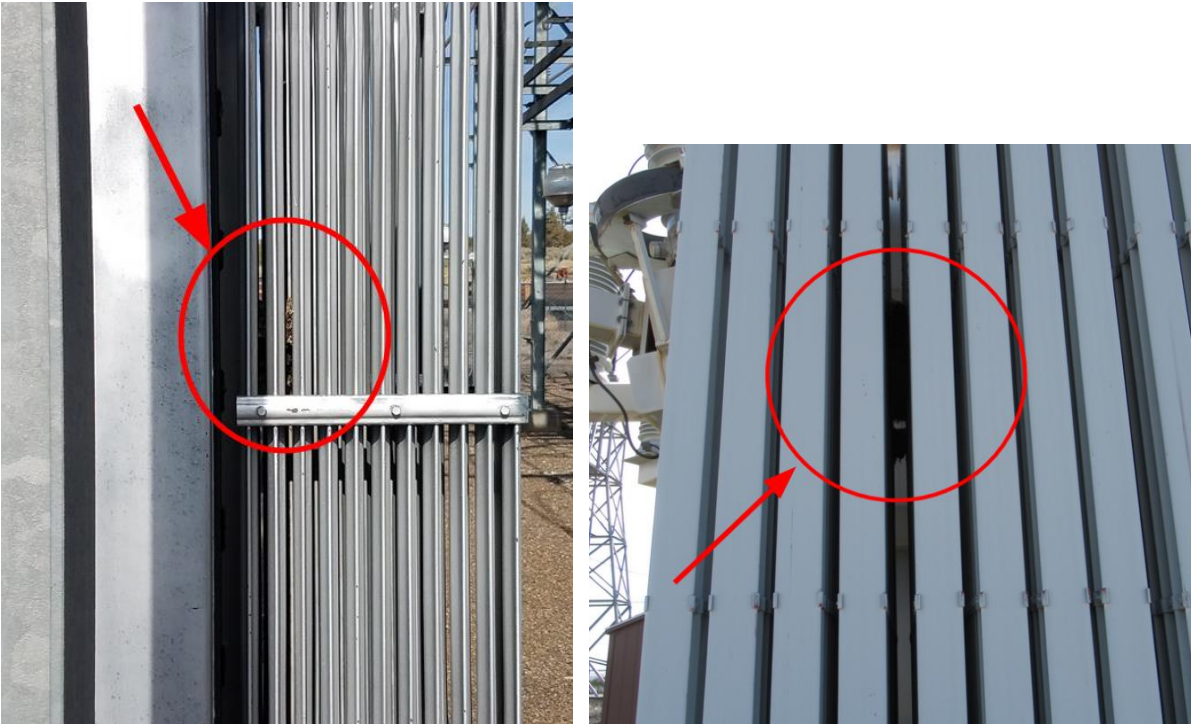
1.3. There are bird nests in the Transformer 3617 and Regulator 405 radiator fins.

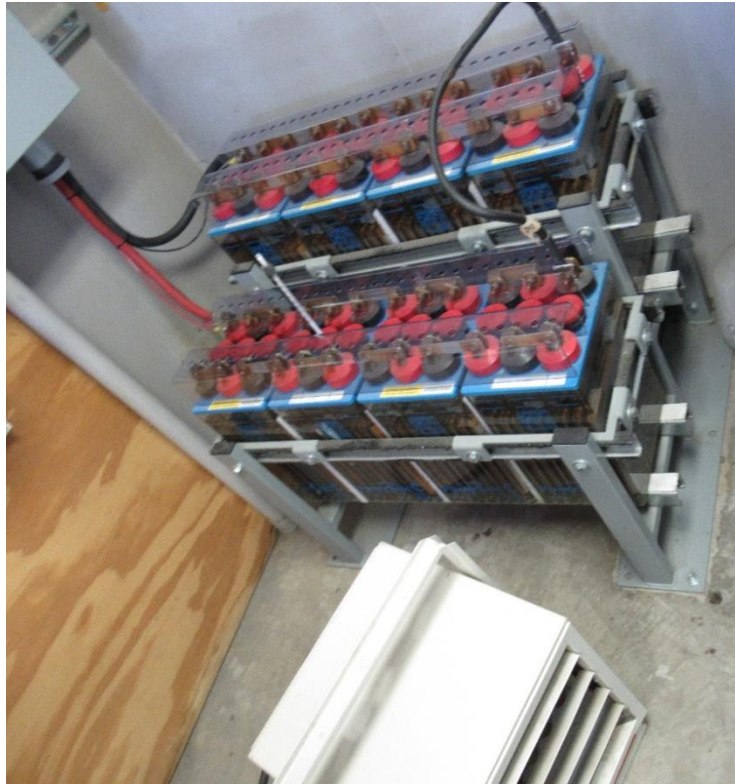
1.4. The substation battery system lacks secondary containment.

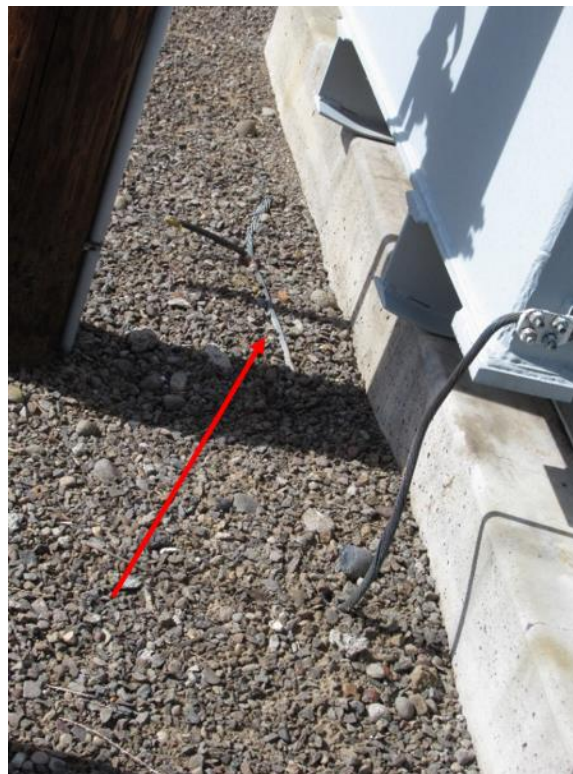
1.5. There is an exposed ground conductor from Transformer R1574.

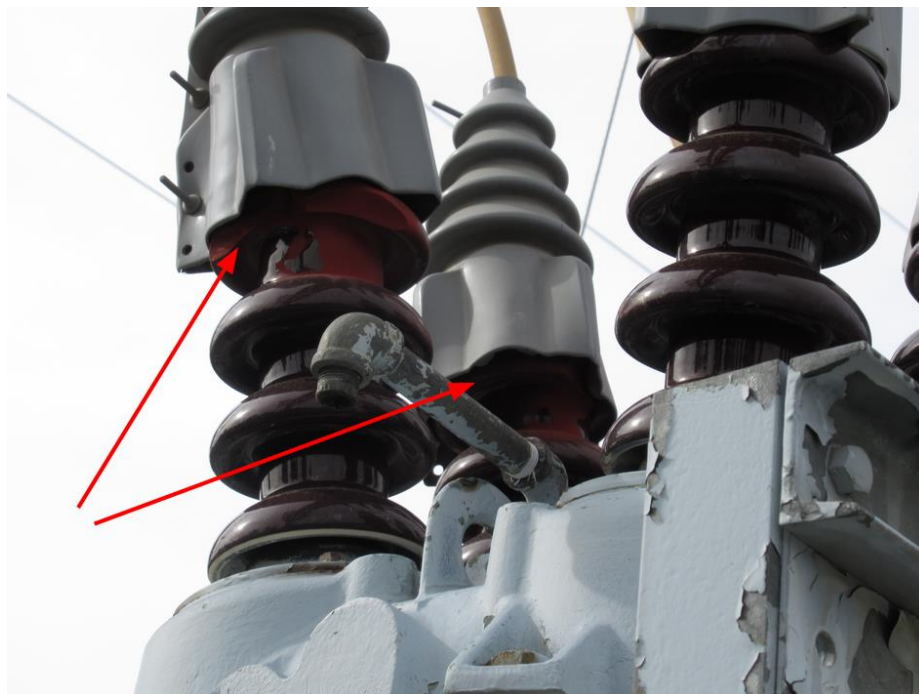
2.1. There are two damaged insulators under the animal abatement jackets on Breaker 5L70.

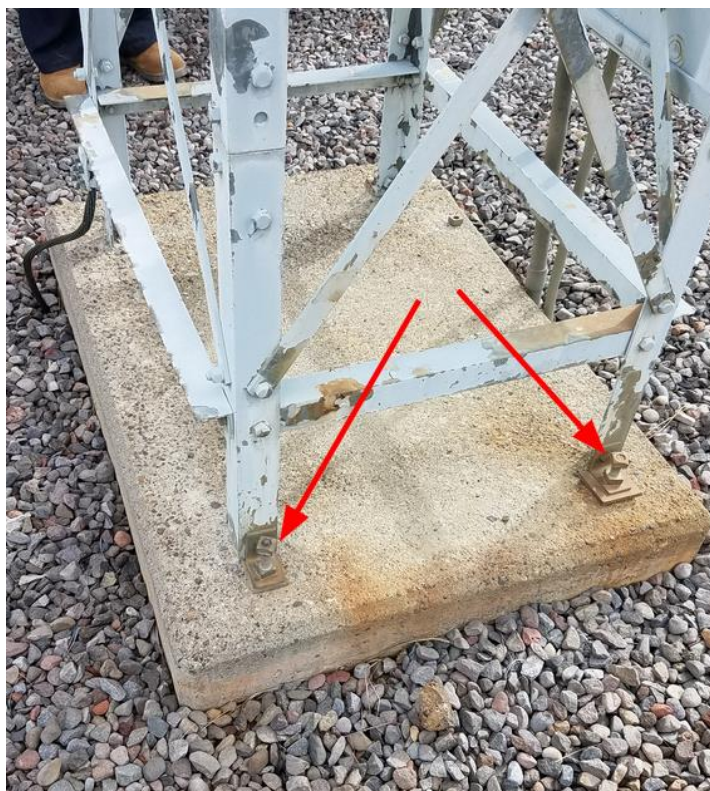
2.2. There are untightened nuts on the anchor bolts that support Breaker 5L70.

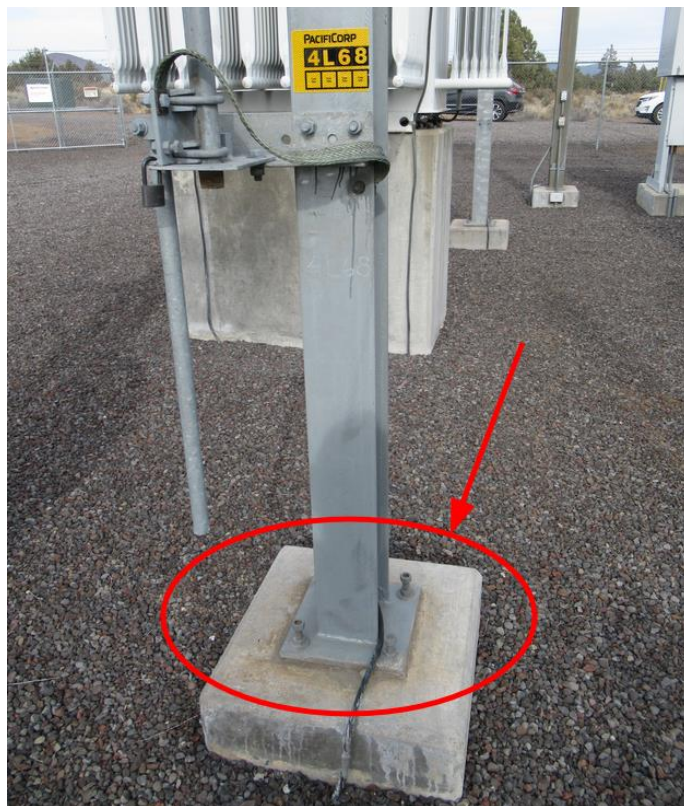
3.1. There are four untightened nuts on the anchor bolts that support Switch 4L68.

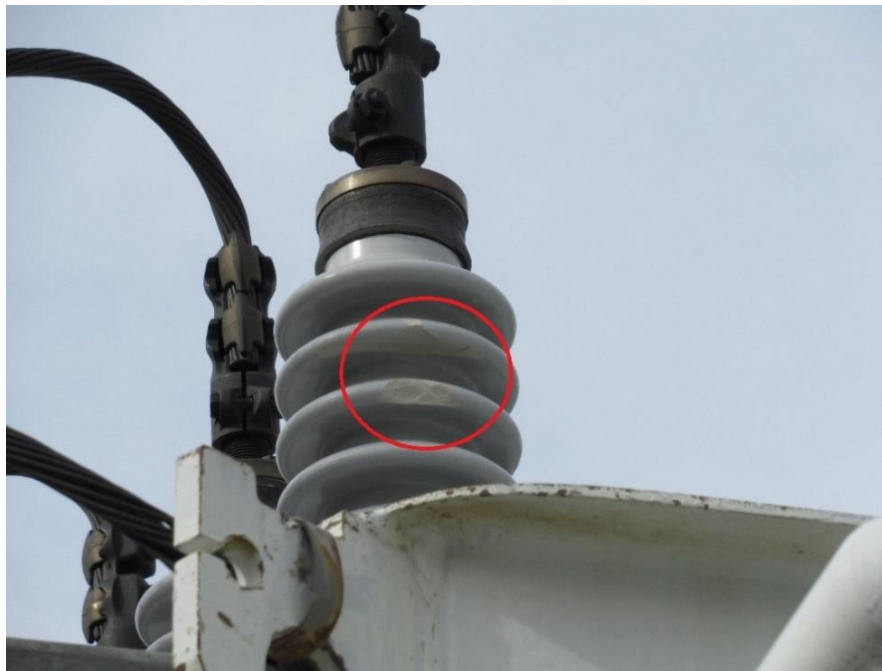
3.2. There is a chipped insulator bushing on Transformer 33-8306.

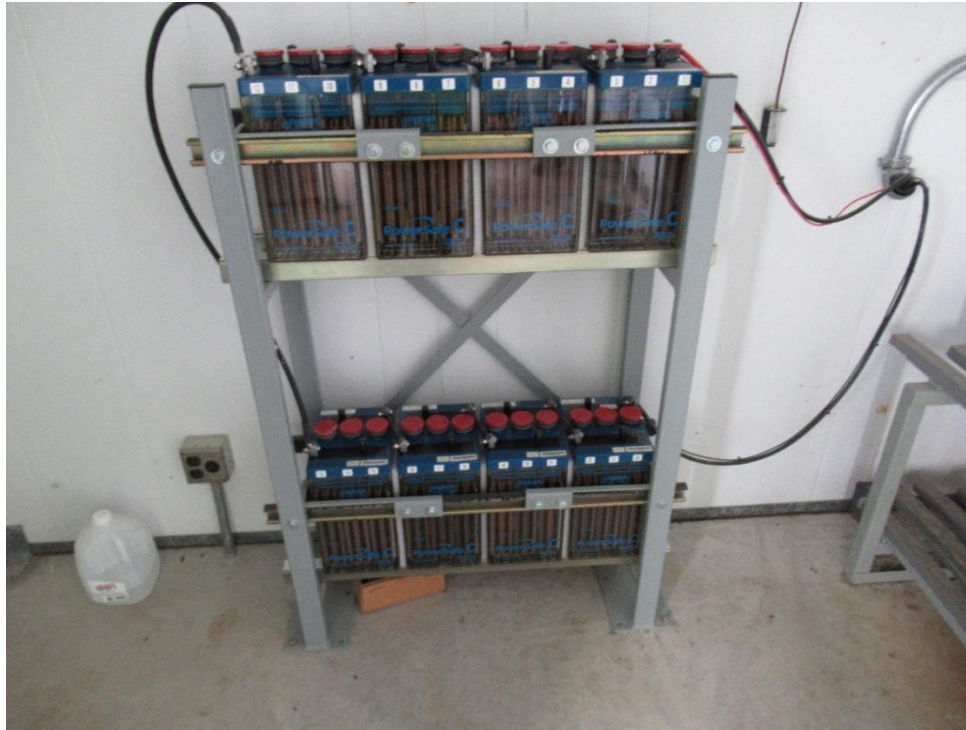
3.3. The substation battery system lacks secondary containment.

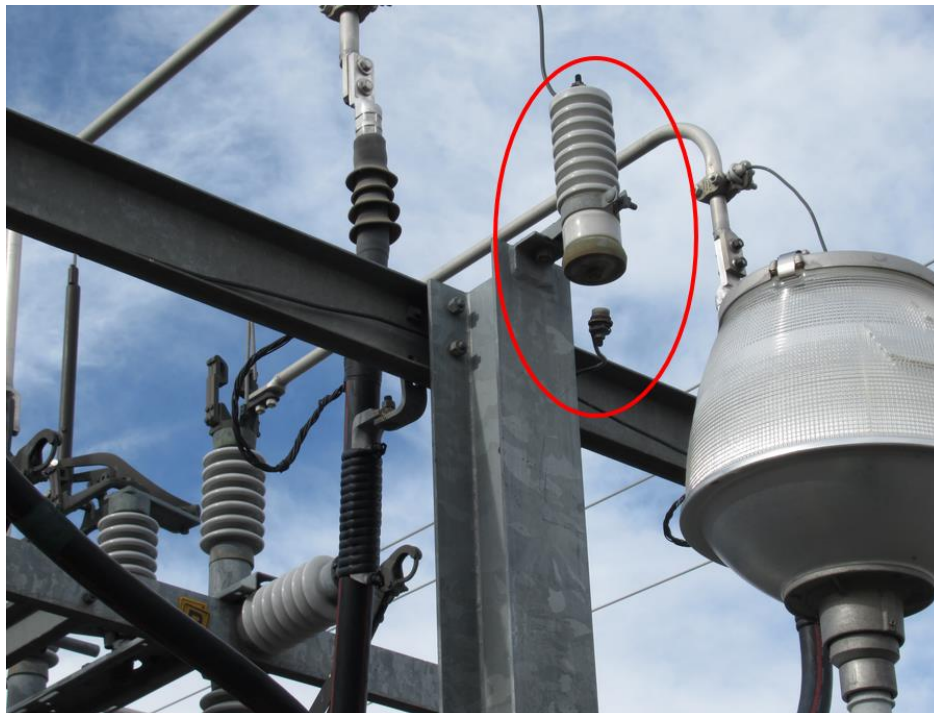
Similarly, on September 1, 2016, PacifiCorp identified a blown lightning arrestor at the Newell Substation and created work order #16606972. PacifiCorp Inspectors continuously noted the blown arrestor during the August 15, 2019 and July 16, 2019 substation inspections, but the work order is still open at 1099 days and counting. Additionally, PacifiCorp has an ongoing toggle switch replacement program that has been open for almost five years.

4.1. Arrestor 5L68 is blown. ESRB observed this condition during the audit which PacifiCorp has identified in September 2016 under PacifiCorp's Corrective Maintenance Order #16606972.

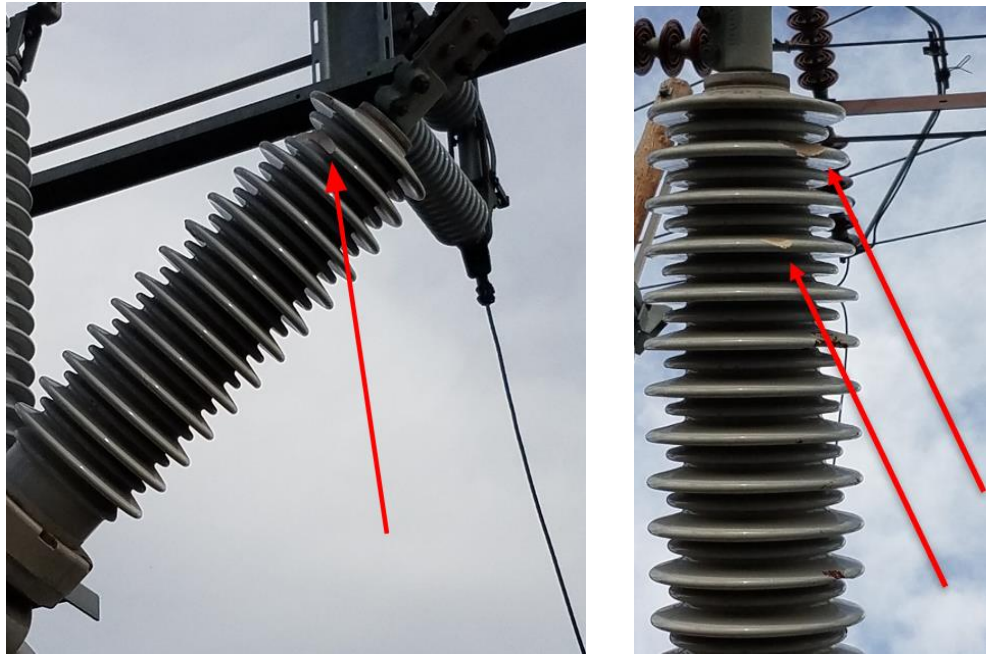
4.2. There are damaged insulator bushings on Breaker 3L25.

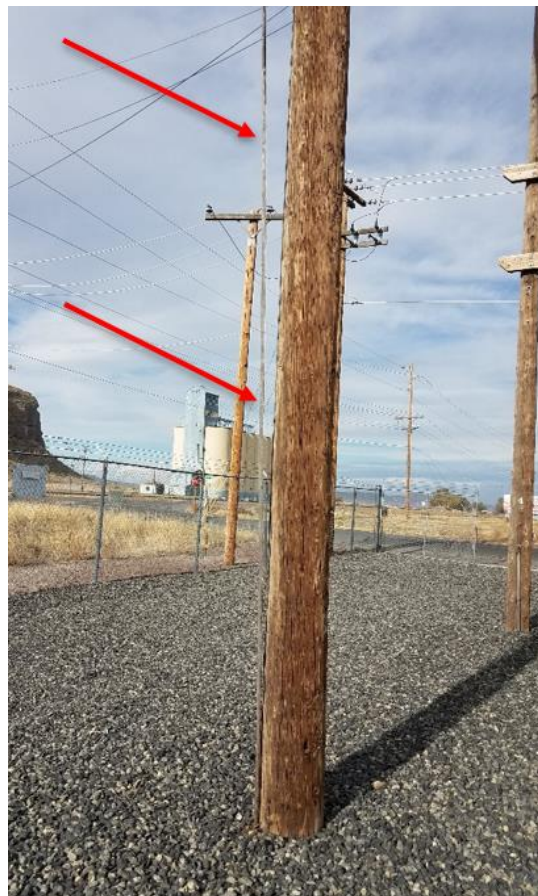
4.3. There is an unsecured ground wire molding on a wooden pole near Breaker 3L25.

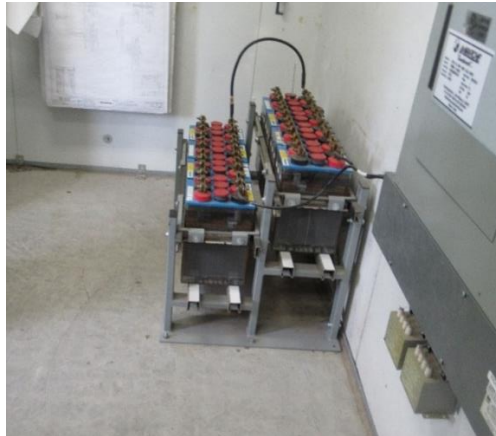
4.4. The substation battery system lacks secondary containment.

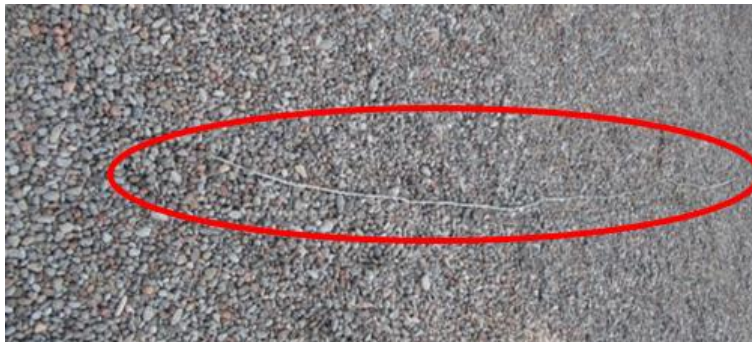
5.1. There is an exposed ground conductor lying across the substation yard.

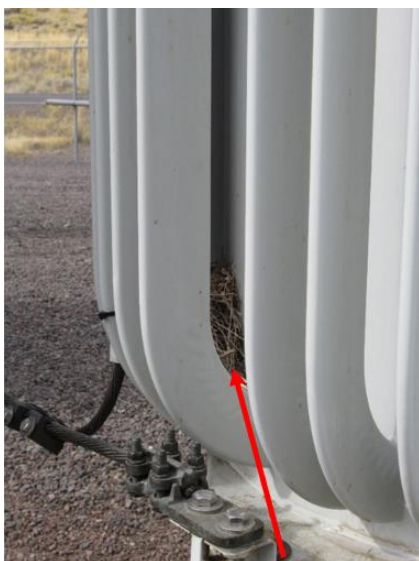
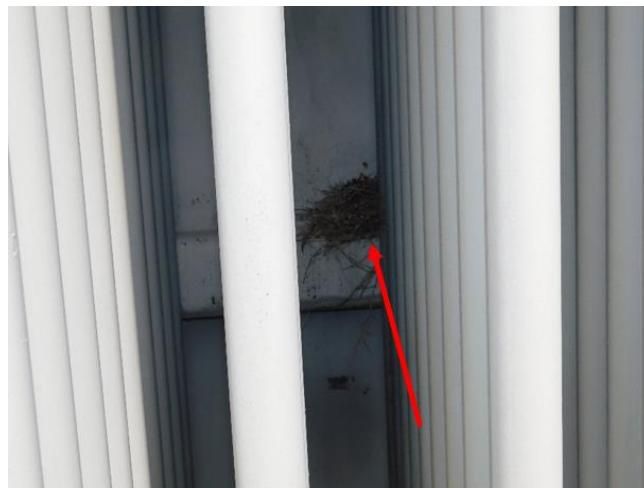
5.2. There are bird nests in the radiator fins of Regulator 2, Regulator 3, Transformer 2784, and Transformer 2786.

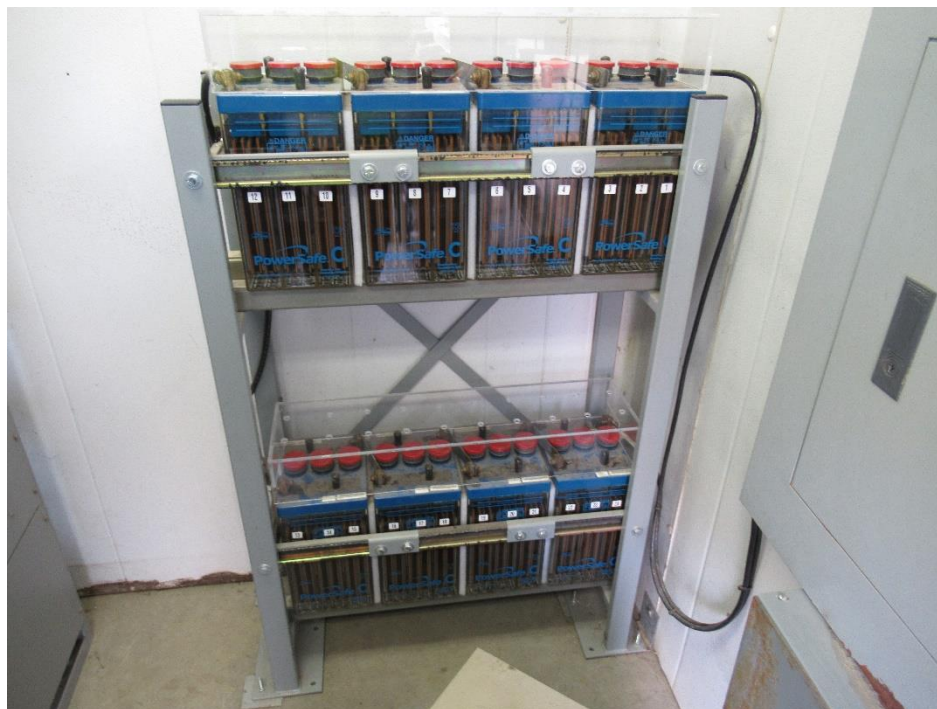
6.1. The substation battery system lacks secondary containment.

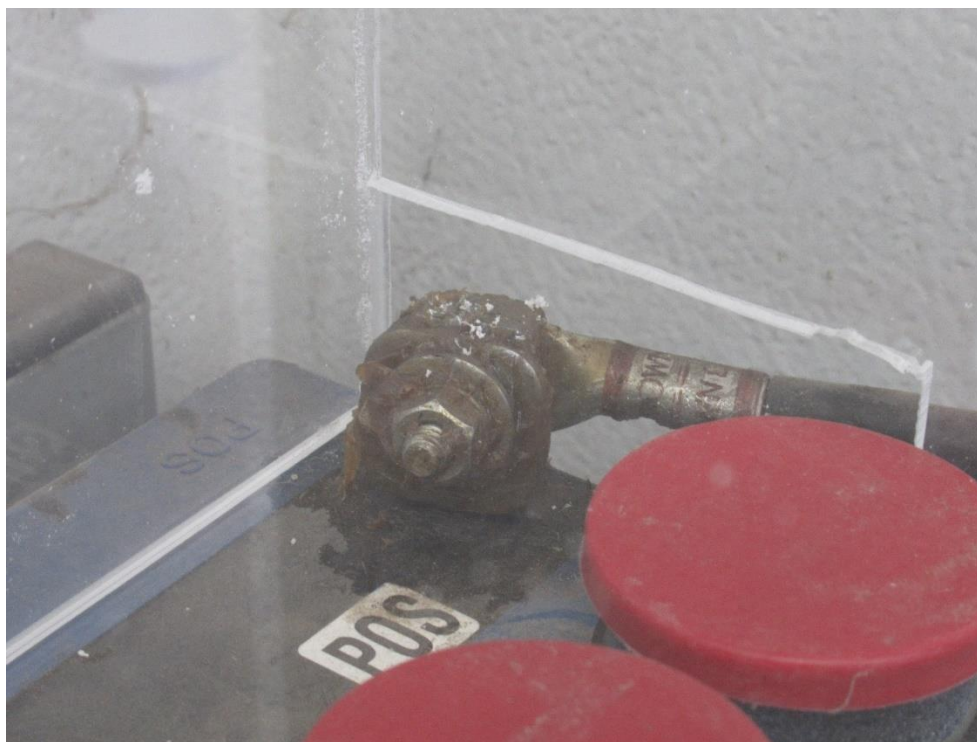
6.2. There is corrosion forming on the Battery Cell 1 terminal.

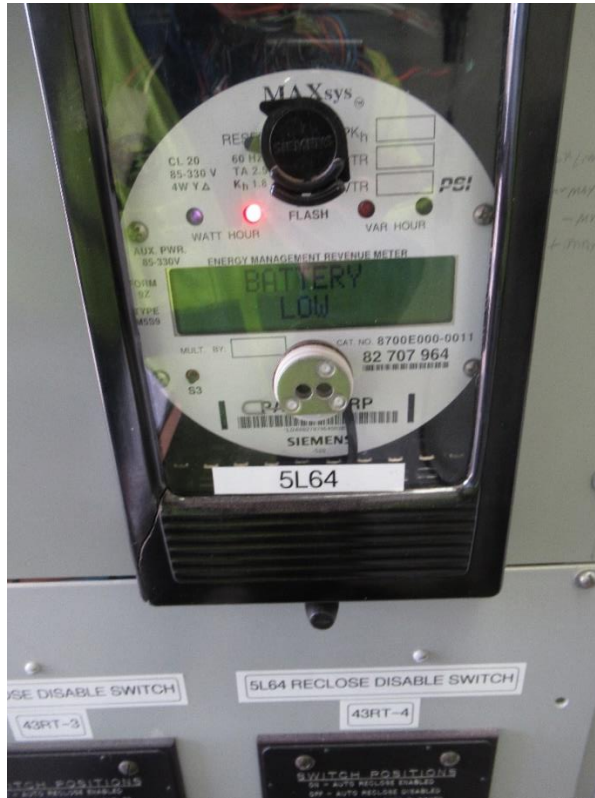
6.3. There is a low battery alarm on the meter for Breaker 5L64.

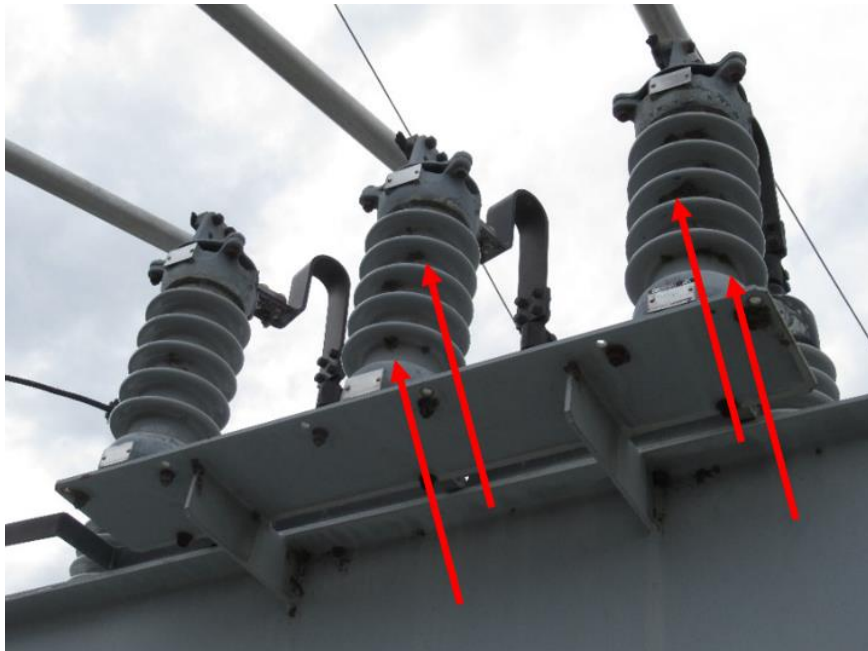
7.1. Dirt tracking is forming on Transformer 3520's low-side insulator bushings.

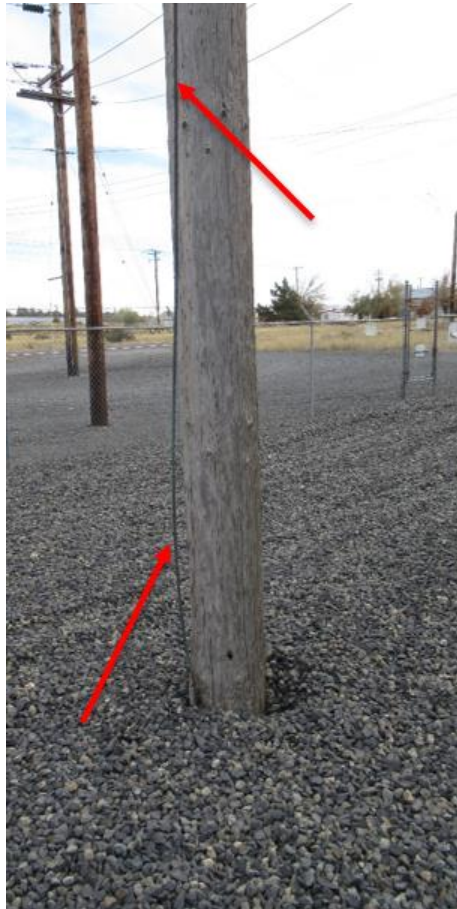
7.2. There is a ground wire on a wooden pole inside the substation yard that is missing a molding cover.

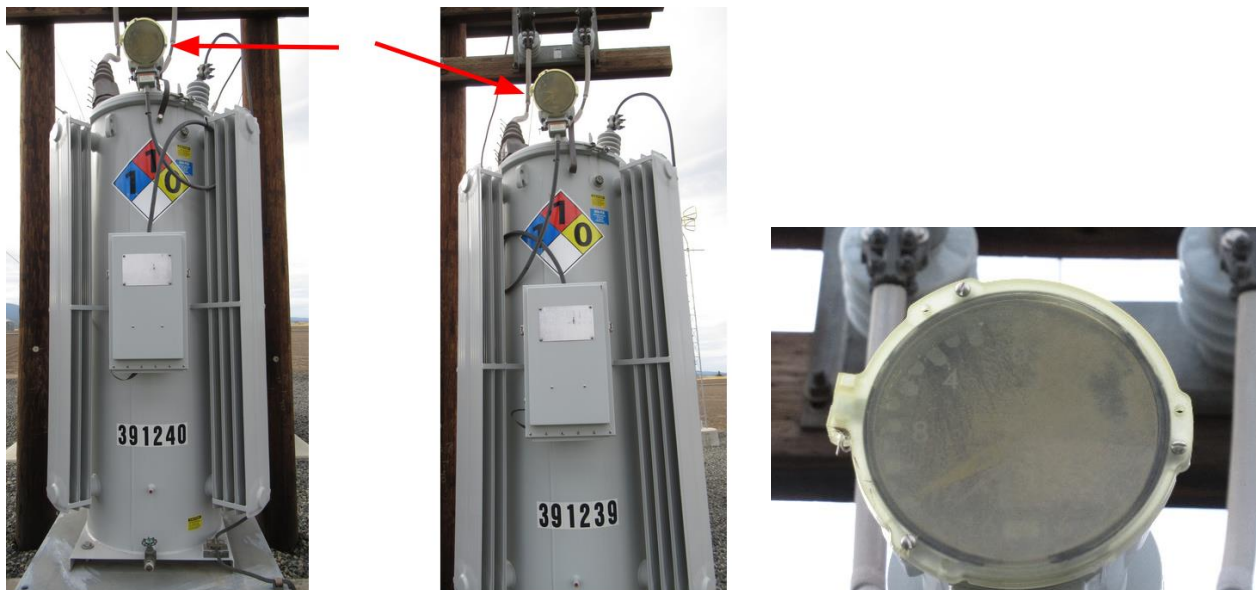
7.3. The position gauges on Regulator 391240 and Regulator 391239 are illegible.

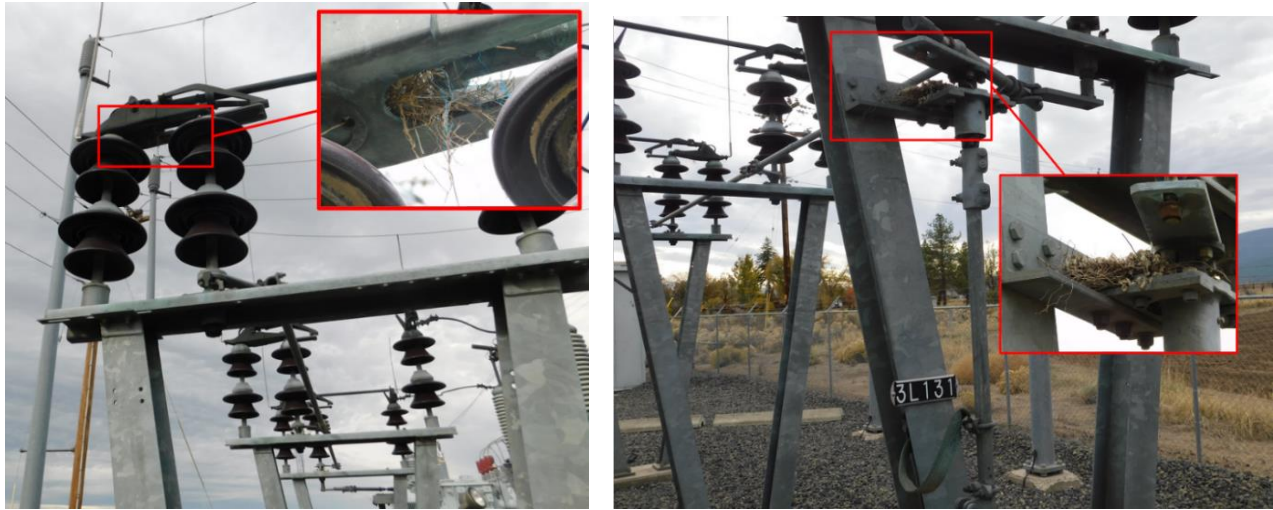
7.4. There are bird nests that could obstruct the motion of Switch 3L131's linkages.

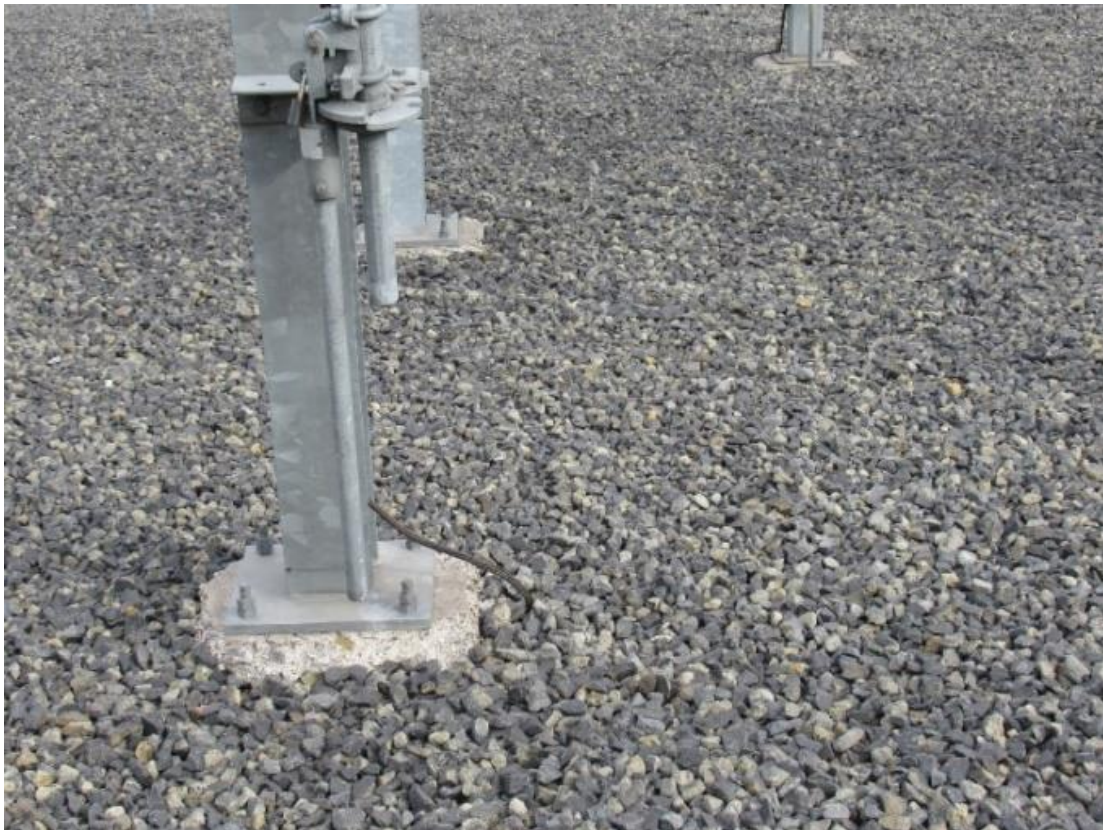
7.5. Multiple concrete foundations that support the low-side bus work from Transformer T-3520 show evidence of deterioration.

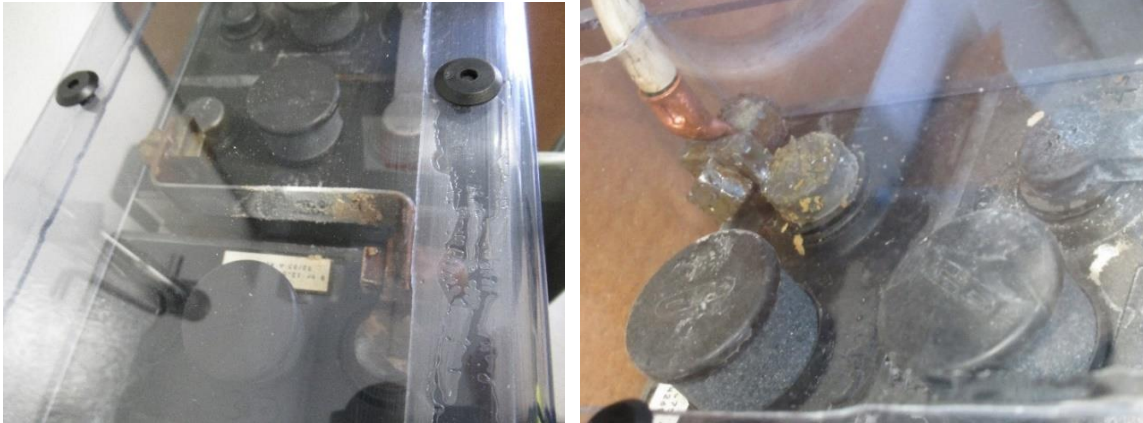
8.1. There is corrosion on the linkage between Battery Cells 9 and 10. There is also corrosion forming on the Battery Cell 24 terminal.

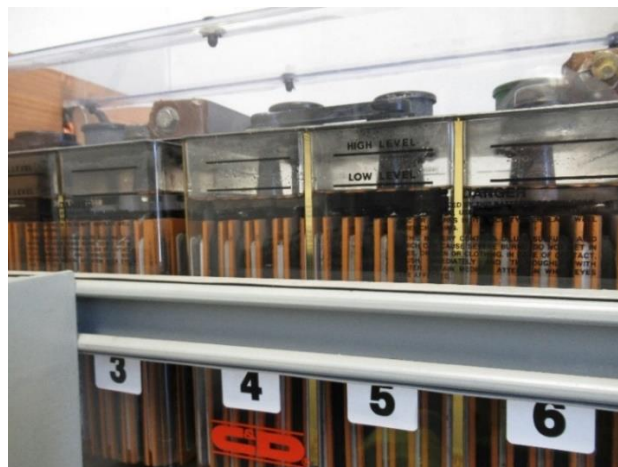
8.2. Many of the fluid levels on the 24-cell battery system are low.

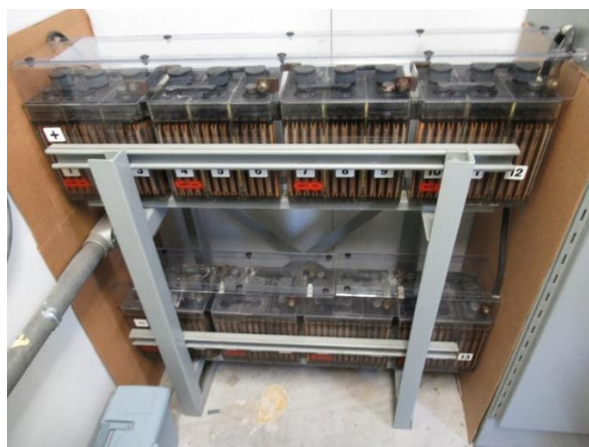
8.3. The substation battery system lacks secondary containment.

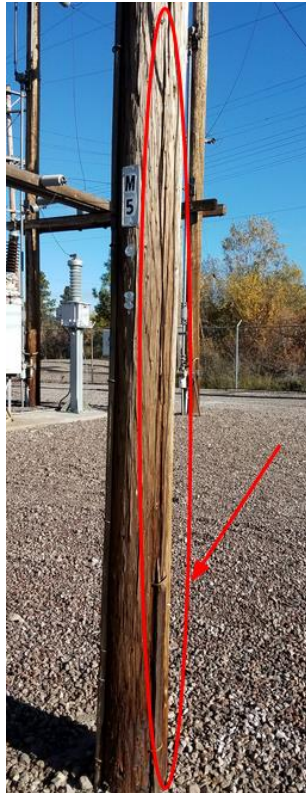
8.4. There is a broken ground molding cover on a wooden pole inside the substation yard.

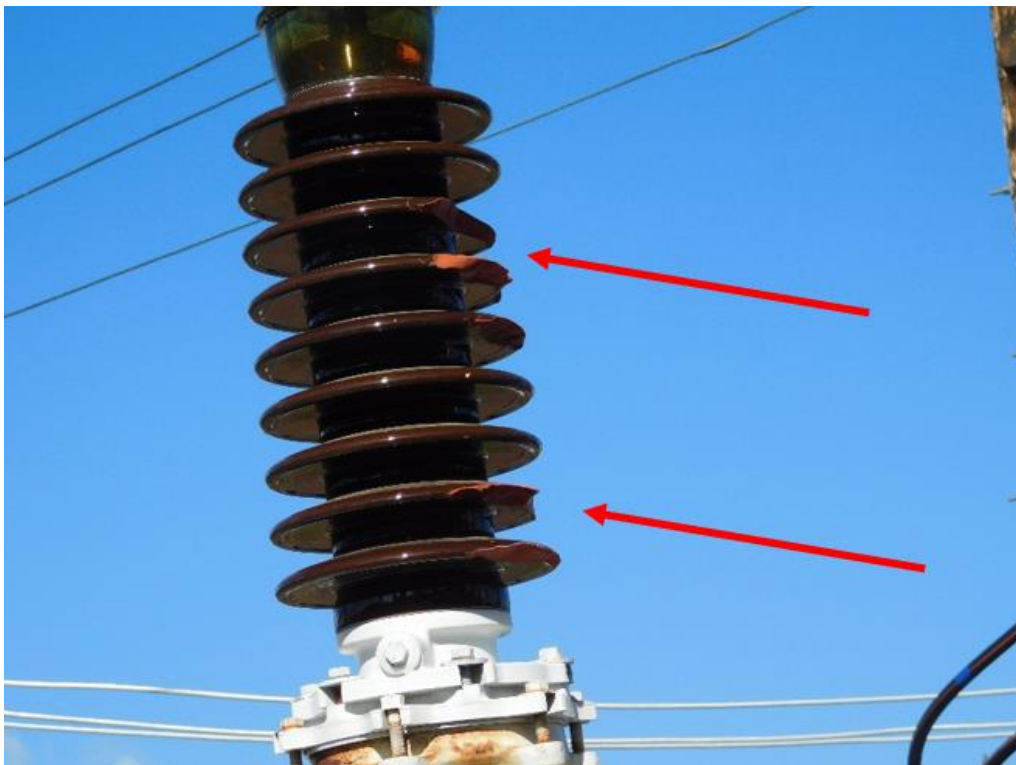
8.5. There is a chipped insulator bushing on a potential transformer near the rear of the substation.

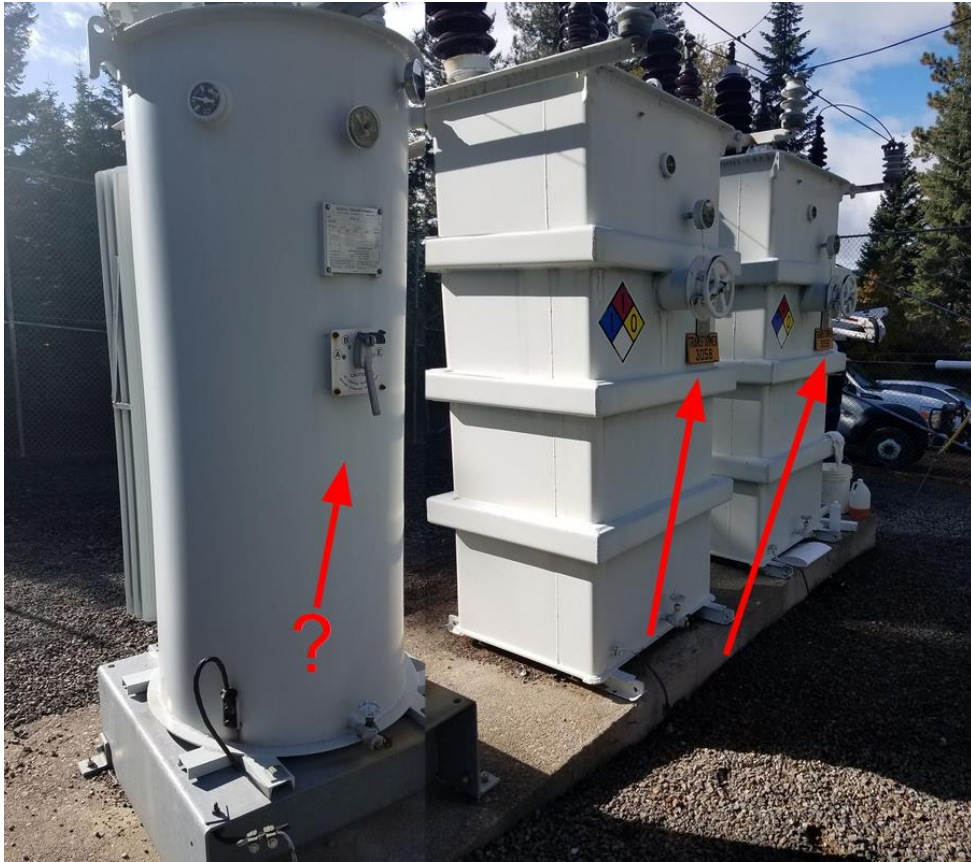
9.1. Transformer 3057 is missing its identification signage.
