PUBLIC UTILITIES COMMISSION

EA2021-925

SUBJECT: Electric Distribution Audit of Plumas Sierra Rural Electric Cooperative (Plumas Sierra) - Portola

**PLUMAS SIERRA RURAL ELECTRIC COOPERATIVE
ELECTRIC DISTRIBUTION AUDIT FINDINGS
November 15-19, 2021**

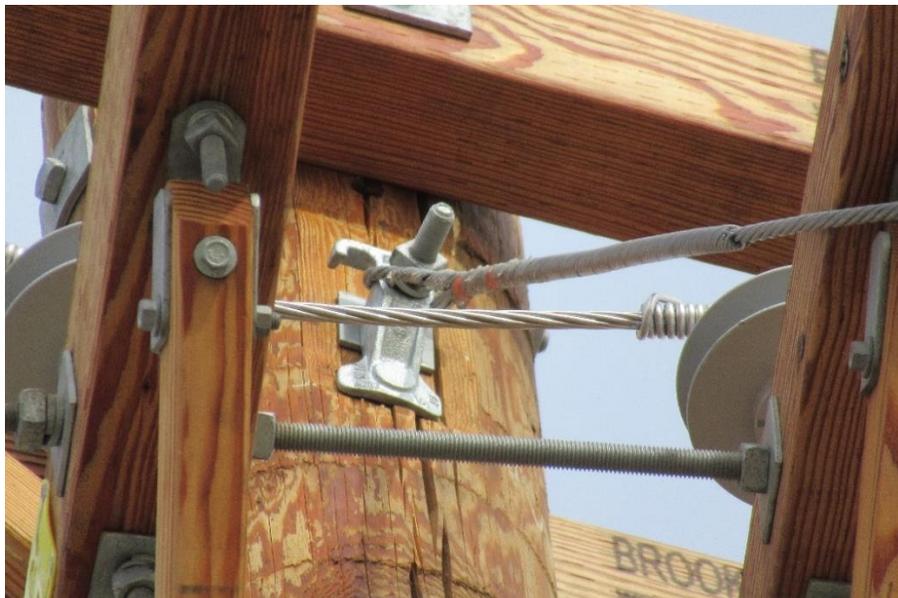
- 4.1. The down guy on the pole with equipment number 3454, two spans east of Johnson’s Metal Recycling in Quincy (Location 7), was contacting the communication span.
- 4.2. The down guy on the pole at the intersection of Graeagle Johnsonville Rd and CA-89 in Graeagle (Location 22) was contacting the communication span.
- 4.3. The down guy on the pole with equipment number 11635 on Harrison Ranch Rd in Beckwourth (Location 59) was less than the required three inches from the overhead neutral conductor, shown below in Figure 1.

Figure 1: Down guy in proximity to the neutral conductor
