JOB# J-045679

SCN RESOLUTION & PHOTO

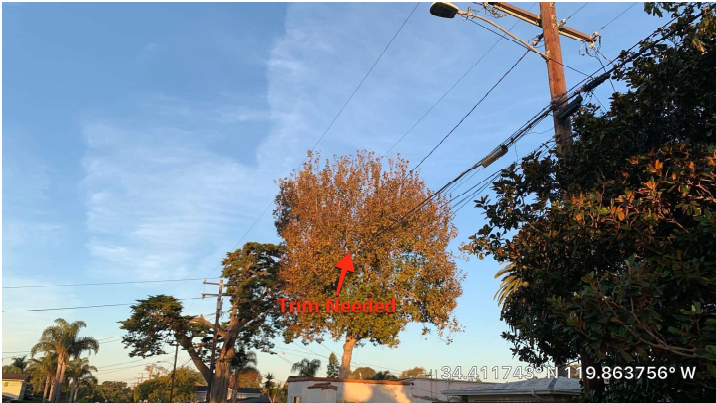
Before Photo #2 (If Necessary)	After Photo #2 (If Necessary)

Crown Castle communications conductor had less than 12 inches of vertical separation from a third-party communications conductor.

<p>A photograph of a tree with a red arrow pointing to its canopy and the text "Trim Needed". The coordinates 34.411743° N 119.863756° W are visible at the bottom.</p>	  <p>A photograph of a tree with a red arrow pointing to its canopy and the text "Trimmed Tree 45". The coordinates 34.411798° N 119.863600° W are visible at the bottom.</p>
Before Photo #3 (If Necessary)	After Photo #3 (If Necessary)

Raised 1 Cable 6"

Placed Guard Arm and Fiber Tag

Trimmed Tree 65'

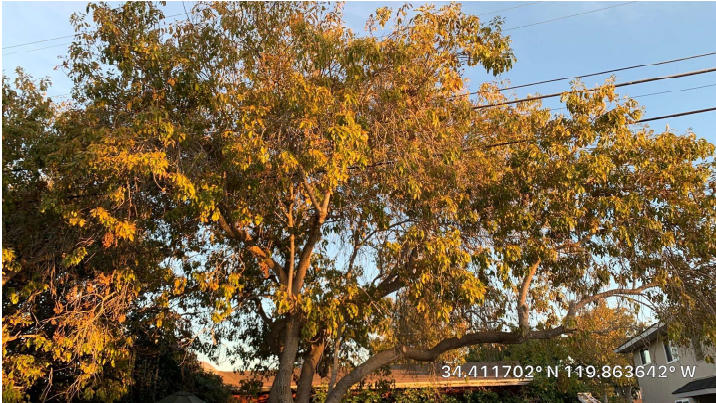
<p>A photograph of a tree with a red arrow pointing to its canopy and the text "Trim Needed". The coordinates 34.411702° N 119.863612° W are visible at the bottom.</p>	  <p>A photograph of a tree with a red arrow pointing to its canopy and the text "Trimmed Tree 45". The coordinates 34.411798° N 119.863600° W are visible at the bottom.</p>

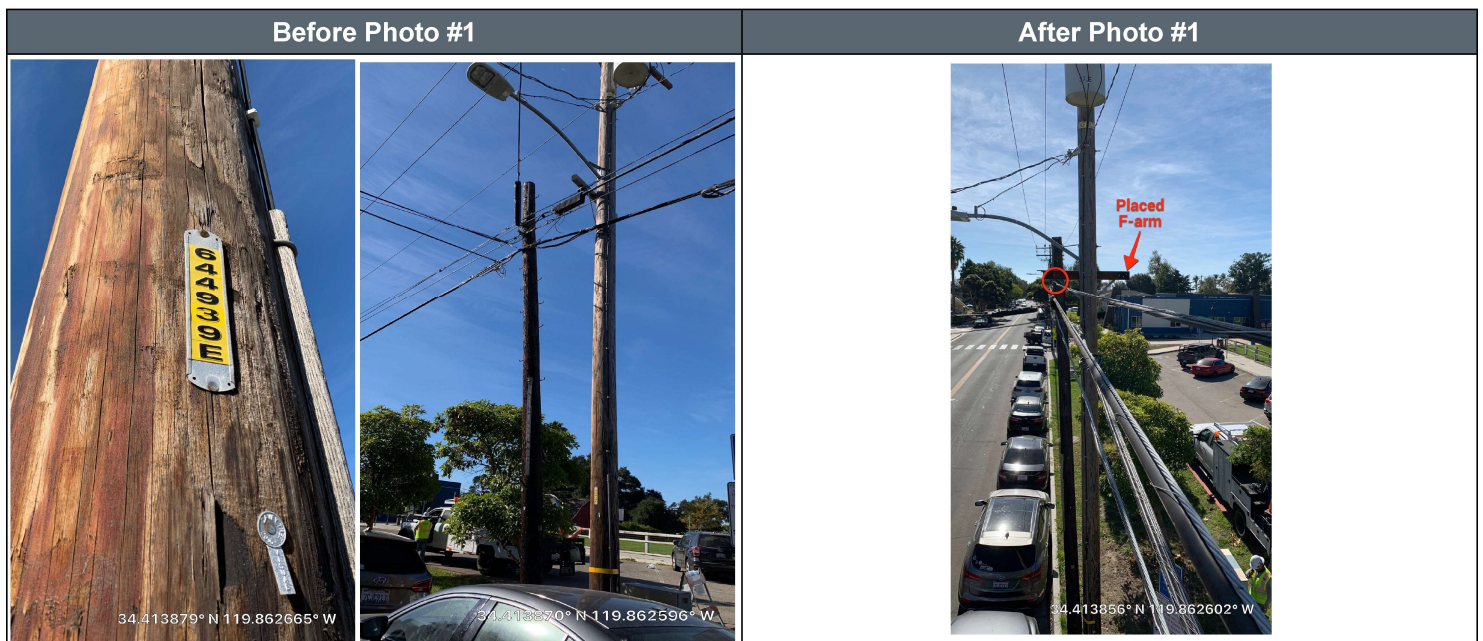
Crown Castle needs to transfer its facilities from the buddy pole to the new pole.
CAMINO DEL SUR W/S 1271' S/O COLEGIO RD

Removed Guard Arm and Replaced with F-Arm
Placed Fiber Tag
Trimmed Tree 65'

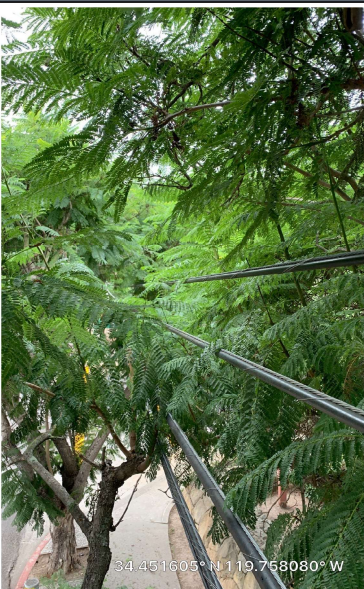
Before Photo #1		After Photo #1

Crown Castle communications conductor supported on Pole number 1081714E was touching a third-party communication down guy wire
1061 Foothill Rd Santa Barbara, Ca 93110

Placed Box Guard
Trimmed Tree 100'

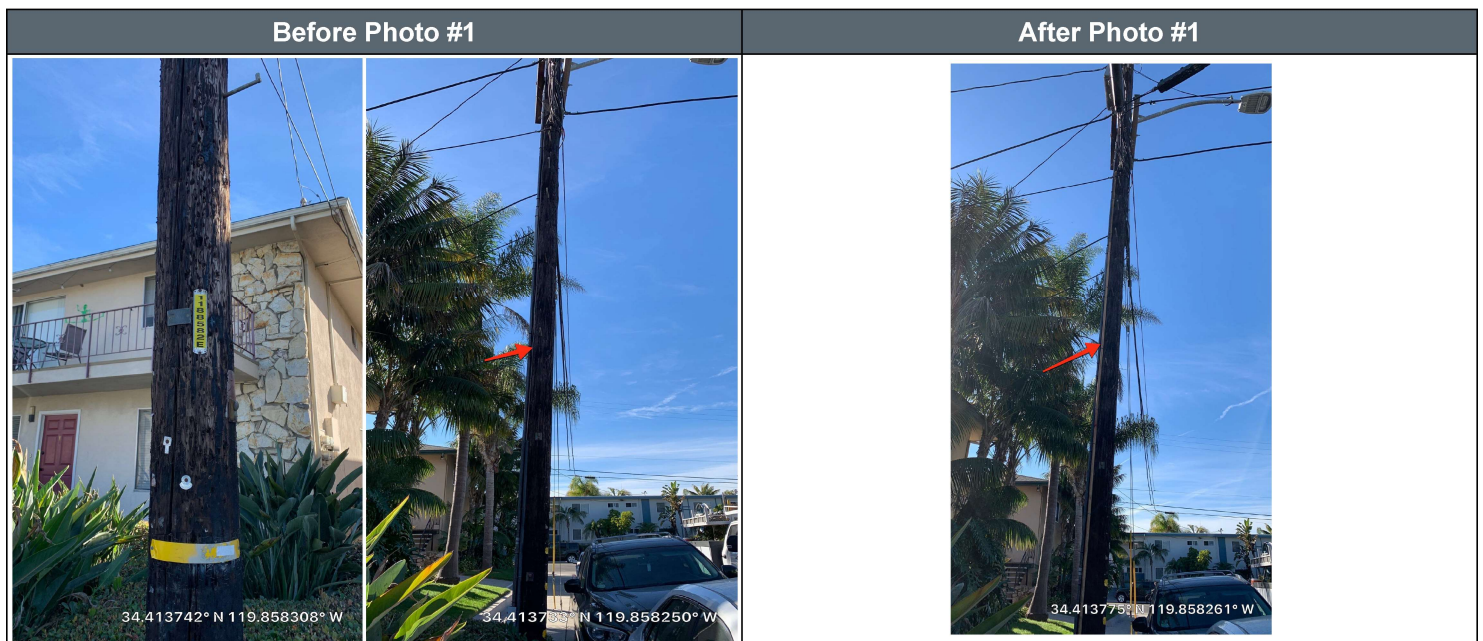
The ground moulding attached to each of the following poles was damaged
EMBARCADERO DEL MAR P/P 330 W 920 N/O TRIGO RD

Placed Molding Stick, Fiber Tag and Guy Guard on Down Guy

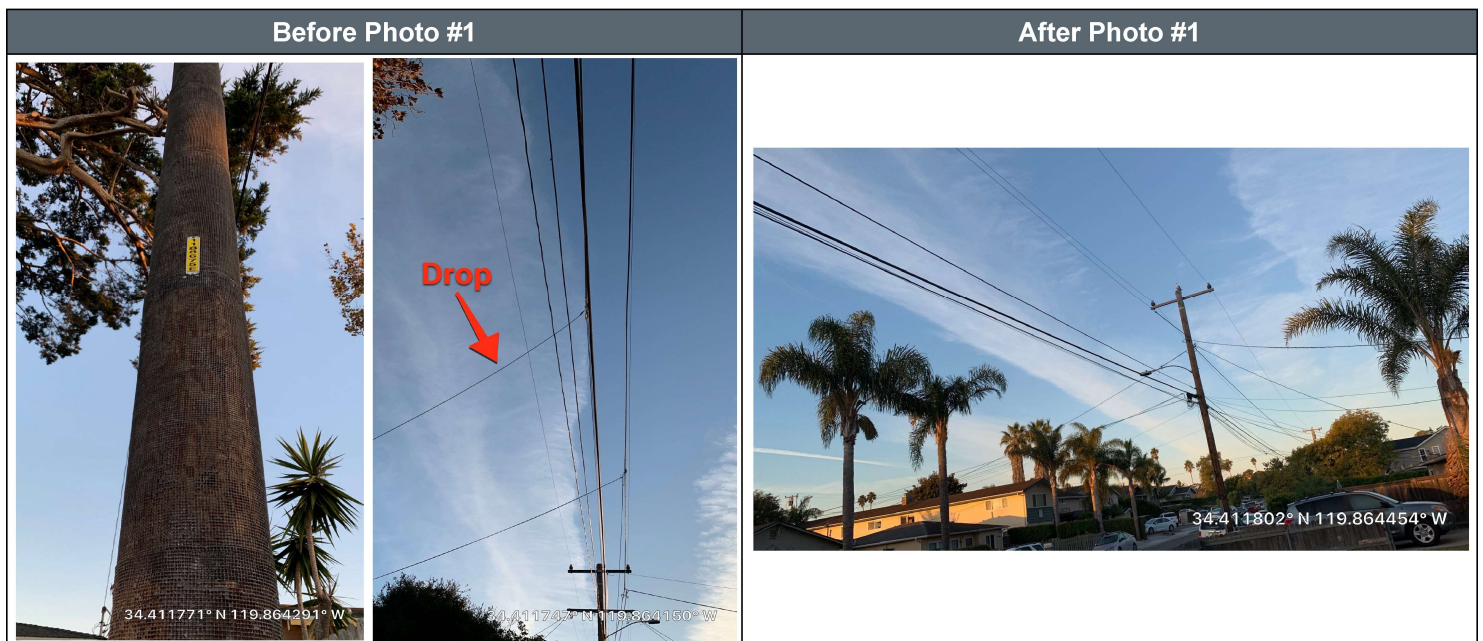
Crown Castle communications conductor was touching a third-party communications service drop.
PASADA RD N/S 470' W/O CAMINO DEL SUR

Fixed Box Guard and Spec Hardware
Re-tension span
Removed Drops from Lead and Placed Fiber Tag

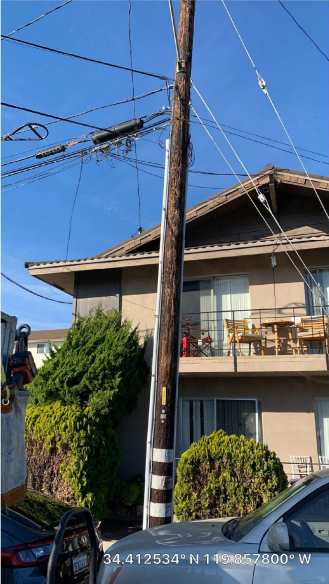
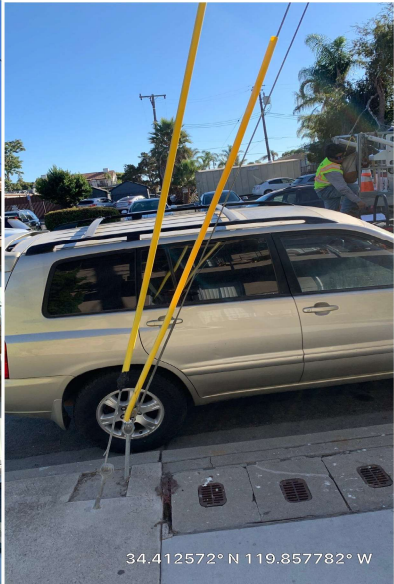
Before Photo #1		After Photo #1

The Crown Castle down guy wire supporting Pole 1256346E was not taut
CAMINO PESCADERO P/P 260' E 1' S/O SL/O SUENO RD EXTD

No Work Needed

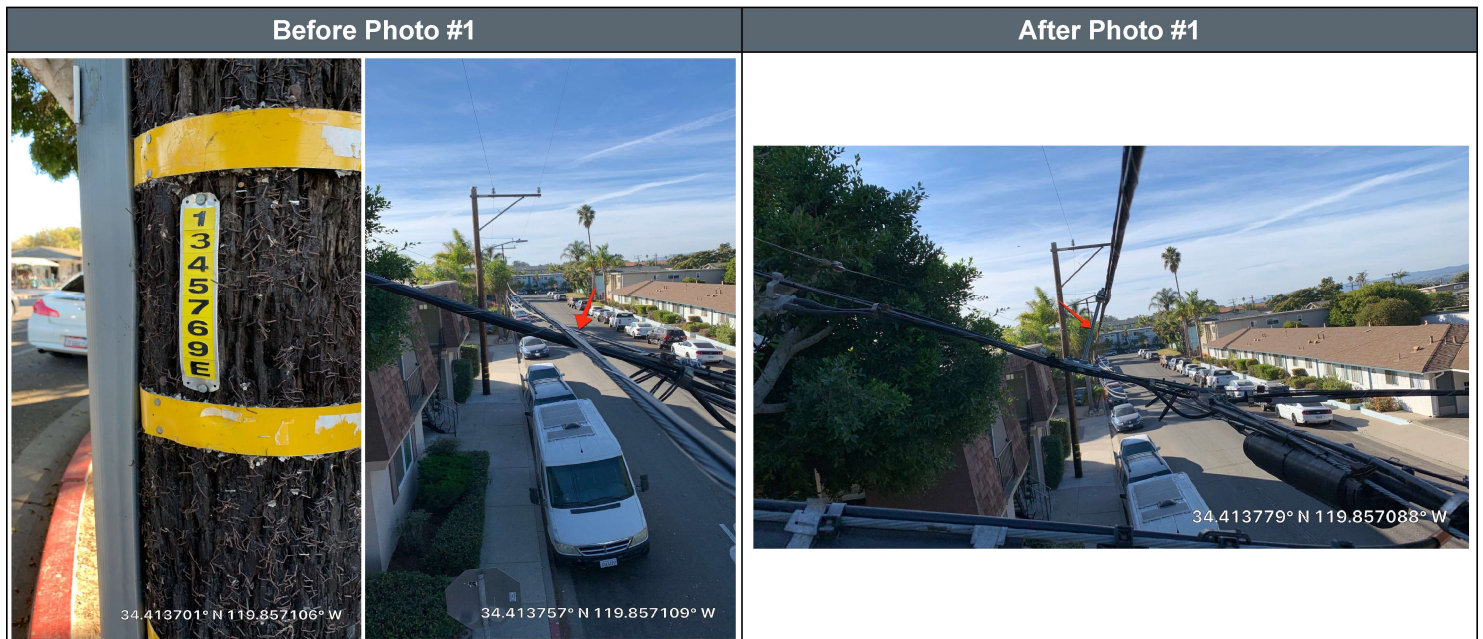
Crown Castle communications conductor was touching a third-party communications conductor.
EMBARCADERO DEL MAR W/S 910' N/O TRIGO RD

Placed Spreader Bolt

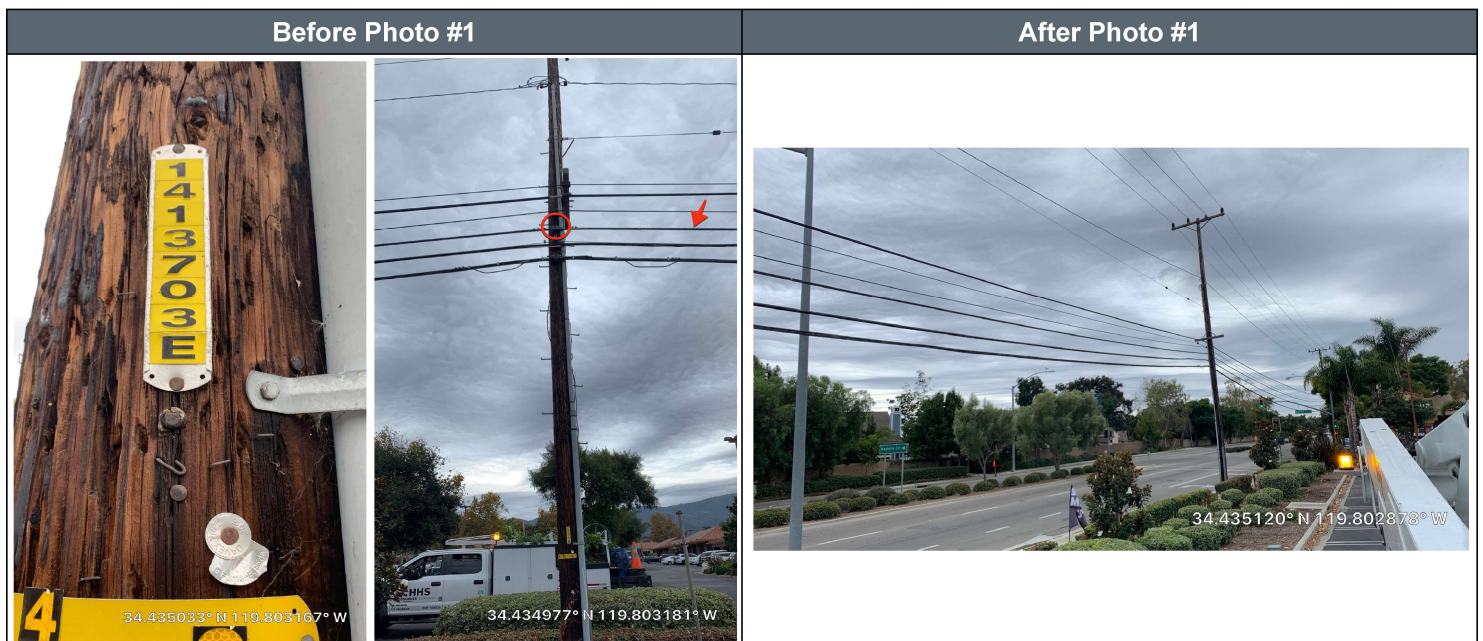
Crown Castle lashing wire was broken

Placed Fiber Tag
Repaired Lashing Wire

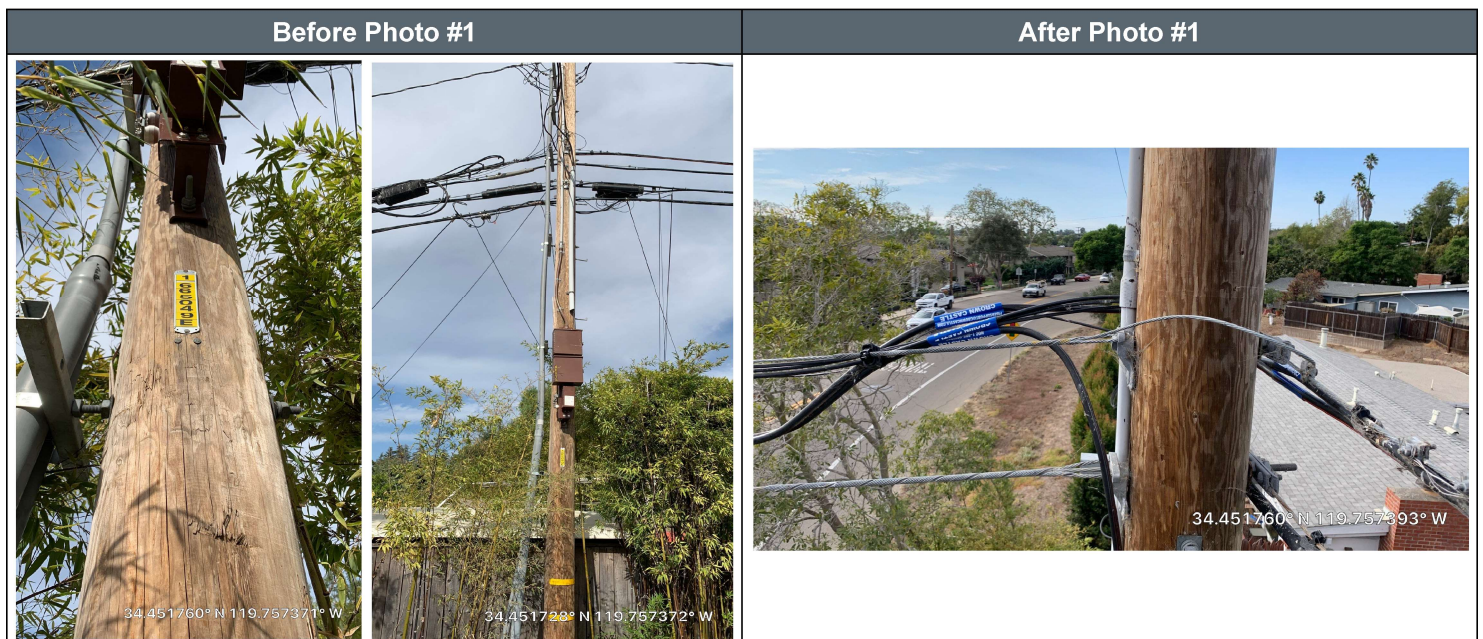
Crown Castle communications conductor splice box was touching a third-party communications conductor.
FOOTHILL RD N/S 140' W/O COCOPAH DR Santa Barbara, CA 93110

Placed Fiber Tag
Untangled Lines
Placed 2 Spreader Bolts to Prevent 3rd Party Communication Line from Touching Splice Case
Cleaned up Splice Case

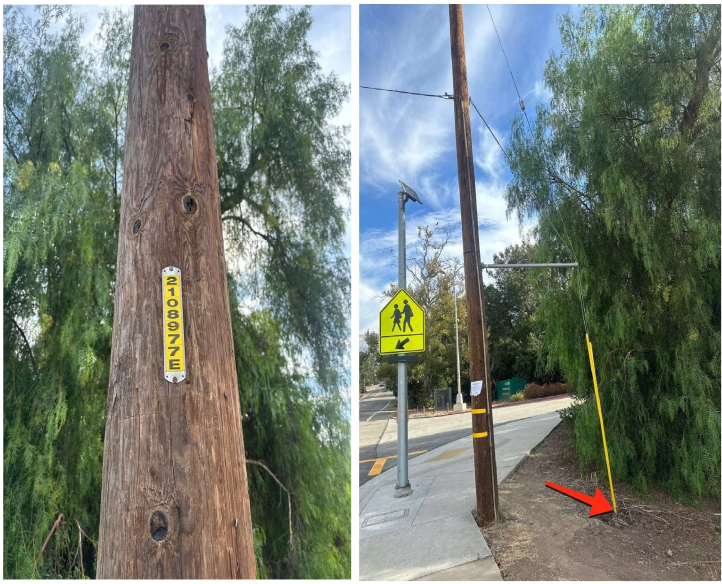
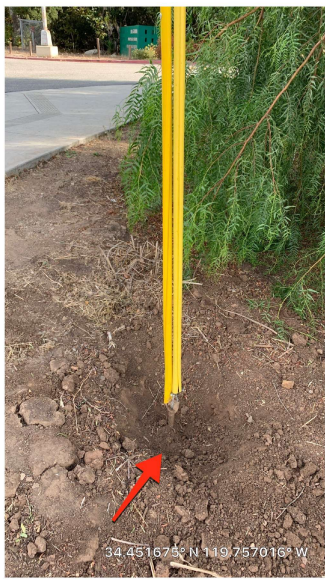
Before Photo #1	After Photo #1

The "eye" of the Crown Castle down guy anchor supporting the pole was buried.
FOOTHILL RD S/S 730' E/O CIENIGITAS RD

Molding Completed Upon Arrival

Dug up to Reveal Anchor

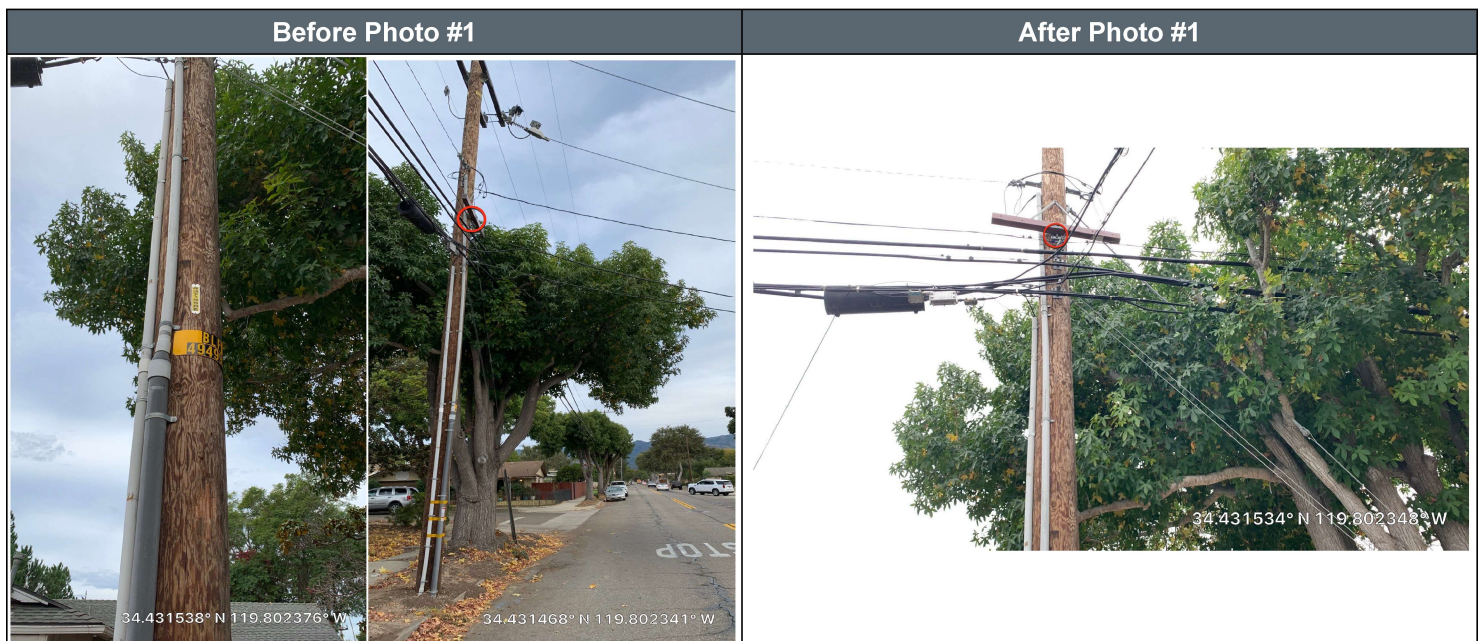
Crown Castle communication conductor supported on each of the following poles was strained by vegetation.
S WALNUT LN W/S 1200' S/O HOLLISTER AV

Placed 2 Box Guards
Swap Hardware
Tree Trimming 140'

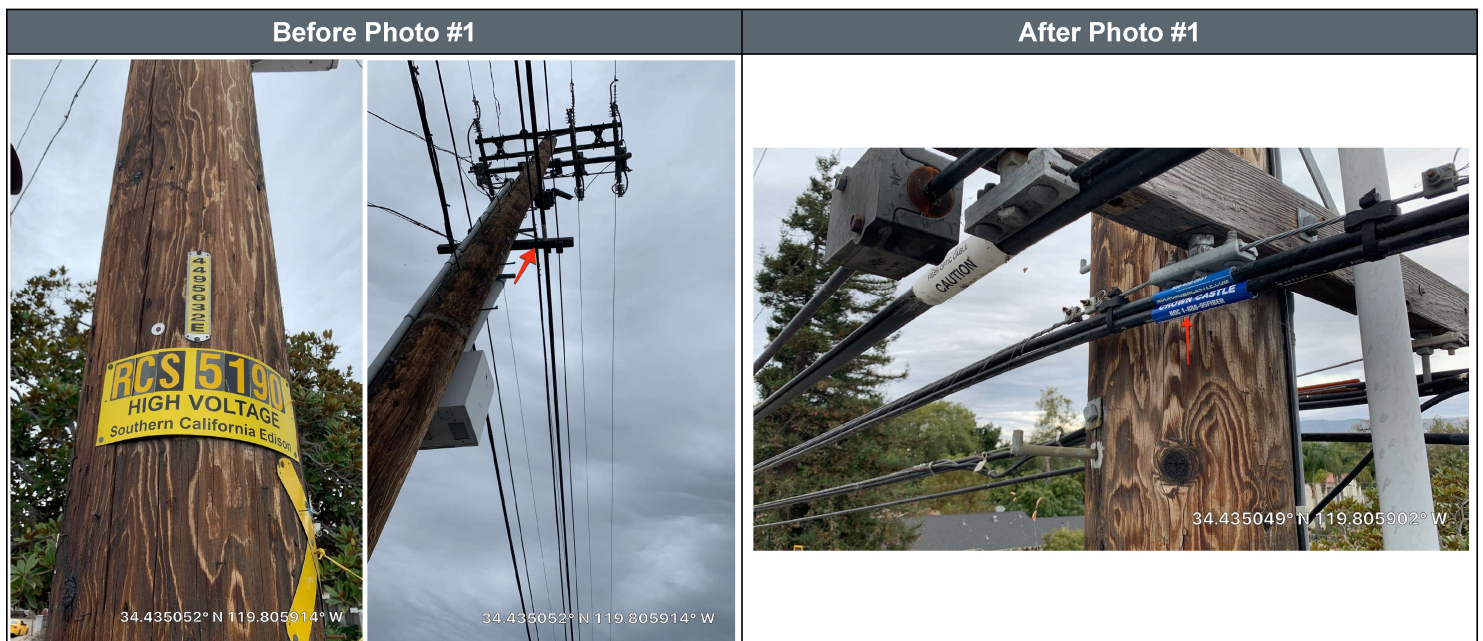
Crown Castle communications conductor had less than 12 inches of vertical separation from a third-party communications conductor.

Moved Frame 6"
Placed Fiber Tab
Spec Hardware

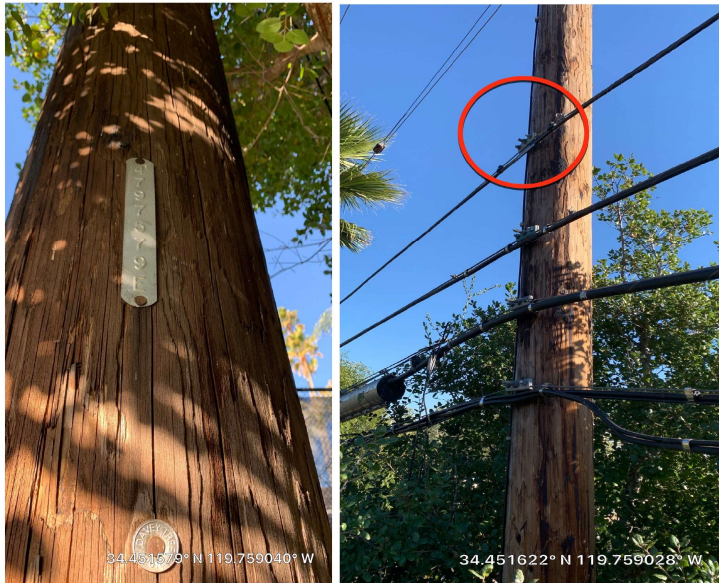
Before Photo #1

Crown Castle communications conductor had less than 12 inches of vertical separation from a third-party communications conductor.

Placed Snow Show
Trimmed Tree Approx 20'
Placed Fiber Tag

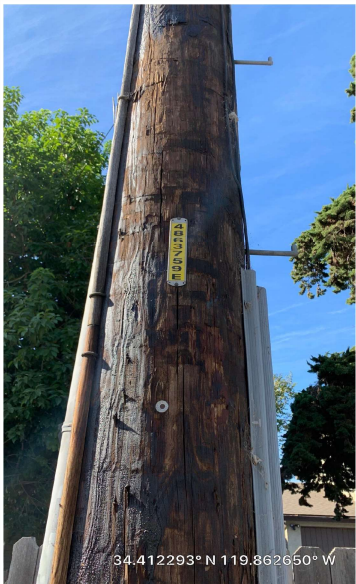
Before Photo #1		After Photo #1

A Crown Castle communication conductor supported on each of the following poles was strained by vegetation
CAMINO DEL SUR W/S 200' N/O PASADO RD

Trimmed Tree 20'
Spec Hardware
Placed Fiber Tag

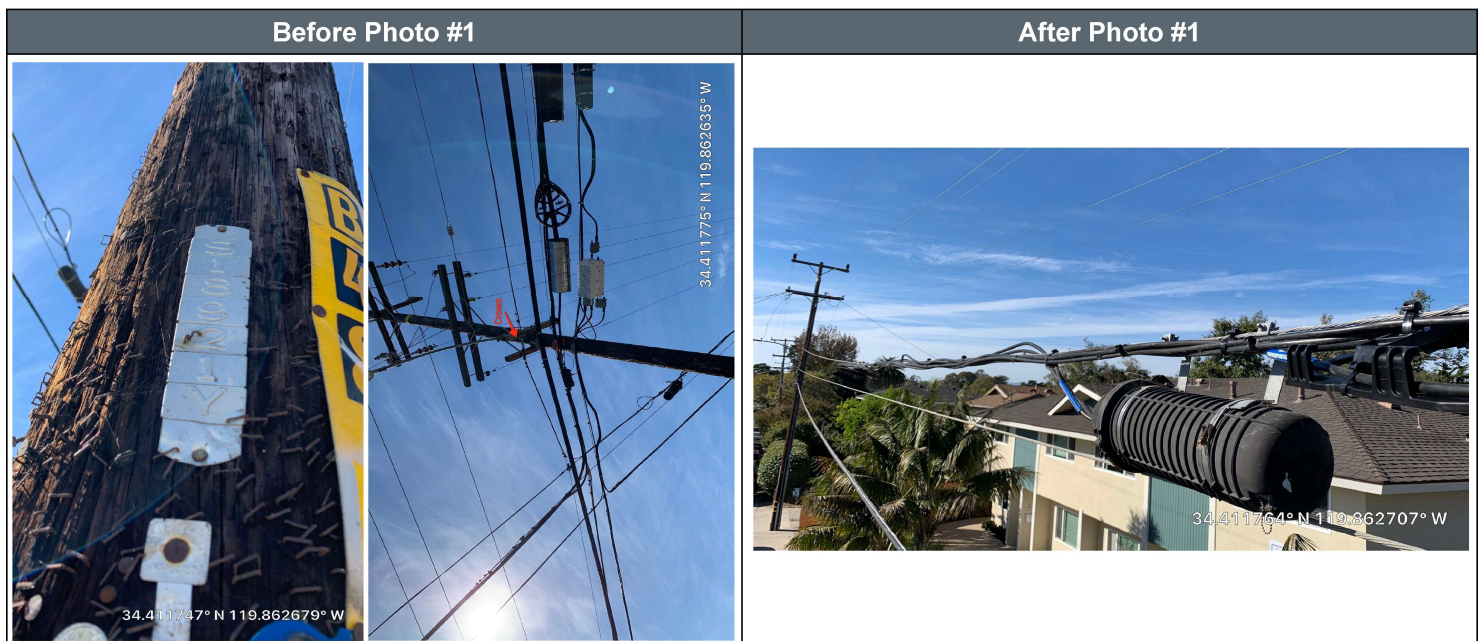
A Crown Castle splice box was loose and not secured to the pole.
CAMINO DEL SUR N/W COR/O PASADO RD

Re-Secure Splice Case
Placed Snow Shoe
