SA2023-1068

SUBJECT: Substation Audit of PG&E's Oakport Headquarters (HQ)

**CPUC AUDIT FINDINGS OF PG&E OAKPORT
SUBSTATION HEADQUARTERS
March 13 - 17, 2023**

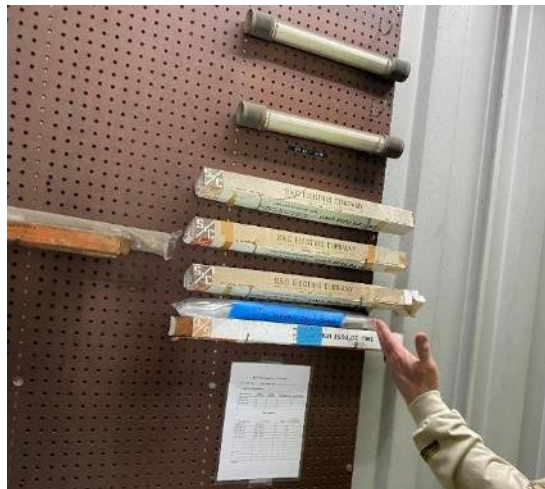
1.1. The fuse inventory list needs to be updated.

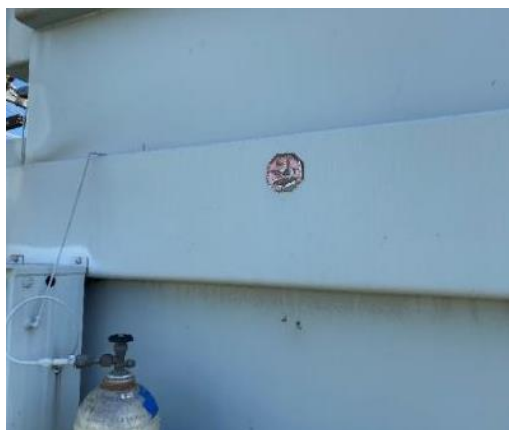
1.2. The “Entry Procedure Required” sign is faded/damaged at Transformer Bank 2.

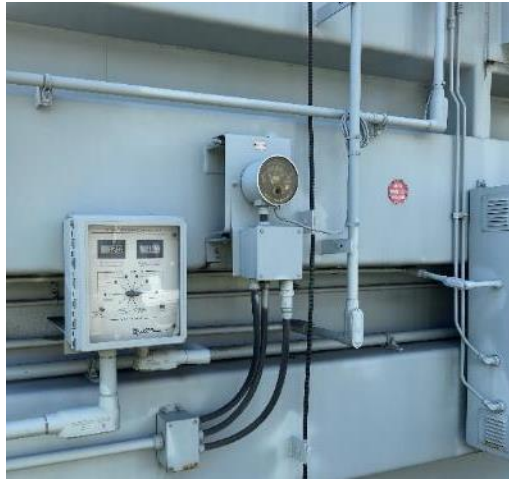
1.3. The “Entry Procedure Required” sign is faded/damaged at Transformer Bank 3.

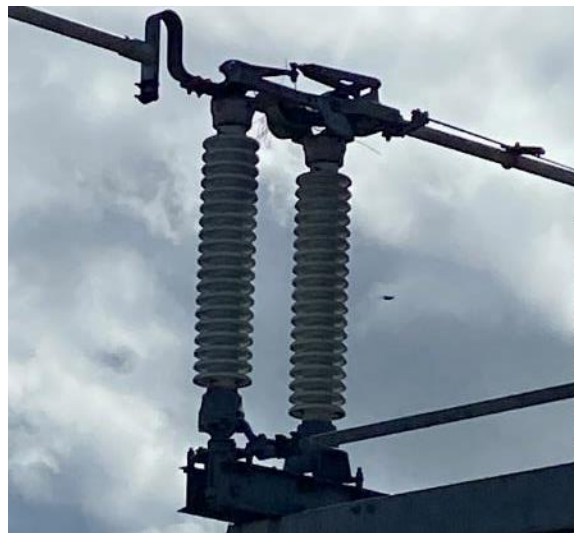
1.4. There is a bird nest in between insulators on Switch 185.

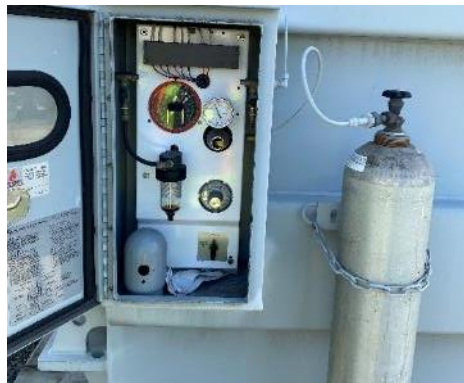
1.5. The nitrogen tank pressure was high at Transformer Bank 2. PG&E corrected the issue during the audit.

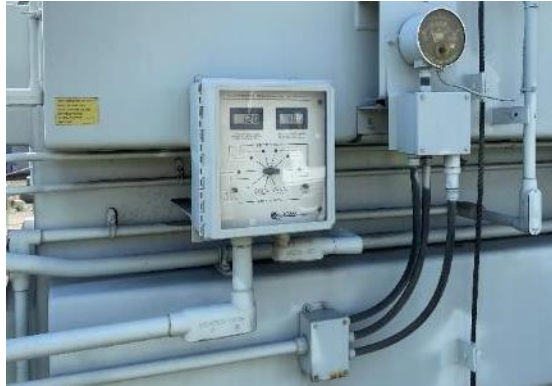
1.6. There is a digital temperature monitor malfunction indicating high liquid and winding temperatures at Transformer Bank 2. PG&E has a preexisting LC notification (#121481756) to correct this issue.

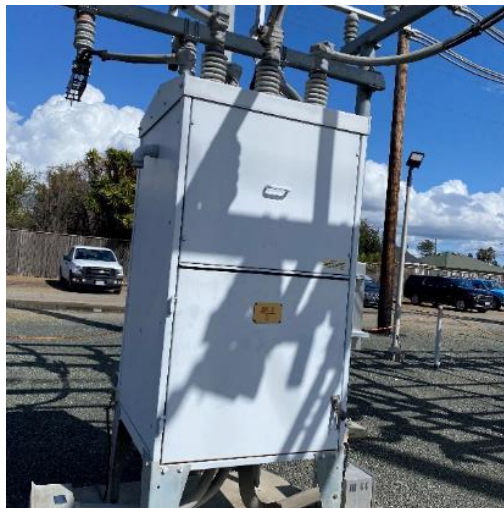
1.7. Circuit Breaker (CB) 2/2 is slow to close. PG&E has a preexisting LC notification (#125584792) to correct this issue.

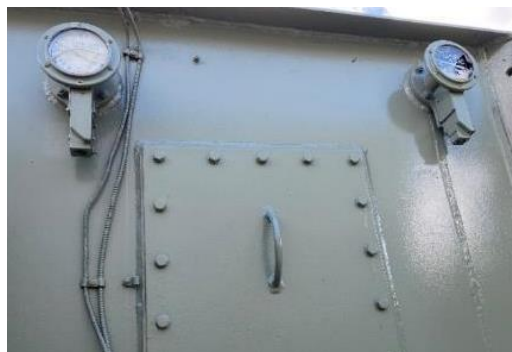
The Load Tap Changer (LTC) fluid level gauge is broken at Transformer Bank 401.

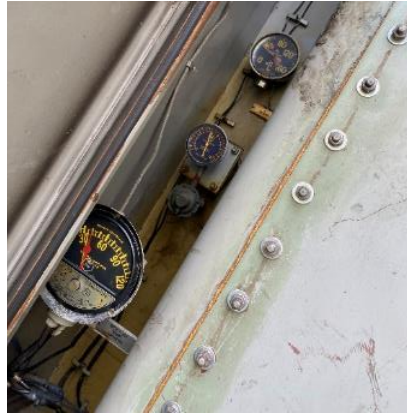
3.1. The nitrogen tank pressure is low on both 12/4 kV Transformers. PG&E has a preexisting LC notification (#125633620) to correct this issue.

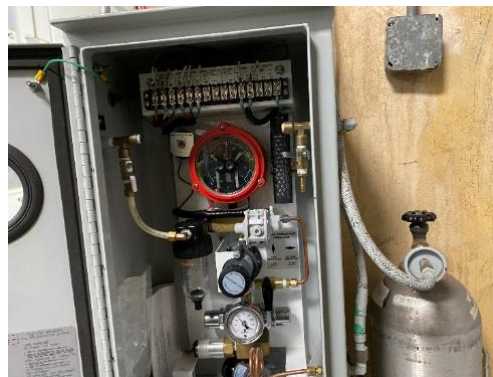
3.2. The nitrogen tank pressure is low at Transformer Bank 5. PG&E has a preexisting LC notification (#125633620) to correct this issue.

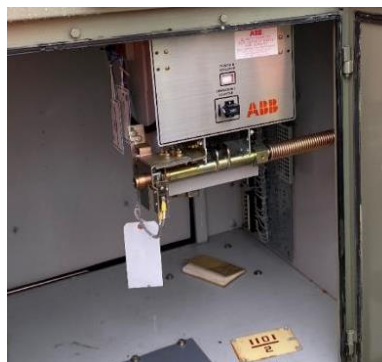
4.1. The position indicator is faded on CB 1101/2. PG&E has a preexisting LC notification (#125552589) to correct this issue.

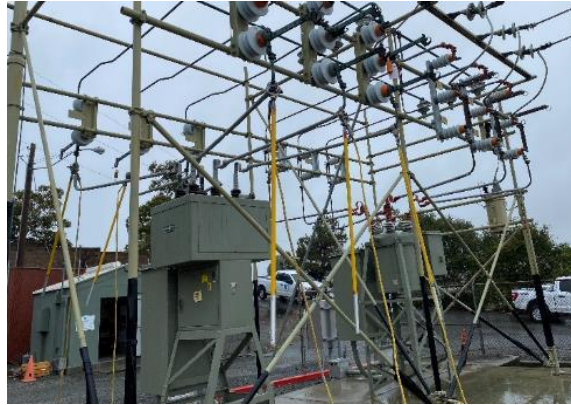
4.2. CB 1103/2 requires replacement. PG&E has a preexisting LC notification (#125338092) to correct this issue.

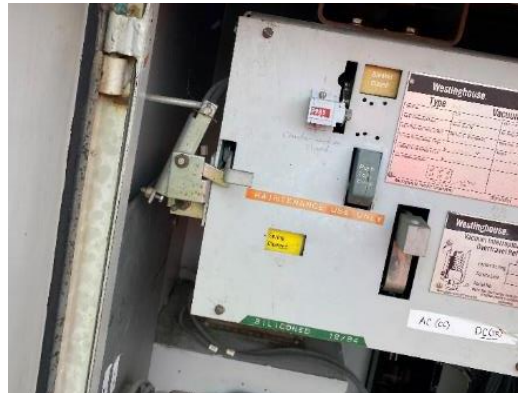
5.1. The counter is illegible at CB 1106/2.

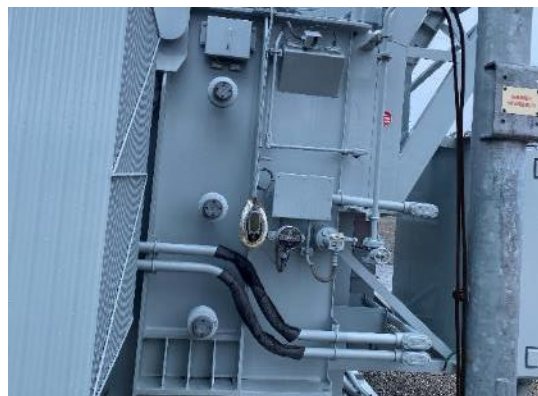
5.2. There is an oil leak at the gas sampling port on Transformer Bank 1. PG&E has a preexisting LC notification (#125567750) to correct this issue.

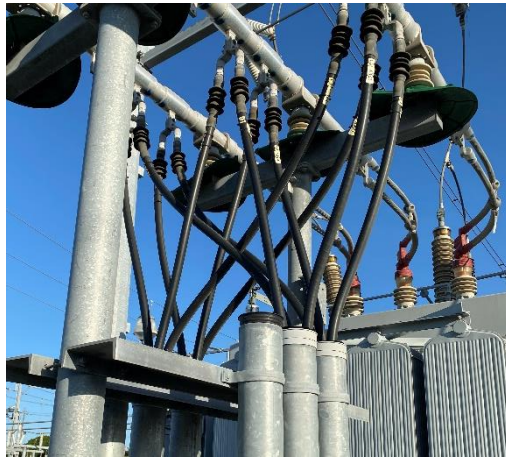
- 6.1. There is a communications issue on Phase A to SCADA. PG&E has a preexisting LC notification (#125230318) to correct this issue.
- 6.2. Transformer Bank 2 distribution cables not marked for phase and voltage per PG&E Standard 033582. PG&E created CAP (#125807386) to track installation of the voltage tags during the next routine maintenance.

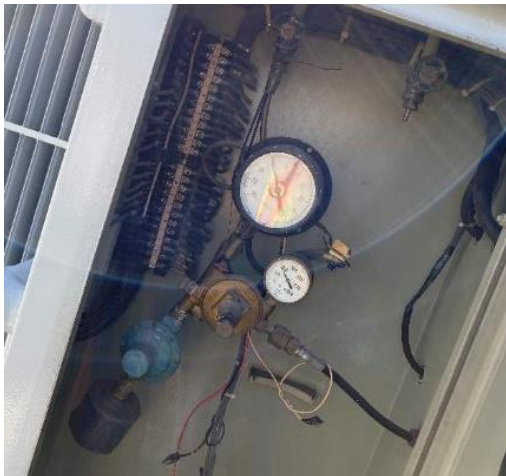
- 7.1. The nitrogen tank pressure is low at Transformer Bank 5 and the gauge is difficult to read at low pressures.

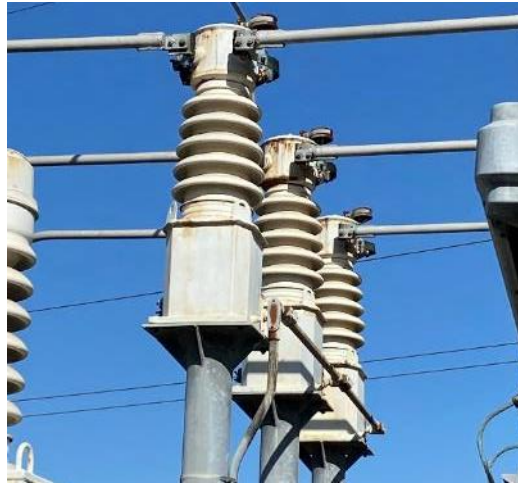
7.2. There is rust/corrosion on the PG&E owned and maintained BART 34.5 kV supply PTs/CTs.

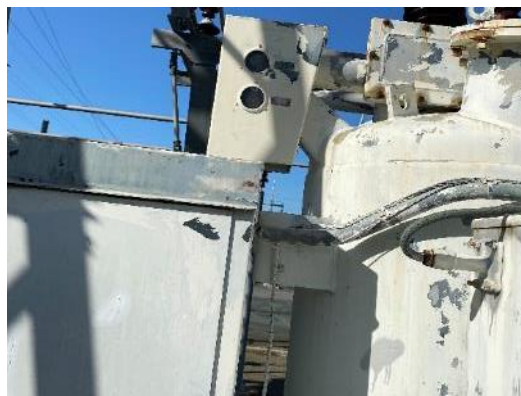
7.3. The Closed/Open indicator is faded on CB 192. PG&E has a preexisting LC notification (#125635193) to correct this issue.

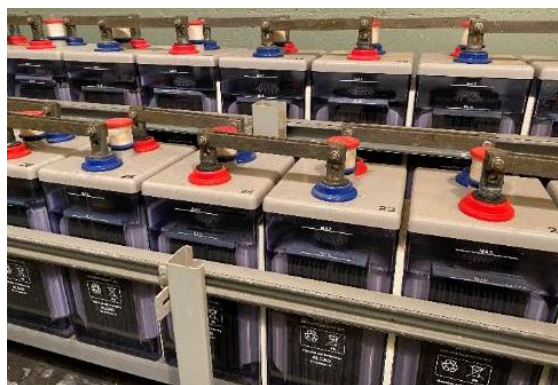
7.4. The electrolyte level is low on cells 22, 23, 24, and 39 in the main building battery room. PG&E has a preexisting LC notification (#125507373) to correct this issue.

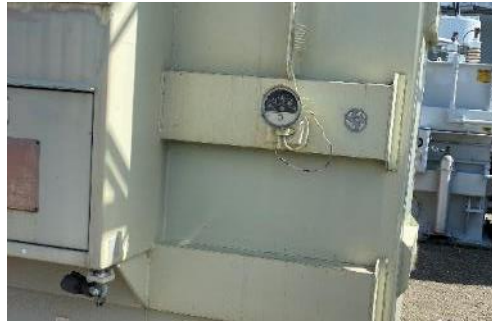
9.1. The “Entry Procedure Required” sign was missing at Regulator F-1103. PG&E corrected this issue during the audit.

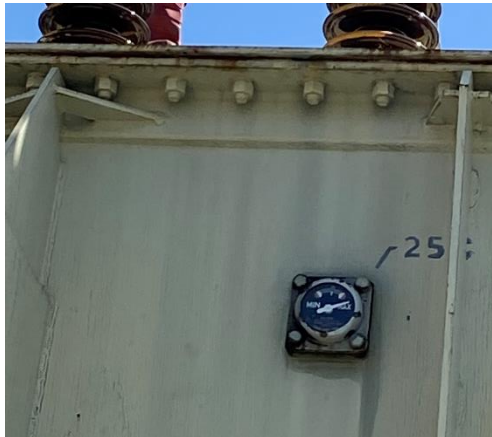
9.2. The Oil Level gauge on Regulator F-1103 is not calibrated to the gauge readings. Inspection records do not alert inspectors that the gauge readings do not reflect actual oil level. PG&E created an LC notification (#125573321) to correct this issue.

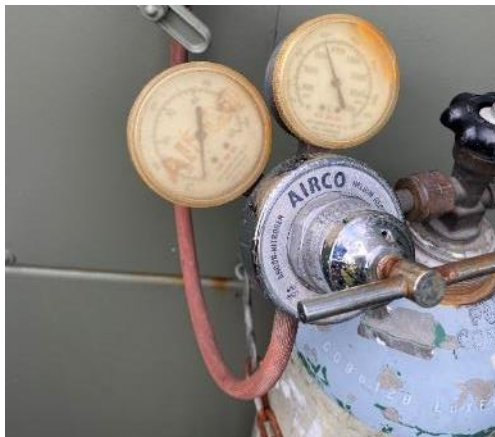
11.1. The nitrogen tank pressure was zero at Transformer Bank 1. PG&E corrected this issue during the audit.

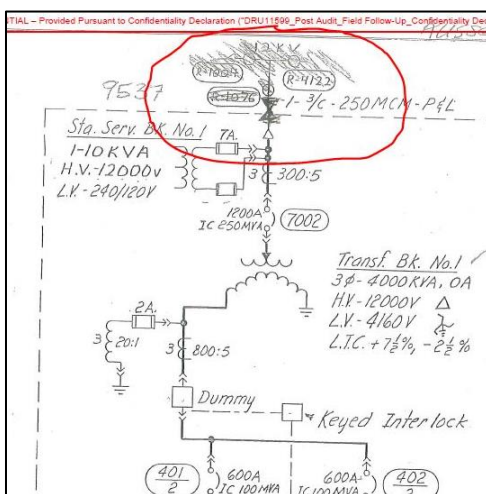
11.2. The single-line diagram Drawing # 050897 Rev. 3 has unapproved, handwritten changes.

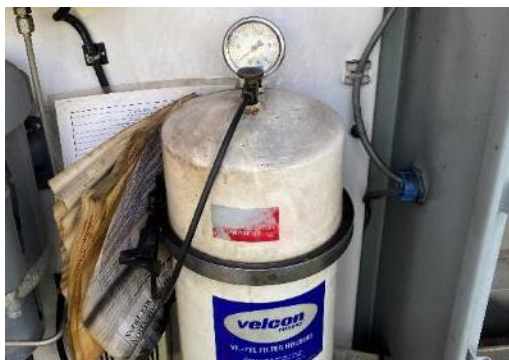
12.1. The LTC oil filtration gauge needle is missing at Transformer Bank 4.

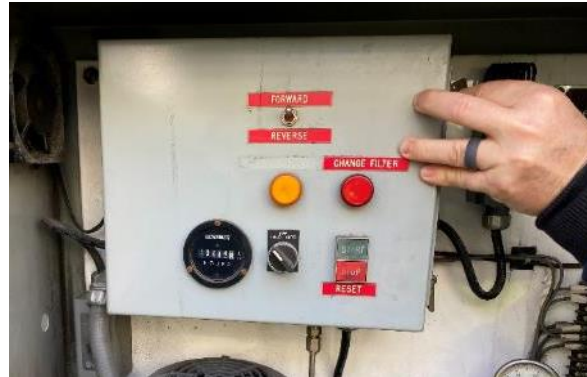
12.2. The compressor power indicator light was not working at Transformer Bank 3. PG&E corrected this issue during the audit.

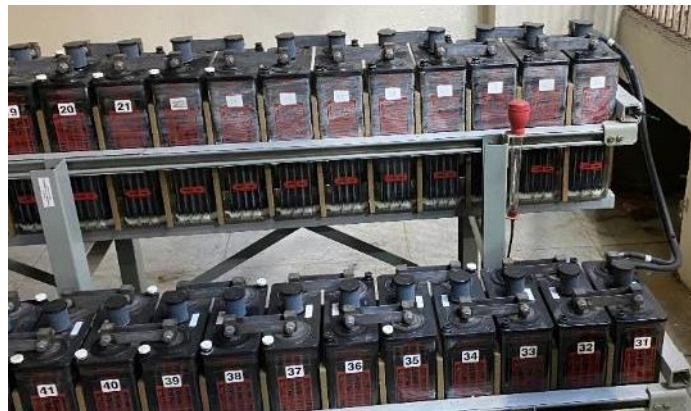
12.3. The battery cells were covered with coating making it difficult to read the electrolyte level and battery cells 22-30 were missing label markings. PG&E has a preexisting LC notification (#124137786) to correct this issue.

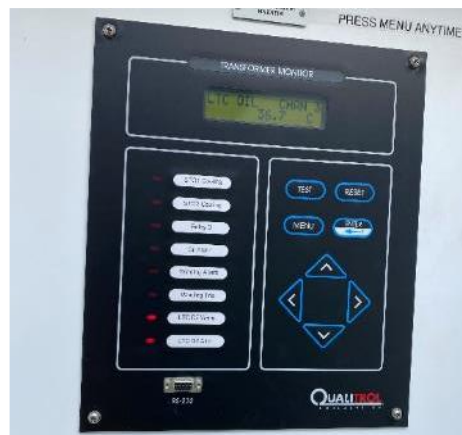
12.4. A temperature difference alarm is on at the Transformer Bank 6 LTC. PG&E could not clear the alarm. PG&E has a preexisting LC notification (#125496676) to correct this issue.

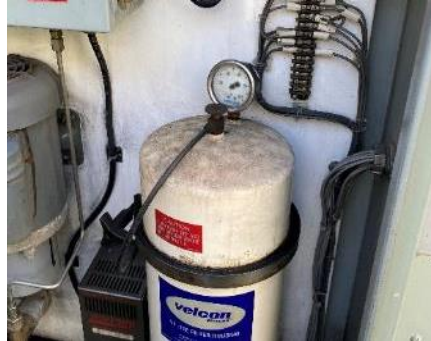
12.5. The LTC oil filtration gauge needle is missing at Transformer Bank 3. PG&E has a preexisting LC notification (#125640823) to correct this issue.

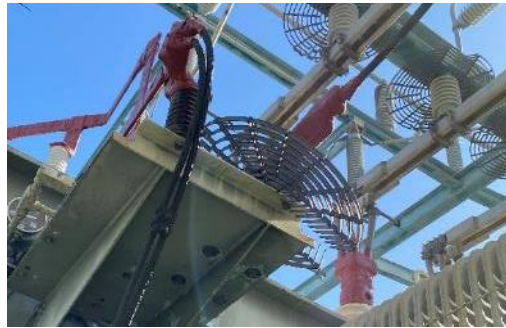
12.6. The animal abatement disk at the tertiary CT is broken. PG&E has a preexisting LC notification (#125640707) to correct this issue.

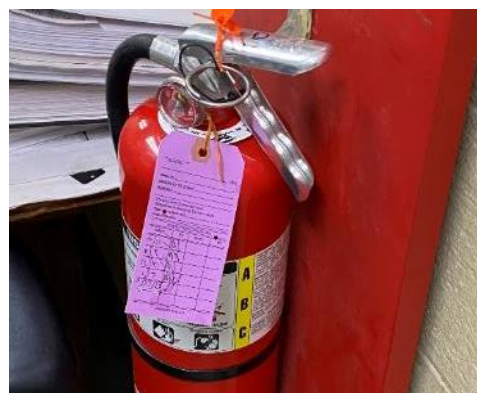
12.7. The 115 kV control room fire extinguisher is missing a February 2023 inspection. PG&E has a preexisting LC notification (#125636362) to correct this issue.

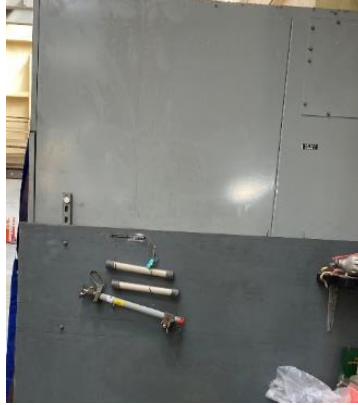
13.3. The fuse inventory list needs to be updated. PG&E has a preexisting LC notification (#125611157) to correct this issue.

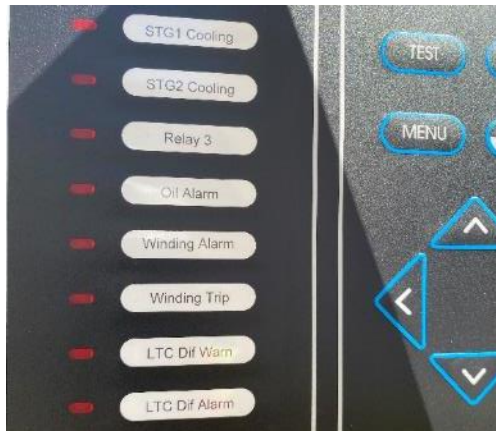
13.4. A temperature difference alarm is on at the Transformer Bank 3 LTC. PG&E could not clear the alarm. PG&E has a preexisting LC notification (#124539961) to correct this issue.

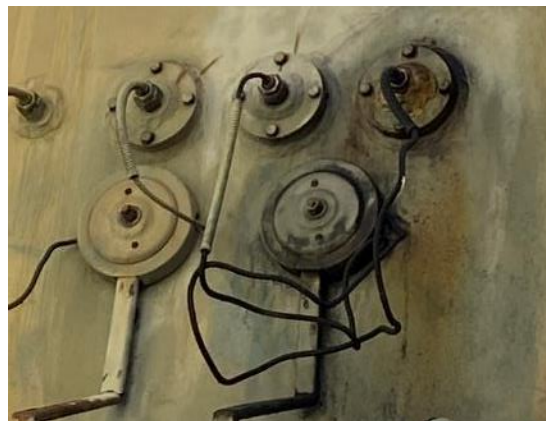
13.5. The temperature probe has an oil leak at Transformer Bank 1. PG&E has a preexisting LC notification (#125612186) to correct this issue.

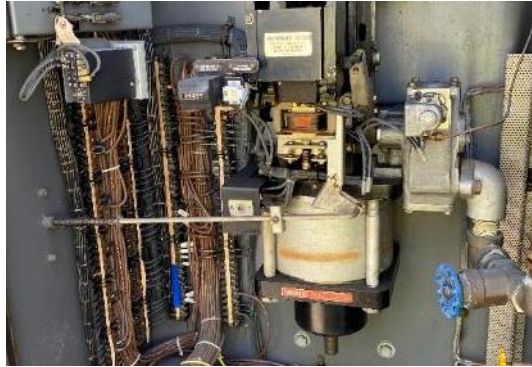
13.6. The counter is illegible at CB 312. PG&E has a preexisting LC notification (#125611836) to correct this issue.

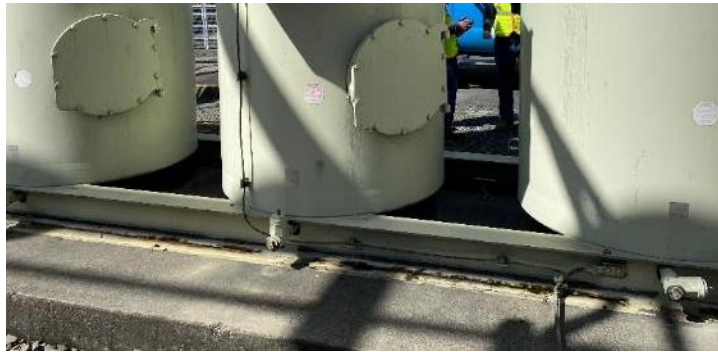
13.7. The “Entry Procedure Required” signs were faded at CB 412. PG&E corrected this issue during the audit. PG&E had a preexisting LC notification (#125611835) to correct this issue.

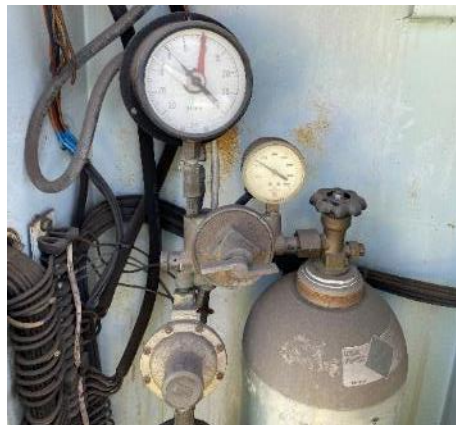
14.1. The nitrogen tank pressure was low at Transformer Bank 6. PG&E corrected this issue during the audit.

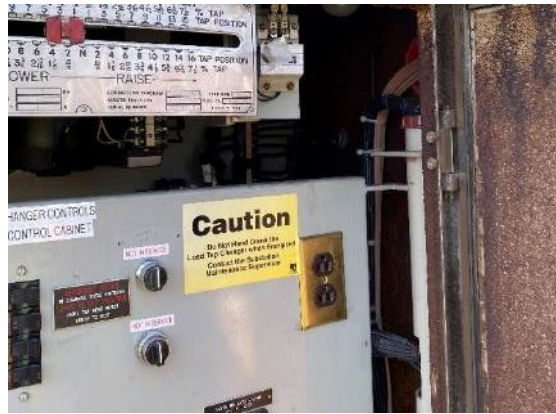
14.2. The Transformer Bank 6 LTC counter is illegible.

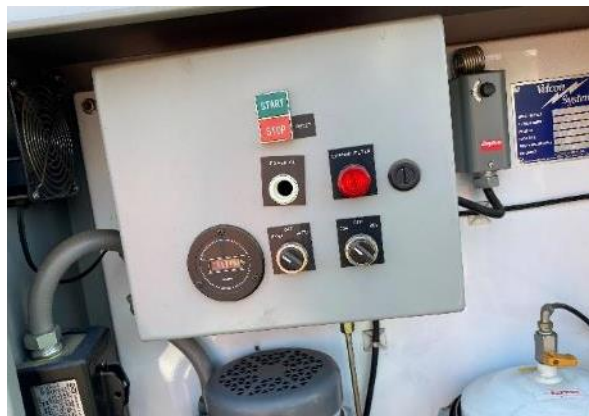
14.3. The compressor power indicator light was not working at Transformer Bank 10. PG&E corrected this issue during the audit.

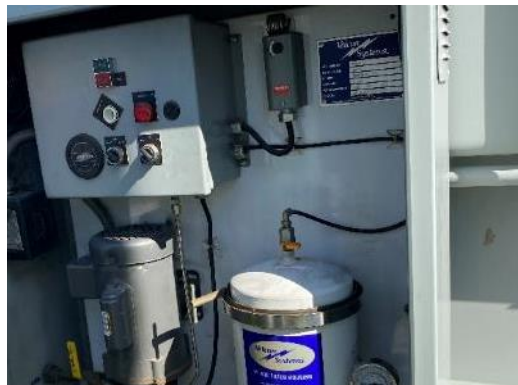
14.4. The compressor power indicator light was not working at Transformer Bank 1. PG&E corrected this issue during the audit.

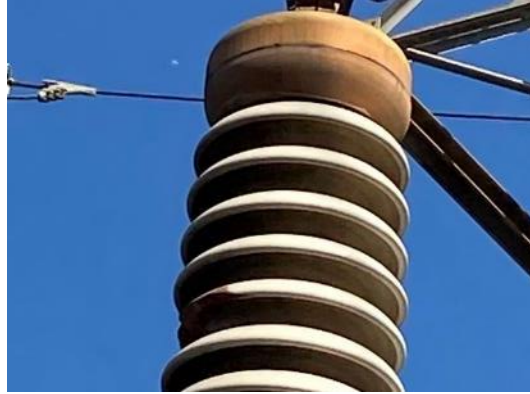
14.5. A PT bushing is chipped at CX-2 Switch 173, C Phase.

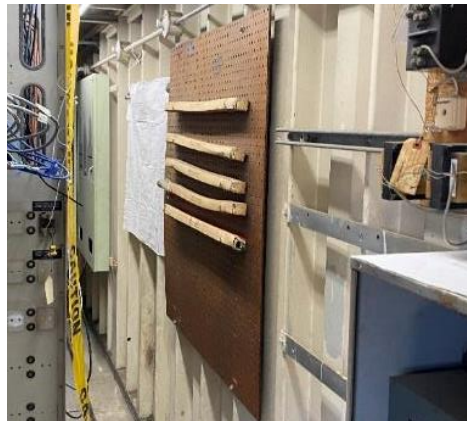
14.6. The transmission fuse inventory list needs to be updated. PG&E has a preexisting LC notification (#125566866) to correct this issue.

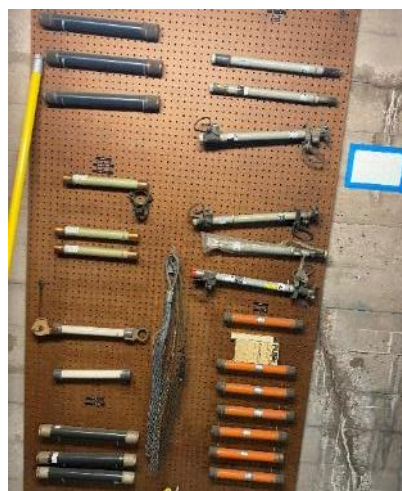
14.7. The distribution fuse inventory list needs to be updated. PG&E has a preexisting LC notification (#125616403) to correct this issue.

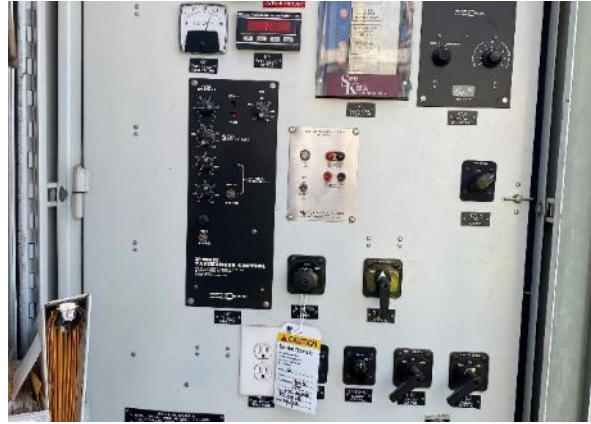
14.8. The Transformer Bank 5 LTC has a “Run to whole” control issue. PG&E has a preexisting LC notification (#125255310) to correct this issue.

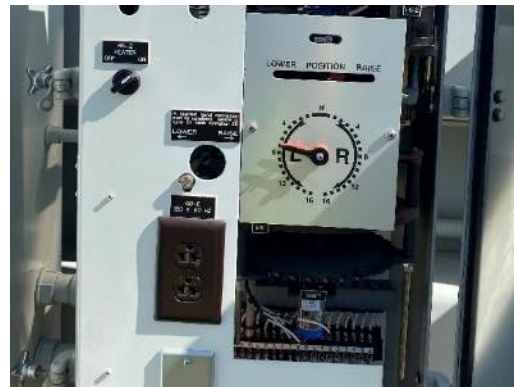
14.9. Transformer Bank 10 has an annunciator alarm on and the LTC has an “off step” alarm on. PG&E was unable to clear these alarms. PG&E has a preexisting LC notification (#125015431) to correct these issues.

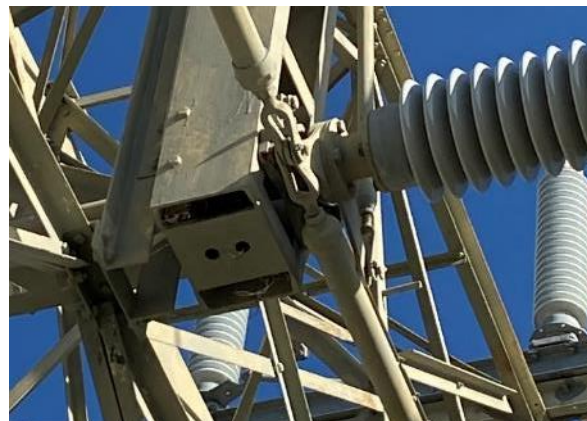
15.1. There is a bird nest at the B Phase insulator on Switch 173.

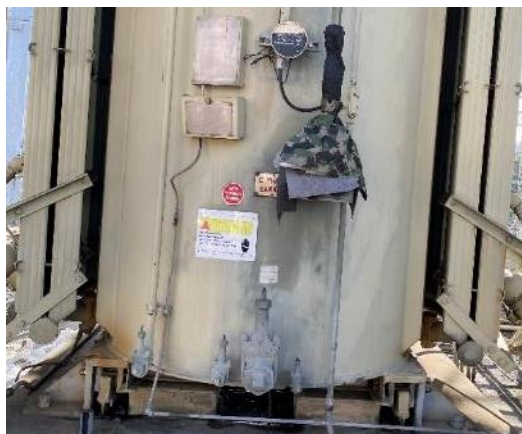
15.2. There is an oil leak at Transformer Bank 2 C Phase. PG&E has a preexisting LC notification (#125602290) to correct this issue.

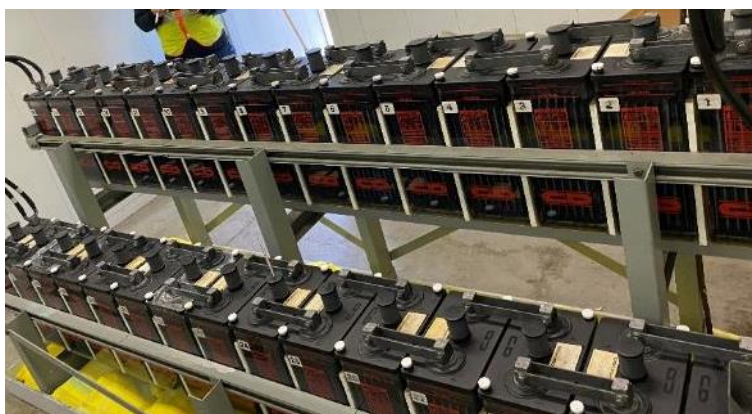
15.3. There is corrosion on several battery cells at the transmission battery bank. PG&E has a preexisting LC notification (#125601812) to correct this issue.
