**PG&E KERN DIVISION
ELECTRIC DISTRIBUTION AUDIT FINDINGS
NOVEMBER 18-22, 2024**

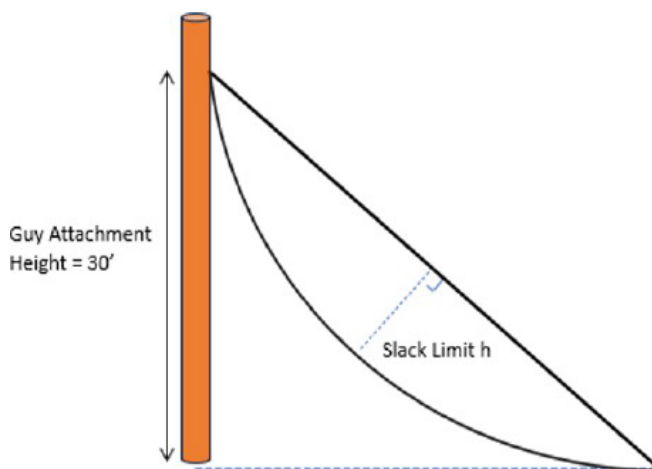
Figure 2: Guy slack limit, TD-2305M-JA02

PG&E’s TD-2305M-JA02, Job Aid: Overhead Assessment, March 25, 2024 Rev. 13, Miscellaneous Other Compelling Abnormal Conditions, Guy Broken/Slack/Corroded states, *“Pole must be straight with Guy no more than an arm’s length (3ft) from taut, that does not have significant impact on the structural integrity of the pole.”* See Figure 2.

Per GO 95, Rule 56.2, guys are to be maintained taut.²⁶ PG&E’s TD-2305M-JA02 allows a deviation from taut by as much as 3 feet without regard to length or angle of attachment.²⁷

PG&E’s TD-2305M-JA02, Job Aid, Miscellaneous Other Compelling Abnormal Conditions, Guy Broken/Slack/Corroded does not comply with GO 95, Rule 56.2 requiring guys to be maintained taut in all circumstances.

²⁷ ESRB revised PG&E’s FDA Tag Evaluation, Guy Loose/Adjust ATS Report 006.4.3-23.9 Sept 2023, an analysis of guy slack limits to achieve a taut guy at a lean of 10 %. The analysis assumed 30-foot attachment points and various angles of down guys. The analysis did not evaluate stresses on poles without guying per Rule 56.2 nor the effects of slack guys on Safety Factors per Rule 44. The analysis included the statement: “Pole overload and pole lean are two different phenomena, and pole may be overloaded without guy support before overall lean reaches [PG&E’s] allowable limit.”
