**Re: Audit of Verizon Communications (Verizon) Network in Riverside County Group**

**CPUC AUDIT FINDINGS OF  
VERIZON RIVERSIDE COUNTY GROUP  
SERVICE AREAS AUGUST 11-15, 2025**

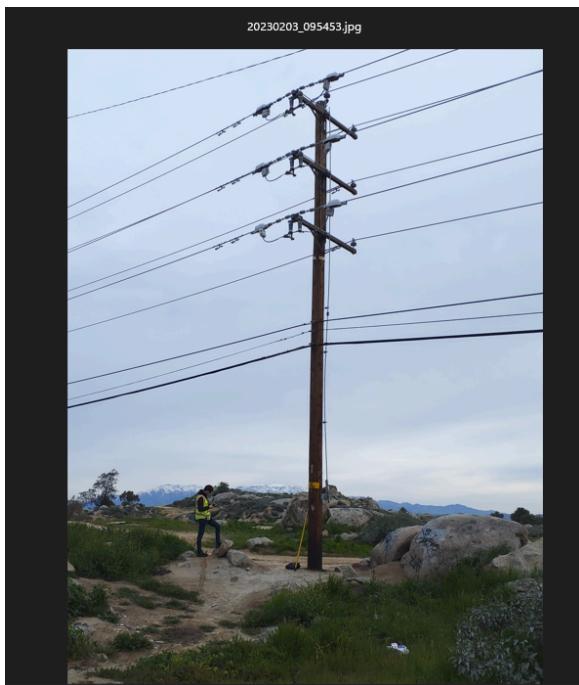
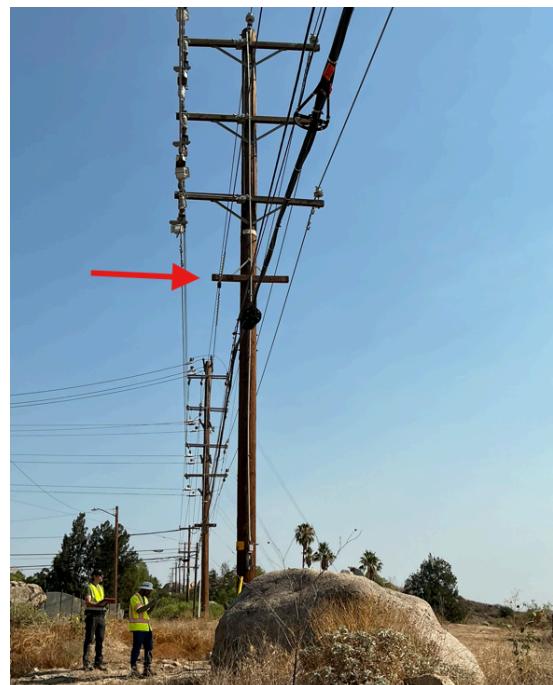
- My staff observed that loading calculations by Verizon communication for Pole No. 1796632E was missing a secondary crossarm and a span guy at a height of 23.5 ft.

Verizon's loading calculations were accurate. The Verizon pole loading calculation was performed in 2023, and did not include the mentioned equipment, because the SCE cross arm and span guy were added after 2023. See attached photos (the first photo reflects the pole in 2023 when Verizon attached to it and the second photo with the red arrow shows the additions that were made subsequently in 2025).
