PG&E CENTRAL COAST DIVISION
ELECTRIC DISTRIBUTION AUDIT FINDINGS RESPONSE
April 21-25, 2025

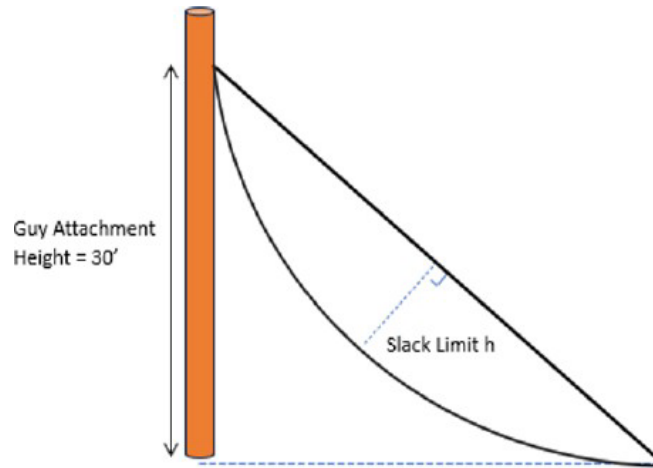
Figure 3: Guy slack limit, TD-2305M-JA02

PG&E’s TD-2305M-JA02, Job Aid: Overhead Assessment, Rev. 14, Effective January 14, 2025 Miscellaneous Other Compelling Abnormal Conditions, Guy Broken/Slack/Corroded states, *“Pole must be straight with Guy no more than an arm’s length (3ft) from taut, that does not have significant impact on the structural integrity of*

the pole.” See Figure 3.

Per GO 95, Rule 56.2, guys are to be maintained taut. PG&E’s TD-2305M-JA02 allows a deviation from taut by as much as 3 feet without regard to length or angle of attachment.

PG&E’s TD-2305M-JA02, Job Aid, Miscellaneous Other Compelling Abnormal Conditions, Guy Broken/Slack/Corroded needs revision to comply with GO 95, Rule 56.2 requiring guys to be maintained taut in all circumstances.
