Subject: Electric Substation Audit of Sacramento Municipal Utility District (SMUD)

SMUD'S RESPONSE TO CPUC SUBSTATION AUDIT FINDINGS

APPENDIX A: Field Inspection Photographs

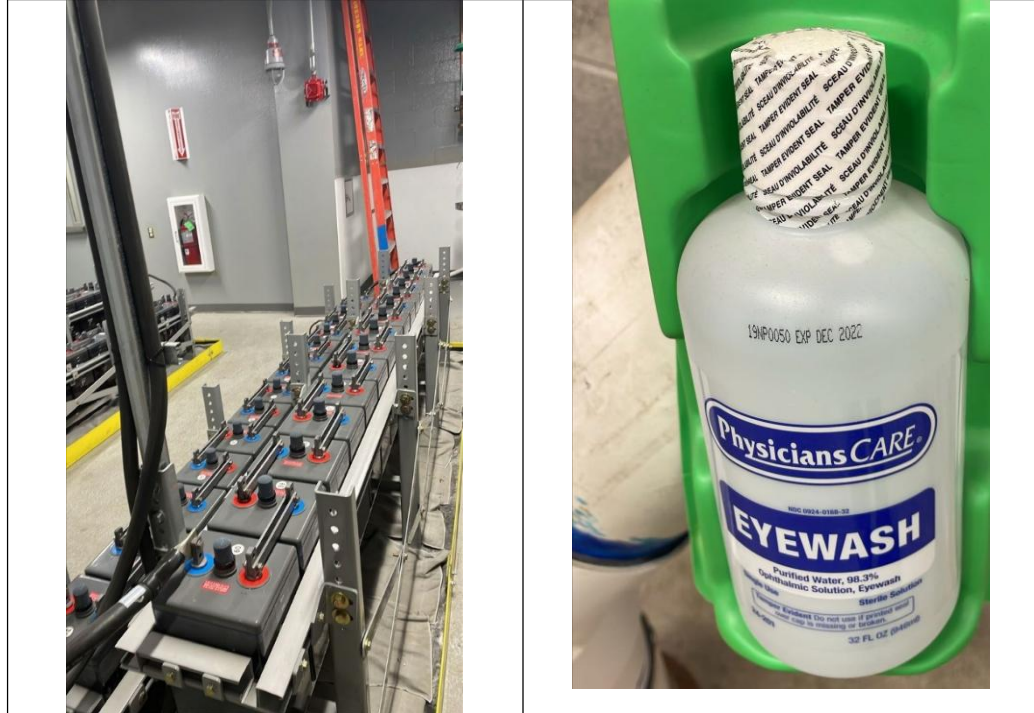
1. STG Substation

SMUD disagrees with this finding. STG substation has a dedicated eyewash station onsite. Pictures of the eyewash station are provided in Appendix A. The expired eyewash bottle may have been made available during construction of the station and has been removed.

- a. Eyewash adjacent to the battery room expired in December 2022.

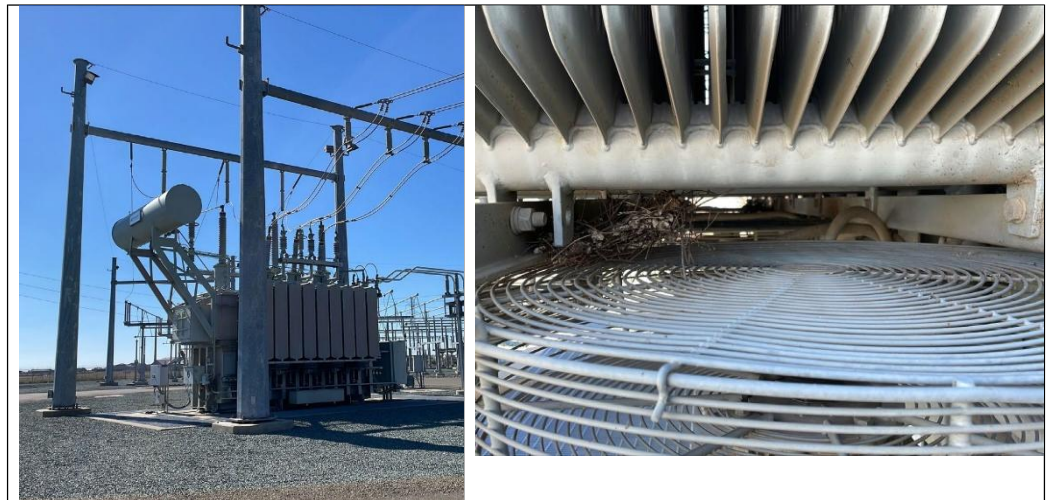
2. COR Substation

SMUD disagrees with this finding. SMUD’s environmental team requests that bird nests not be removed unless they present a hazard, and in this instance, the nests do not pose any safety, reliability, or operational risk to the transformer cooling fans. In the spirit of voluntary cooperation, Work Order 12037849 with an Urgent priority was created to remove the bird nests resting on the cooling fans and the corrective work was completed on February 5, 2026. Pictures are provided in Appendix A.

- a. Bird nests have fallen out of the transformer bank radiators and are resting on the cooling fans.

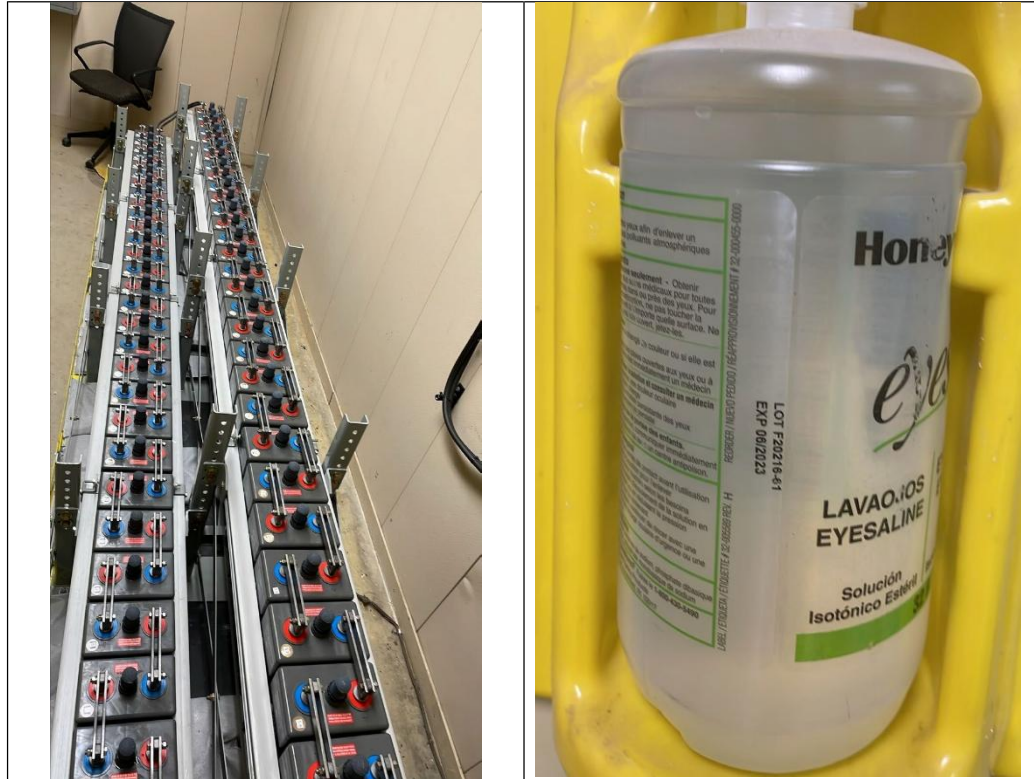
3. RSS Substation

SMUD disagrees with this finding. RSS substation has portable eyewash stations onsite that are inspected and water and solutions are changed out every quarter. Pictures of the portable eyewash stations are provided in Appendix A. The expired eyewash bottle observed during the audit was not designated for usage and has since been removed.

- a. Eyewash adjacent to the battery room expired in June 2023.

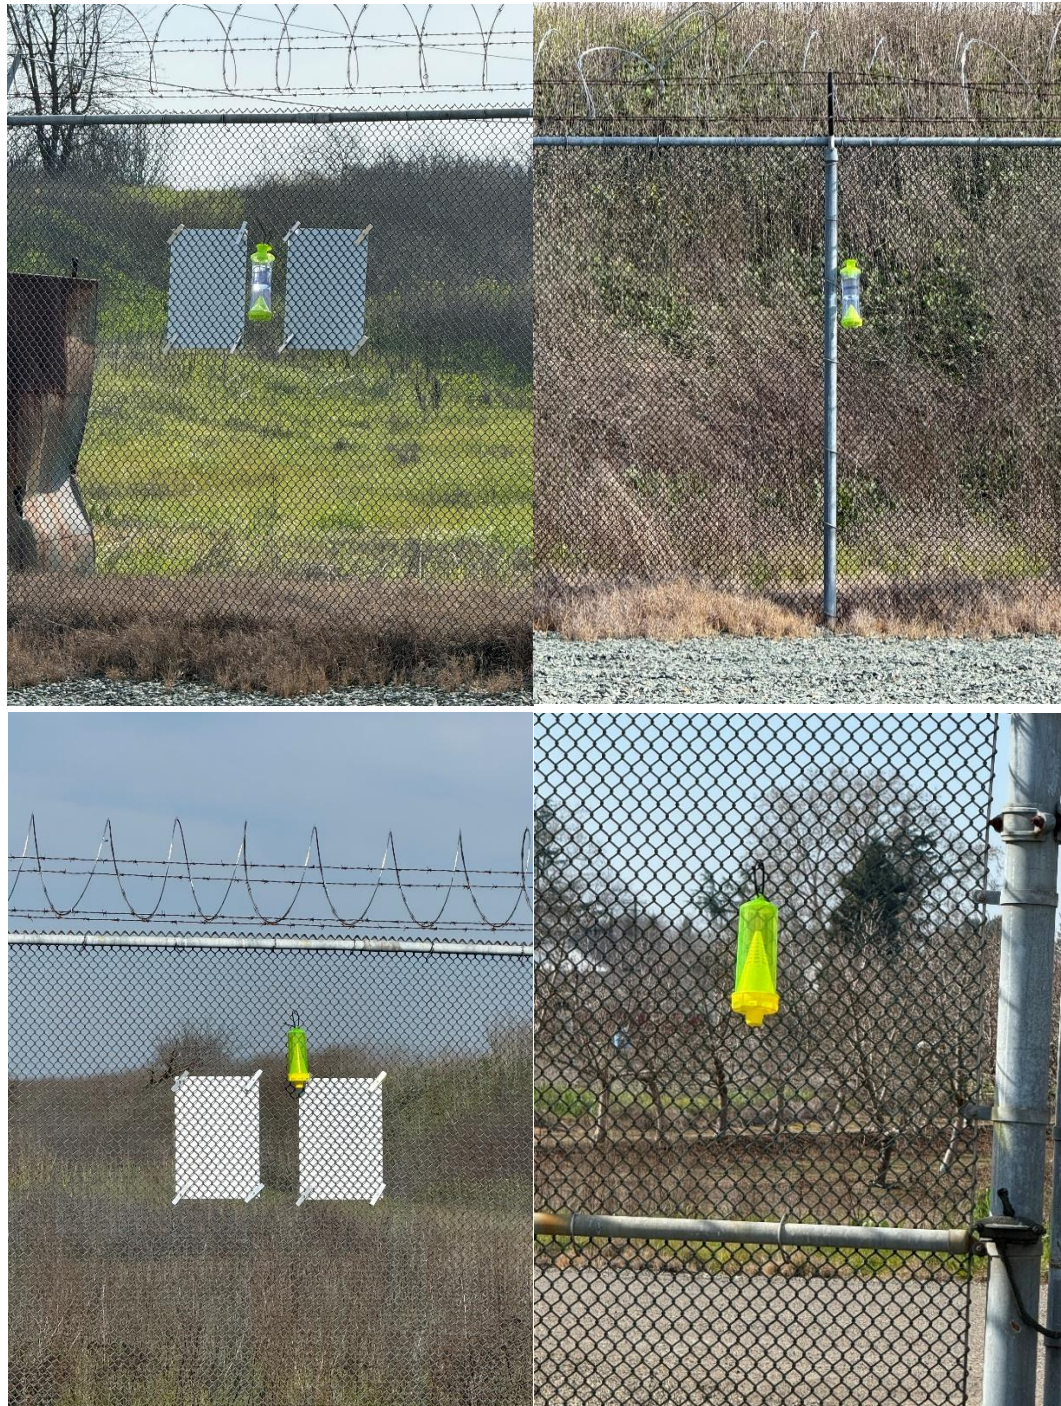
4. Hood – Franklin Substation

SMUD acknowledges that wasps within the metal-clad enclosure limited ESRB's inspection as the substation is located in a rural area. SMUD performs monthly inspections and wasp nests get removed each month and plastic wasp traps for baits are put up around substation fence to help mitigate the number of wasps. In the spirit of voluntary cooperation, Work Order 11130706 with an Urgent priority was created to set up wasp traps, and the corrective work was completed on February 6, 2026. Pictures of the wasp traps are provided in Appendix A.

- a. ESRB’s inspection was limited due to wasps within the metal-clad unit enclosure. Regular removal of wasp nests ensures inspection, maintenance, and repair work can be performed unimpeded while safeguarding worker health and safety.

SMUD has set up wasp traps:

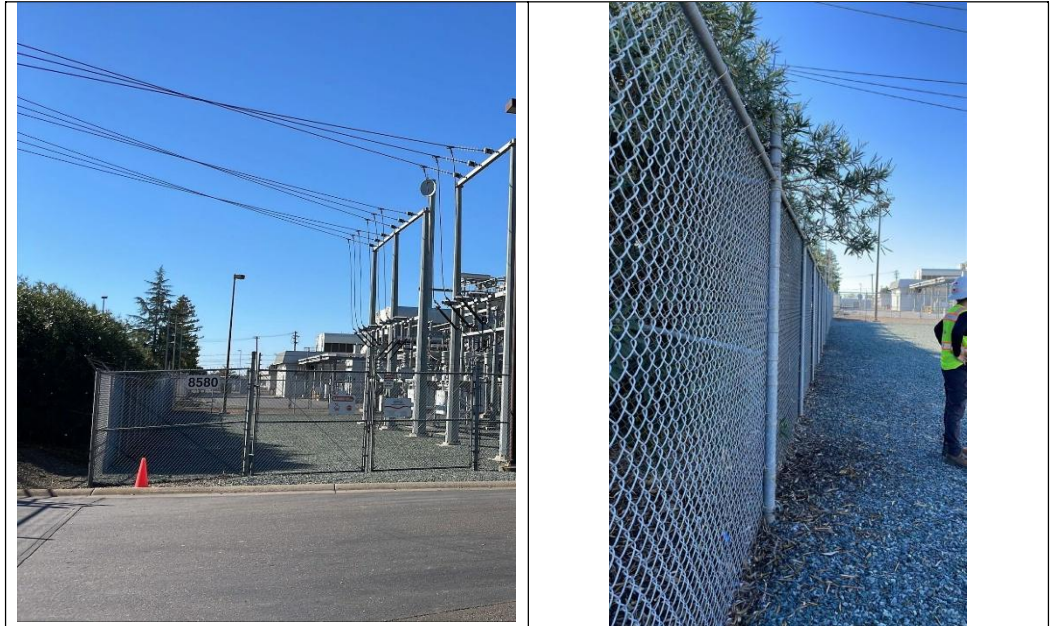
5. CNX Substation

- a. Vegetation is growing over the perimeter fence.

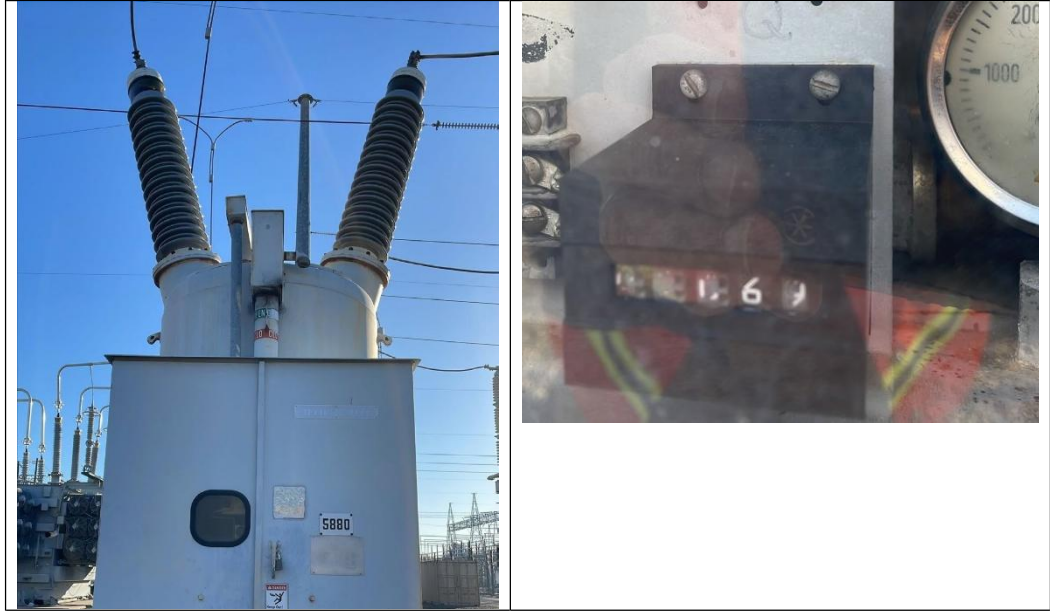
6. HUR Substation

Nonetheless, SMUD disagrees with this finding. The counter is neither damaged nor malfunctioning. SMUD acknowledges that, although paint on some of the numbers have faded, the numbers are raised and remain legible. The condition of the counter does not pose any safety or operational issues. In the spirit of voluntary cooperation, Work Order 12037530 with Urgent priority was created and the counter was replaced on February 4, 2026. Pictures of the completed work are in Appendix A.

a. Damaged counter on CB 5880.
