Re: Electric Substation Audit of PG&E Martin Headquarters (HQ)

IV. Field Inspection – Violations List

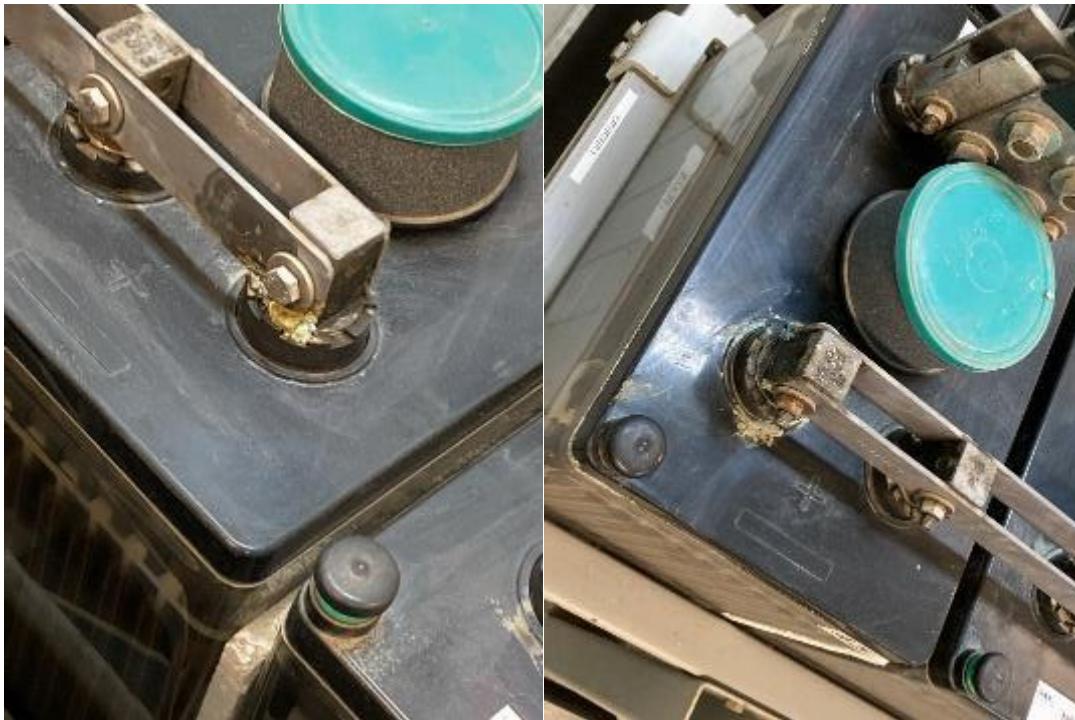
- 1.1. There is corrosion on battery cells 45 and 49 in the 230 kV Battery Room. PG&E has an open LC 129520898 to clean the batteries.

129520898 was established in our system of record, SAP, prior to the field audit to address the corrosion on battery cells 45 and 49 in the 230 kV Battery Room at Martin Substation. This LC notification was worked in accordance with our maintenance procedures and completed on June 27, 2025.

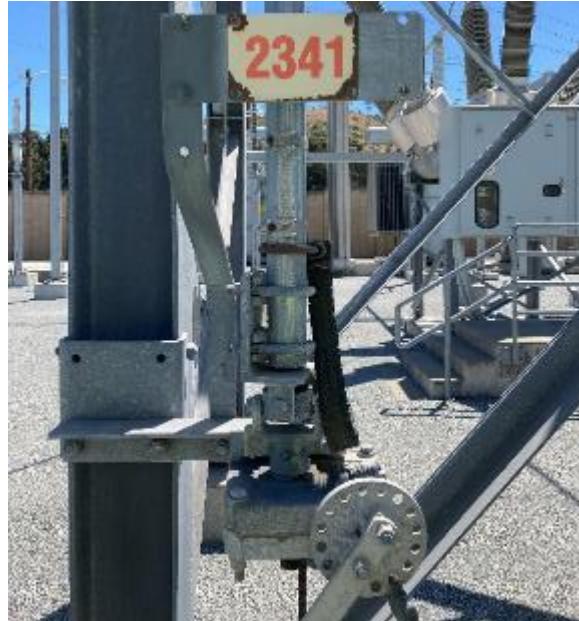
1.2. Switch 2341 closed semaphore is faded.

While we remain committed to maintaining equipment in a condition that promotes safety and adequacy of service, we believe this finding does not reflect a material deficiency under GO 174, Rule 12 because it allows for design and maintenance practices based on local conditions and accepted operational procedures. The semaphore in question is not used to verify switch position. Rather, switchmen confirm the position through direct observation of the switch mechanism itself.

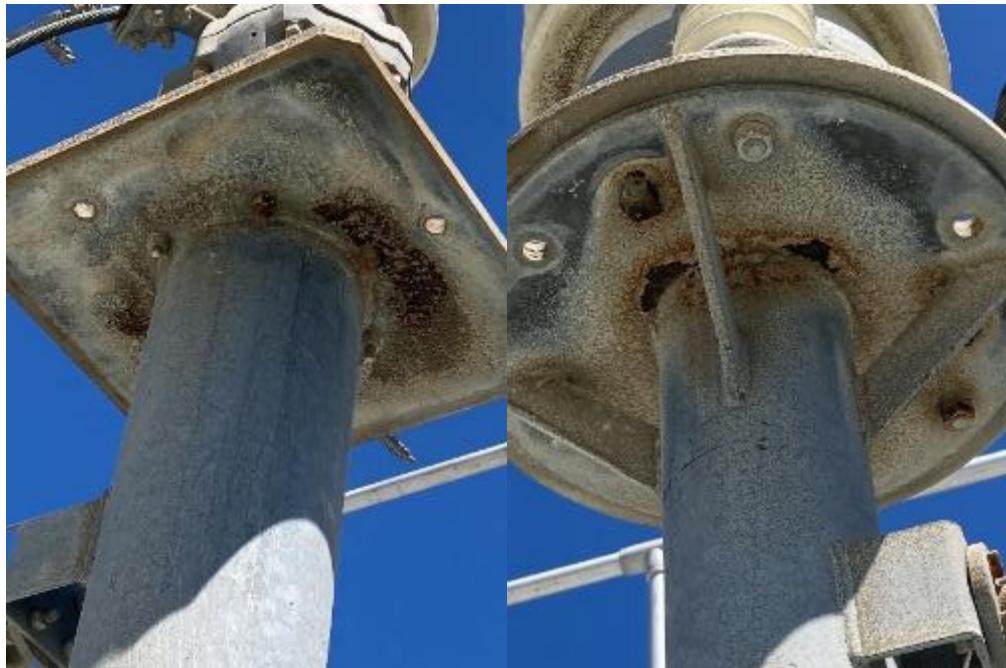
1.3. The bus structure hardware is corroded at the HZ-2 230 kV Cable.

We acknowledge the presence of corrosion observed on the potheads located on buss structure HZ-2 at Martin Substation. However, we disagree that this condition violates GO 174, Rule 12, as the affected equipment pertains to transmission underground infrastructure and falls under the scope of GO 128. A pre-existing LC notification 130111917 was established in our system of record, SAP, prior to the field audit to address this condition. The notification has been added to our transmission underground workplan and will be addressed in accordance with current prioritization and material availability.

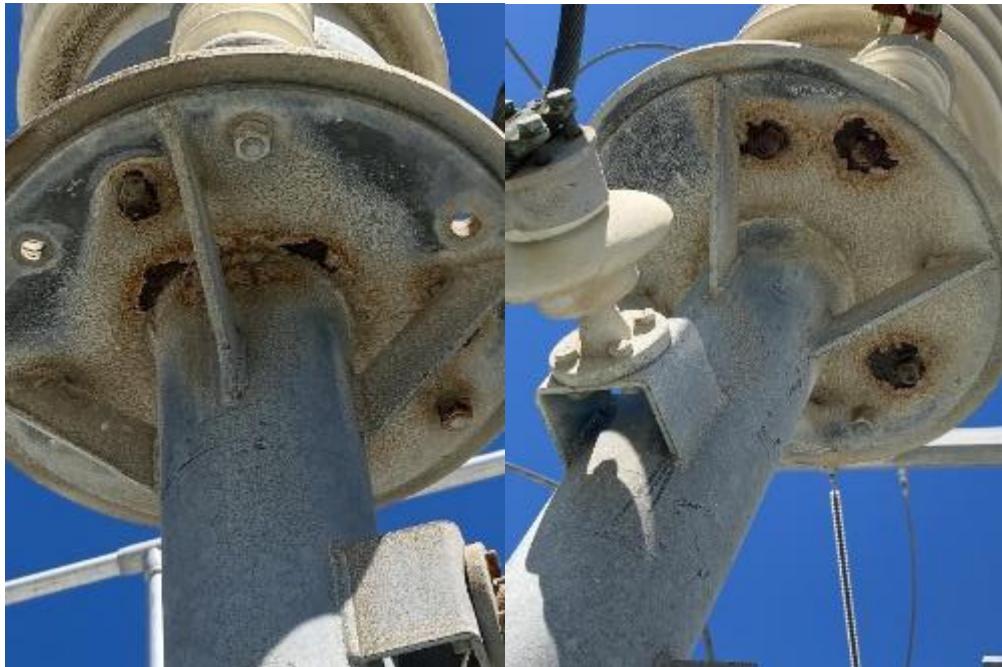
1.4. San Mateo-Martin bus structure hardware is corroded.

We created LC Notification 131841557 to address ESRB's finding regarding the lightning arrestor corrosion, added it to the workplan and will be addressed in accordance with current prioritization and material availability.

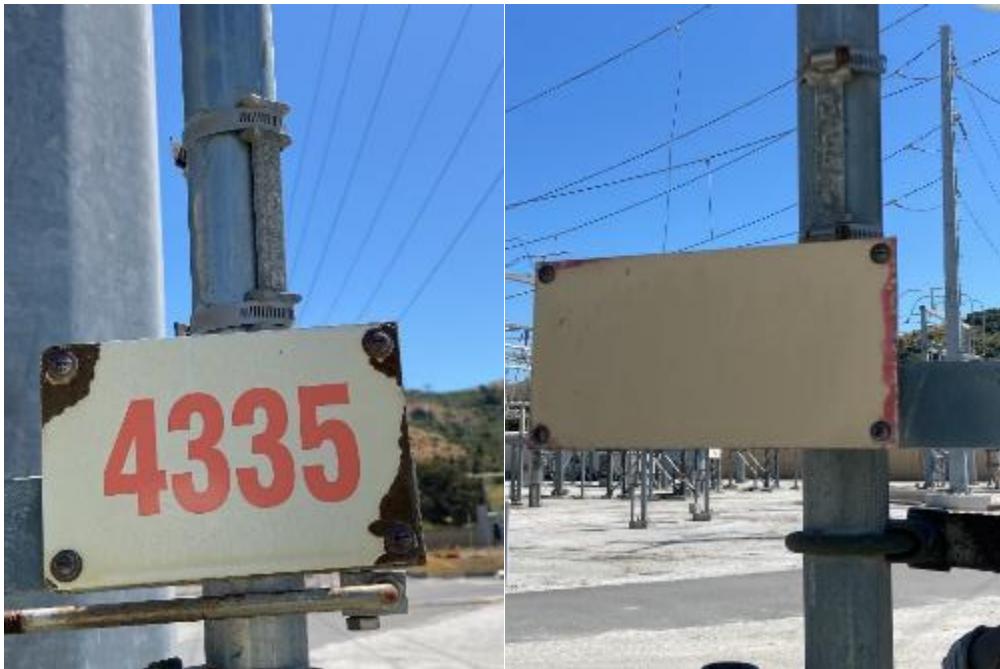
1.5. Faded closed semaphore and faded caution sign at Switch 4335.

We disagree that the condition results in a violation of GO 174, Rule 12. Pre-existing LC Notification 129521985 to address the faded caution sign on Switch 4335 at Martin Substation was established in our system of record, SAP, prior to the field audit. The LC notification was completed on time in accordance with our maintenance procedures on July 23, 2025.

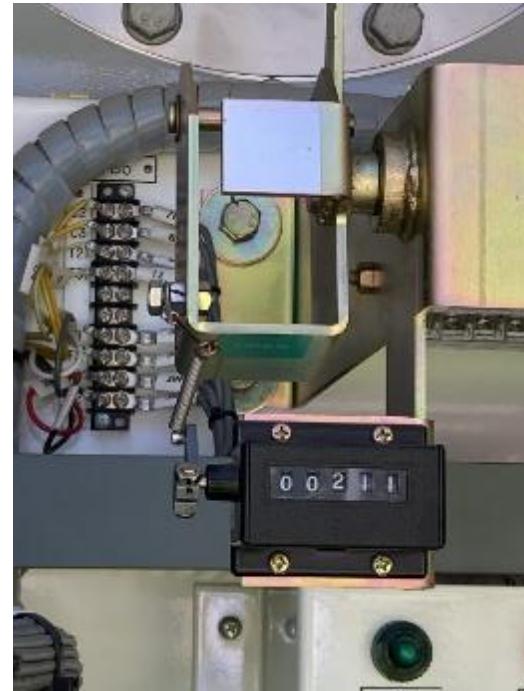
1.6. Closed semaphore faded at CB 4632.

We created LC Notification 131385178 to address ESRB's finding regarding the faded "closed" semaphore, added it to the workplan and completed it on September 14, 2025.

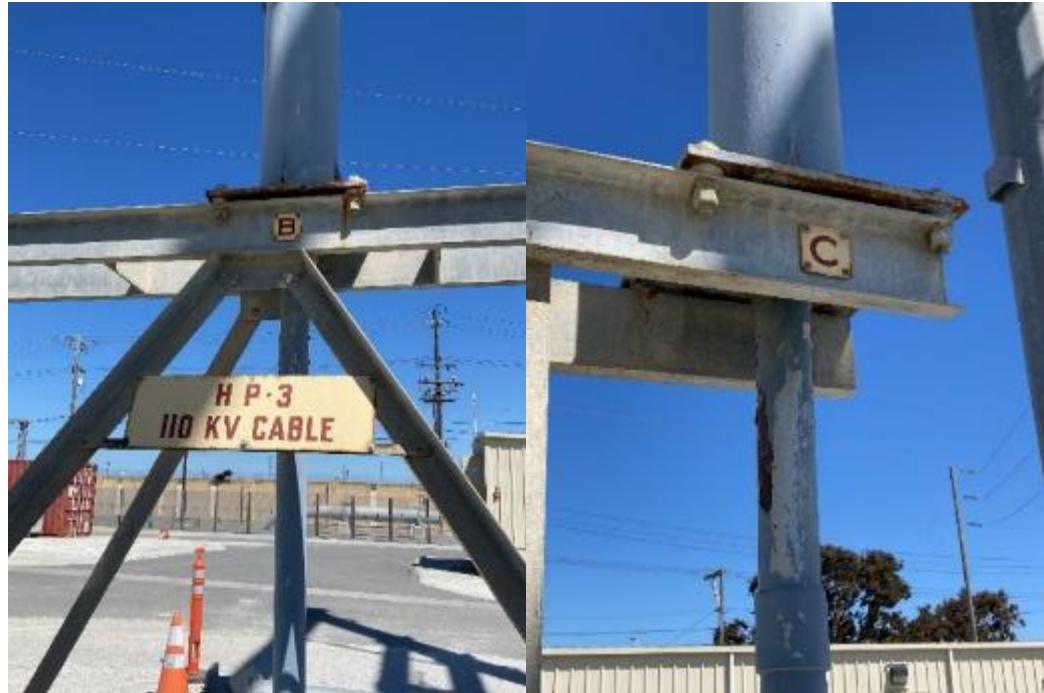
1.7. HP-3 Pothead structure is corroded.

While we acknowledge the presence of corrosion on the HP-3 pothead structure at Martin Substation, we do not agree that this condition constitutes a violation of GO 174, Rule 12. The equipment pertains to our underground infrastructure and falls under the scope of GO 128. However, to address this issue, we created Notification 131813533, which has been added to our Transmission Underground workplan and will be addressed in accordance with current prioritization and material availability.

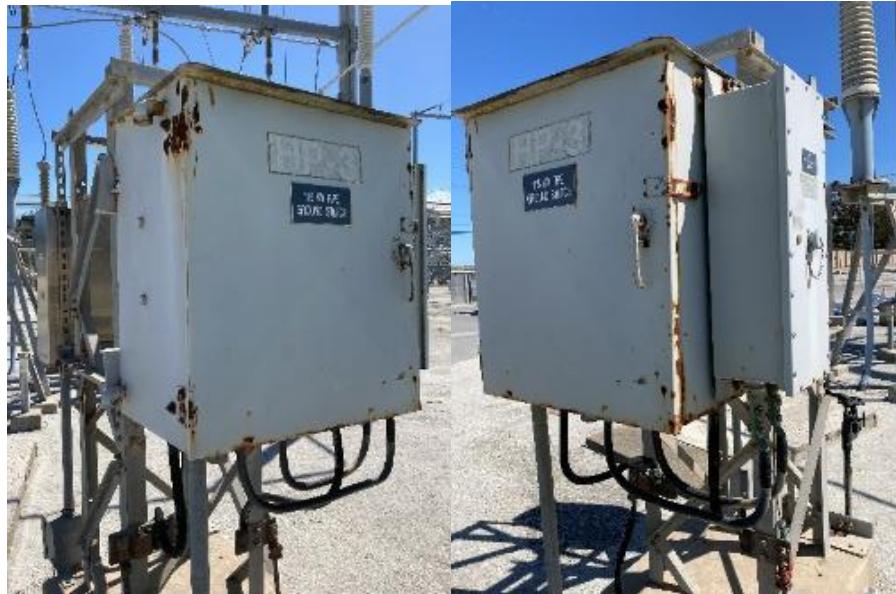
1.8 HP-3 115 kV Pipe Ground Switch cabinet has significant corrosion.

While we acknowledge that there is corrosion on the cabinet for the HP-3 115 kV Pipe Ground Switch at Martin Substation, we do not agree that this condition constitutes a violation of the general orders because this condition had pre-existing LC Notification 129132438 that was established in our system of record, SAP, prior to the field audit. The notification is being actively managed in accordance with our Transmission Underground maintenance procedures and is not past due.

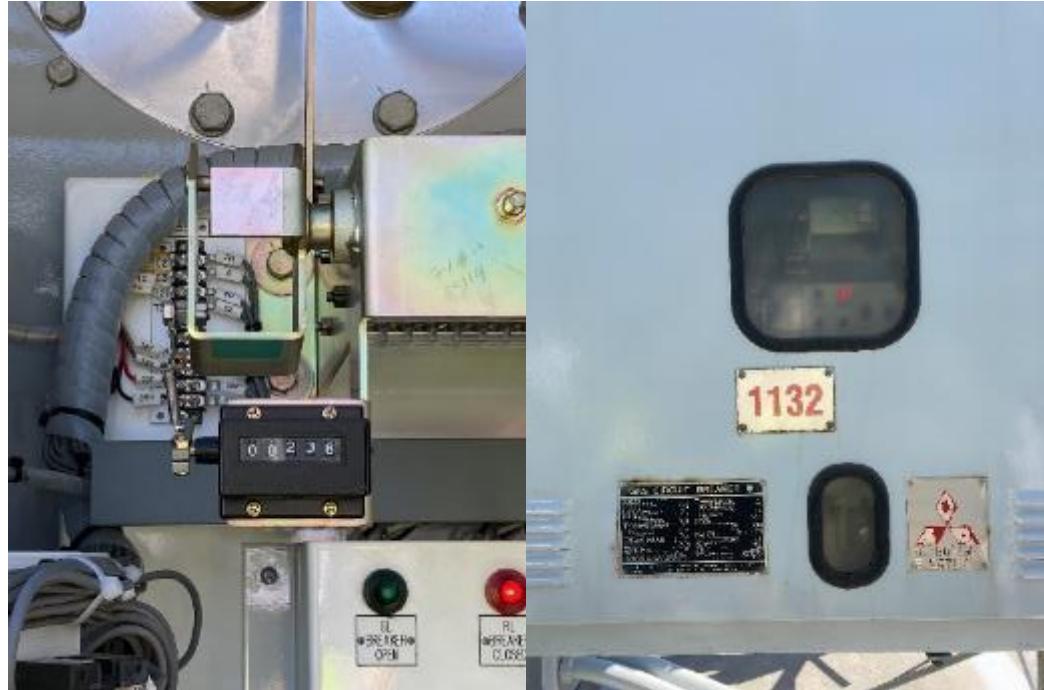
1.10.CB 1132 closed semaphore is faded.

We created LC Notification 131385200 to address ESRB's finding regarding the faded closed semaphore on CB1132 at Martin Substation, added it to the workplan, and completed it on September 14, 2025.

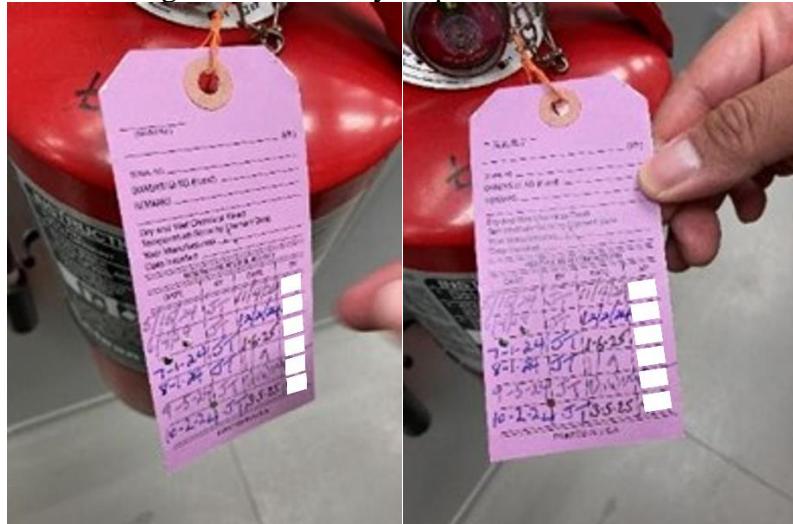
1.12. Both fire extinguishers missing 4/2025 monthly inspection in the 115 kV MPAC #2 control room.

We acknowledge that both fire extinguishers located in the 115 kV MPAC #2 room are missing monthly sign-off for April 2025. While these inspections are conducted monthly, we recognize the importance of ensuring that all inspection activities are properly recorded and will reinforce the requirement to document monthly inspections with the local supervisor.

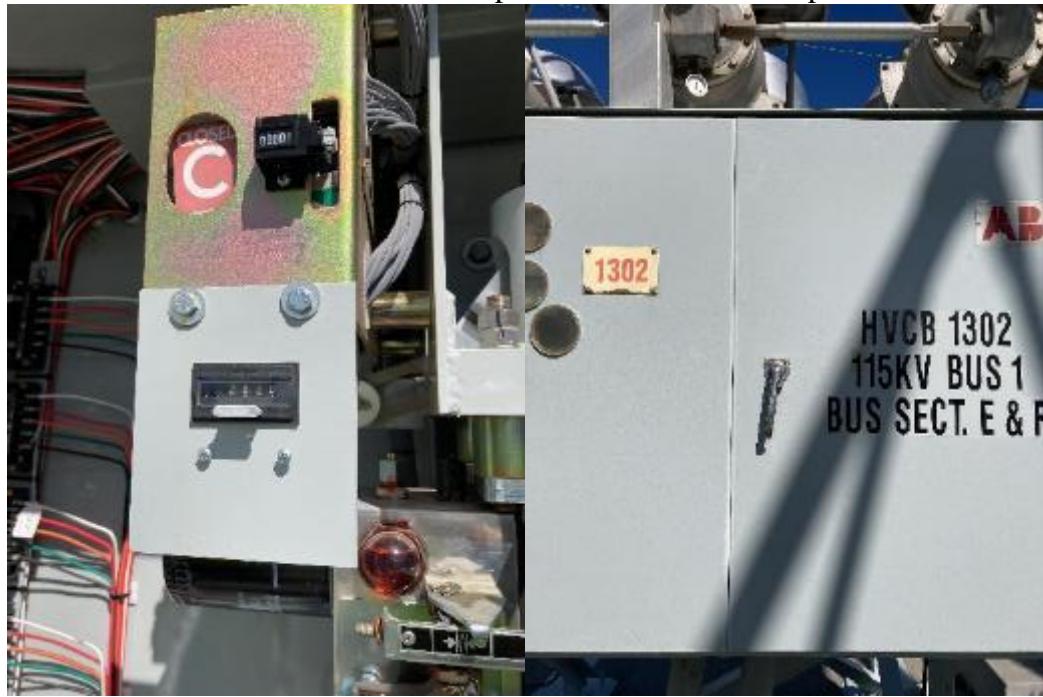
1.13. CB 1302 has a faded counter. PG&E has an open LC 126035884 to replace the counter.

We created LC Notification 131294440 to address ESRB's finding regarding the faded counter on CB1302 at Martin Substation, added it to the workplan, and completed it on June 07, 2025.

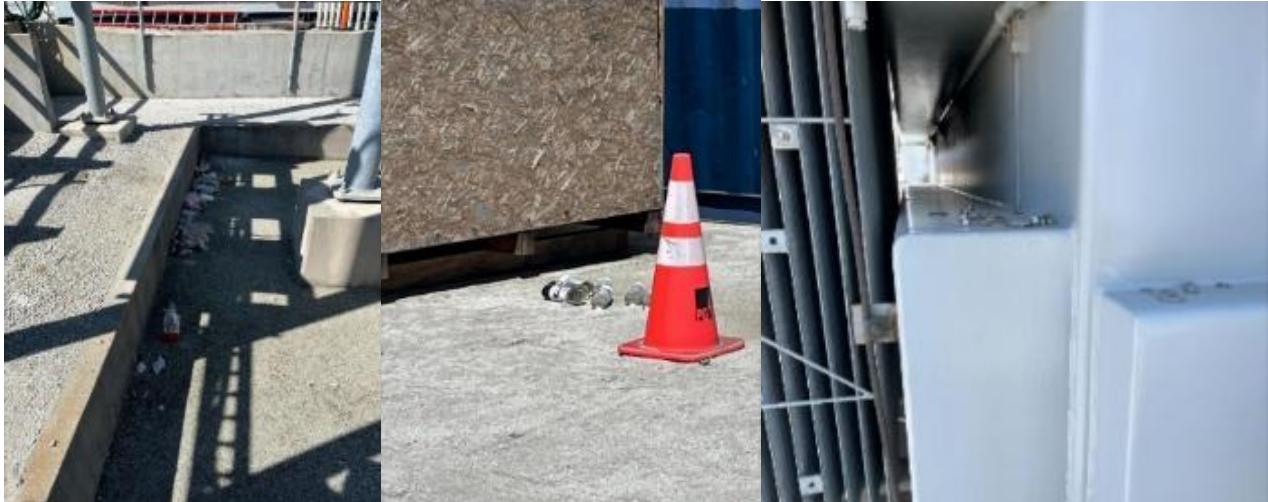
1.15. Housekeeping needs improvement. Buckets, rags, trash, hardware, etc. observed around substation.

We created LC Notification 131234359 to address ESRB's finding regarding the housekeeping issues identified, added it to the workplan, and will complete the LC in accordance with our current work prioritization. Actions to improve substation housekeeping are noted in the introduction.

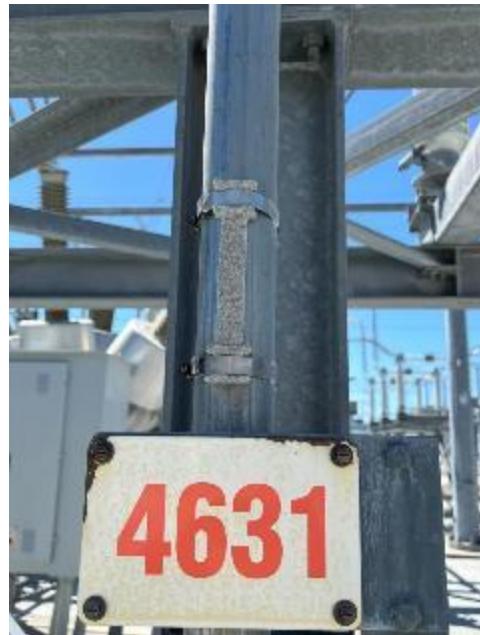
1.17. Switch 4631 closed semaphore is faded.

While we remain committed to maintaining equipment in a condition that promotes safety and adequacy of service, we believe this finding does not reflect a material deficiency under GO 174, Rule 12 because it allows for design and maintenance practices based on local conditions and accepted operational procedures. The semaphore in question is not used to verify switch position. Rather, switchmen confirm the position through direct observation of the switch mechanism itself.

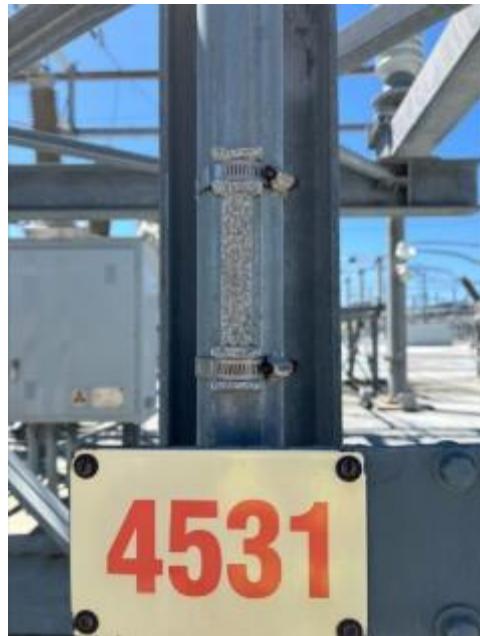
1.18. Switch 4531 closed semaphore is faded.

While we remain committed to maintaining equipment in a condition that promotes safety and adequacy of service, we believe this finding does not reflect a material deficiency under GO 174, Rule 12 because it allows for design and maintenance practices based on local conditions and accepted operational procedures. The semaphore in question is not used to verify switch position. Rather, switchmen confirm the position through direct observation of the switch mechanism itself.

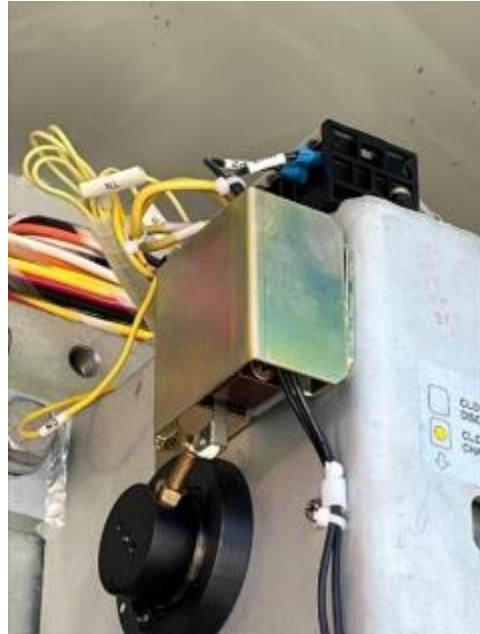
1.19. CB 92 closed/open semaphore is faded.

We created LC Notification 131796240 to address ESRB's finding regarding the faded semaphore on CB92 at Martin Substation, added it to the workplan, and will complete it based on current work prioritization and material availability.

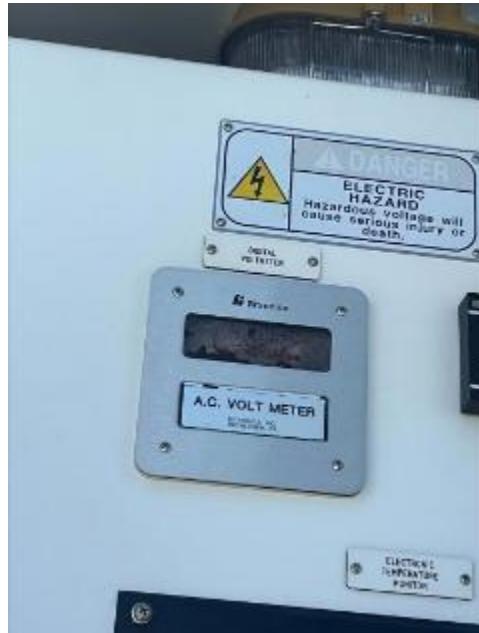
- 1.20. Bank 6 Digital Voltmeter screen is not working. PG&E has an open LC 131235142 to repair the Voltmeter.

Pre-existing LC Notification 131235142 was established in our system of record, SAP, prior to the field audit to address the bank 6 digital voltmeter screen at Martin Substation. This LC notification was completed on time on September 13, 2025 and therefore does not result a violation of GO 174, Rule 12.

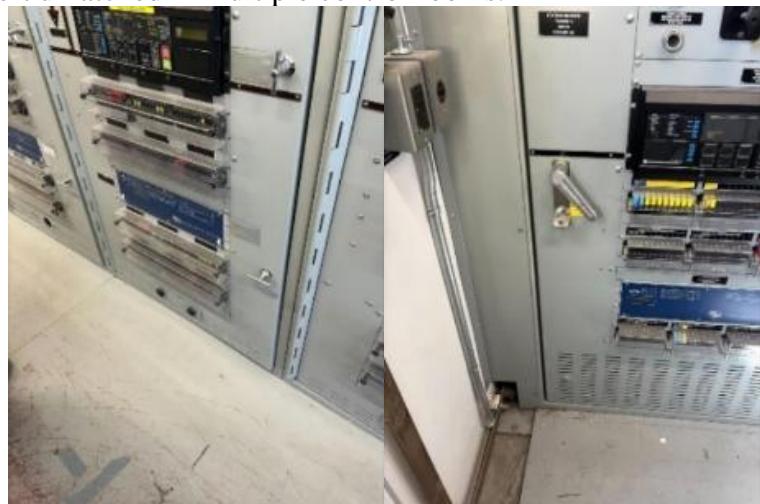
- 1.21. Control cabinets left unlatched in multiple control rooms.

Given the absence of any safety or reliability impact, we do not consider the unlatched control cabinets a material deficiency under the scope of GO 174, Rule 12. The issue was promptly corrected onsite by a PG&E Qualified Electrical Worker (QEWP) on the day of the field audit.

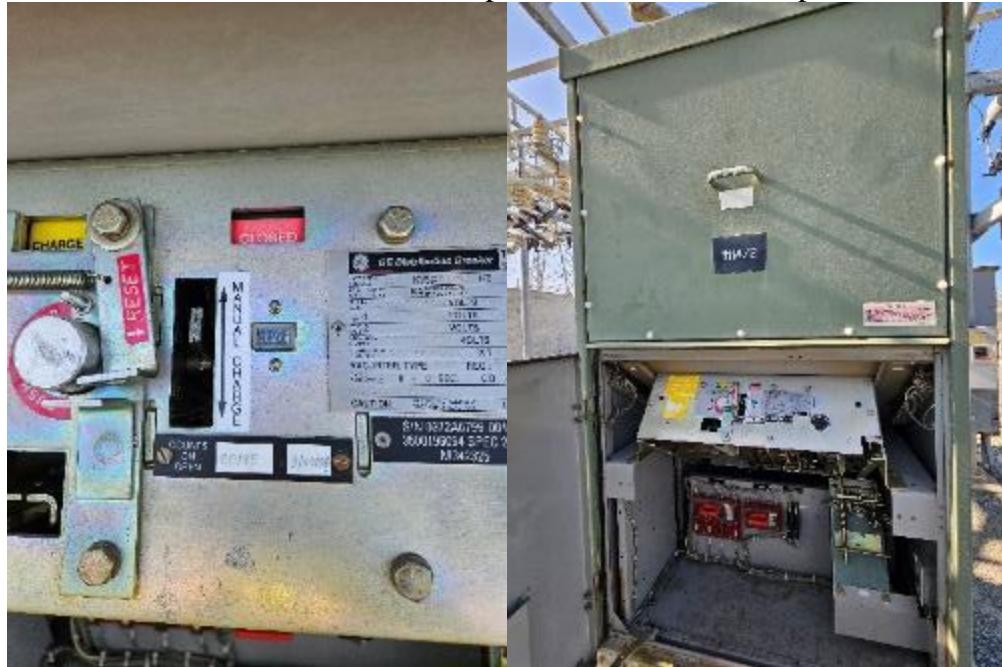
2.1. CB 1114/2 has a faded counter. PG&E has an open LC 130774717 to replace the counter.

Pre-existing LC notification 130774717 was established in our system of record, SAP, prior to the field audit to address faded counter located in circuit breaker 1114/2 at East Grand Substation. This LC notification is being worked in accordance with our maintenance. The notification is being actively managed in accordance with our maintenance procedures and is not past due. Therefore, this finding does not qualify as a violation of GO 174, Rule 12.

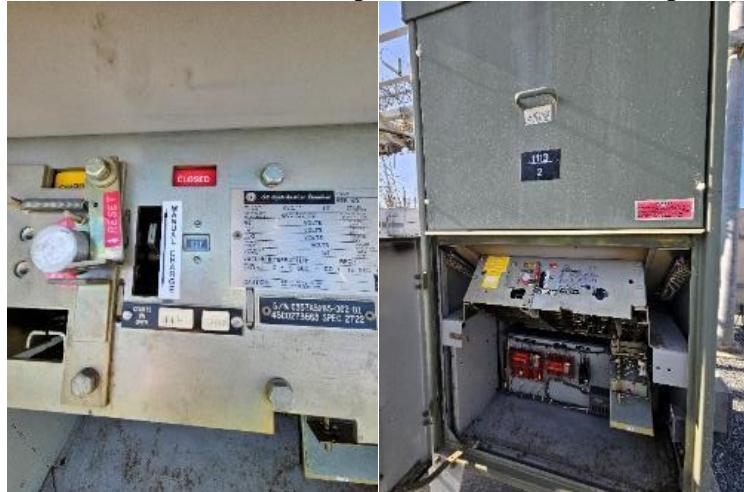
2.2. CB 1113/2 has a faded counter. PG&E has an open LC 129698772 to replace the counter.

Pre-existing LC notification 129698772 was established in our system of record, SAP, prior to the field audit to address faded counter located in circuit breaker 1113/2 at East Grand Substation. We disagree that this finding qualifies as a violation of GO 174, Rule 12 since this LC notification was worked in accordance with our maintenance procedures and completed on time on June 04, 2025.

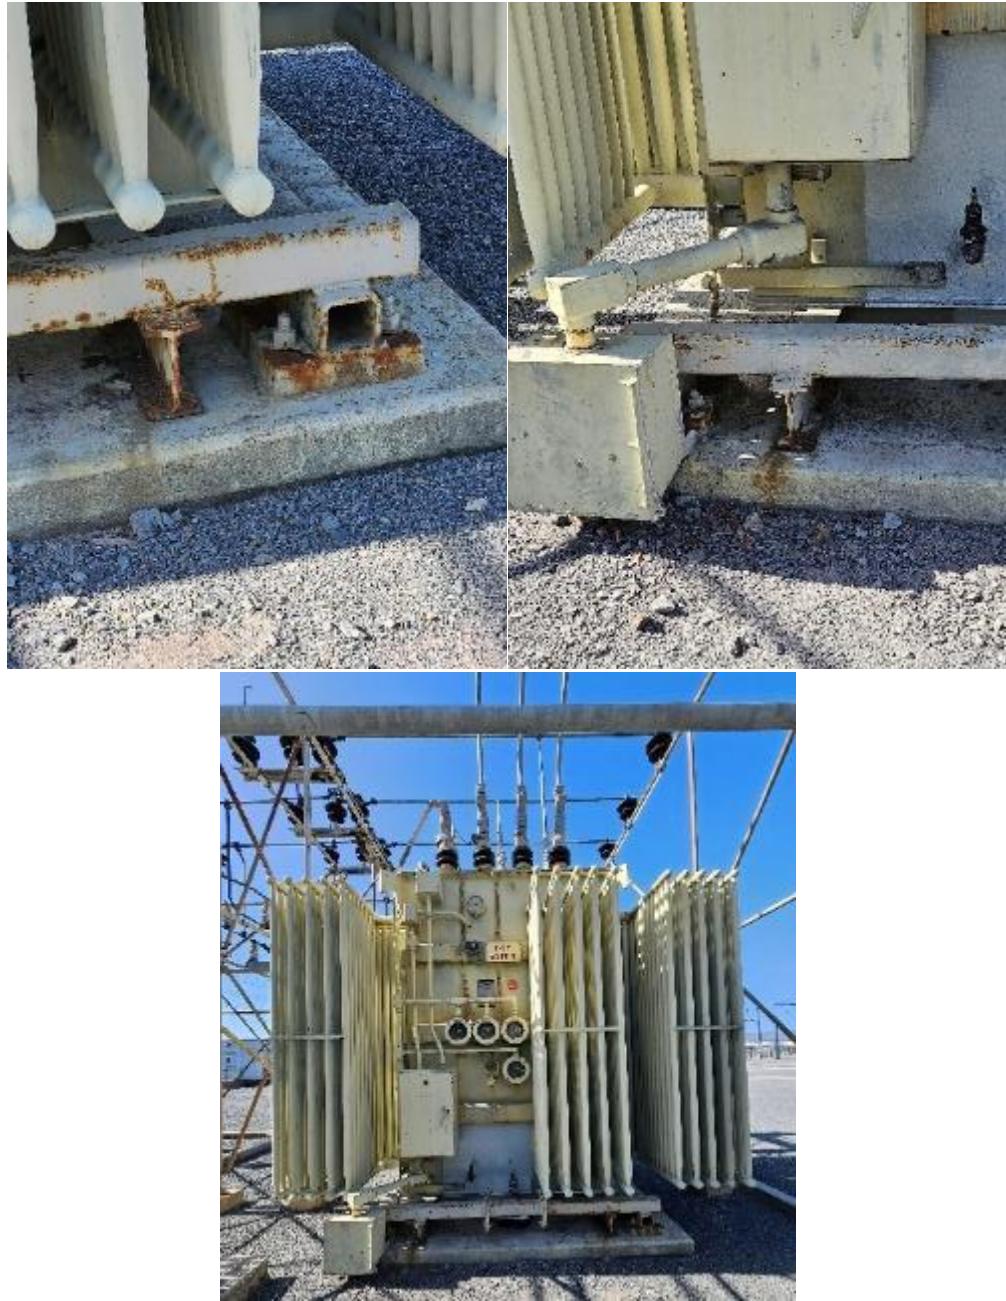
2.3. There is corrosion at the base of TX Bank 3.

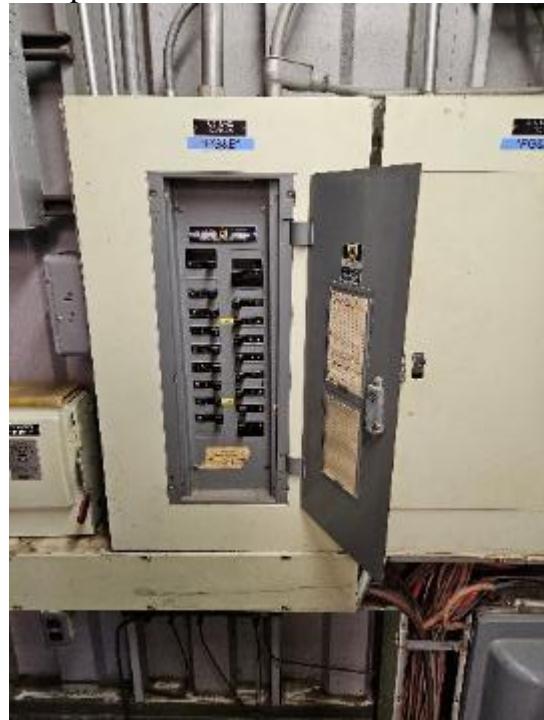
2.4. AC Panel 120/208 V left open.

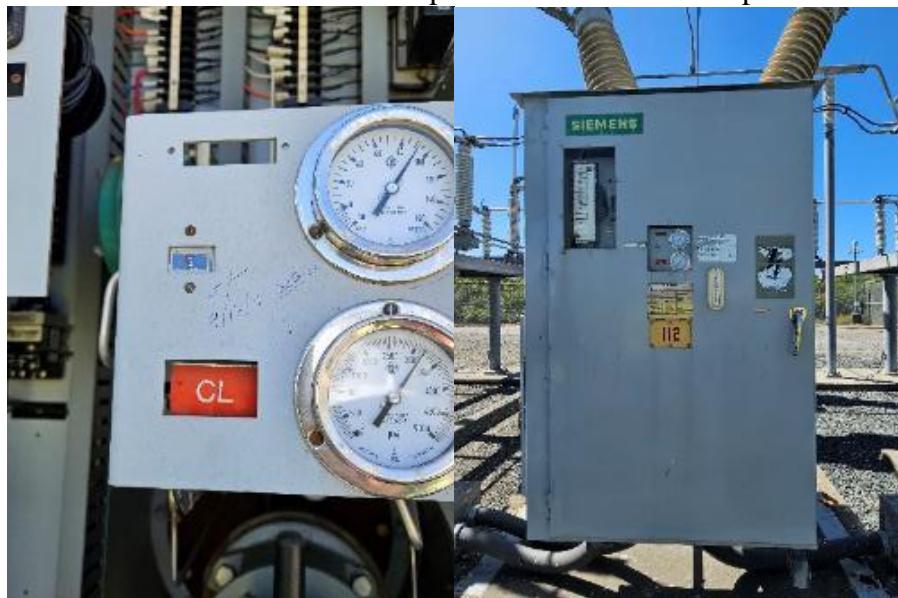
2.5. CB 112 counter is faded. PG&E has an open LC 129282051 to replace the counter.

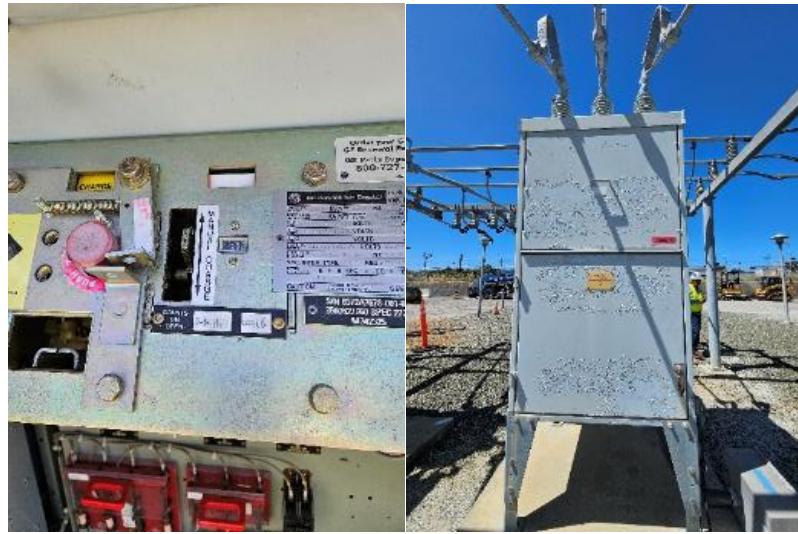
3.2. CB 1106/2 has a faded counter. PG&E has an open LC 131244546 to replace the counter.

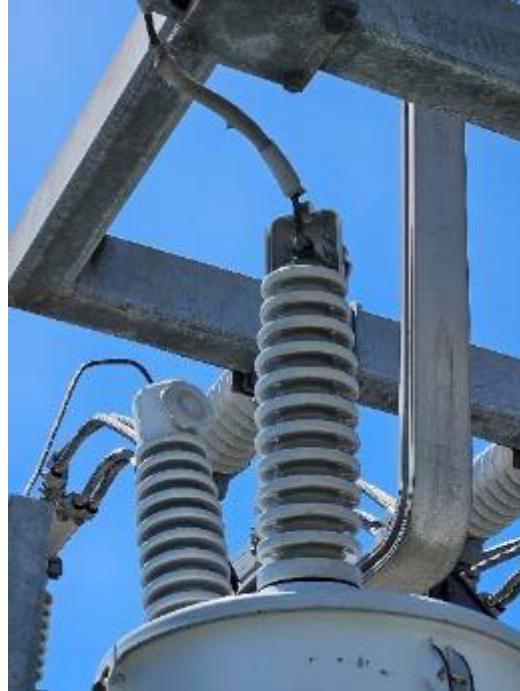
3.3. Station BK 3 1A bushing is missing half of bird guard.

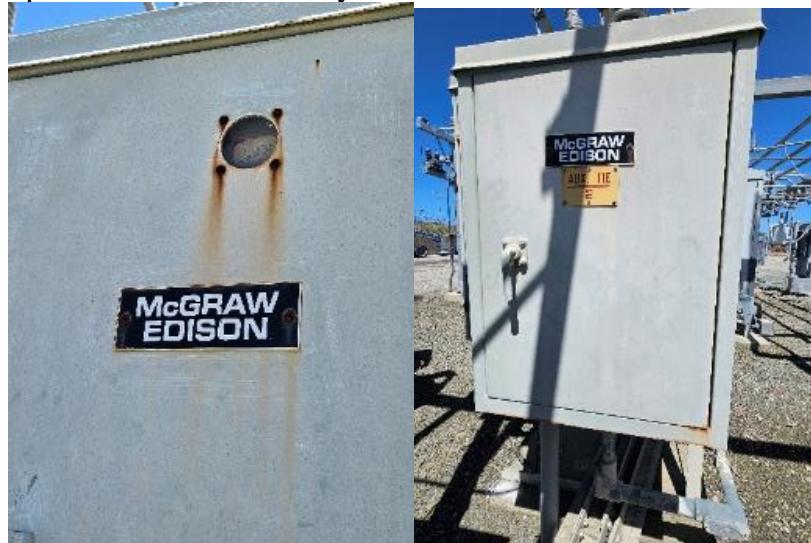
3.4. Closed semaphore faded for Auxiliary Tie 2.

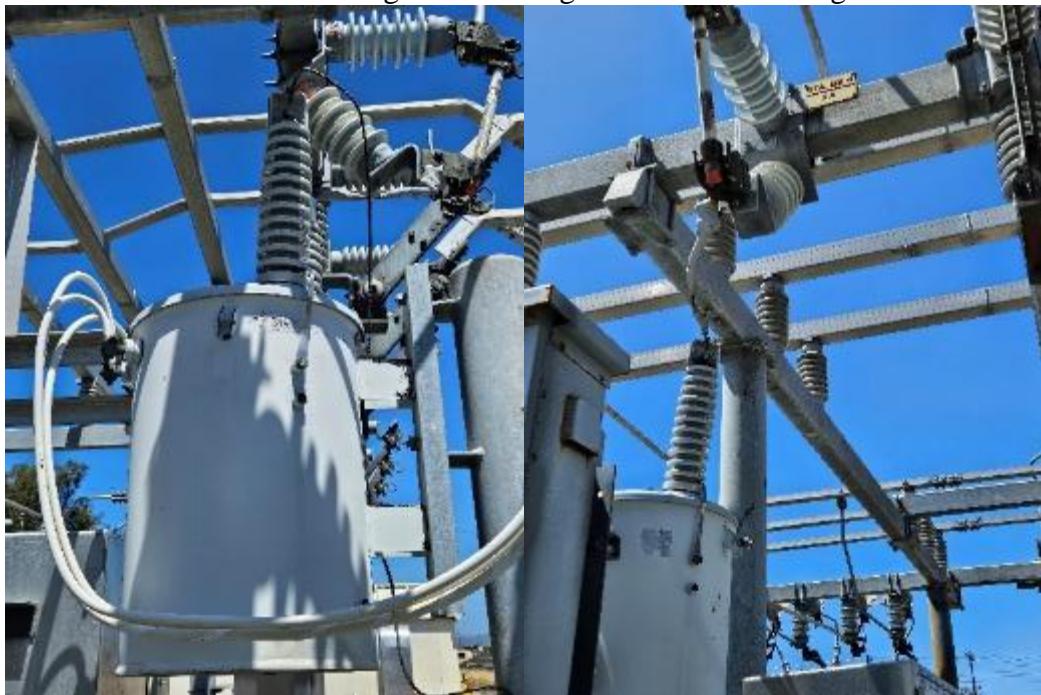
3.5. Station Service BK 4 1A missing half of bird guard on both bushings.

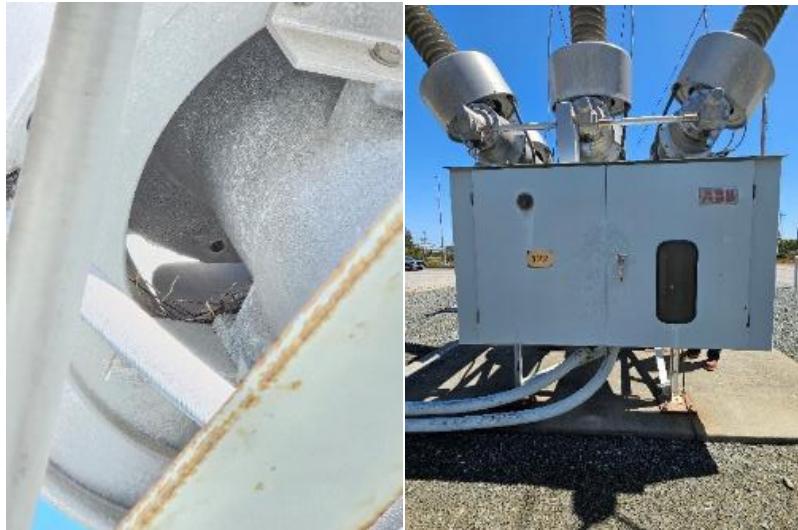
3.6. Bird nest at CB 122.

We created LC Notification 131417632 to address ESRB's finding regarding the bird's nest, added it to the workplan, and completed it on July 20, 2025.

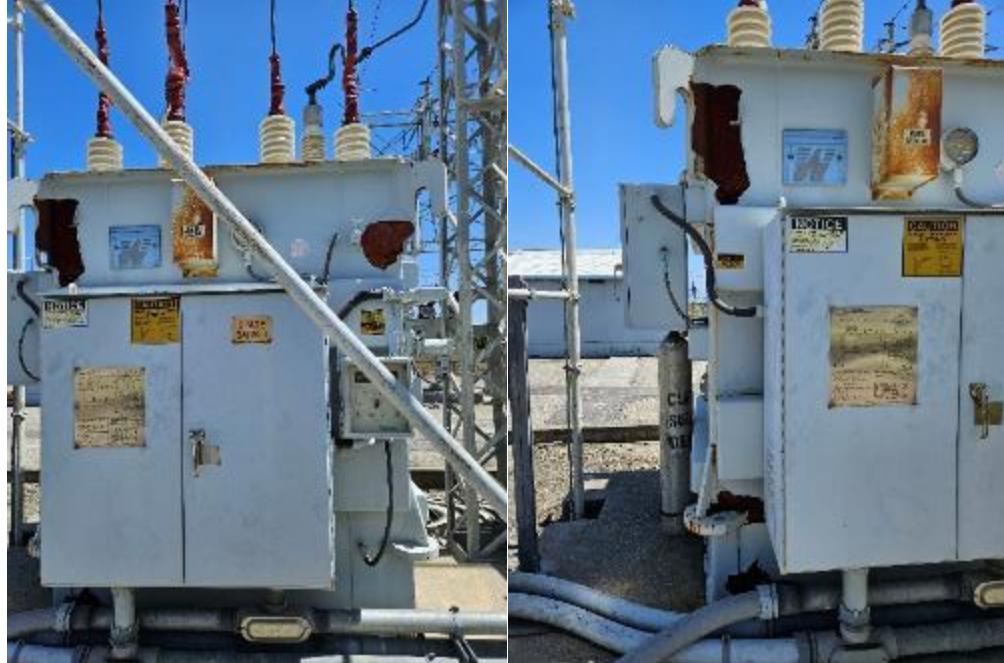
3.8. Corrosion at Spare TX Bank 1.

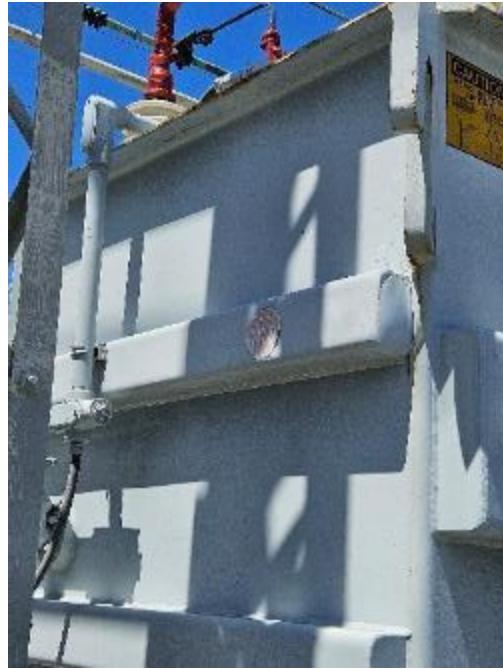
3.9. Faded Entry Procedure sign at TX Bank 1.

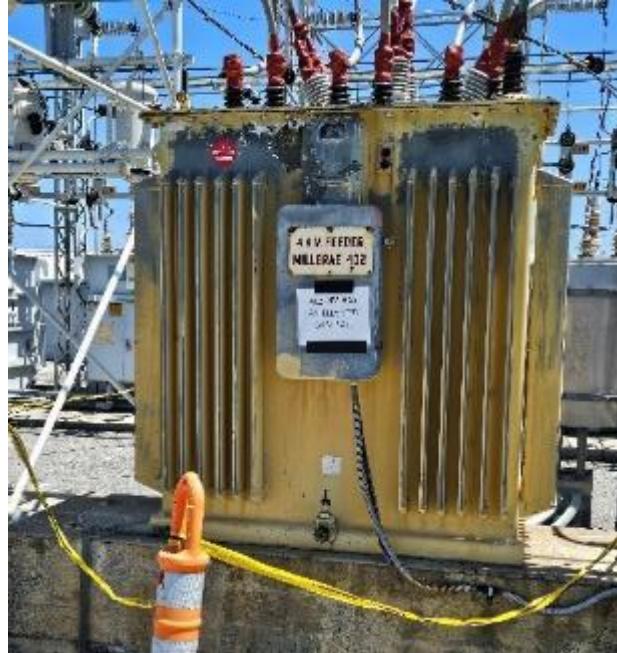
3.10. 402 Regulator (4kV) has an elevated gas level.

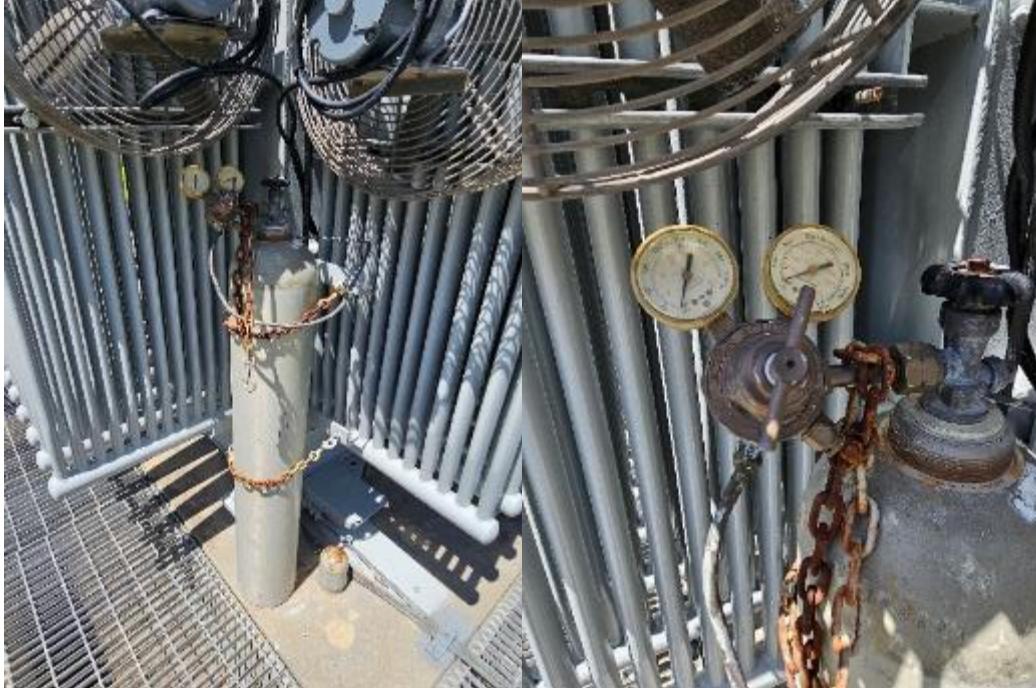
4.1. Nitrogen tank pressure gages broken at TX Bank 1.

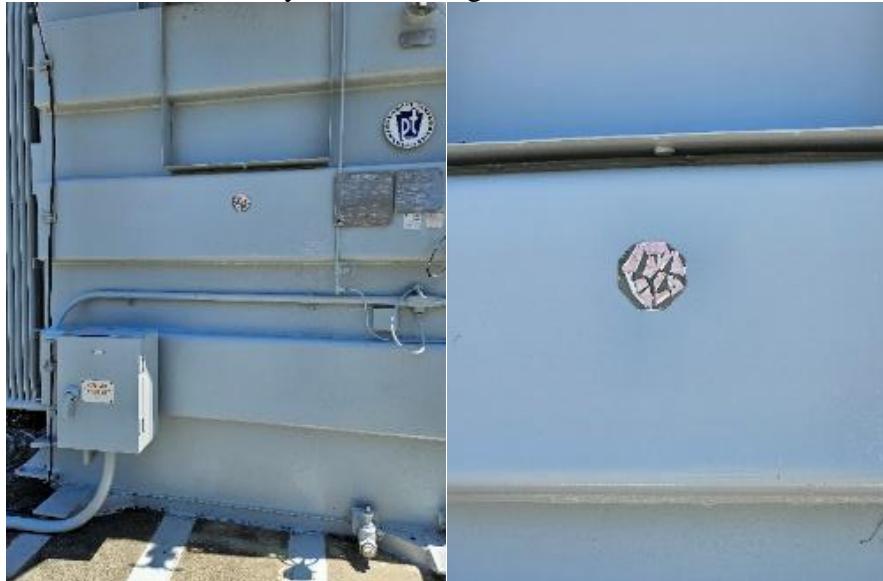
4.2. Bank 1 has a deteriorated Entry Procedure sign.

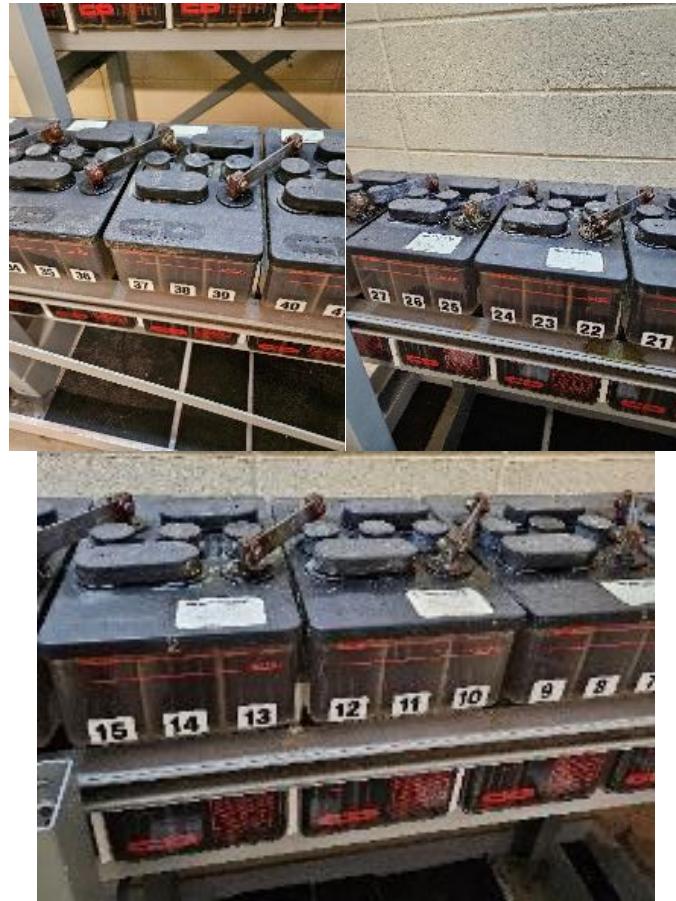
5.1. Corrosion on multiple battery cells in Control Room.

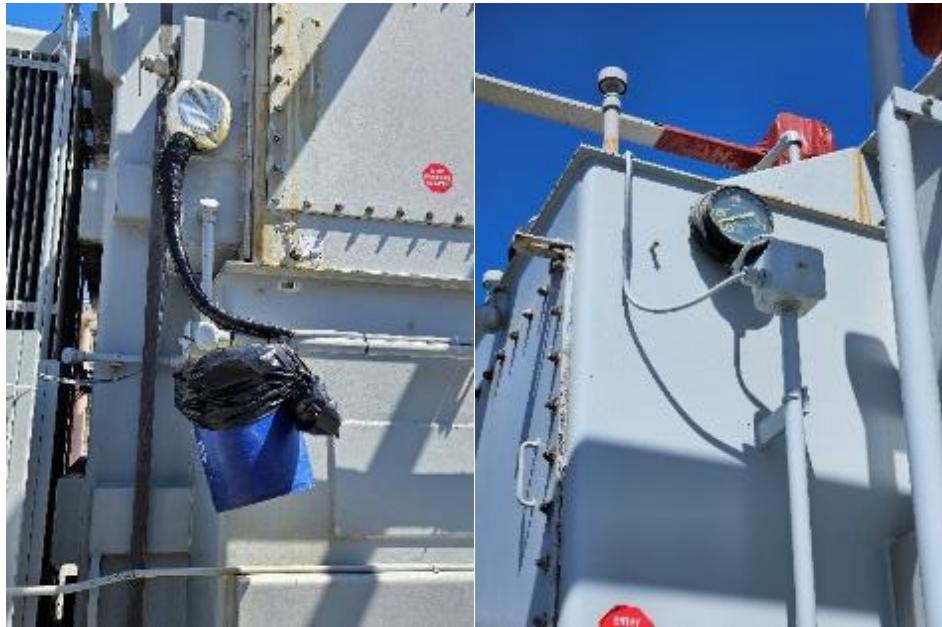
5.2. Bank 1 has a leaking gage and low oil level. PG&E has an open LC 129517779 to repair Bank 1.

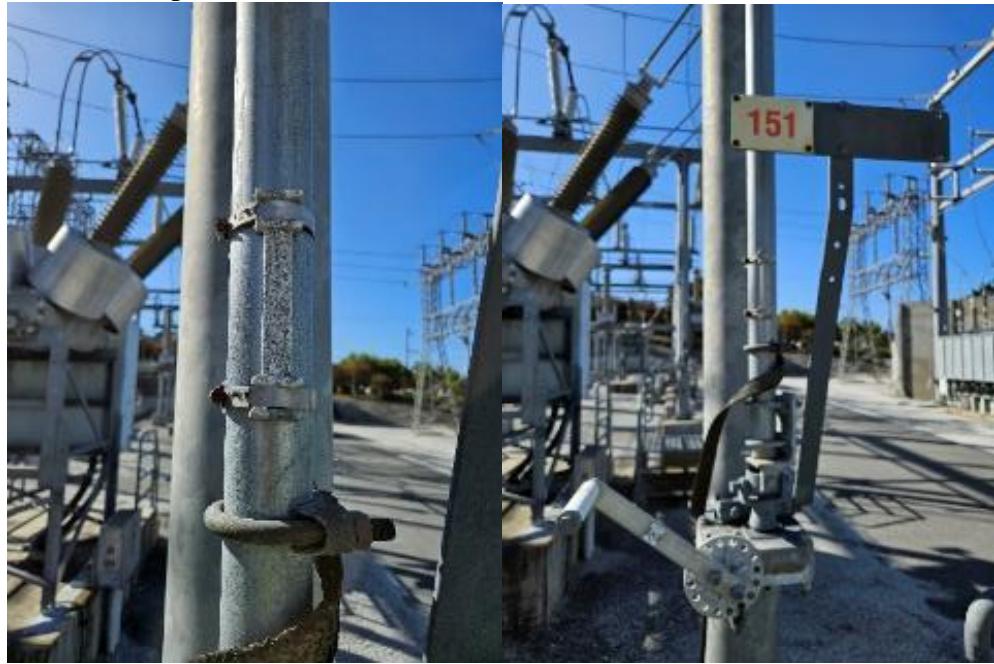
6.1. Switch 151 semaphore is faded.

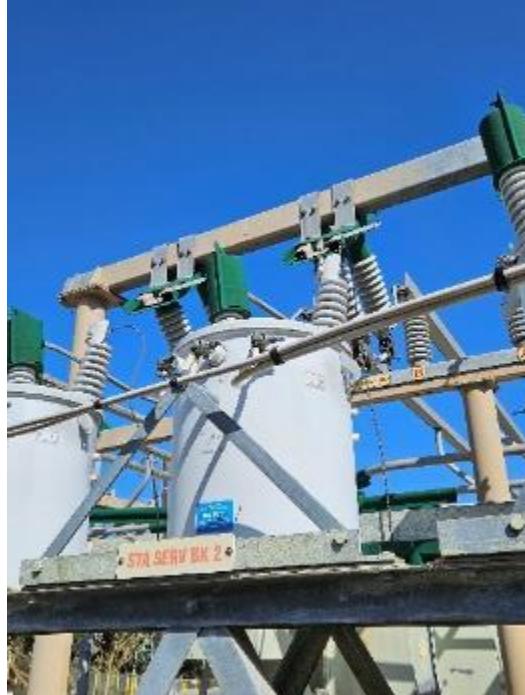
6.2. Station Service Bank 2 has two bushings missing half of the bird guard.

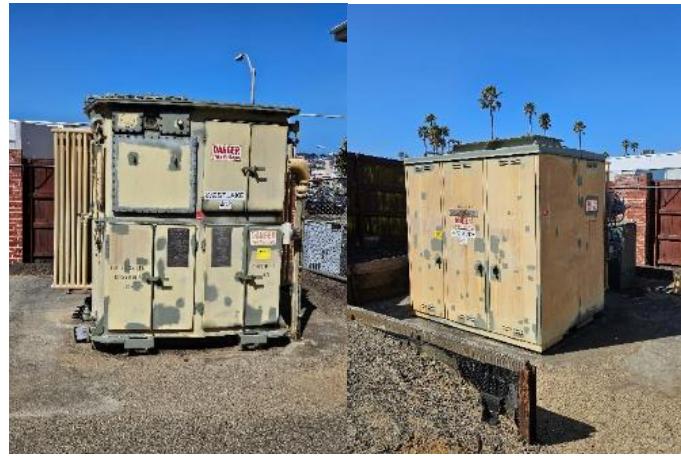
7.1. Unit Sub 403 is deteriorated and at end of life. PG&E has an open CAP Order 130709590 to replace the Unit Sub in 1 year.

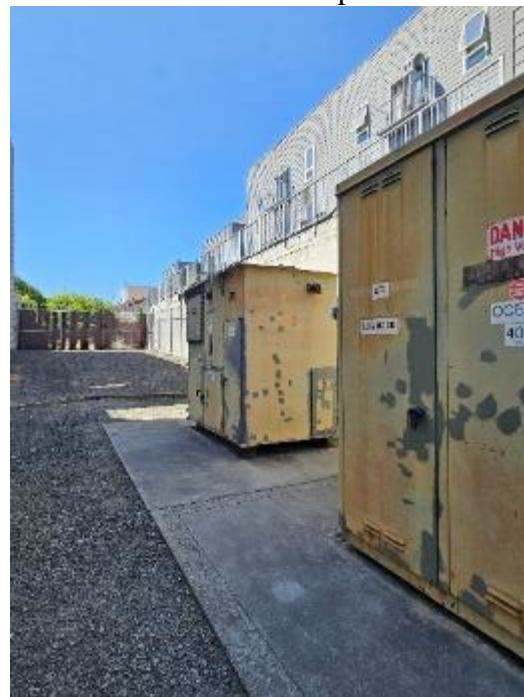
9.2. Bank 2 (402) has moderate rust. PG&E has an open LC 130544674 to repaint it.
