Re: Electric Substation Audit of PG&E Martin Headquarters (HQ)

IV. Field Inspection – Violations List

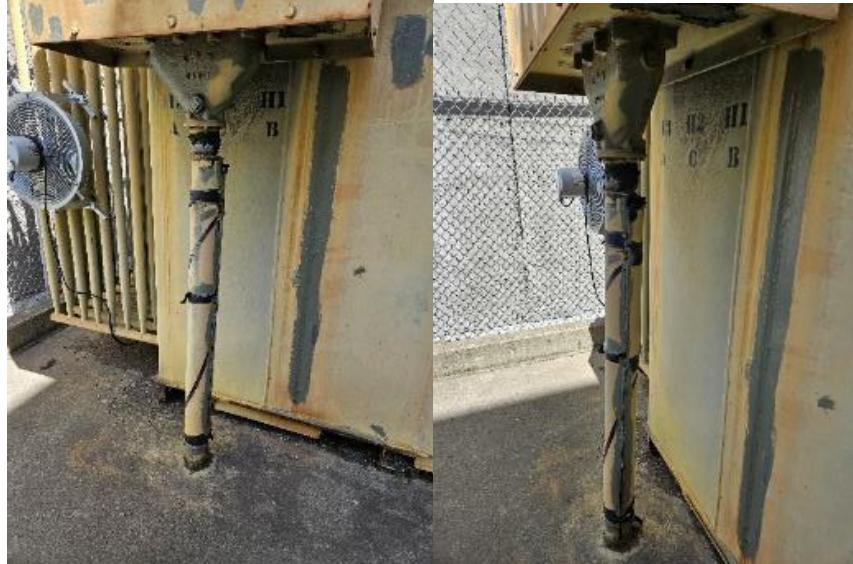
9.3. Distribution riser cover damaged and wrapped with tape.

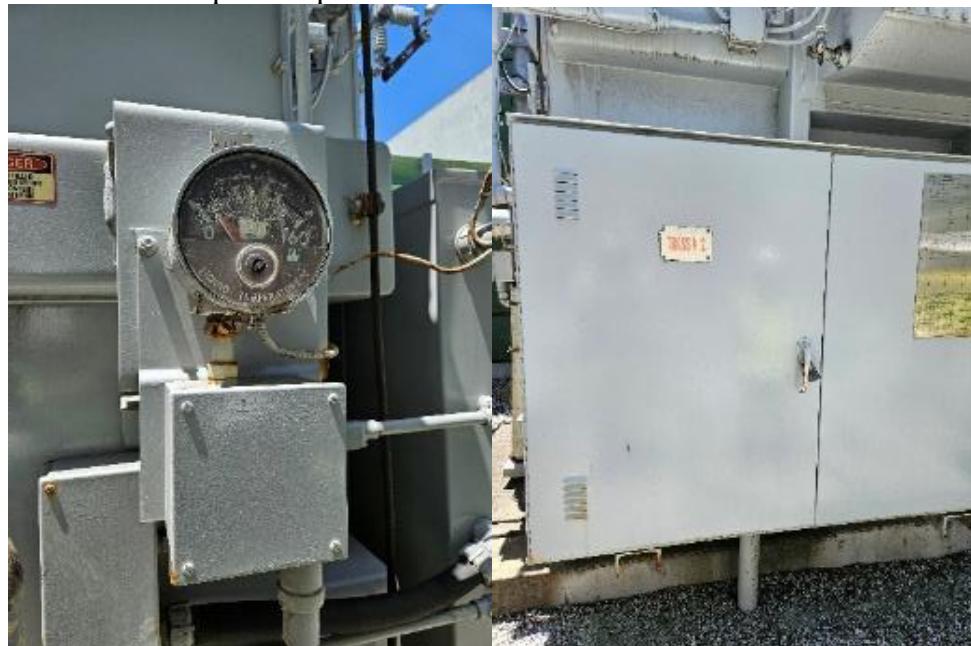
10.1. Bank 2 LTC has a liquid temperature alarm.

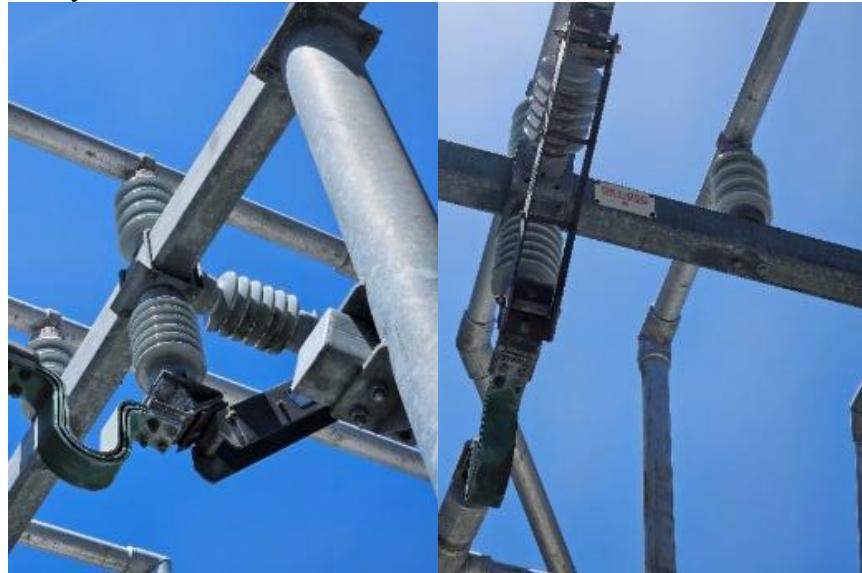
10.2. Insulators dirty at Bank 1 DSC.

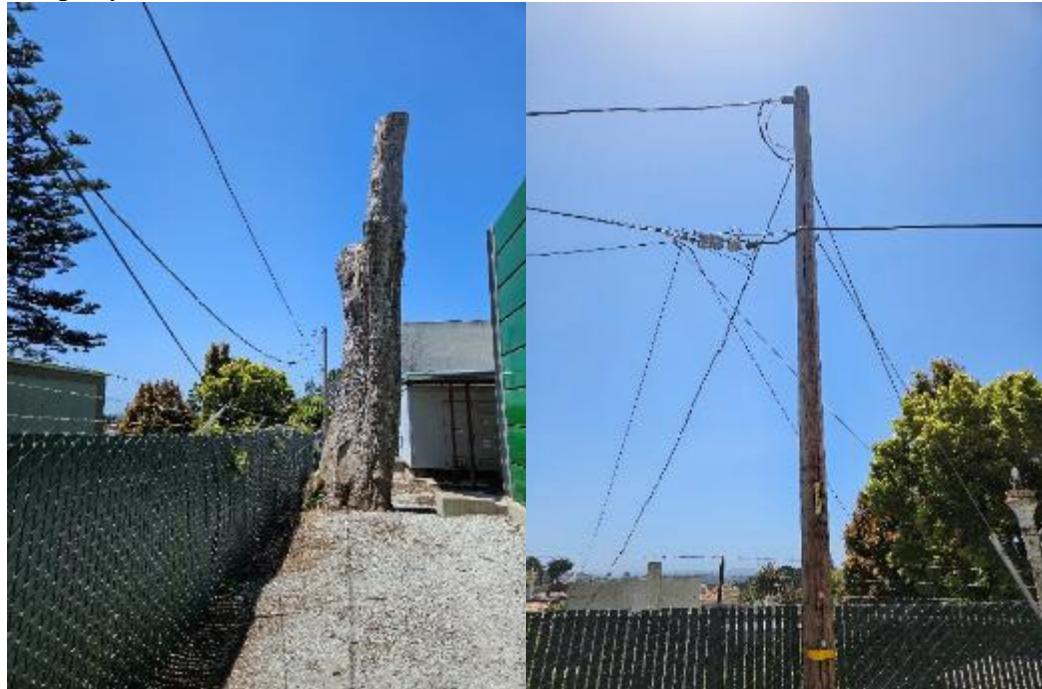
10.4. Third party comms line slacked and low in Substation.

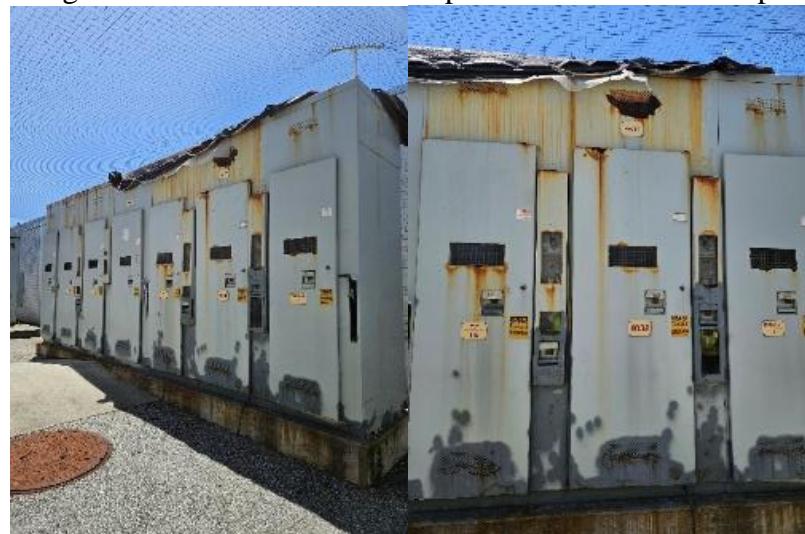
11.1. Rust at Switchgear cabinets. PG&E has an open LC 129349625 to repaint them.

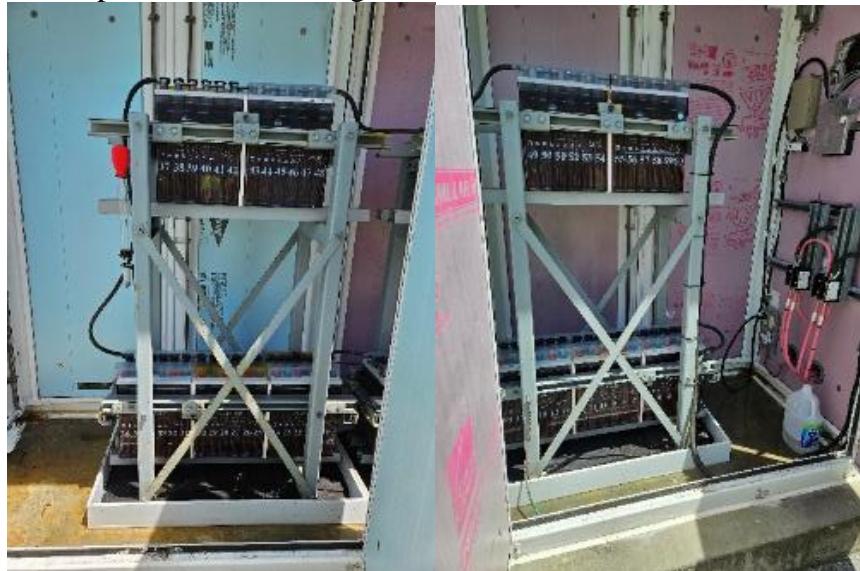
11.2. Water damage due to condensation buildup in Battery Shed. PG&E has an open LC 129349480 to repair the water damage.

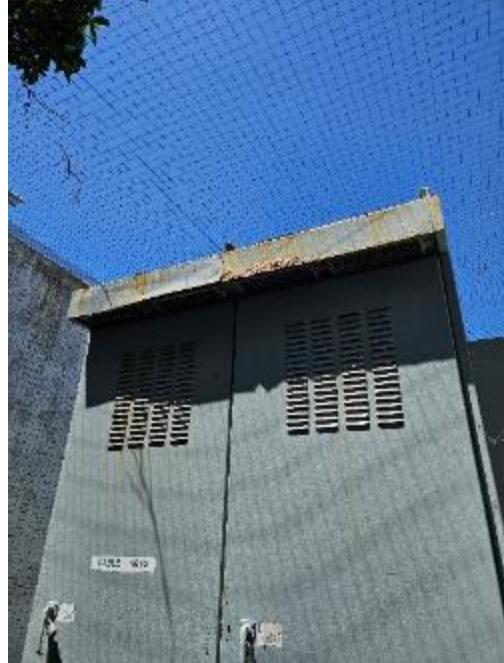
11.4. Rust at CB 401/2. PG&E has an open LC 129350326 to repaint it.

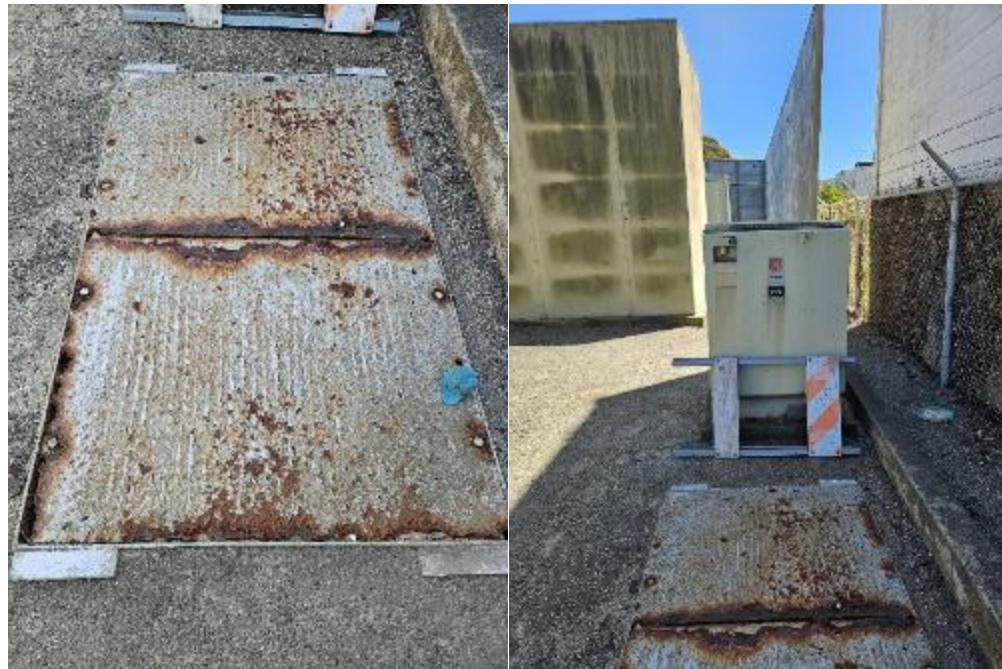
12.1. Significant rust at vault by Switch 3766.

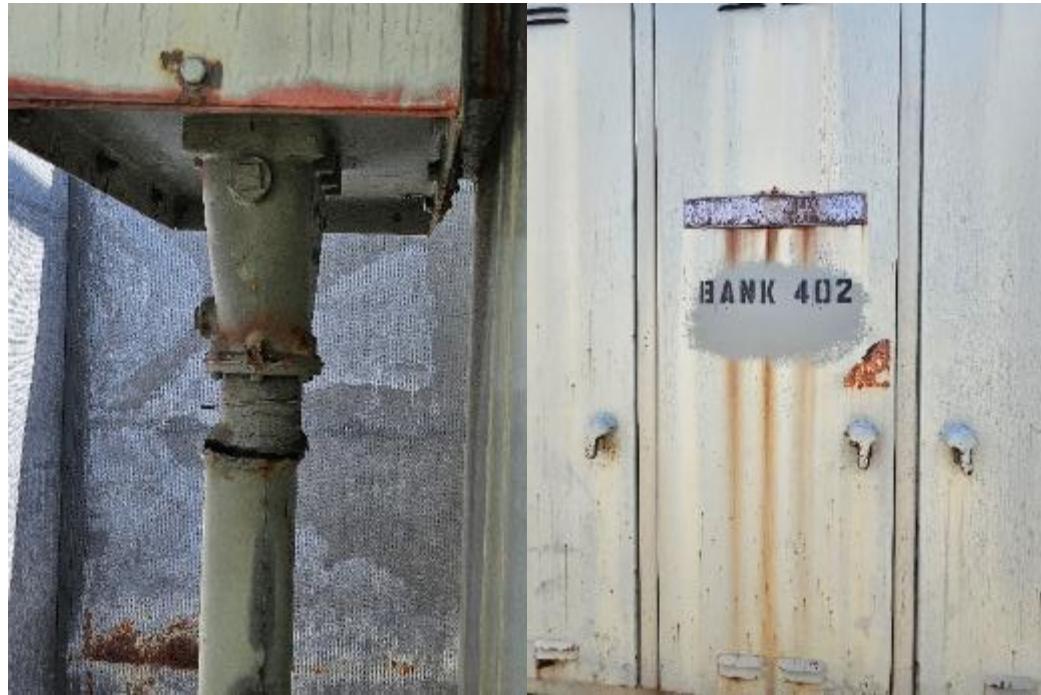
12.2. Pothead riser needs duct seal at Bank 402.

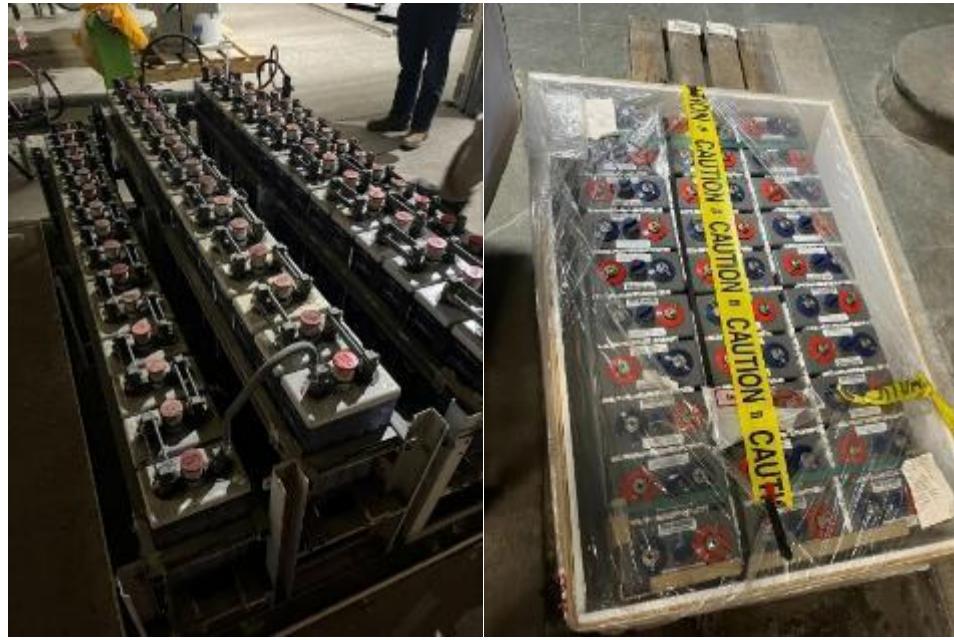
13.1. Station batteries are at end of life. PG&E has a Capitol Order 121830140 to replace the batteries.

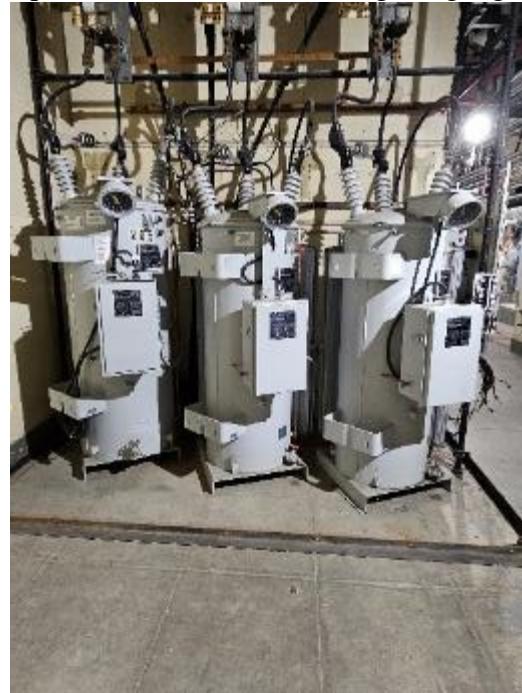
13.2. The 205 Regulators require chain/barrier and Danger signage.

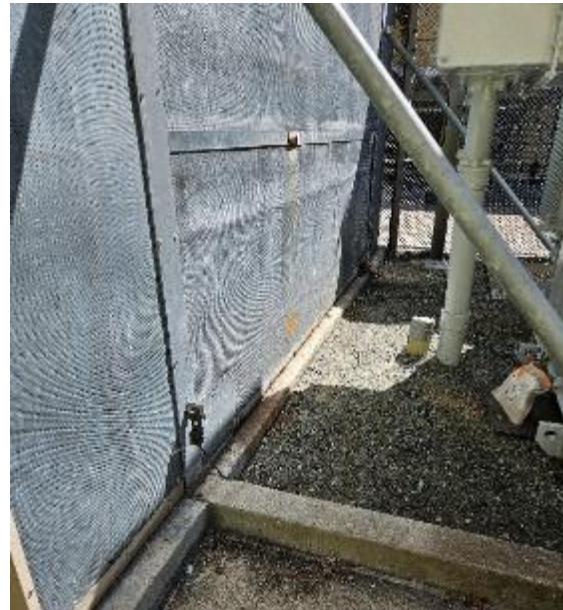
14.1. Fence ground wire is a tripping hazard and needs to be buried and clamped down.

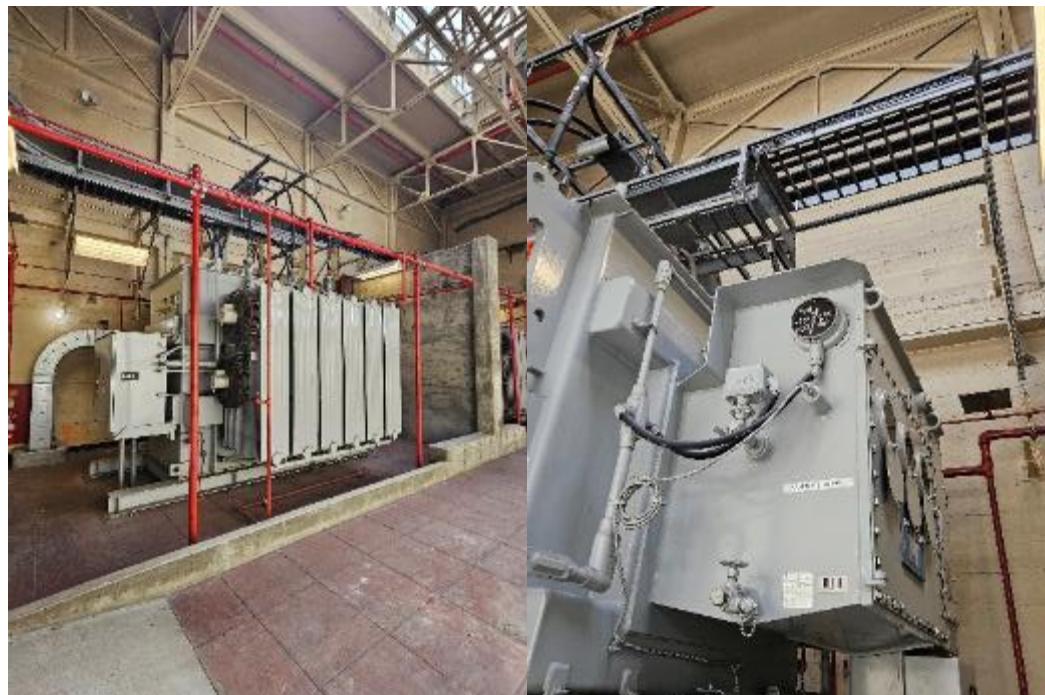
15.1. Bank 1 LTC fluid gauge is broken. There is a sign on the gauge, but PG&E has not created an LC notification to address the issue.

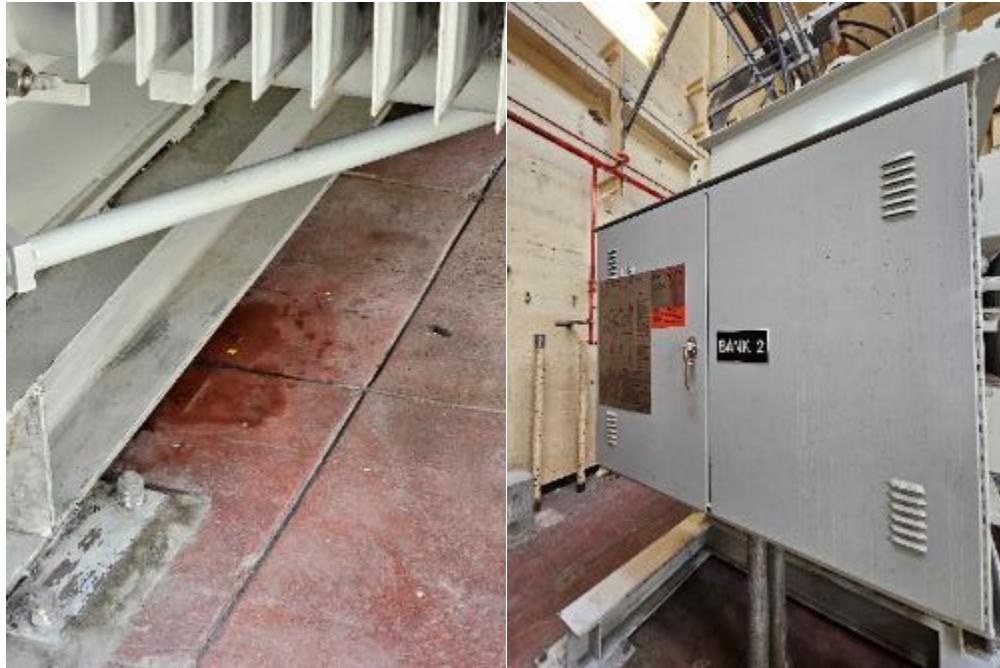
15.2. Bank 2 has an oil leak at the radiator flange. PG&E has an open LC 122446898 to repair the leak.

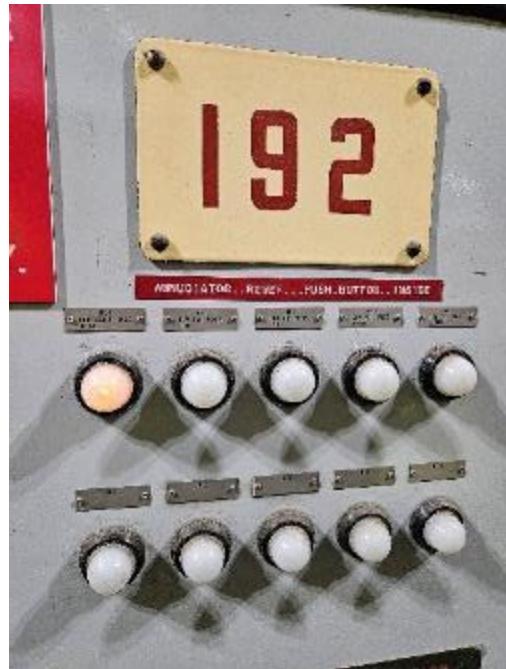
16.1. CB 192 has an alarm for compressor loss of AC. PG&E has an open LC 129794806 to correct this issue.

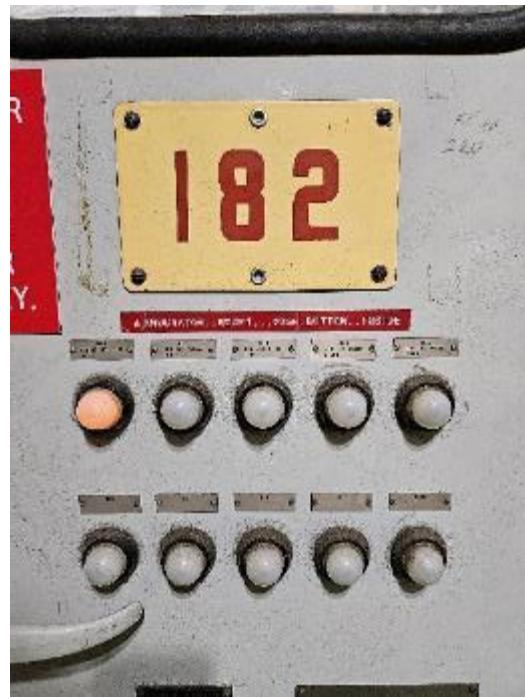
16.2. CB 182 has an alarm for compressor loss of AC. PG&E has an open LC 129400819 to correct this issue.

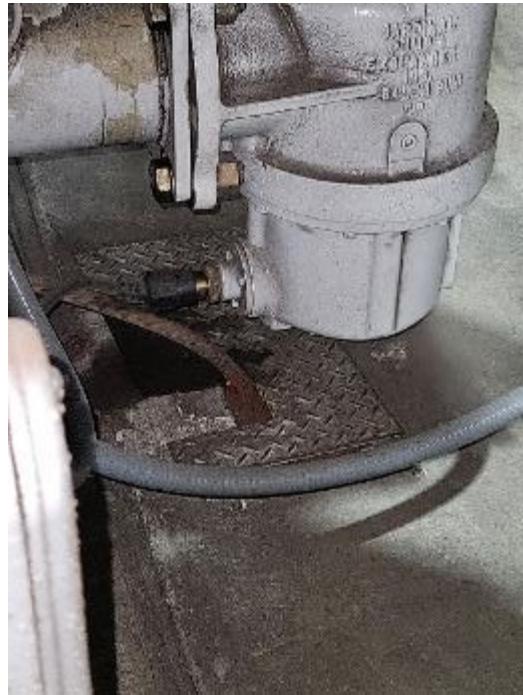
16.3. Minor oil seep at middle pipe near the Bank 1 cooling fans.

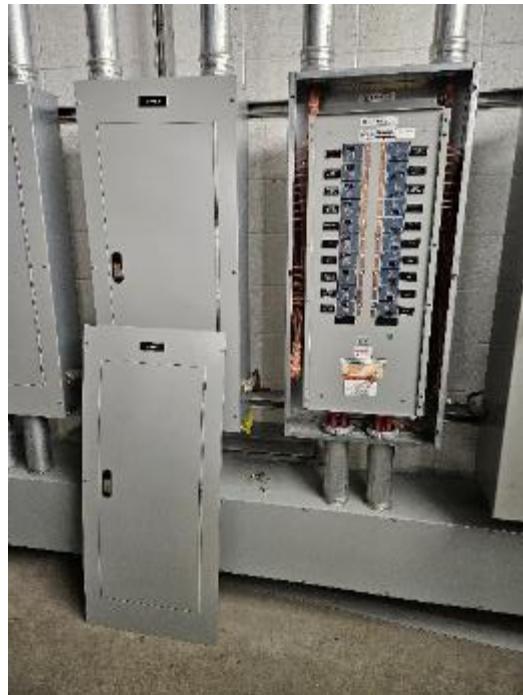
16.4. DC Panel 8 cabinet door not attached due to active construction.

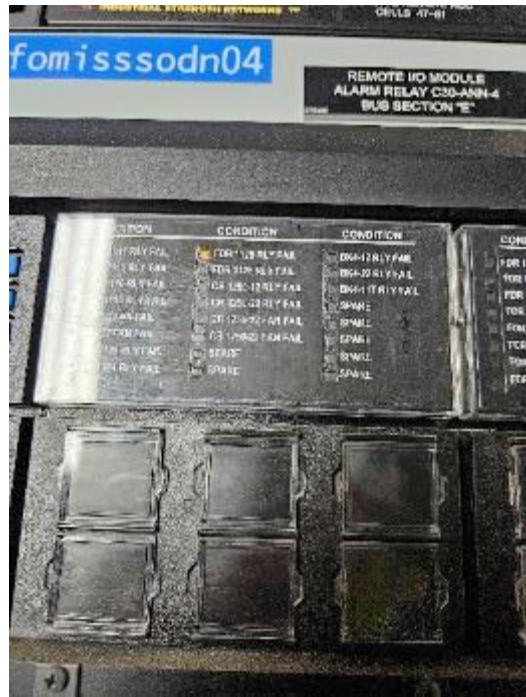
17.2. Alarm Relay C30-ANN-4 has an alarm for FSR 1125 Relay fail at Cell 45 BK4-22.

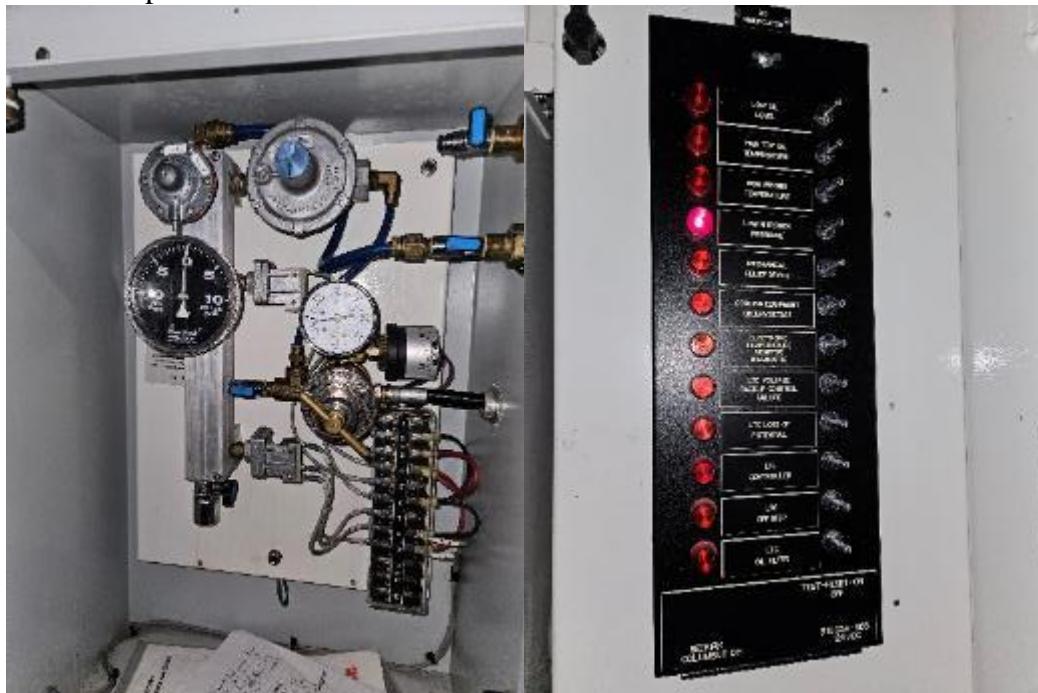
17.3. Broken Nitrogen gauge at Bank 1 and “Low Nitrogen Pressure” alarm shown at the Annunciator panel.

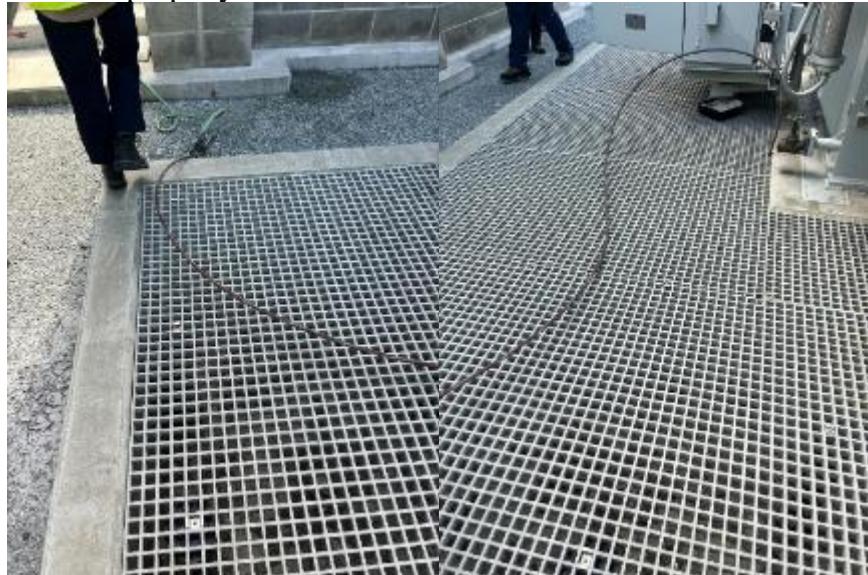
18.1. Ground wire not properly secured at Shunt Reactor 1.

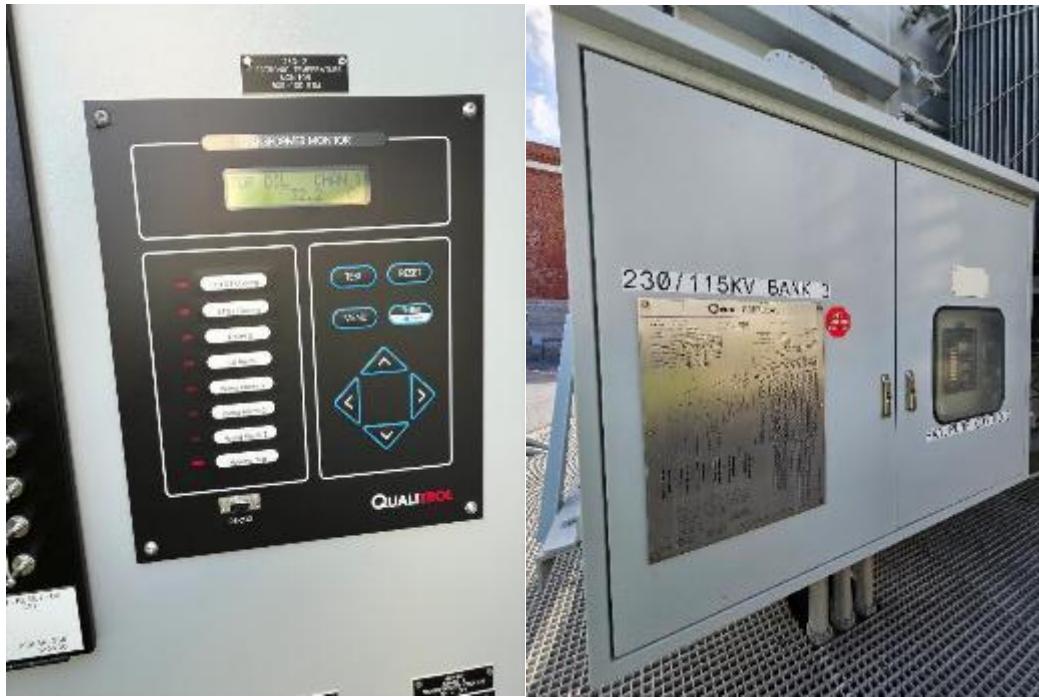
18.2. Winding Trip alarm at 230/115 kV Bank 3. PG&E has an open LC 129113085 to correct the issue.

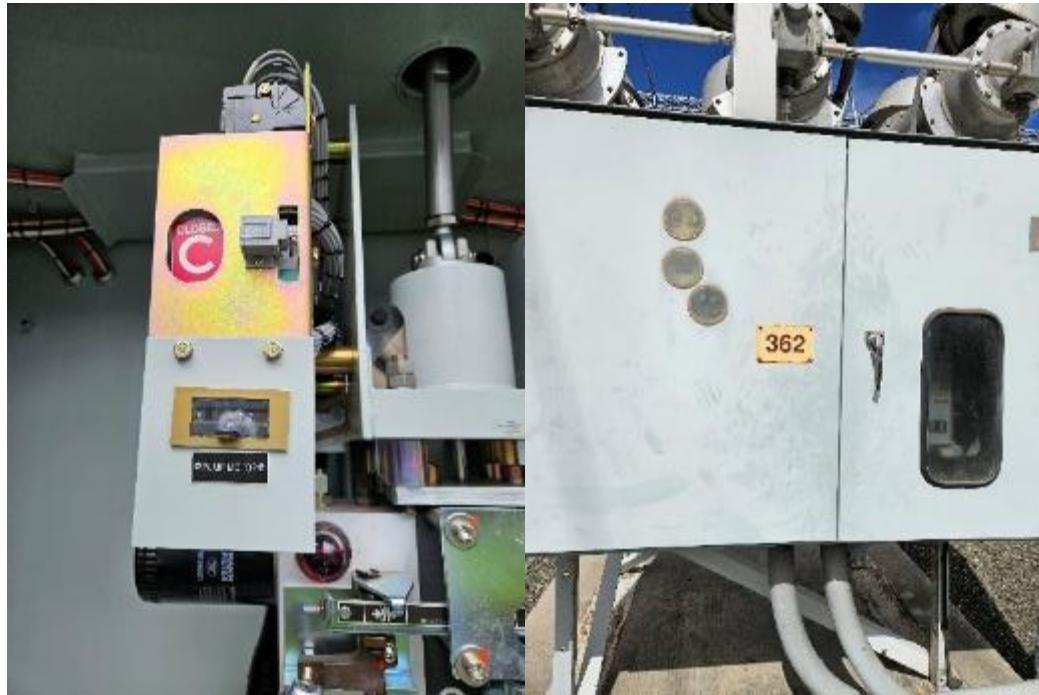
18.3. Pump motor counter faded at CB 362. PG&E has an open LC 129477721 to replace the counter.

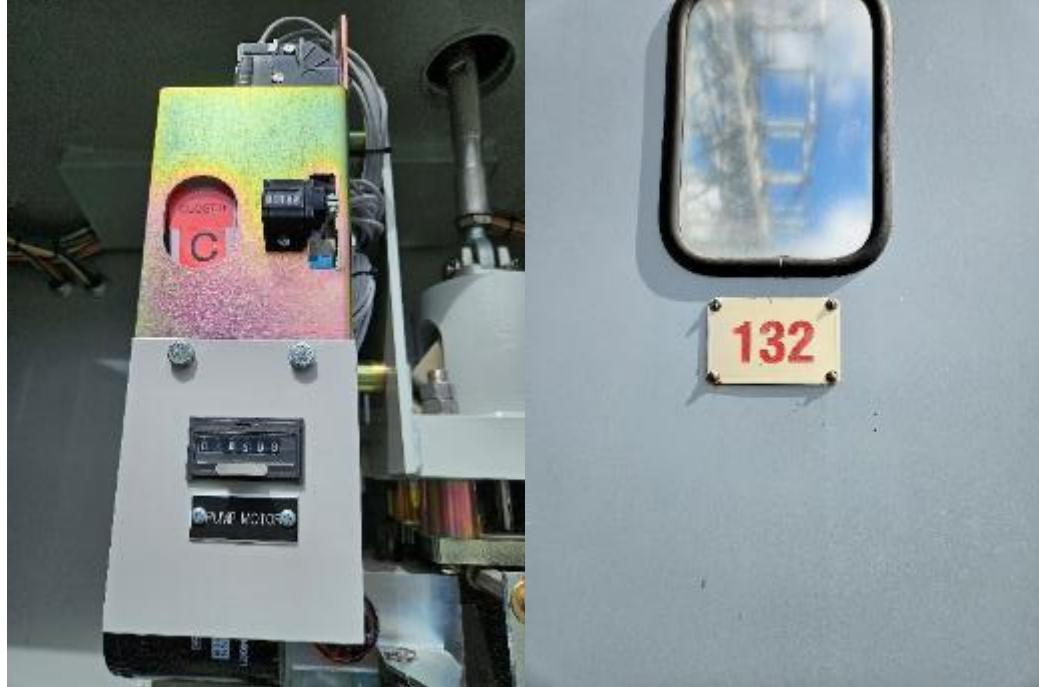
18.4. Pump motor counter faded at CB 132.

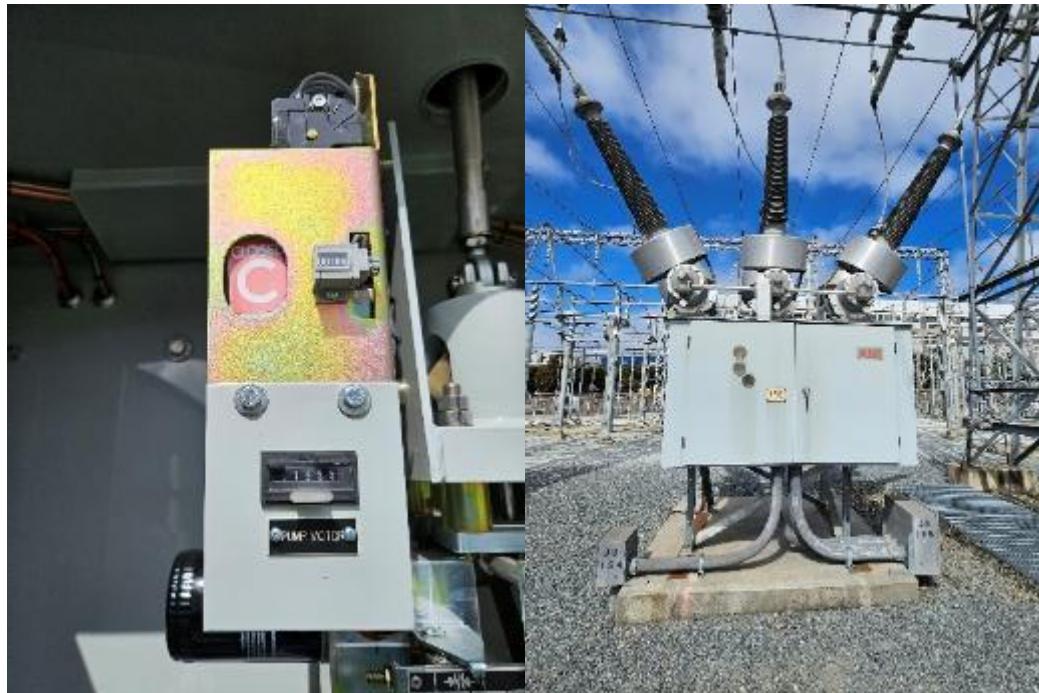
18.5. Pump motor counter faded at CB 182. PG&E has an open LC 129477720 to replace the counter.

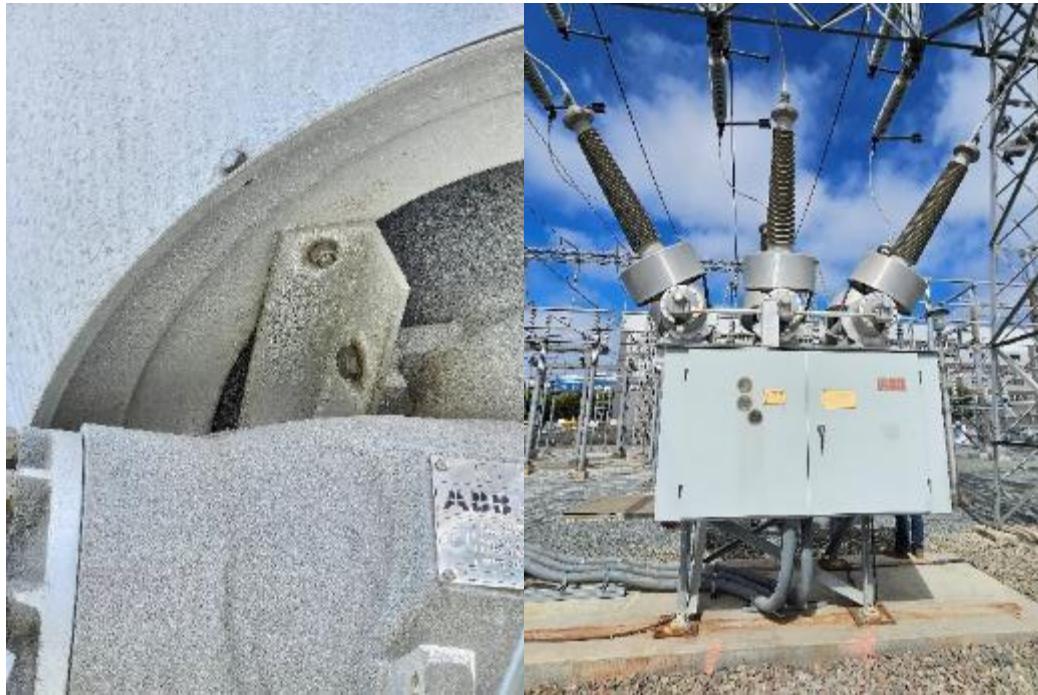
18.6. Bird nest under the middle bushing at CB 192. PG&E has an open LC 129477848 for the bird nest.

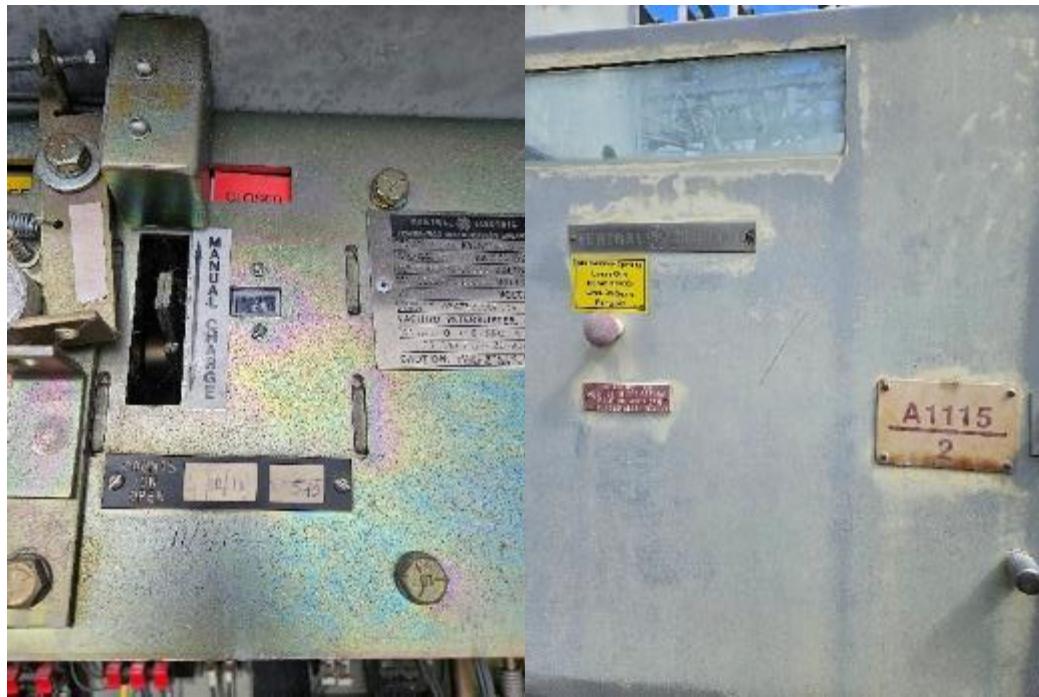
- 18.7. Faded counter at CB A1115/2. PG&E has an open LC 125983508 to replace the counter.

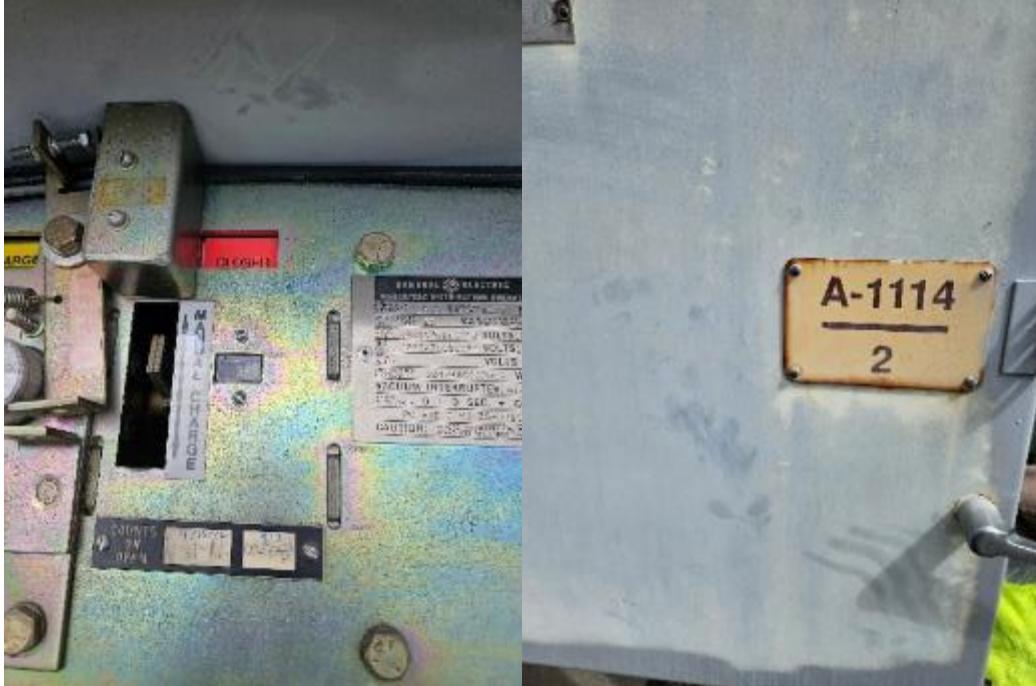
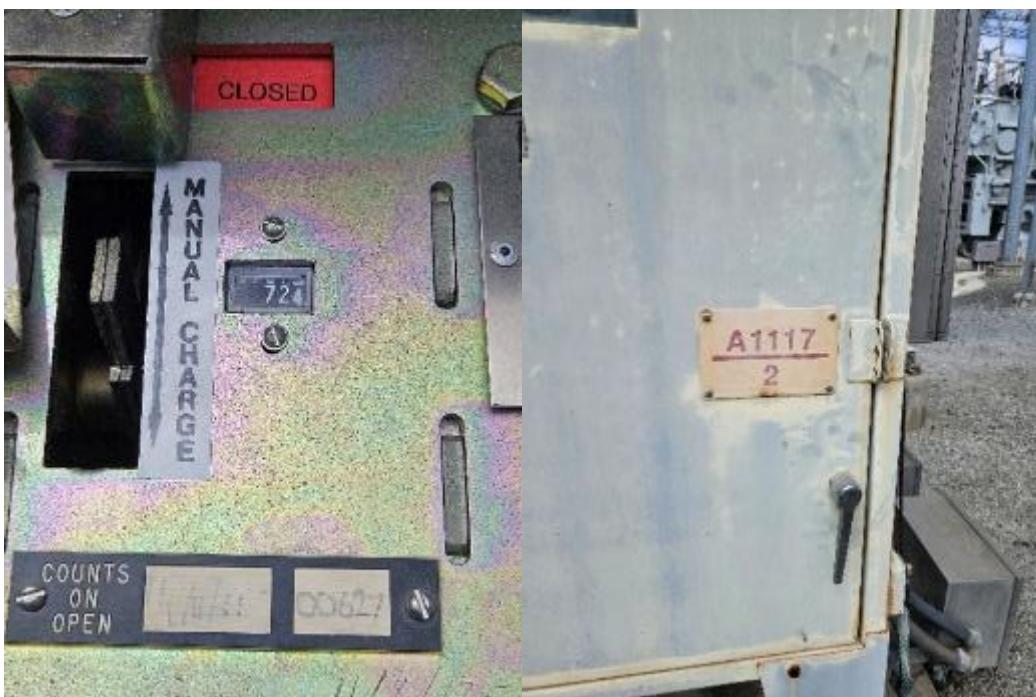
18.9. Faded counters at CB A-1114/2 and CB A1117/2. PG&E has an open LC 128457081 to replace the counters.

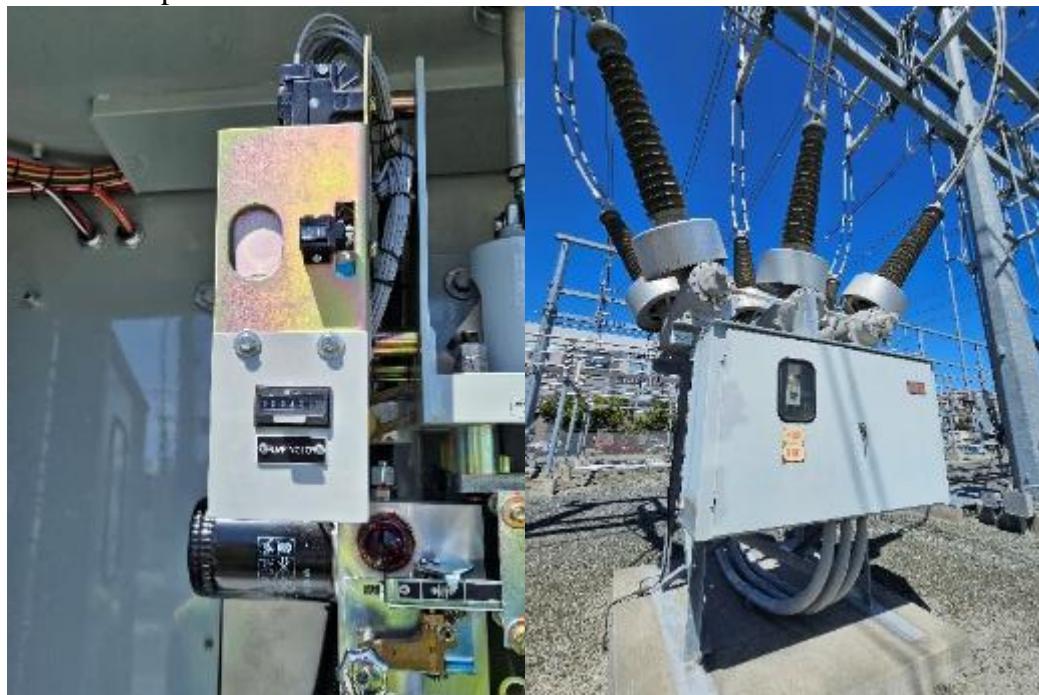
18.10. Faded semaphore at CB 432.

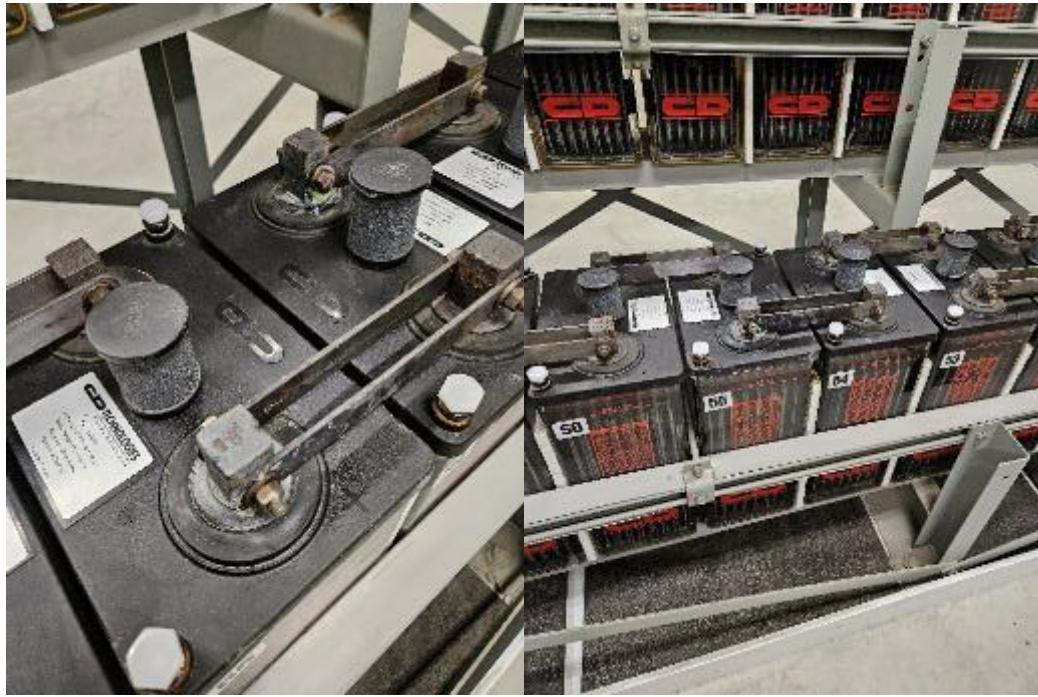
18.11. Corrosion on battery cells 54 and 55 in the Station Battery Room. PG&E has an open LC 130533738 to clean the corrosion.

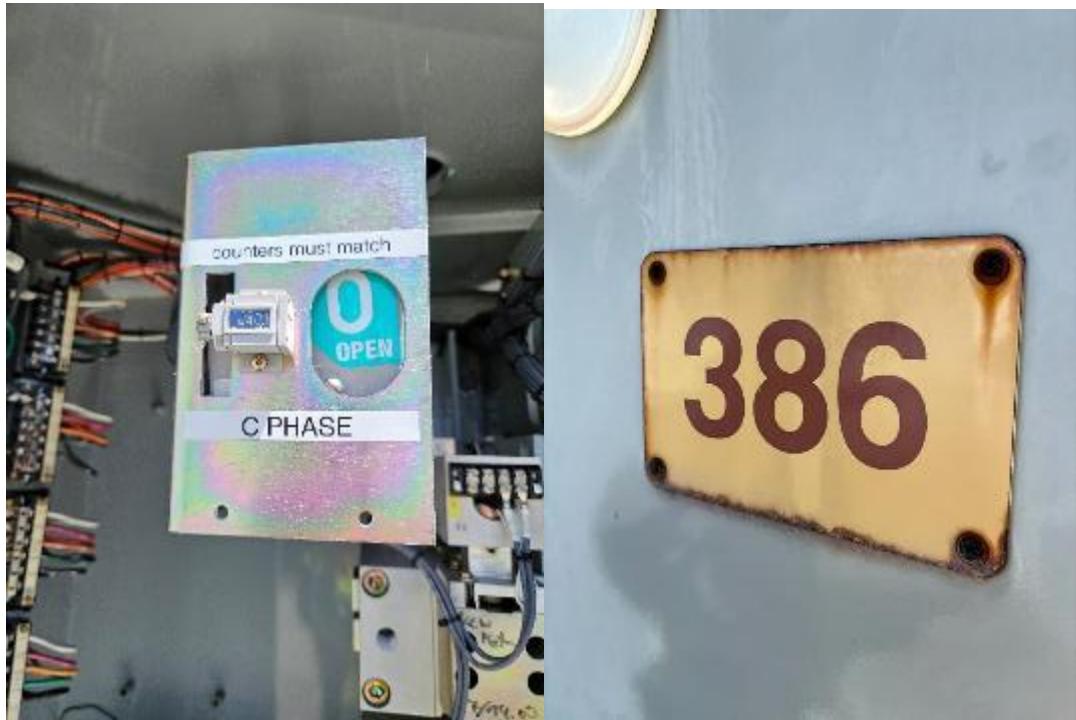
18.12. Faded counter at CB 386. PG&E has an open LC 129477723 to replace the counter.
