PUBLIC UTILITIES COMMISSION

SA2025-1423

SUBJECT: Electric Substation Audit of PG&E Concord Headquarters

CPUC SUBSTATION AUDIT FINDINGS
PG&E Concord Headquarters
November 3 – 7, 2025

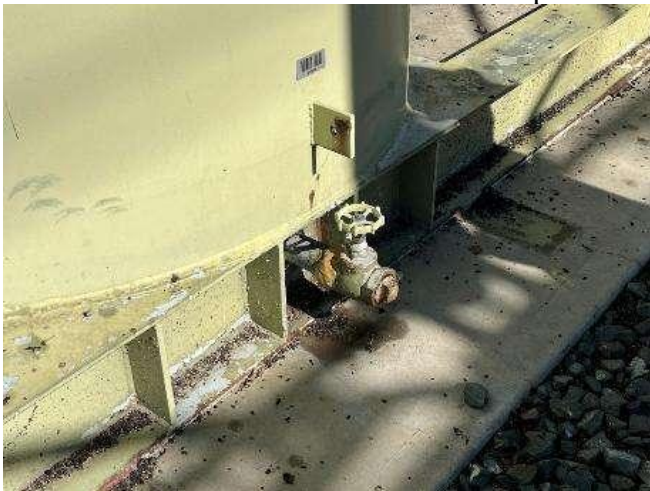
1.1 Circuit Breaker 580 Oil Reservoir B Sample Valve Oil Leak

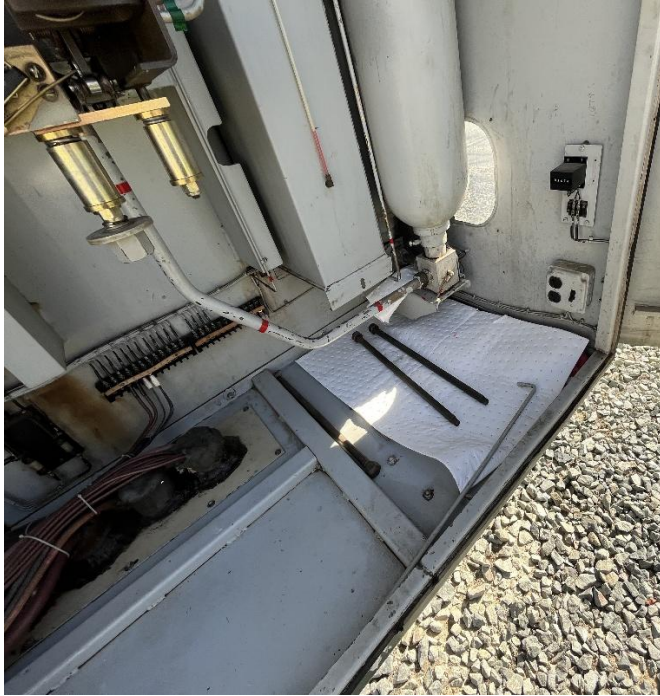
1.2 Circuit Breaker 580 Hydraulic Oil Leak Existing LC Tag#131965868

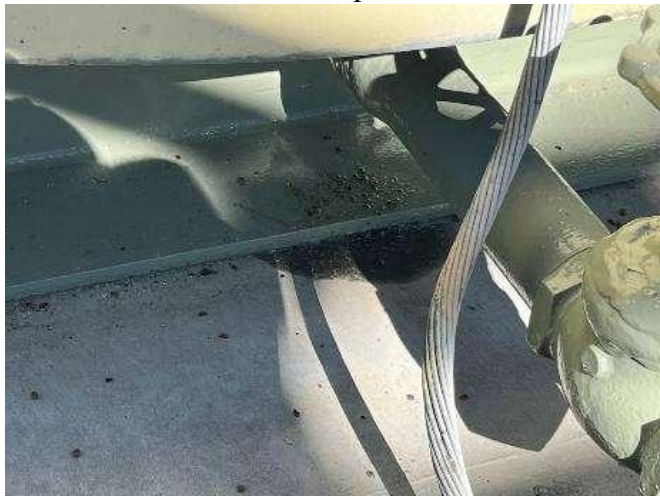
1.3 Circuit Breaker 500 B Sample Valve Oil Leak Existing LC Tag#131965860

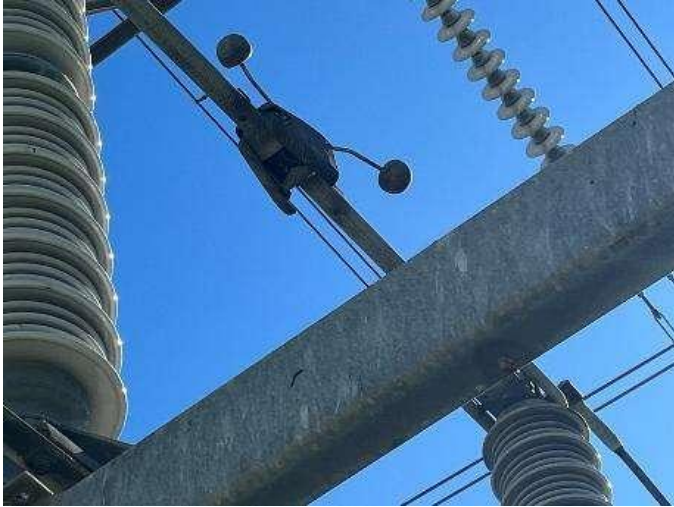
1.4 Bird Nest Near Circuit Breaker 500 Bus Work, Existing Station Bird's Nest LC Tag#131966674

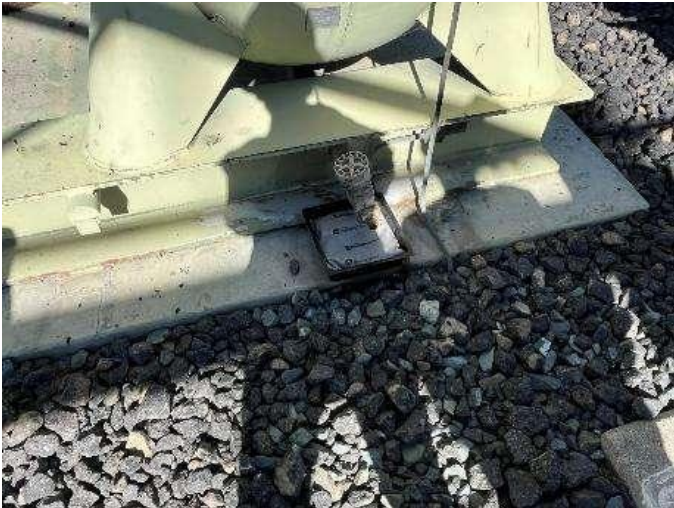
1.5 Circuit Breaker 570 (Out Of Service) Reservoir C Sample Valve Oil Leak Existing LC Tag#131965864

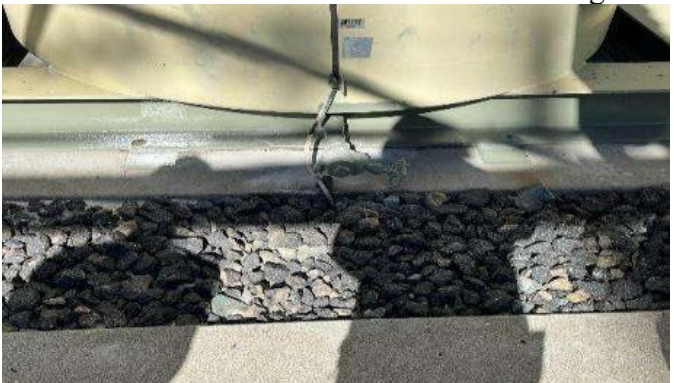
1.6 Circuit Breaker 400 B Phase Oil Leak Existing LC Tag#131966608

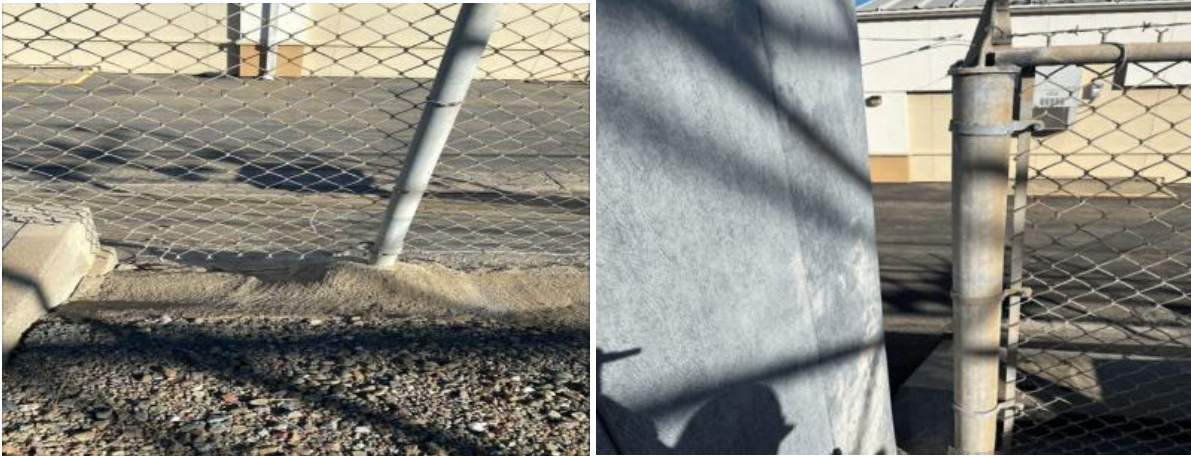
2.6 Perimeter Fence Gap > 6 inch Existing LC Tag#131956745

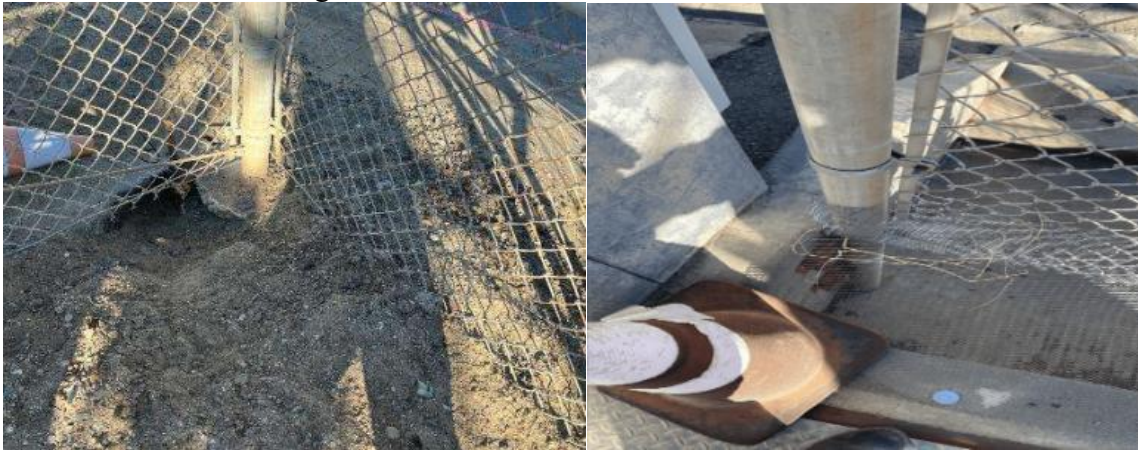
2.7 Perimeter Fence Missing Ground Rod at Two Corner Posts

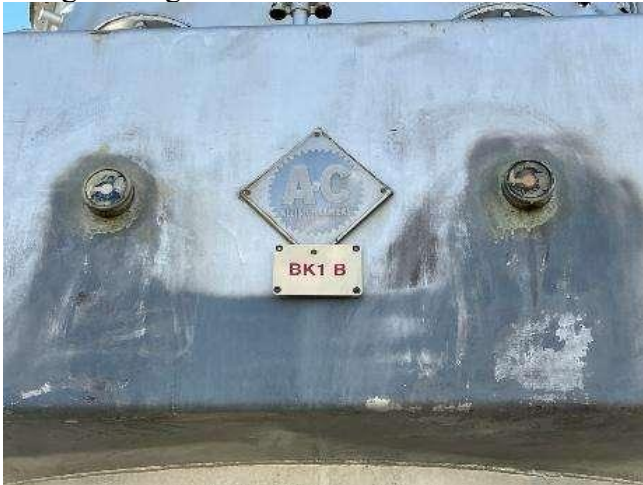
2.8 Transformer Bank 1B Nitrogen Blanket Overpressure Gauge Sight Glass Poor Visibility Existing LC Tag#130852919

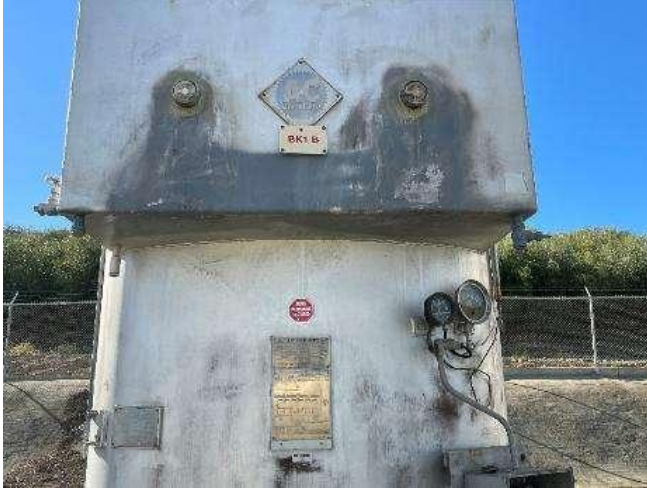
2.9 Nitrogen System Replace Valves (Lower Left in Photo) Phase A LC#131956749, Phase B LC#131956981, Phase C LC#131957855 on Small Lines Going to Upper Part of Transformer

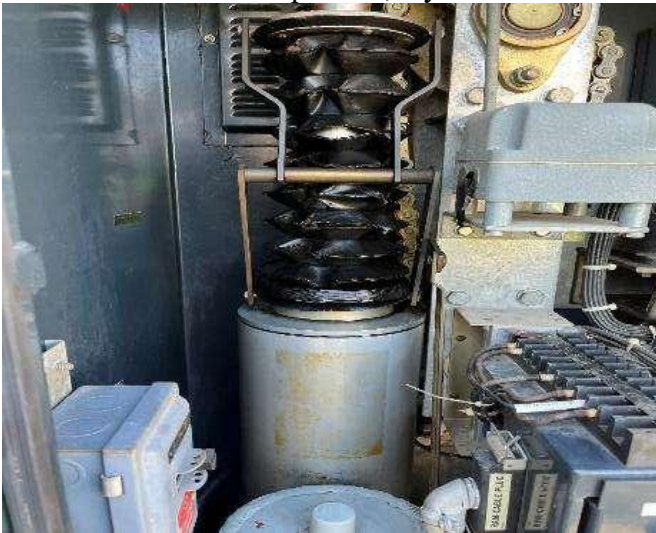
3.1 Switch 27 Motor Operated, Hydraulic Oil Leak/Torn Bellows Existing LC Tag #131965014

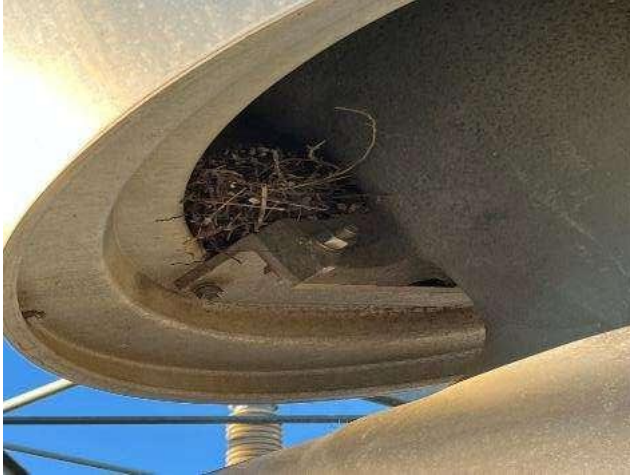
4.3 Circuit Breaker 262 Has Birds Nest Existing LC Tag#131972416

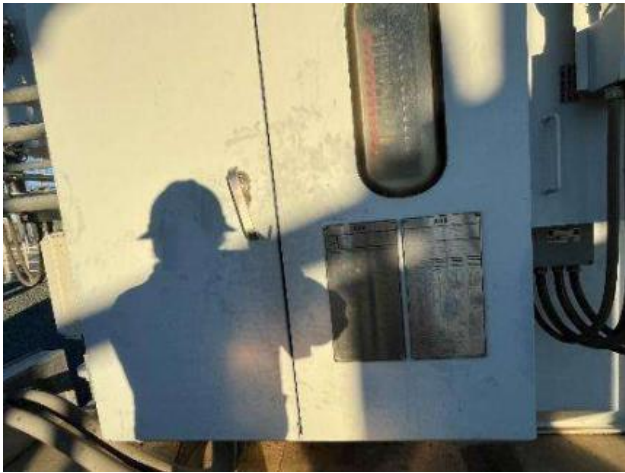
4.4 Observation: Transformer Bank 2 Missing Label For Target Plate Bank Number – Fixed In Field

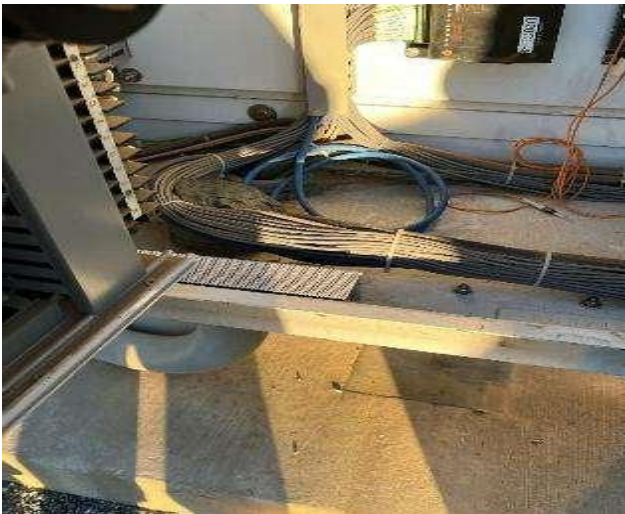
4.5 Transformer Bank 2 Two Conduits in Cabinet Missing Sealant Around Cables – Fixed In Field

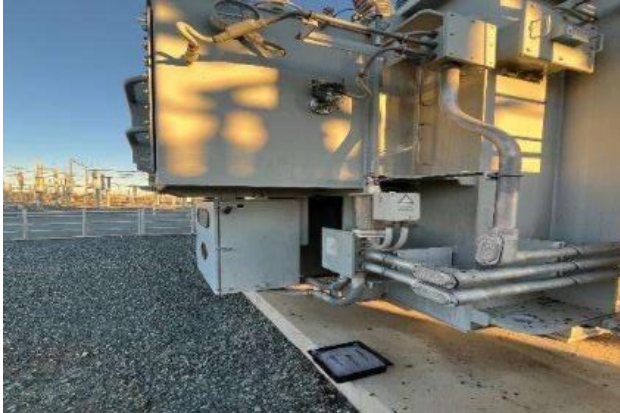
4.6 Transformer Bank 3 Oil Leak Repair Existing LC Tag#131940481 and Load Tap Changer Oil Leak Repair Existing LC Tag#131940434

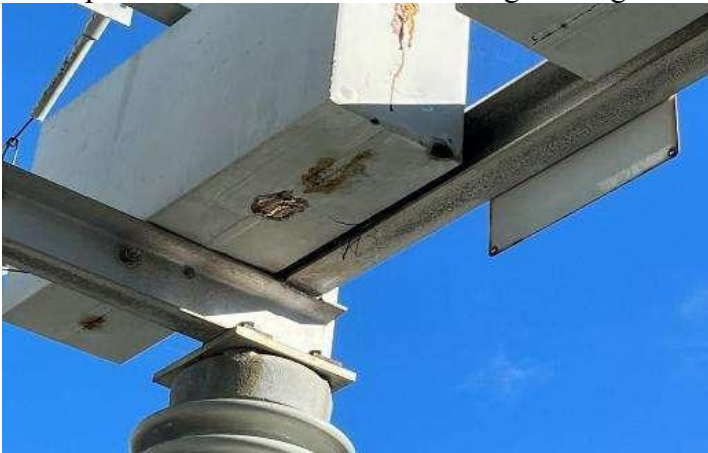
5.4 Capacitor Bank 1 Bird Nest Existing LC Tag#131966145 Station Bird Nest Tag

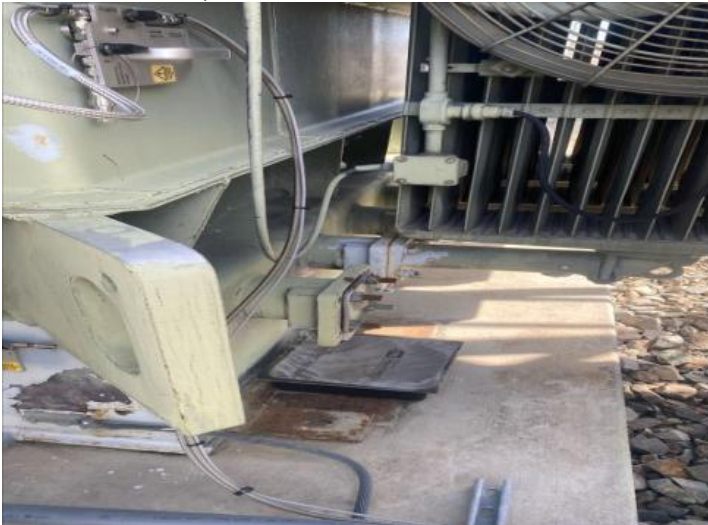
5.5 Transformer Banks 1A, 1B & 1C Oil Leak Mitigation Existing Tags LC#131966024, LC#131966026, & LC#131966029. Photo Below is Bank 1C

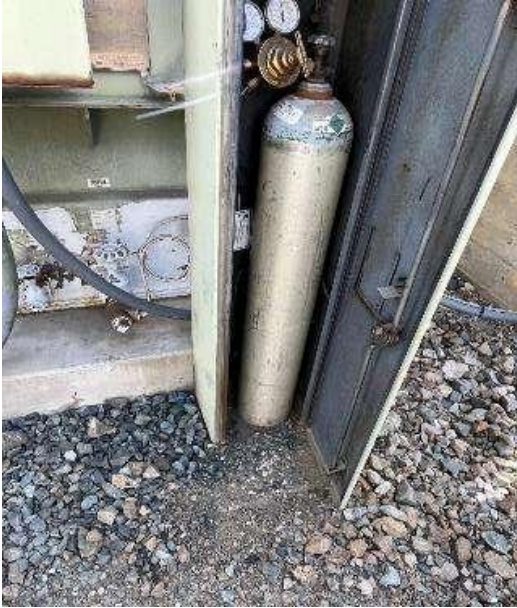
5.6 Transformer Banks 1A, 1B & 1C No Strap for Nitrogen Bottles. Photo Below is Bank 1C

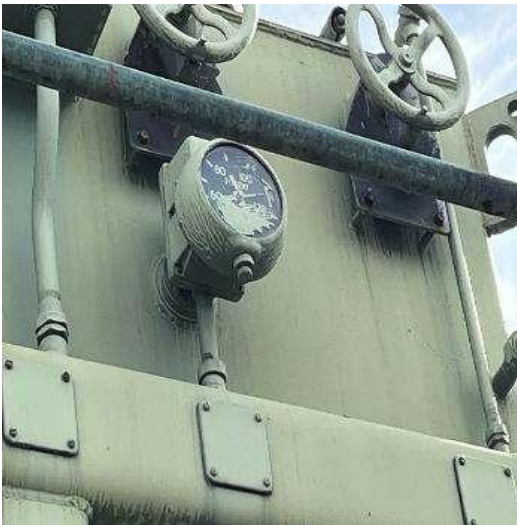
5.7 Transformer Banks 1A, 1B, 1C Thermal Load Gauges Not Working (Gauge Below Horizontal Green Scaffolding). PG&E plans to fix the issue in Capital Project 74066965 - Transformer Bank 1 Reseal All Phases and Replace Bushings

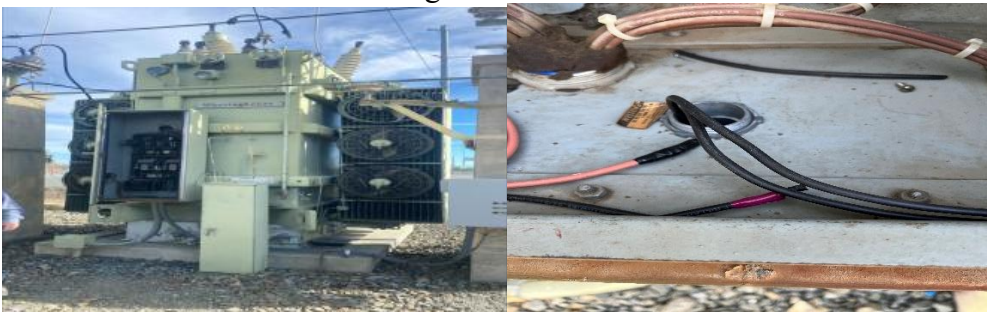
5.8 Transformer Bank 1C Missing Sealant For Conduit In Main Cabinet – Fixed In Field

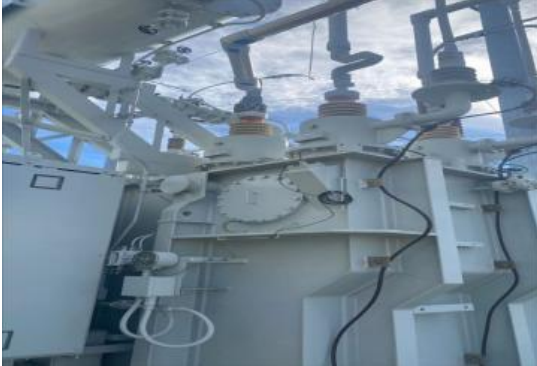
5.9 Transformer Banks 2A, 2B, 2C & Spare - Oil Leak Mitigation Existing LC Tags #131966080, 131973784, 131973810, & 131973813. Photo Below is Bank 2A.

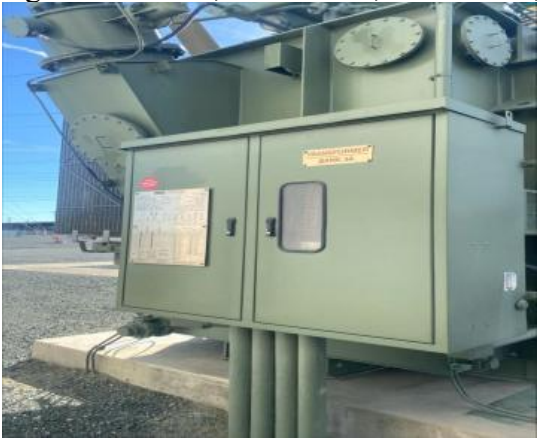
5.10 Transformer Banks 3A, 3B, 3C & Spare - Oil Leak Mitigation Existing LC Tags#131973900, 131973901, 131966148, & 131973903. Photo Below is Bank 3A.

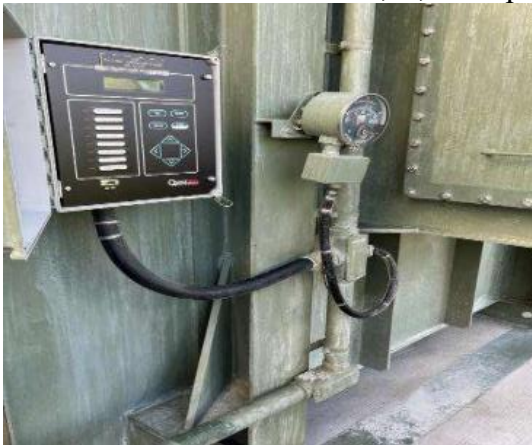
5.11 Transformer Bank 3B Temperature Display Monitor (TDM) Replacement Qualitrol Existing LC Tag# 131645481; TDM not working and being replaced with capital job for All Bank 3TDMs on B, C, and Spare Phase PM 74068922

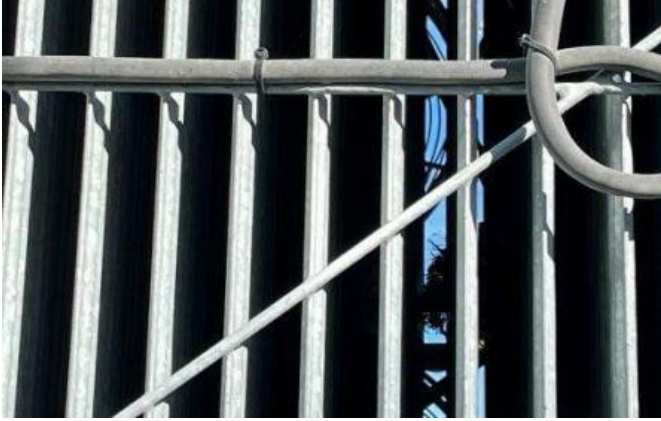
5.15 Transformer Bank 10 Bird Nest in Radiator Existing LC Tag#130927116

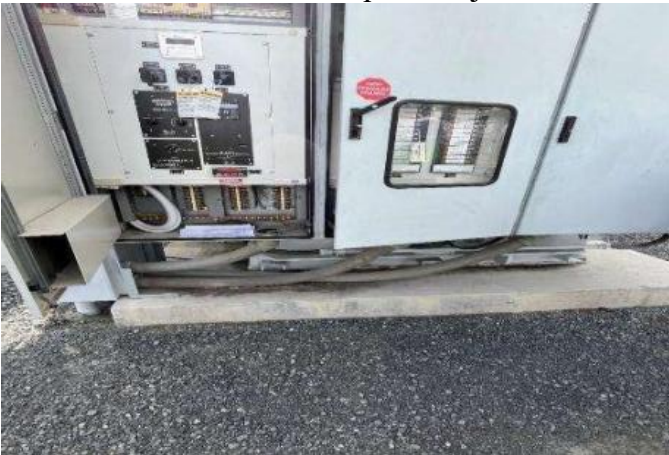
5.16 Voltage Regulator 3 (Currently Out Of Service) Oil Leak Mitigation Existing LC Tag#131966022, Needs Target (Name) Plate Label, Dissolved Gas Analysis Monitor to be Installed as Part of Capital Project

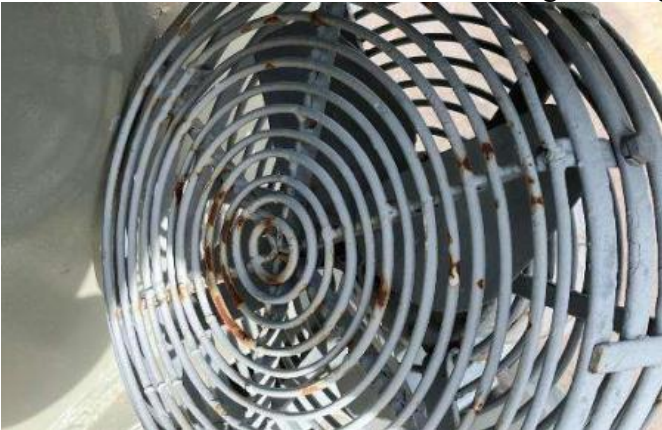
6.2 Transformer Bank 1A Fan Not Working Existing LC Tag#131977606

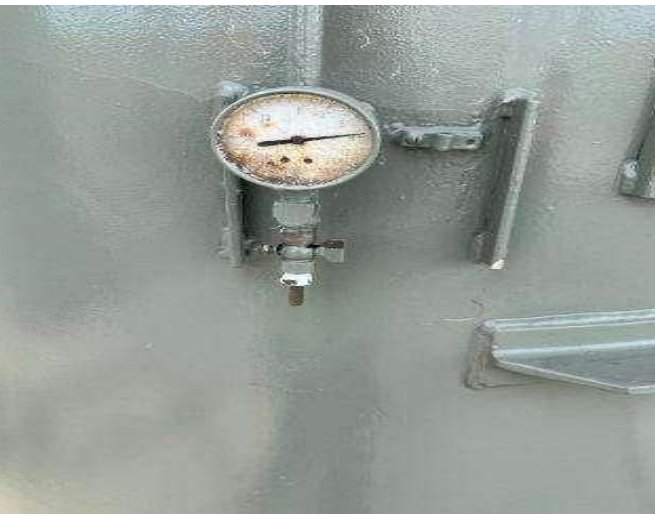
6.3 Transformer Banks 1A, 1B, 1C & Spare Nitrogen Pressure Gauge Faded/Not Accurate Needs to be Replaced Existing LC Tags #131942155, 131942286, 131942414 & 131942416. Photo Below is Bank 1B.

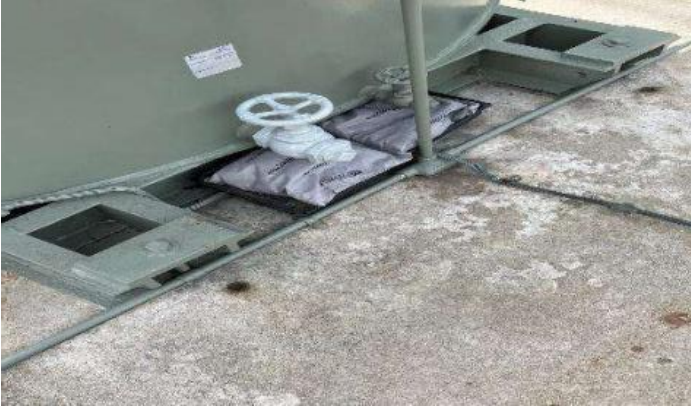
6.4 Transformer Banks 1A & 1B Oil Leak Mitigation Existing LC Tags# 131942159 & 131942289. Photo Below is Bank 1B.

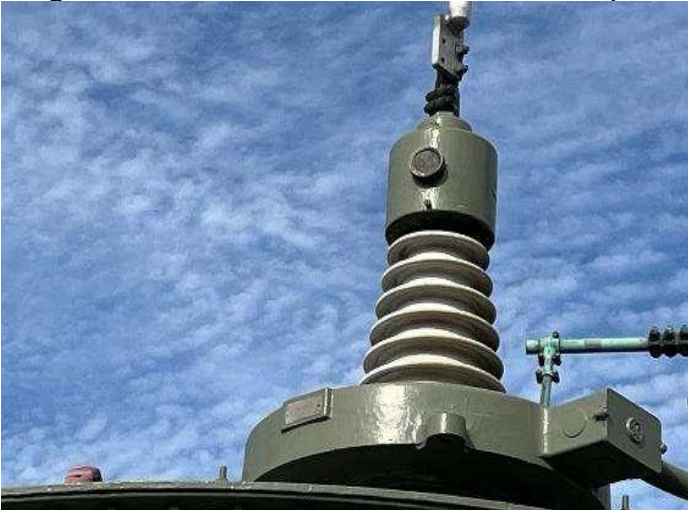
6.5 Transformer Banks 1A, 1B, 1C & Spare - High Side Bushing Oil Gauge Level Not Visible LC Tag# LC131977609. Photo Below is Bank 1 Spare.

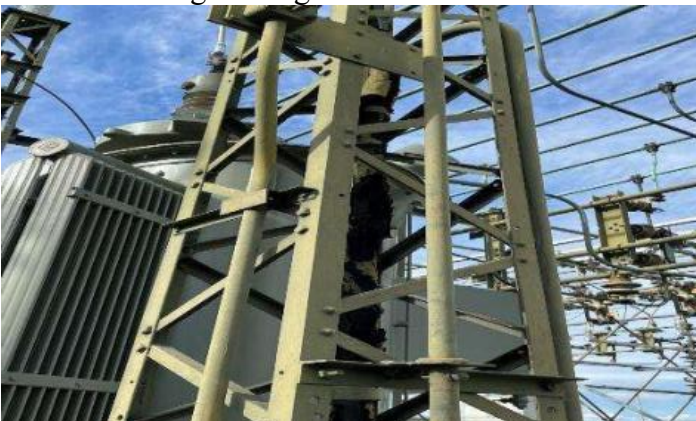
6.6 Transformer Bank 1 Ground Bus Molding Is Broken Weathered and Peeling To Be Removed Existing LC Tag#131966679

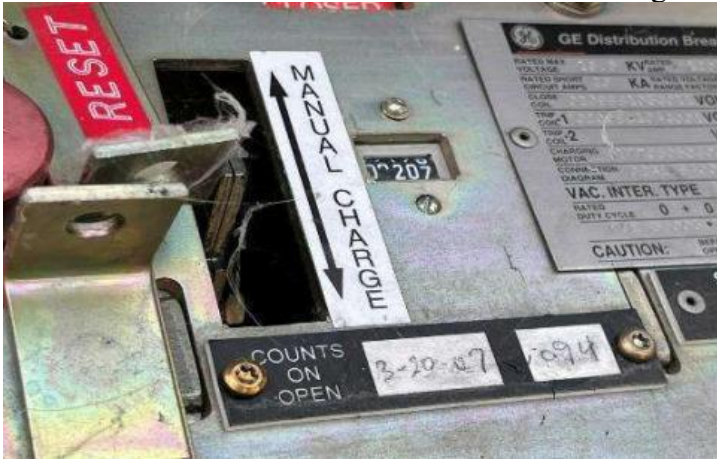
6.7 Circuit Breaker 401/2 Faded Counter New LC Tag#131977676

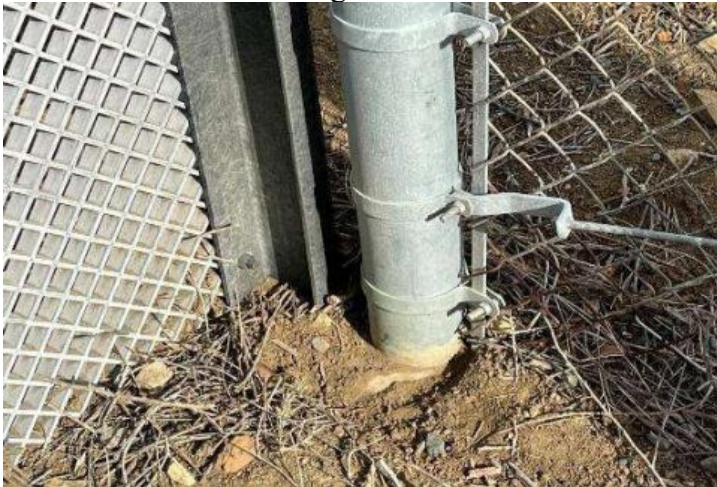
6.8 Perimeter Fence Missing Ground Rod on Corner Post New LC Tag#131977807

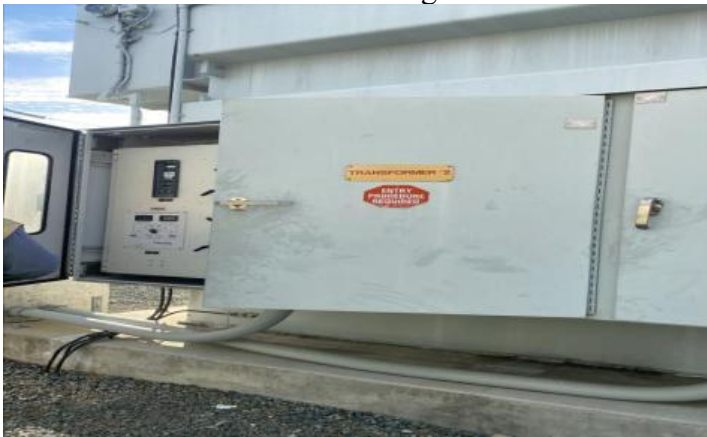
7.2 Transformer Bank 2 Oil Mitigation Clean Oil Residue Existing LC Tag#131964862

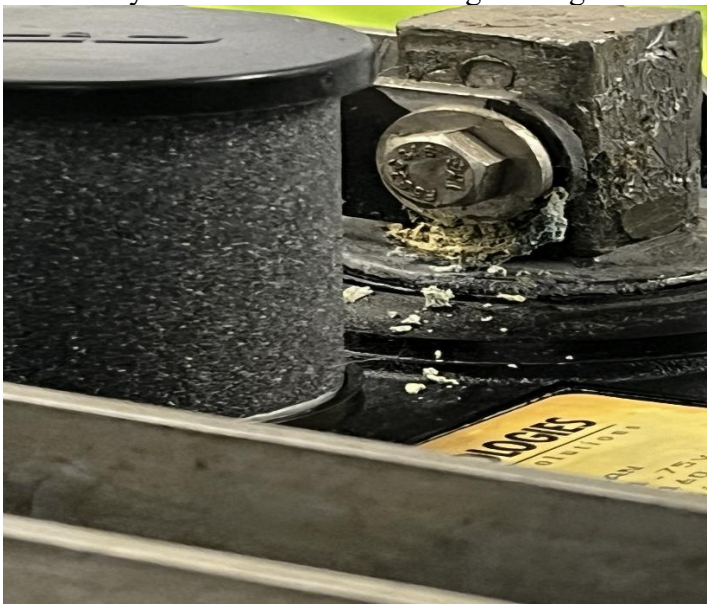
8.1 Battery Corrosion Cell 4 Existing LC Tag#131966506

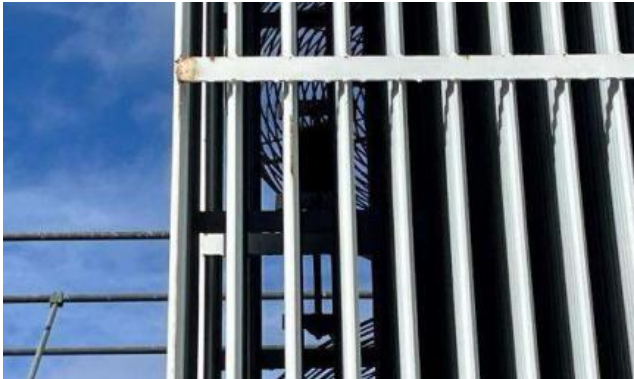
9.3 Transformer Bank 2 Birds Nest Radiator No Existing Tag

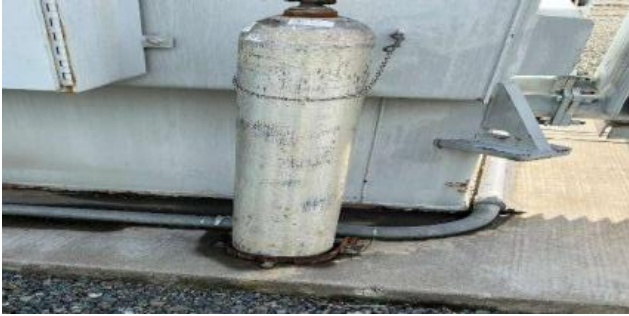
9.4 Transformer Bank 2 Loose Strap for Nitrogen Bottle Add to Existing LC Tag#131966289 on Nitrogen System

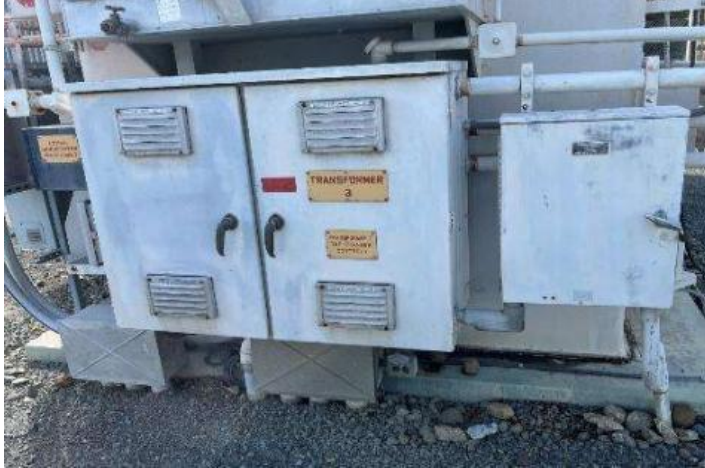
9.7 Transformer Bank 3 Oil Leak Mitigation Existing LC Tag#131980199

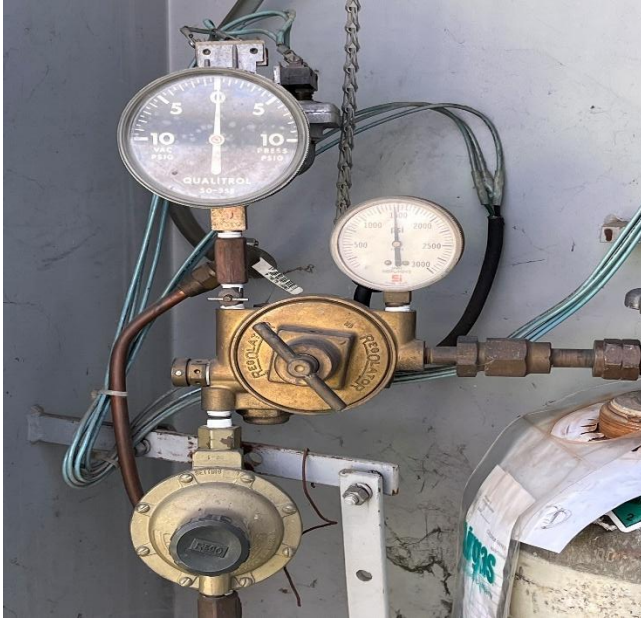
9.9 Transformer Bank 5 Nitrogen Pressure Was 0 psig - PG&E Added Nitrogen - Fixed In Field

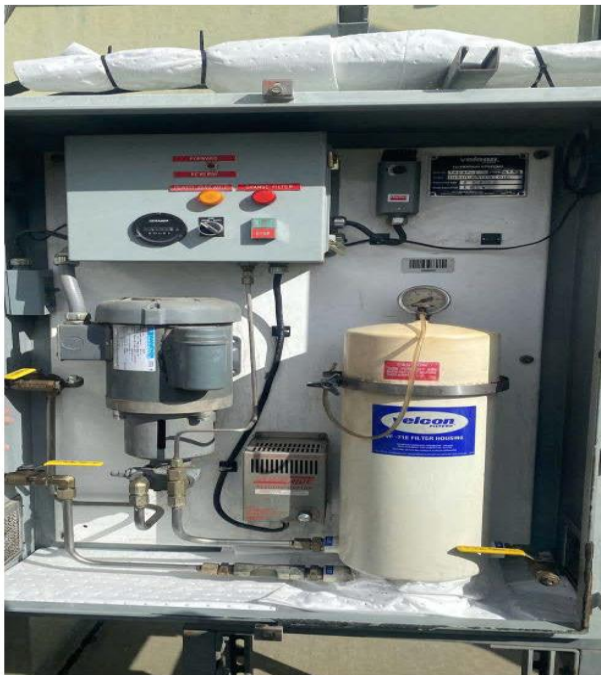
9.10 Transformer Bank 5 LTC Velcon Filtration Unit Oil Leak and Clean Oil Residue Hose Issue Existing LC Tag#131966348

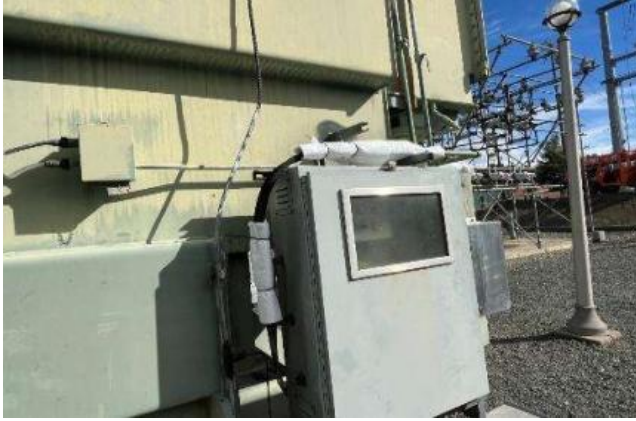
9.11 Transformer Bank 5 Oil Leak Mitigation Existing LC Tag#131966349

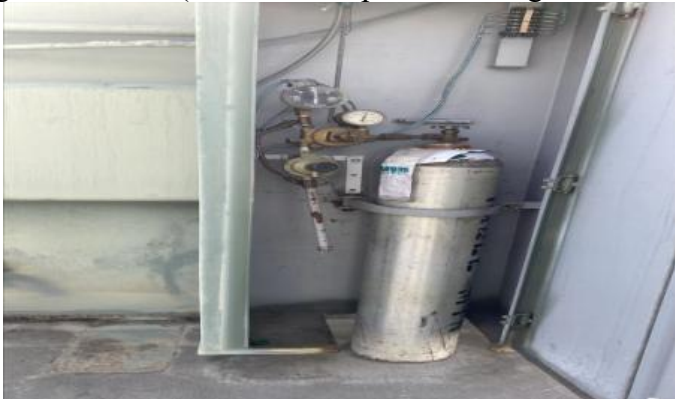
9.12 Transformer Bank 5 Nitrogen System Repair Possible Minor Leak Existing LC Tag#131966342 (Came and Replaced Tubing Where Leak Was & Now Monitoring)

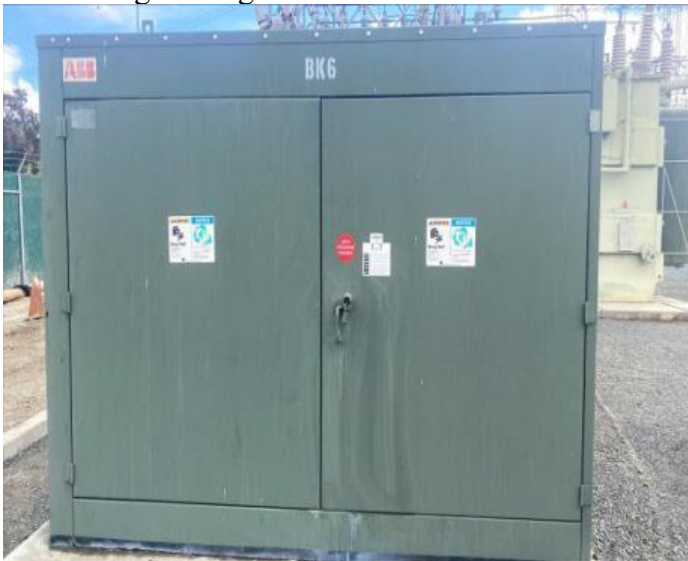
9.13 Transformer Bank 6 Live Front Auto Transformer, Did Not Open, Replace Oil Sample Valve Existing LC Tag#131195947

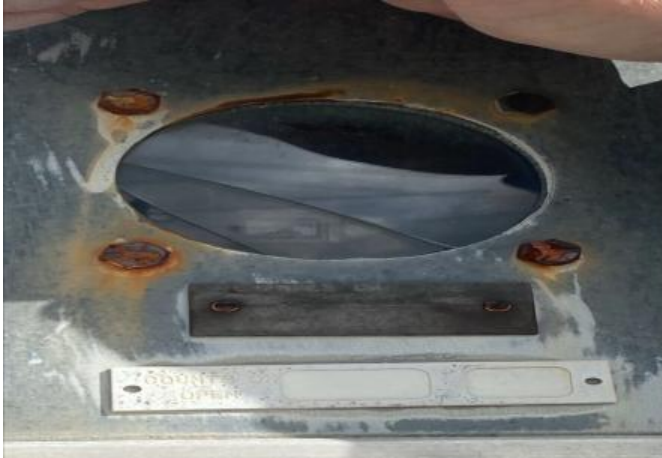
9.14 Circuit Breaker 1103/2 – Cracked Counter Sight Glass Needs Replacement (Possibly Replace CB Looking for Capital Project)

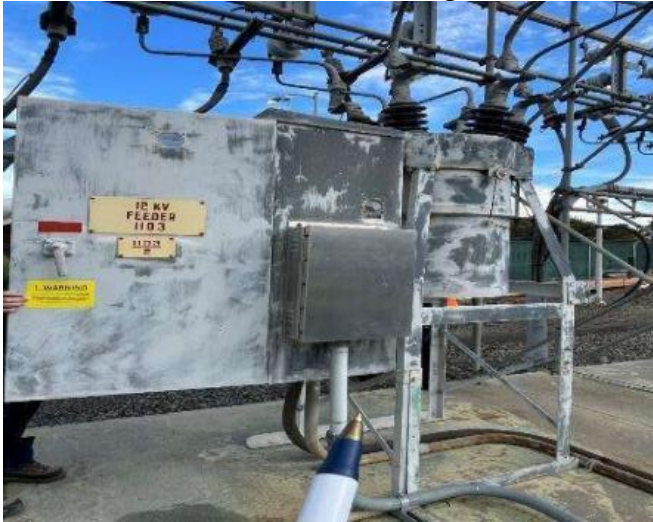
9.15 Circuit Breaker 1103/2- Oil Mitigation and Cleanup Existing LC Tag#131966446

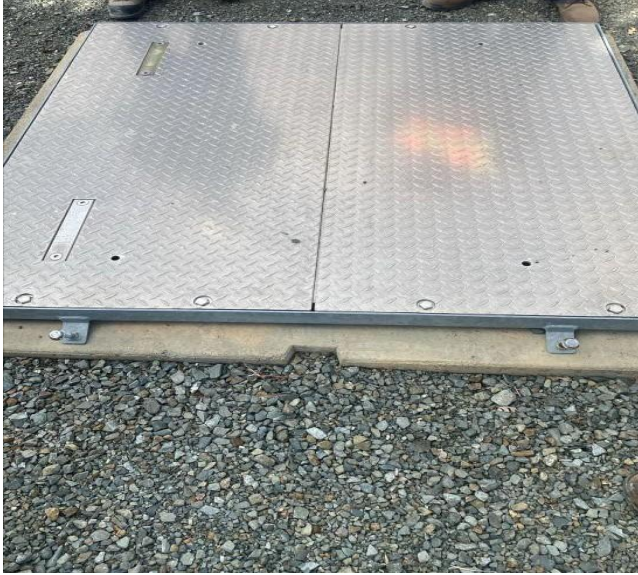
9.16 Under Ground Equipment Box Cover Near CB 1104/2 Was Loose and Not Secured -
Leveled and Secured In Field

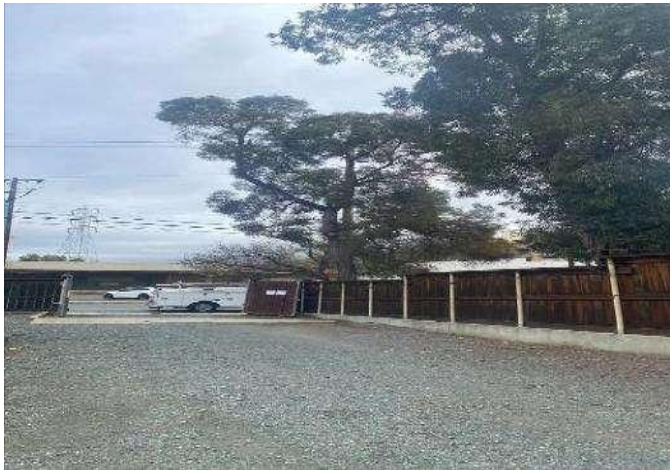
10.3 Vegetation Management – Trees With Large Branches Overhanging Inside Substation
Existing Vegetation LC Tag#131965974 for Trees Close to Fence Line

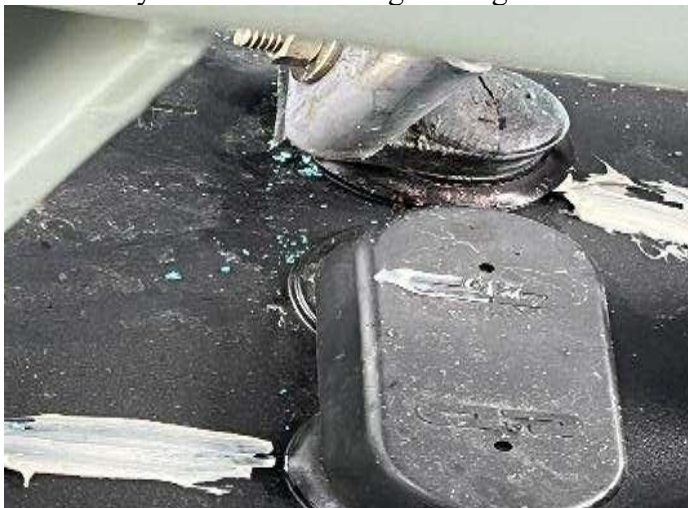
11.1 Battery Corrosion Existing LC Tag#131965138

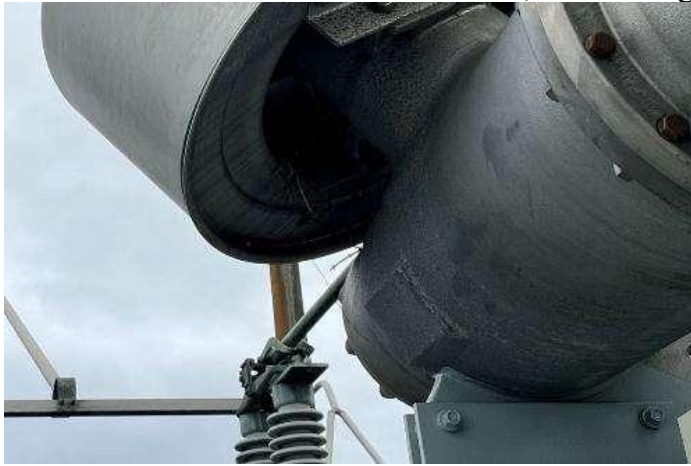
11.2 Circuit Breaker 112 Two Birds Nests, No Existing Tag Created New LC Tag#131982951

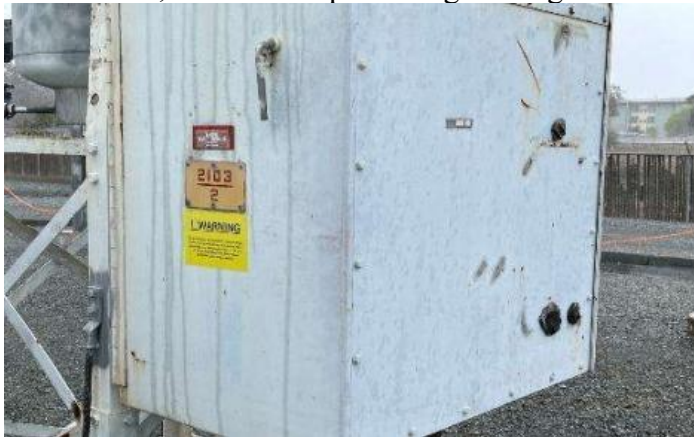
11.3 Circuit Breaker 2103/2 Repair Heater and Clean Up Cabinet Existing LC Tag#131965570, Oil Clean Up Existing LC Tag#131980197

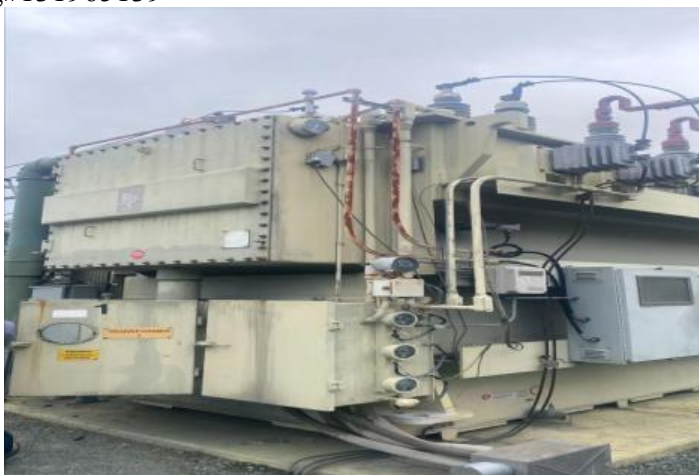
11.4 Transformer Bank 1 Oil Mitigation Leak Repair and Residue Cleanup Existing LC Tag#131965139

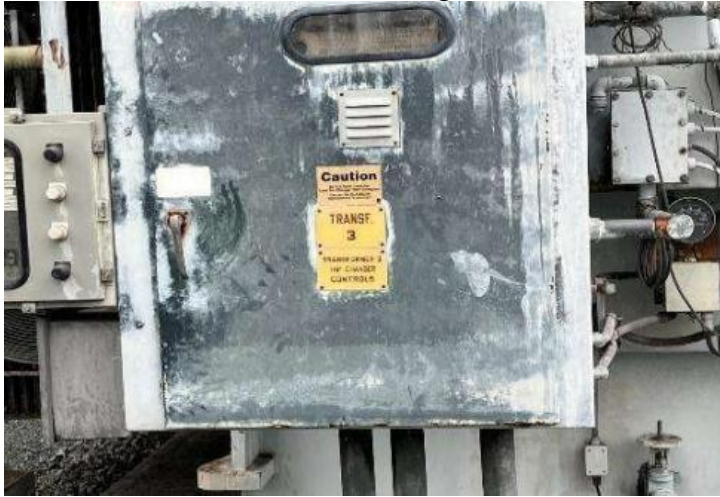
11.6 Transformer Bank 3 Oil Mitigation Residue Clean Up Existing LC Tag#131980352

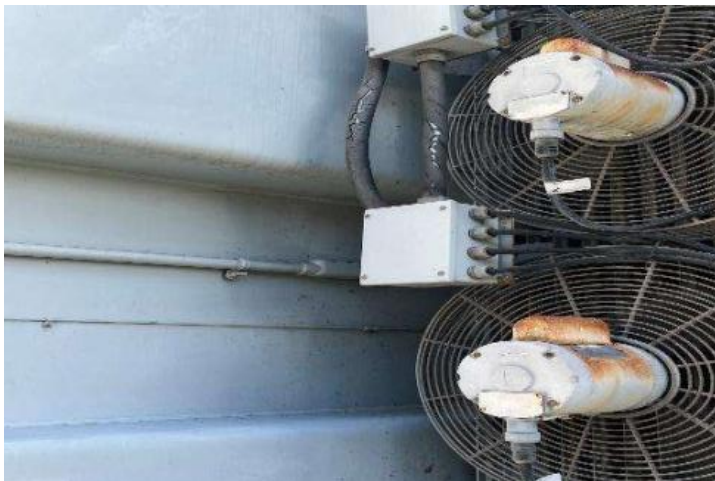
12.1 Transformer Bank 1 Fan Conduit Faded and Cracked Existing LC Tag#131966631

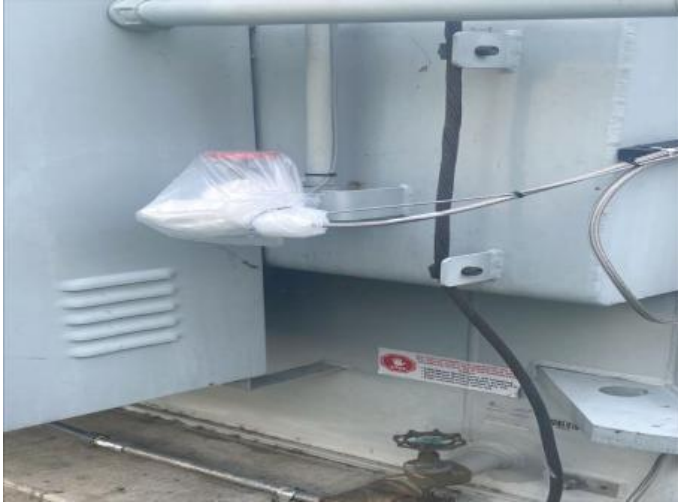
12.2 Transformer Bank 1 Oil Leak at Brass T Sample Valve Existing LC Tag#131900171

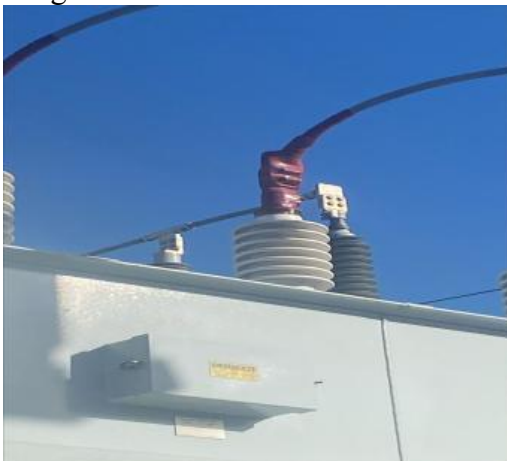
12.4 Transformer Bank 3 Oil Mitigation Clean Residue Near Nitrogen Cabinet Existing LC Tag#131966871, Animal Abatement B Phase Low Side
Rewrap Insulator Gap Existing LC Tag#131966959, Clean Oil Residue from Radiator Existing LC Tag#131967393

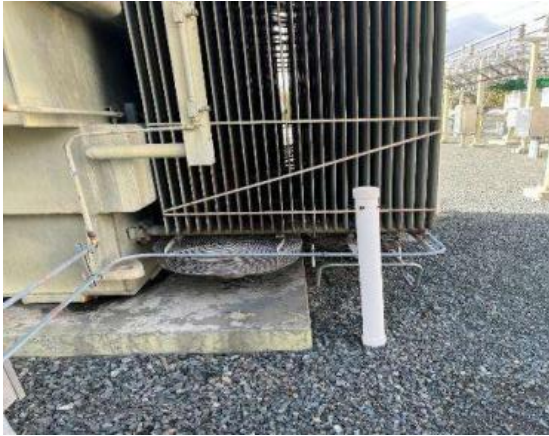
12.5 Transformer Bank 4 Reinhausen Unit Half of Fans Don't Work, Being Replaced Next Year, Capital Replacement Project 74064196

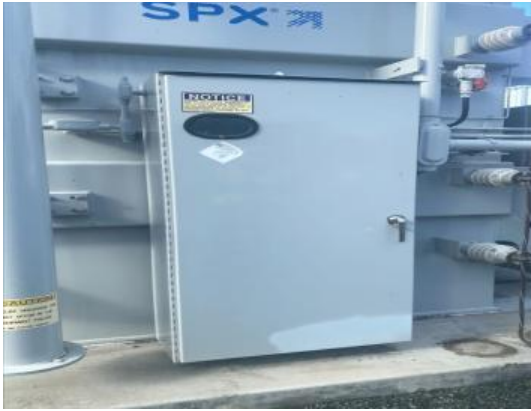
12.6 Transformer Bank 5 Nitrogen Cabinet Needs Sign Removed - Fixed in Field

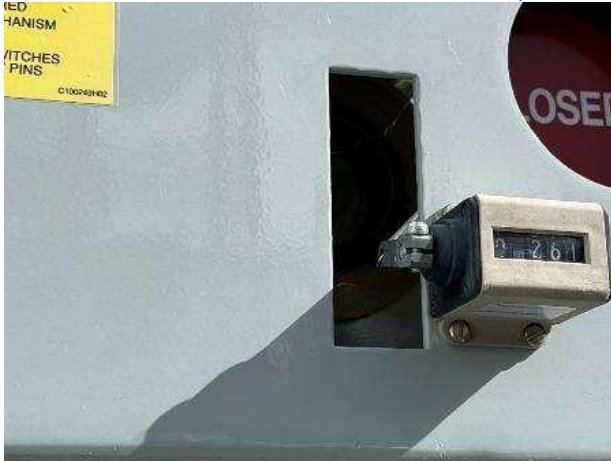
13.2 Circuit Breaker 372 Faded Counter, No Existing Tag, Created New LC Tag#131986539

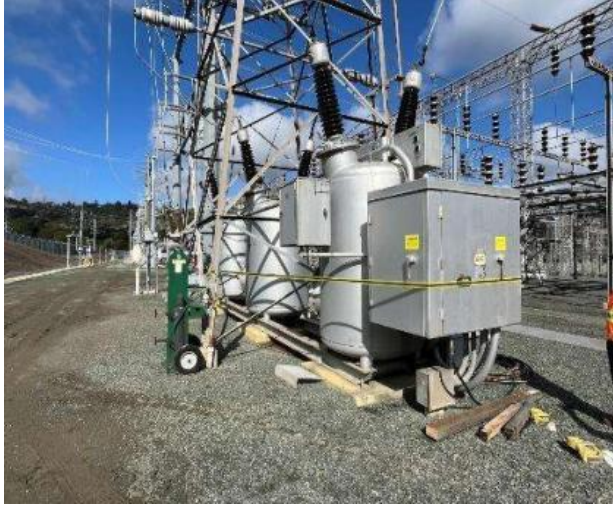
13.3 Oil Circuit Breaker 642 Capital Job PM 74064861 to Replace With SF6 Breaker

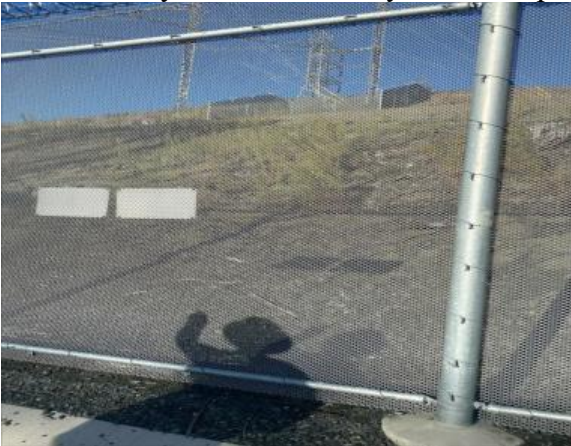
14.2 Wildfire Defensible Space - Observation: Grass is about 2 to 3 Feet Tall Within the 30 Foot Clean Zone. Did Last Defensible Space Trimming in March 2025.

Will put in Preventative Maintenance Tag#131990307 now so that it has the potential to be done earlier 2026 but they have the whole year to complete trimming per Defensible Space standards.

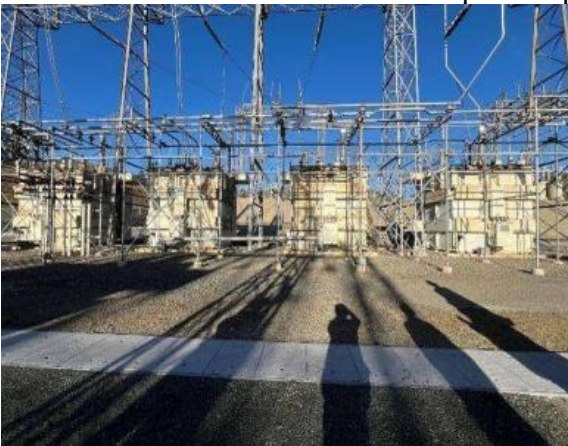
14.3 Transformer Bank 1 Status: Capital Replacement Project for 2027 to Replace The Entire Bank

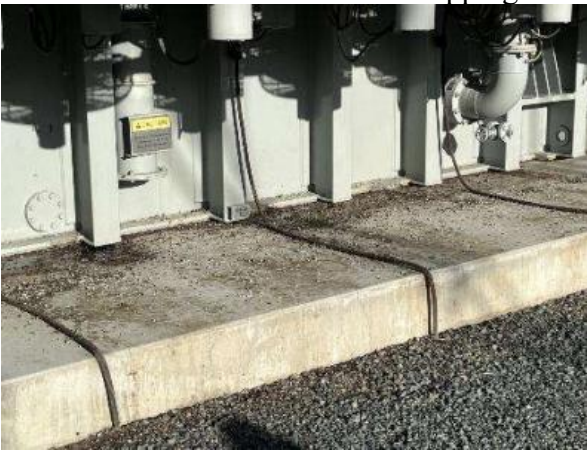
14.8 Transformer Bank 2 Bird Droppings Existing LC Tag#131966309

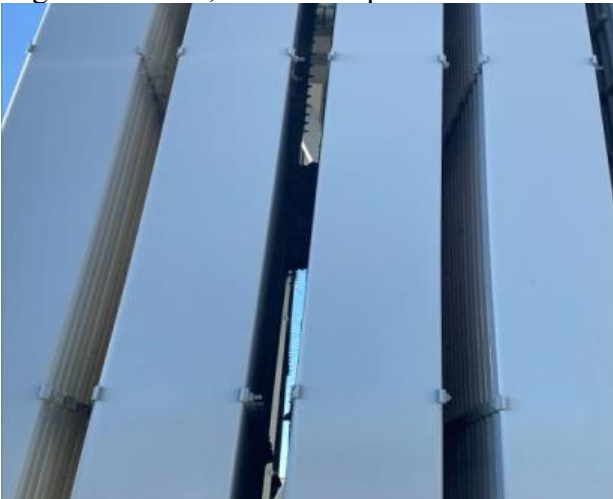
14.9 Voltage Regulator 1 Oil Leak Mitigation Existing LC Tag#131966575, Birds Nest LC Tag#131966574, Will Be Replaced with Transformer Bank 1 Capital Job

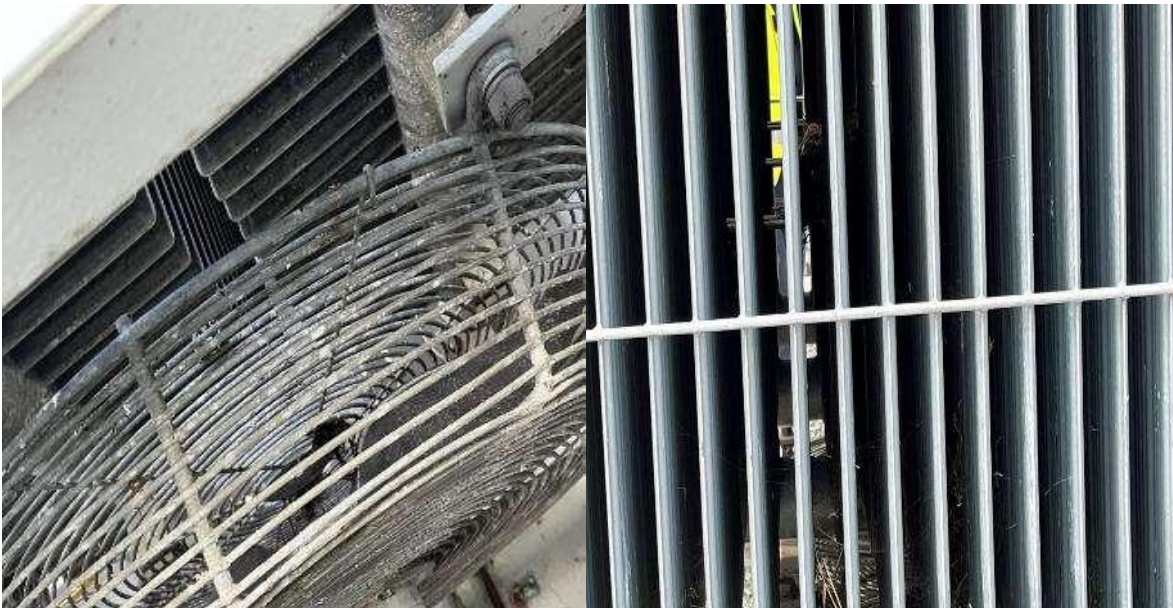
15.8 Transformer Bank 2 Oil Mitigation Existing LC Tag#131990135, Fan Not Working Existing LC Tag#131961741, Birds Nest Existing LC Tag#131963096
