PUBLIC UTILITIES COMMISSION

SA2025-1423

SUBJECT: Electric Substation Audit of PG&E Concord Headquarters

CPUC SUBSTATION AUDIT FINDINGS
PG&E Concord Headquarters
November 3 – 7, 2025

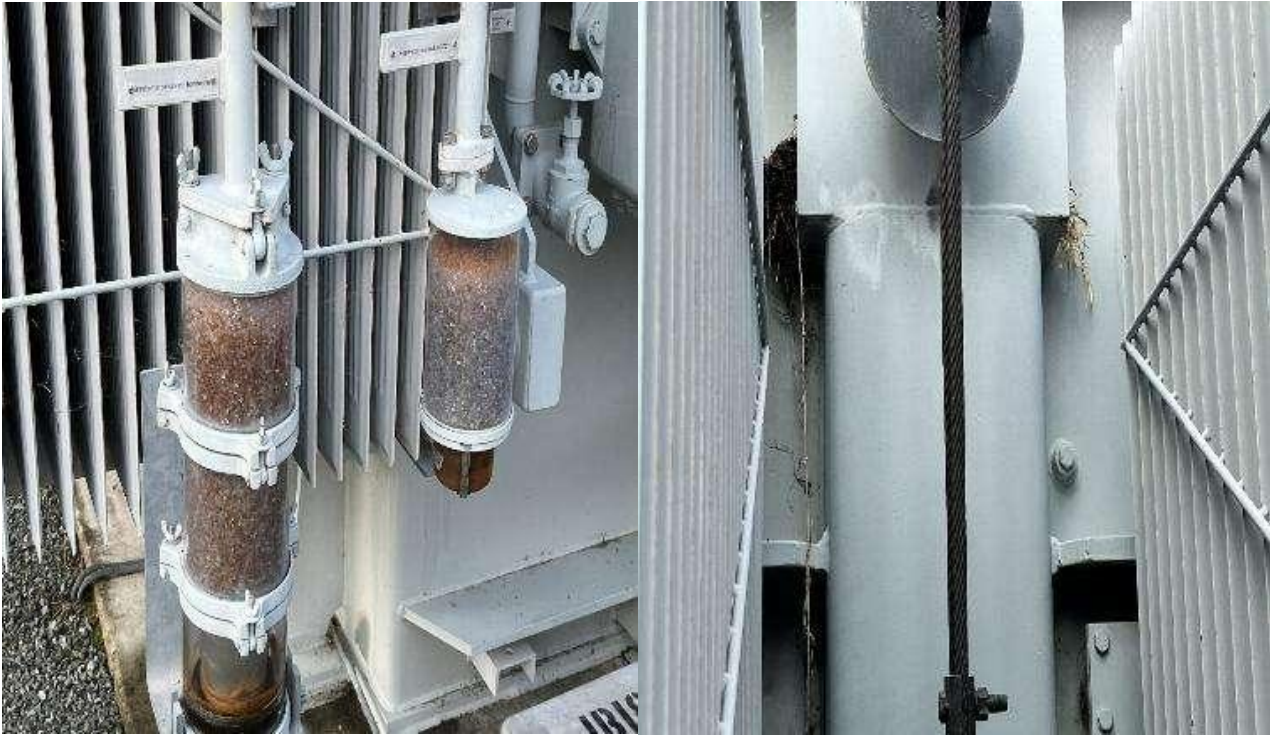
15.9 Voltage Regulator 1 Desiccant Replacement Existing LC Tag#131963348, Oil Mitigation Issues Conservator Tank LC Tag#131963436, Birds Nest LC Tag#131963939

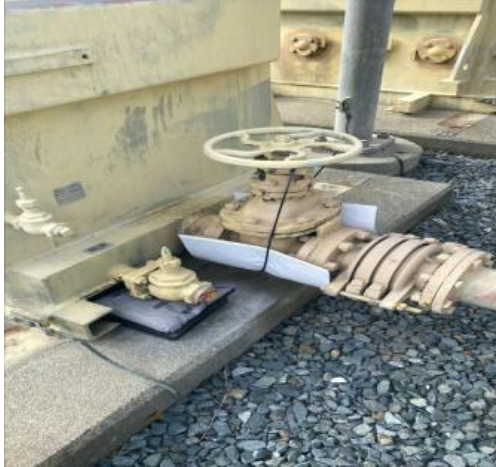
16.2 Transformer Bank 1 Oil Mitigation: A Phase Existing LC Tag#131329613, B Phase LC 131990614, C Phase LC 131990615, Spare LC 131949888. Photo Below is C-A Phase.

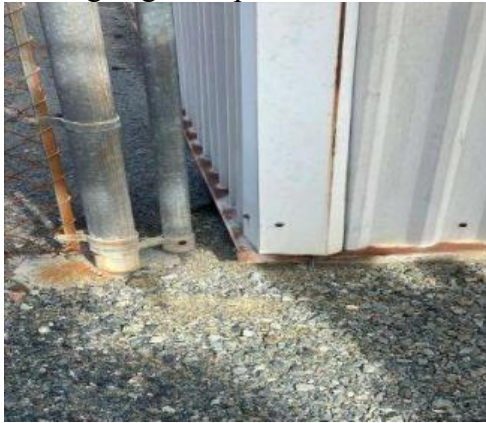
16.3 Perimeter Fence Needs Ground Rod on Corner Post Next to Control Room. Will Add to Existing Tag to Repair Fence Grounds in LC Tag#131990525

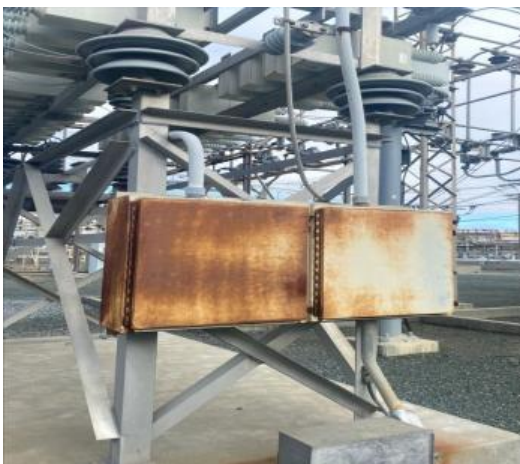
17.1 Capacitor Banks – Rust Banks 1 and 2 Existing LC Tag#131953978 and Banks 3 and 4 Existing LC Tag#131955704

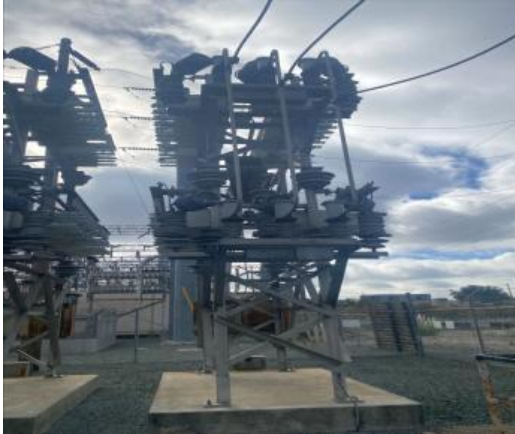
17.2 Capacitor Banks - Oil Leak Banks 3 and 4 Existing LC Tag#131955490; Status – PG&E Assessing Removal of All Capacitor Banks

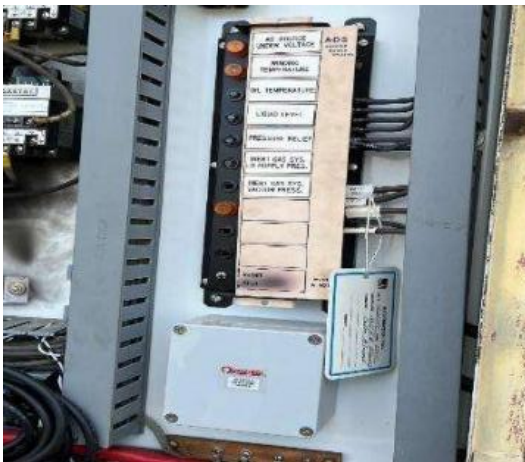
17.3 Transformer Bank 5 - Main Control Cabinet Missing Light Covers and Indicators, Annunciator Tag for All Phases Existing LC Tag#131956205. Photo Below is Bank 5 B Phase Control Cabinet.
