Re: Response to Audit Report for T-Mobile's Orange County Facilities

On behalf of T-Mobile West LLC dba T-Mobile ("T-Mobile"), attached please find T-Mobile's response to the Electric Safety and Reliability Branch's (ESRB) Audit Report for Orange County dated February 12, 2026.

Response of T-Mobile West LLC dba T-Mobile to the Electric Safety and Reliability Branch's Audit Report dated February 12, 2026

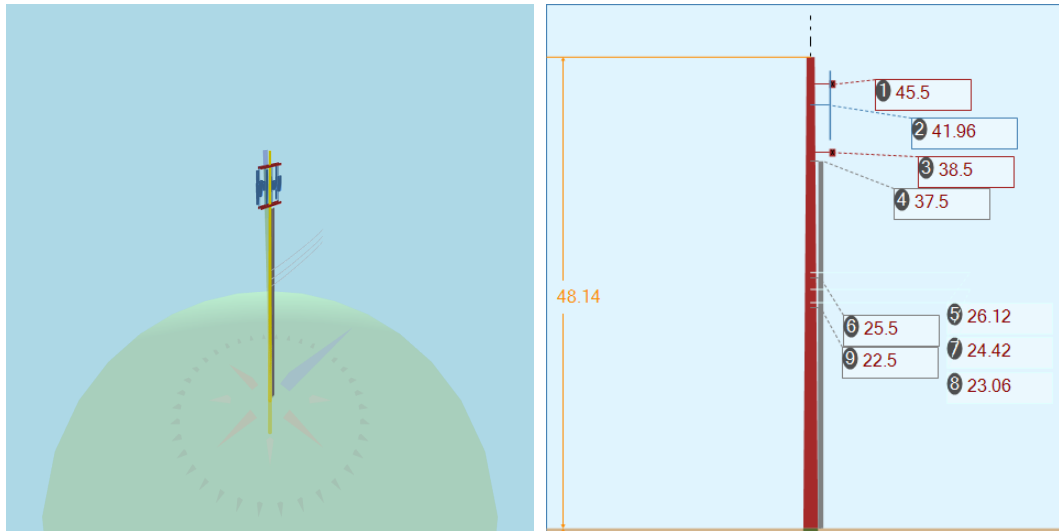
The pole loading calculations provided by T-Mobile communications for pole LA33268B did not include third-party communication conductors at approximately 22 feet high, which were present at the time of the field inspection. Additionally, the pole loading calculations did not include two 2-inch diameter risers, which were present at the time of the field inspection

T-Mobile's policy and procedure is to design, construct, maintain and inspect its facilities on joint utility poles in a manner consistent with the General Order. To that end and consistent with Rule 44.1 of GO 95, T-Mobile's general practice is to conduct – and maintain – pole loading calculations (“PLC”) “upon installation or reconstruction”. Although it is not clear what facilities were present at the site at the time the existing Pole Loading Calculation was performed, T-Mobile has already completed the new PLC to account for all the elements currently on the pole. See Attachment A.

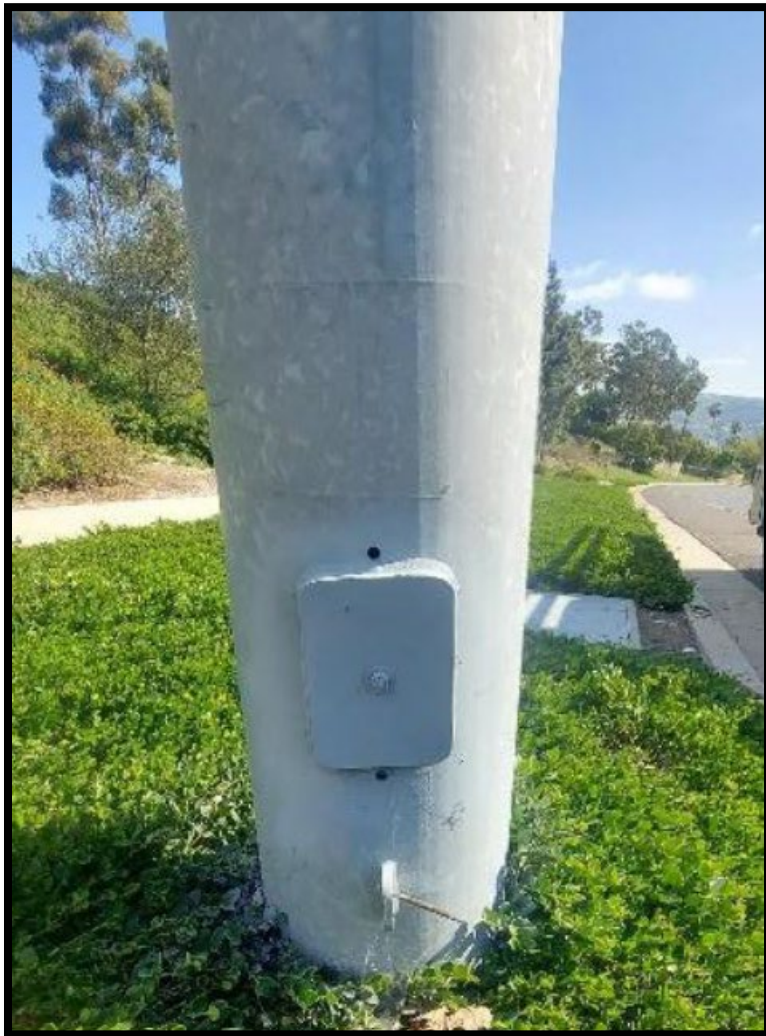
Site ID: LA33441E

Staff Findings: The cover of access hatch at pole was missing.

Consistent with sound business practices and the General Order, T-Mobile further responds that new access hatch covers have been installed at the three poles identified above. See Attachment B (photos of each access hatch covers for the sites identified above).

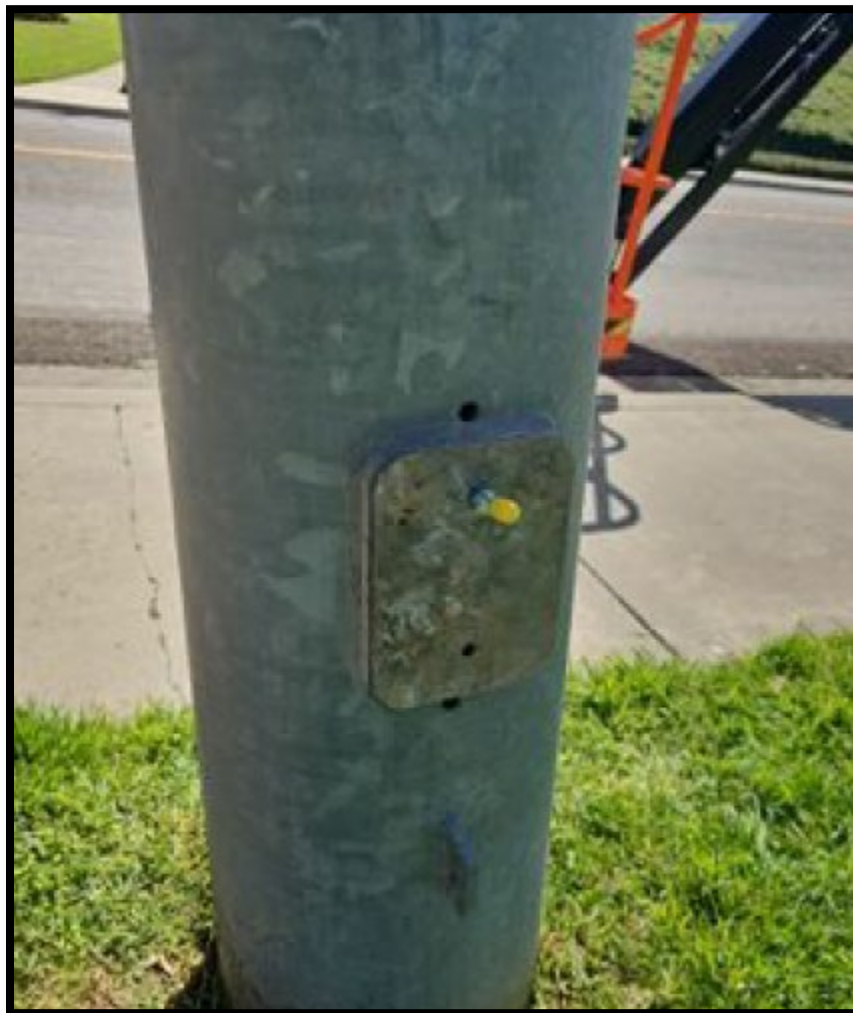
Site ID: LA33867B

Staff Findings: The cover of access hatch at pole was missing.

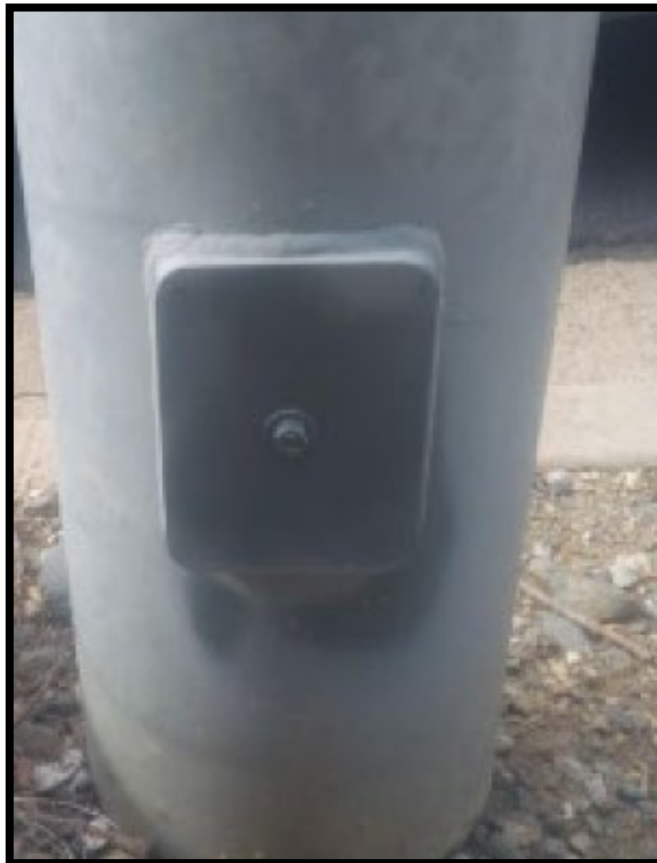
Site ID: LA23192C

Staff Findings: The cover of access hatch at pole was missing.

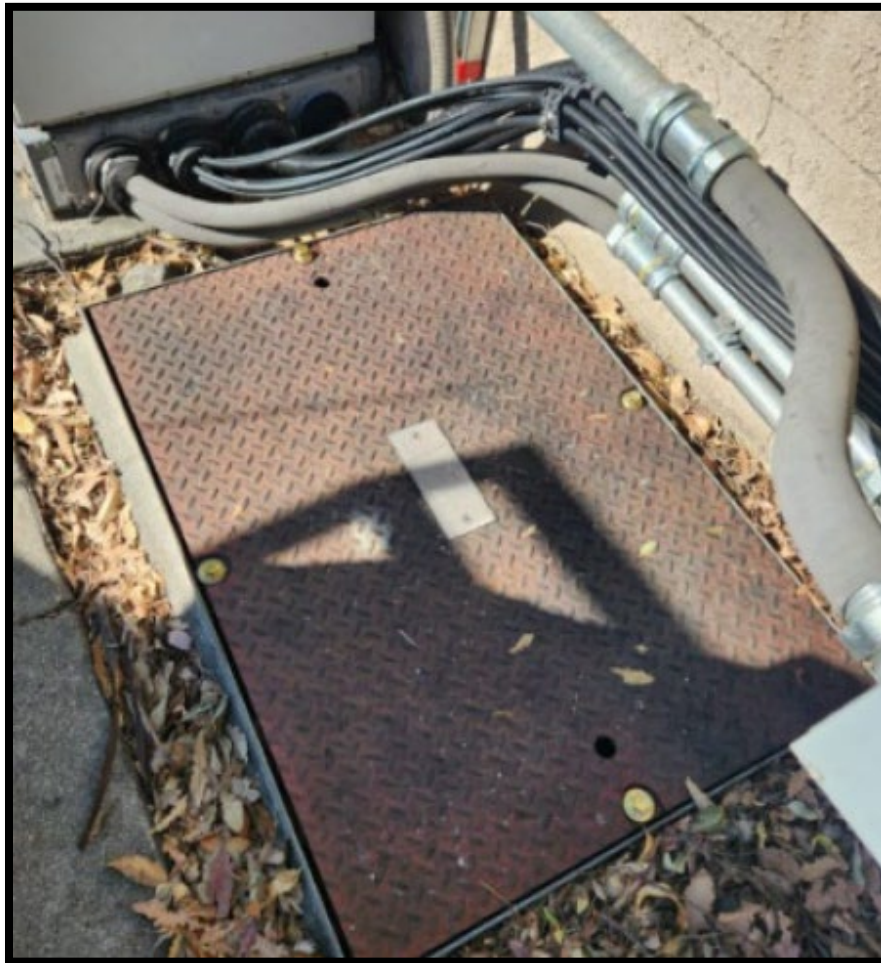
Site ID: LA03015F

Staff Findings: The cover of the handhole at the location was not securely closed, allowing unauthorized access to the structures.

T-Mobile further notes that the handhole covers identified have now all been secured. See Attachment C (photos of the secured handhole cover for each site identified above).

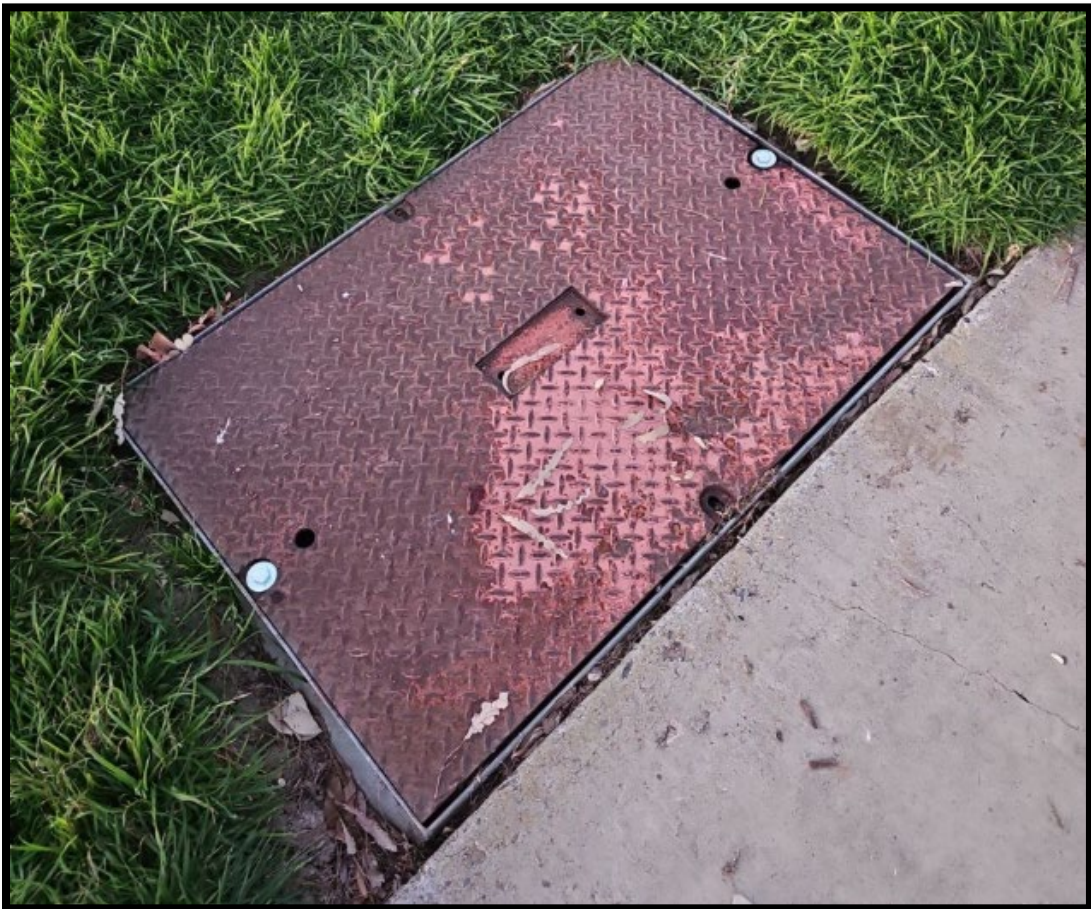
Site ID: LA33867B

Staff Findings: The cover of the handhole at the location was not securely closed, allowing unauthorized access to the structures.

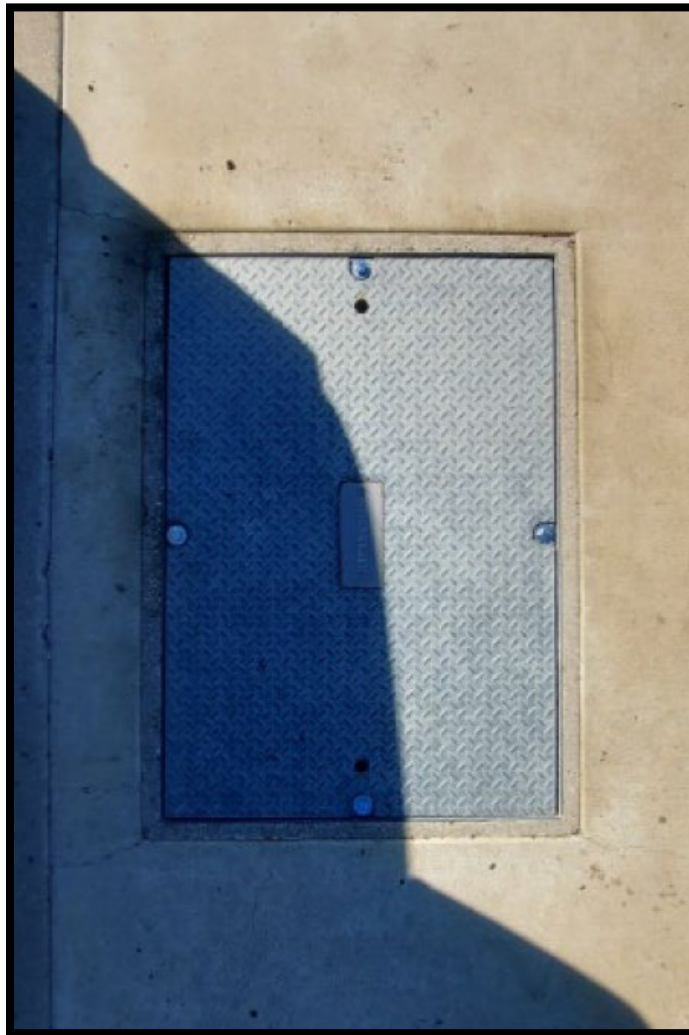
Site ID: LA33451B

Staff Findings: The cover of the handhole at the location was not securely closed, allowing unauthorized access to the structures.

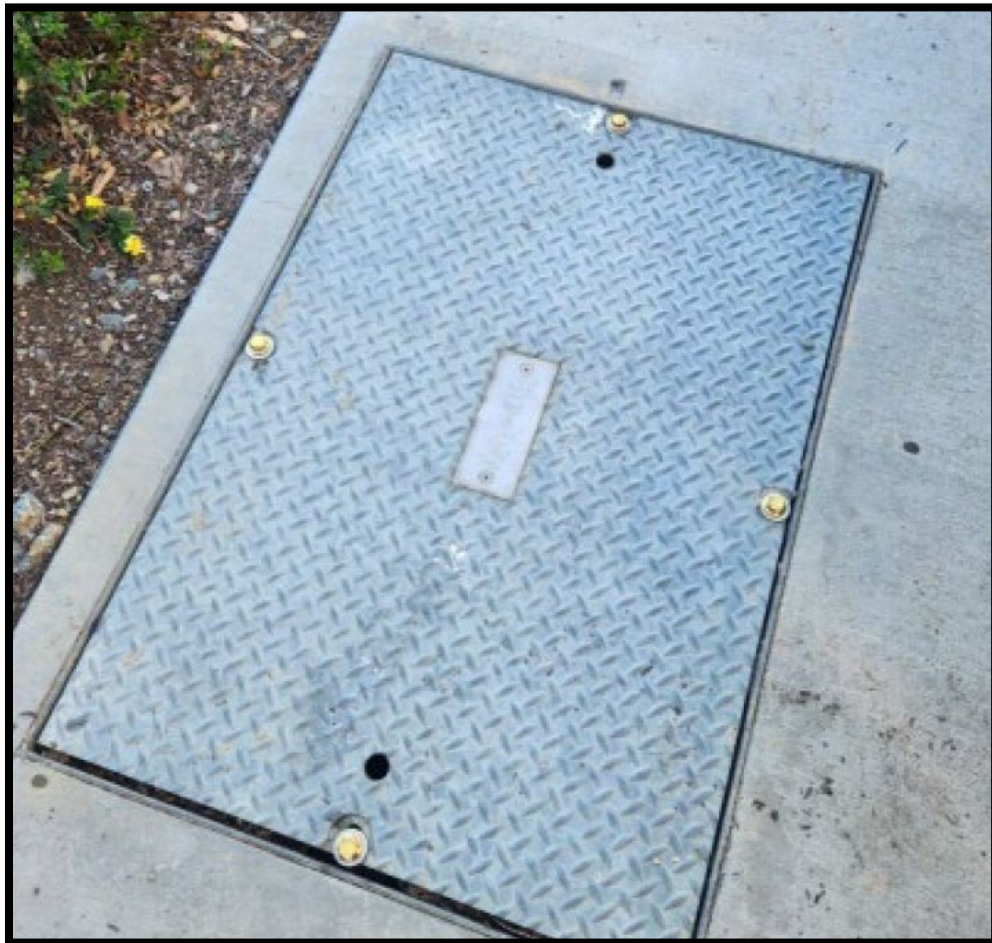
Site ID: LA33445A

Staff Findings: The cover of the handhole located at location was not securely closed, allowing unauthorized access to the structures.

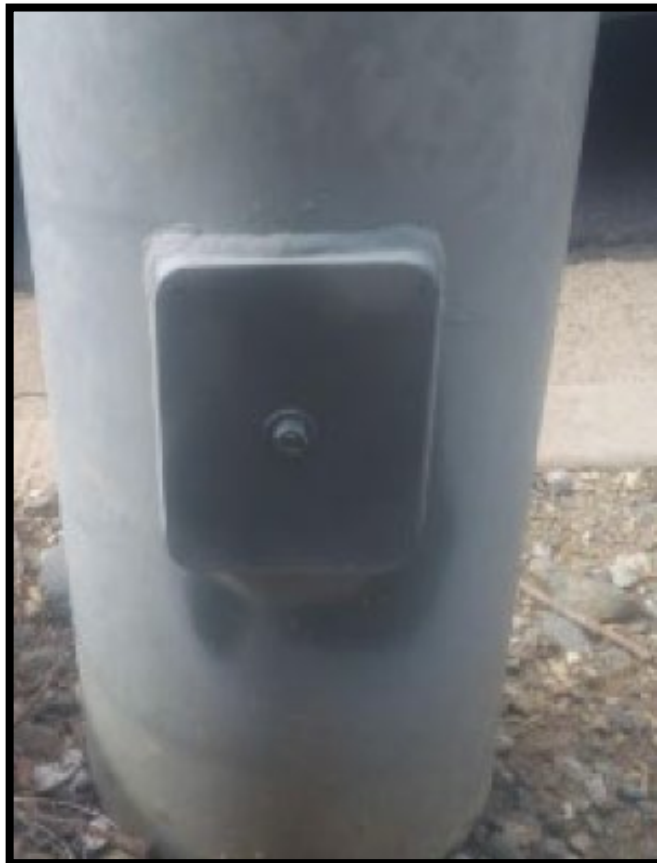
Site ID: LA23192C

Staff Findings: The cover of access hatch at pole was missing.

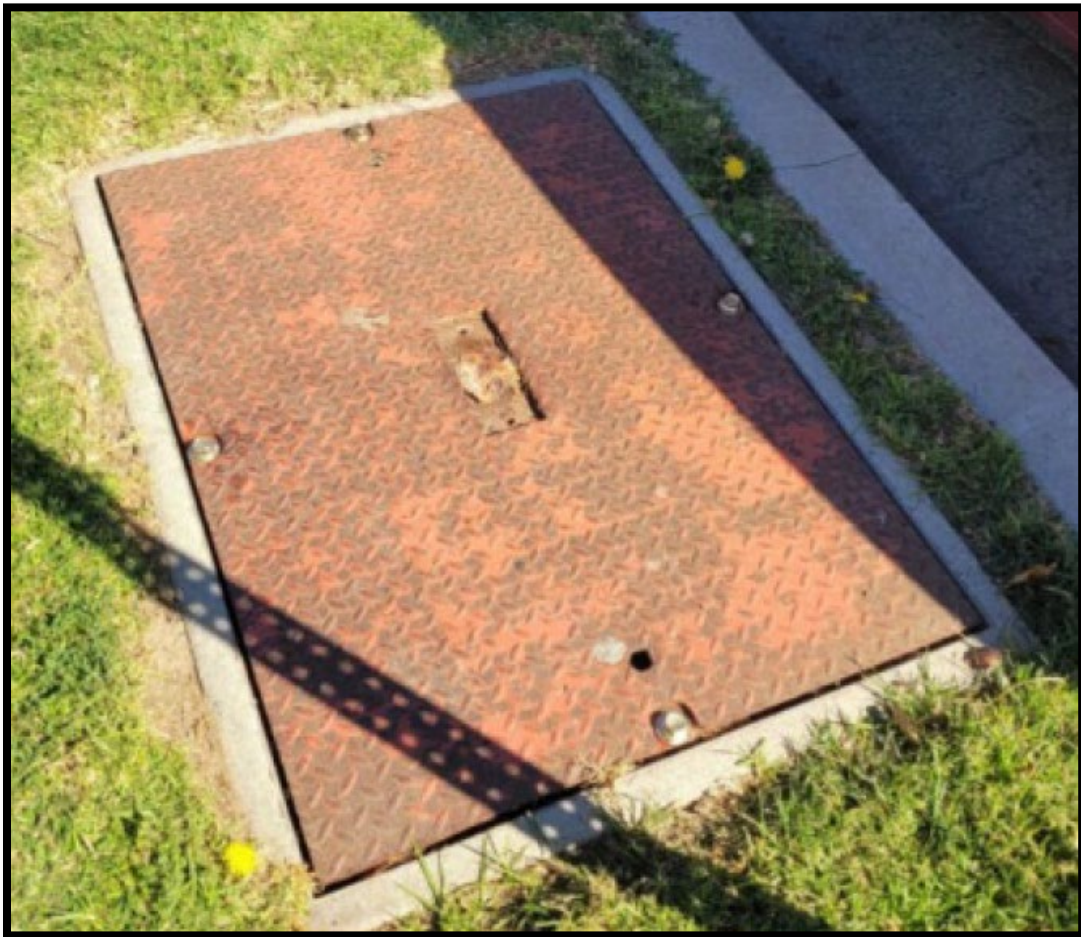
Site ID: LA33493C

Staff Findings: The cover of the handhole located at each of the following locations was not securely closed, allowing unauthorized access to the structures.

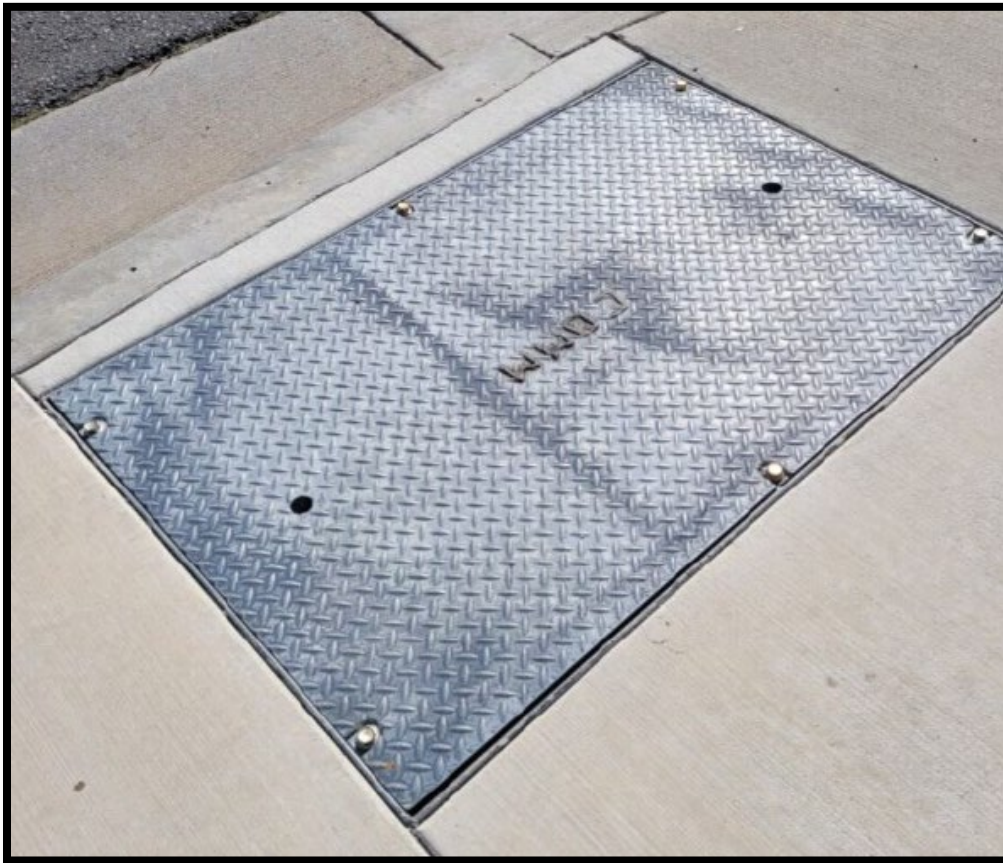
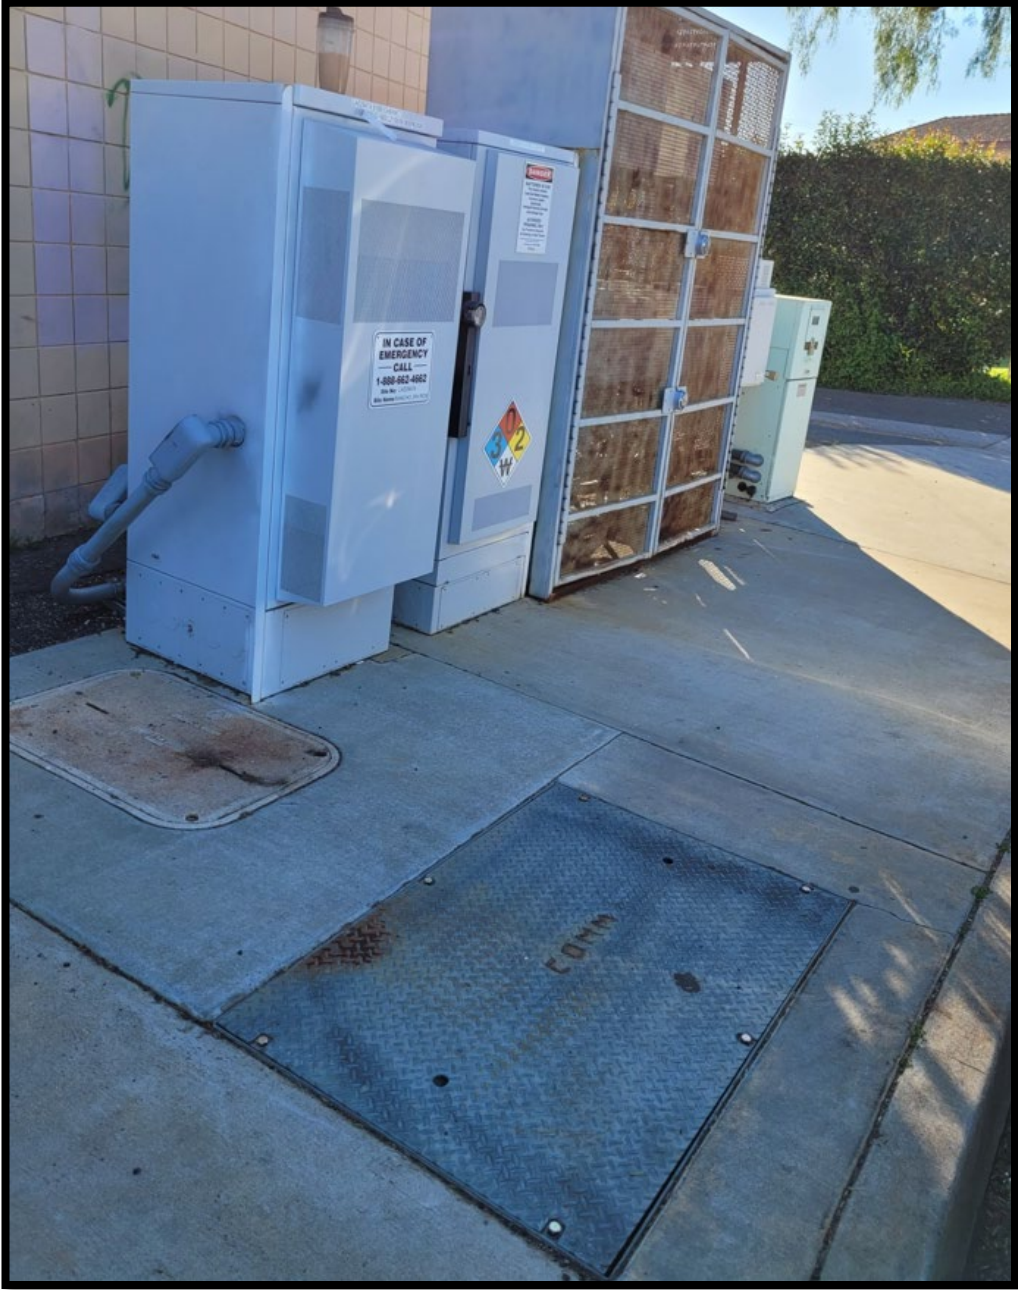
Site ID: LA02947A

Staff Findings: The cover of the handhole at the location was not securely closed, allowing unauthorized access to the structures. (2 handholes)
