**SUBJECT:** Electric Substation Audit of PacifiCorp Yreka Headquarters

## **CPUC SUBSTATION AUDIT FINDINGS**

### **PacifiCorp Yreka Headquarters**

**May 4 – 8, 2026**

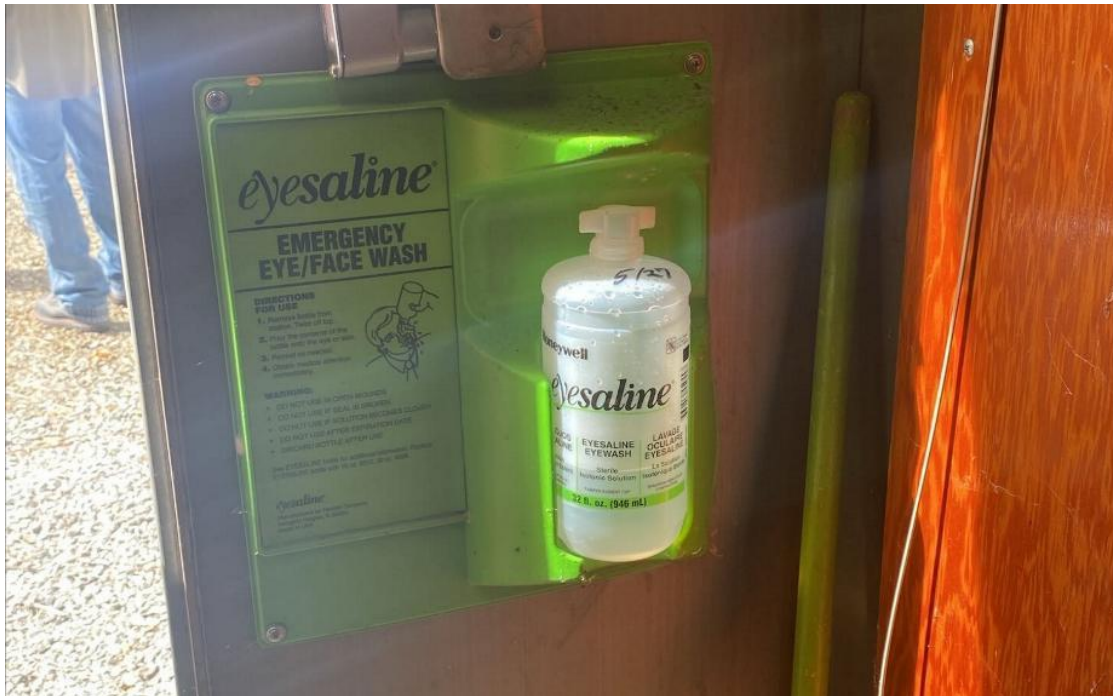
1.2. The station control room has a low eye wash.

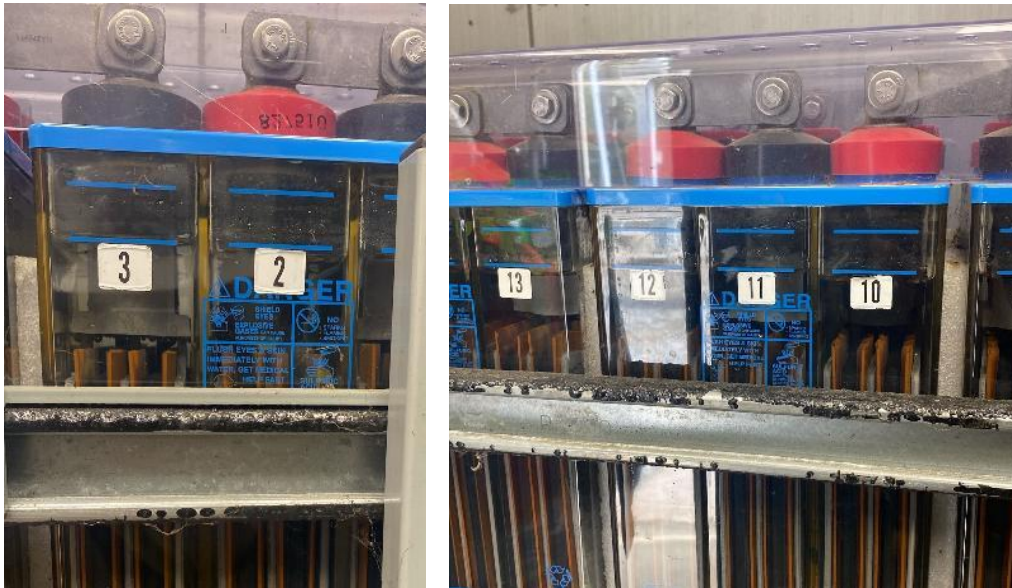
1.3. The station batteries have low water levels.<sup>11</sup>

<sup>11</sup> Post-Audit DR Response, Field Question 2 requested battery manufacturing documentation detailing requirements for water levels and refills. *Energys PowerSafe Type CC Performance Specs US-CC-PS-001 Apr06* provided by PacifiCorp did not provide information on water level requirements or detail that the water level only needs to cover the plates regardless of the minimum and maximum lines, as was discussed in the field.

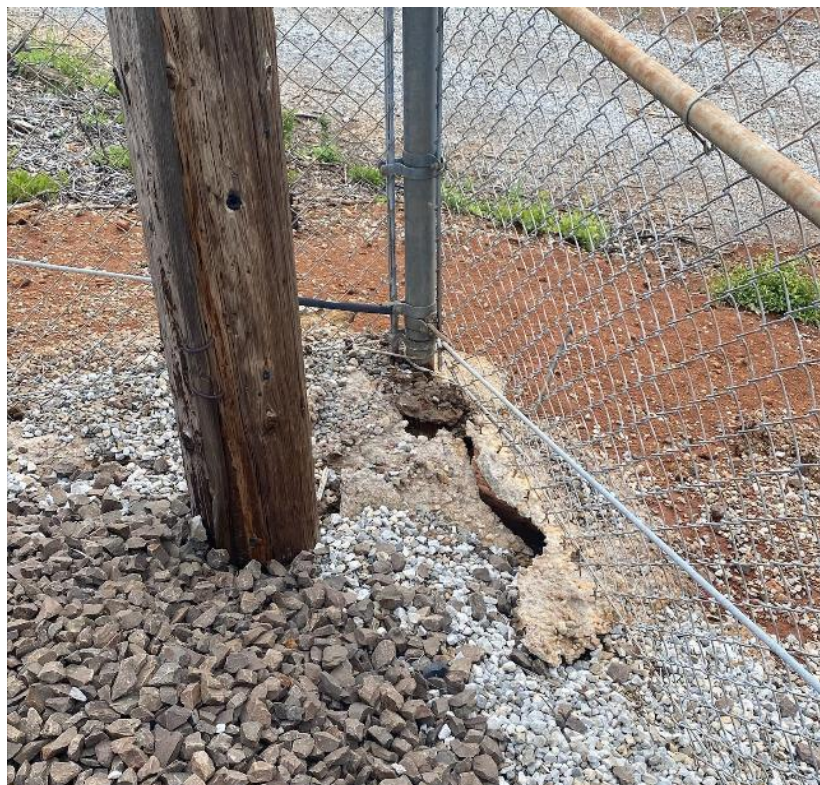
1.4. The station perimeter fence has soil erosion and accessibility issues.

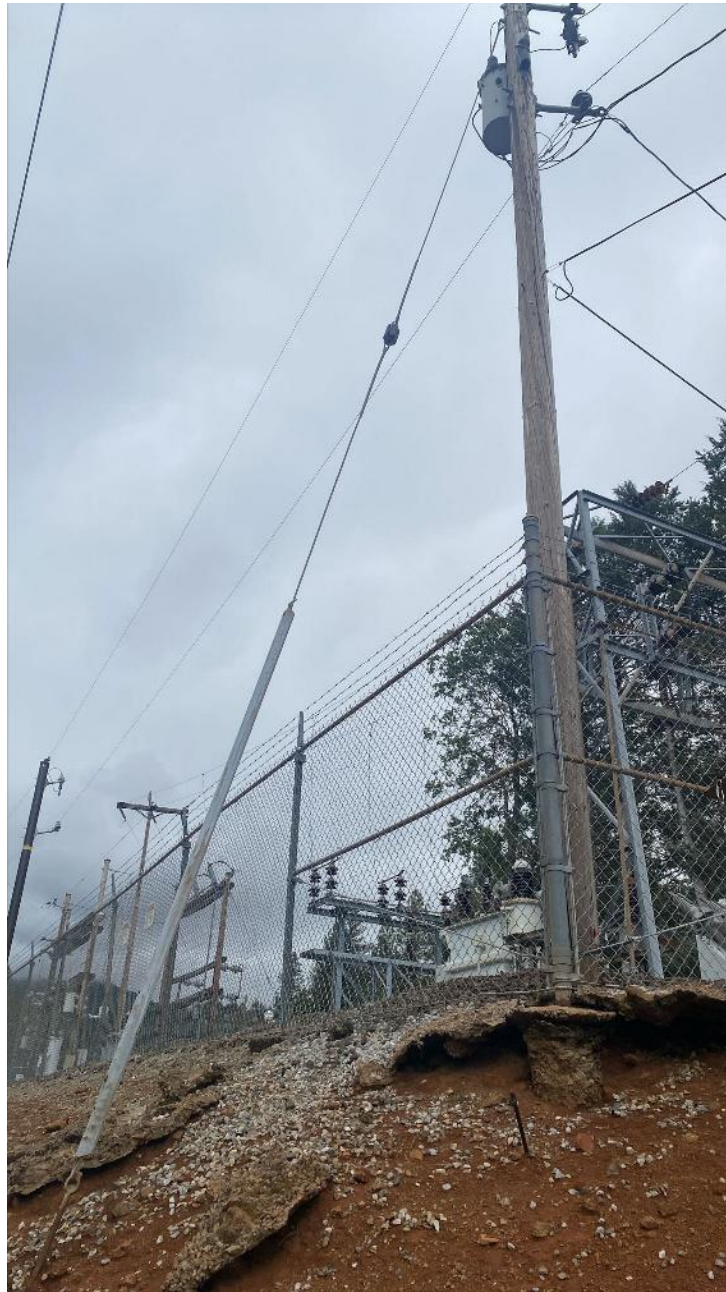
- 1.5. The station perimeter fence and a down guy wire approximately 4 feet from the outside of the fence have touch potential.

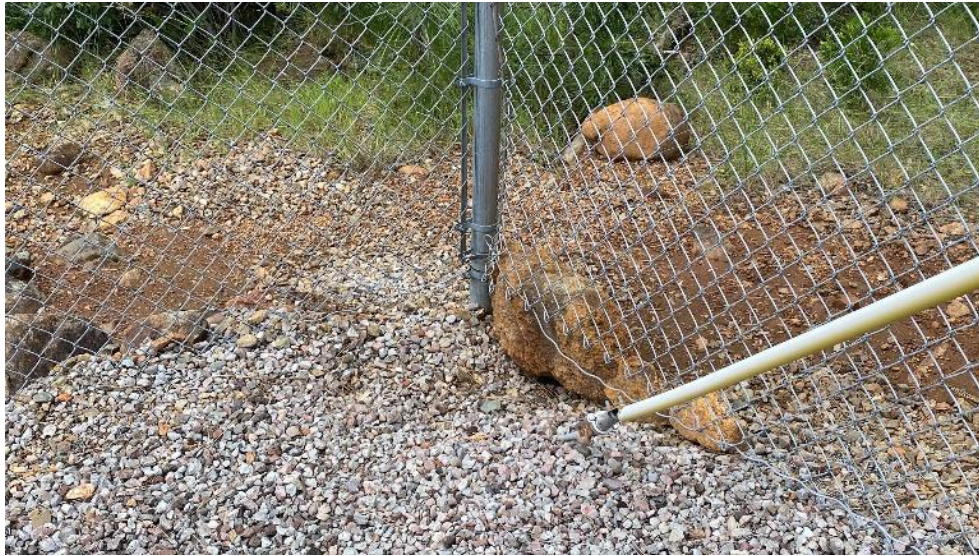
2.2. The station perimeter fence has soil erosion and accessibility issues.

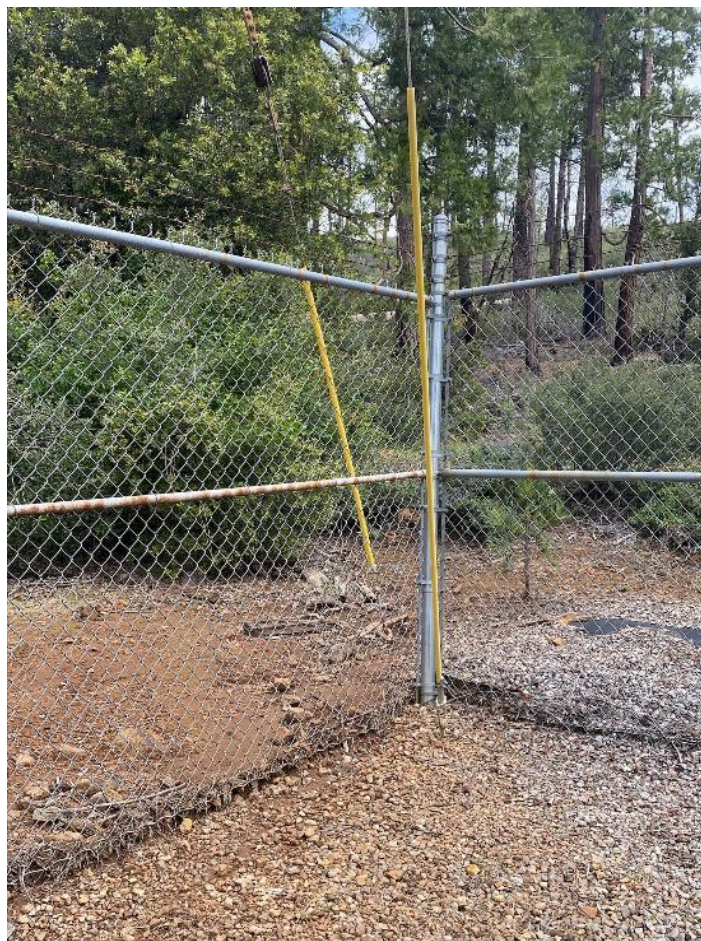
2.3. The station perimeter fence and a down guy wire approximately 4 feet from the outside of the fence have touch potential.

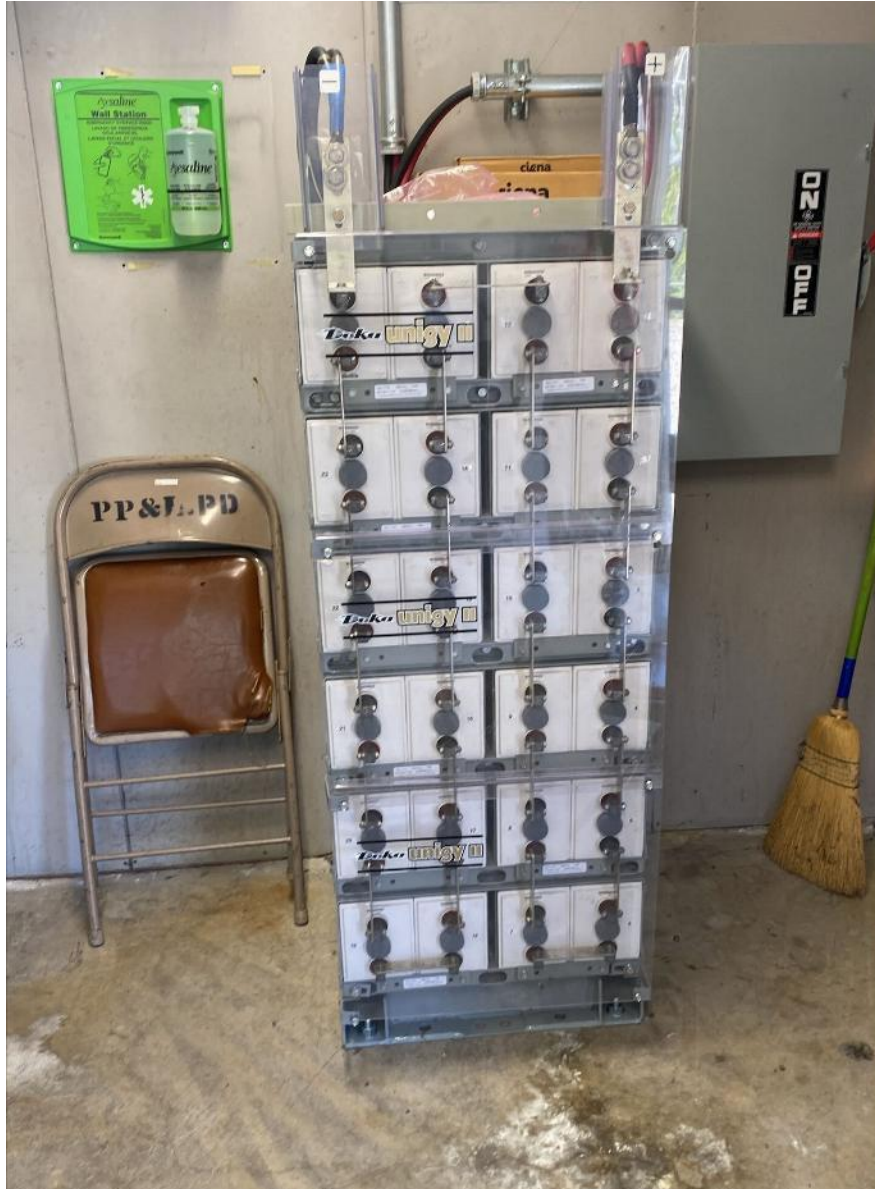
- 3.1. The station single line diagram (SLD) needs to be updated. The SLD shows the control room equipment as future build, but the equipment is installed at the substation.
- 3.2. The station batteries have no provision for containing spilled electrolytes.<sup>12</sup> Containing electrolytes can be accomplished by secondary containment, dams, absorbent materials, or spill pillows.

<sup>12</sup> National Electric Safety Code (NESC 2017), Part 1 Section 14, Item 144 states “Floors of battery areas should be of an acid-resistive material, painted with acid-resistive paint, or otherwise protected. Provision should be made to contain spilled electrolyte.”

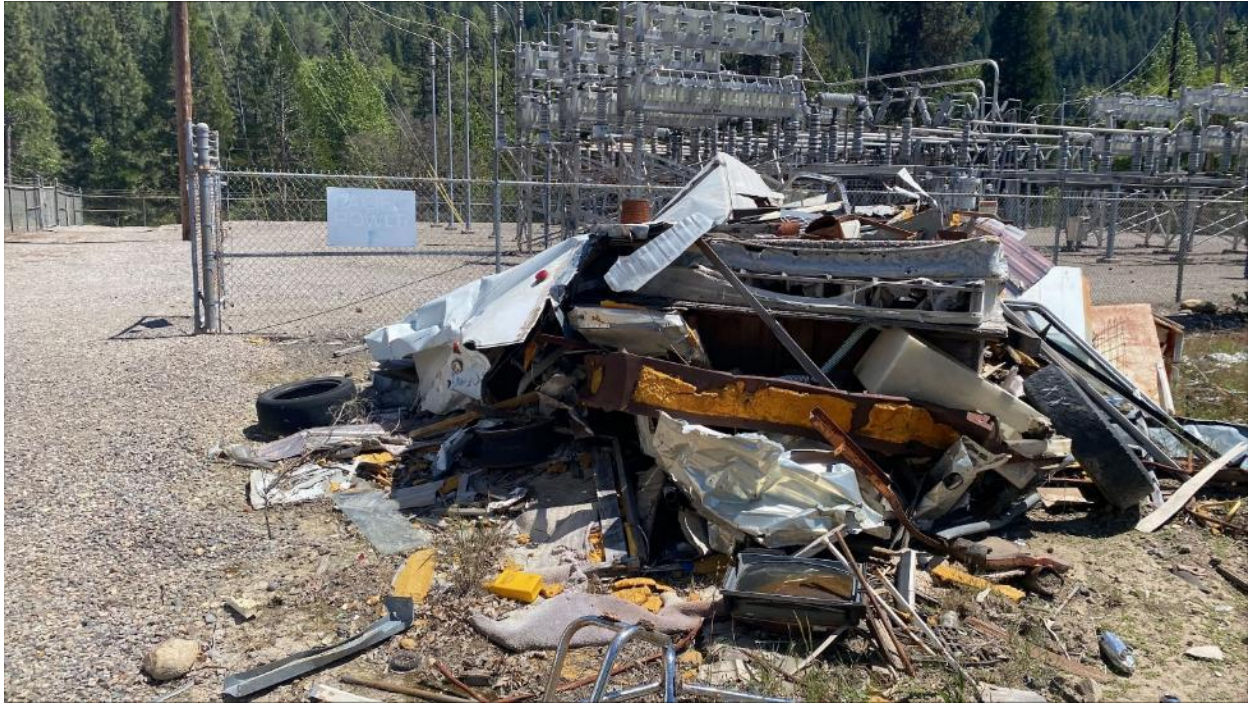
3.3. The station perimeter fence has damage and accessibility issues from a pile of scrap metal/equipment.

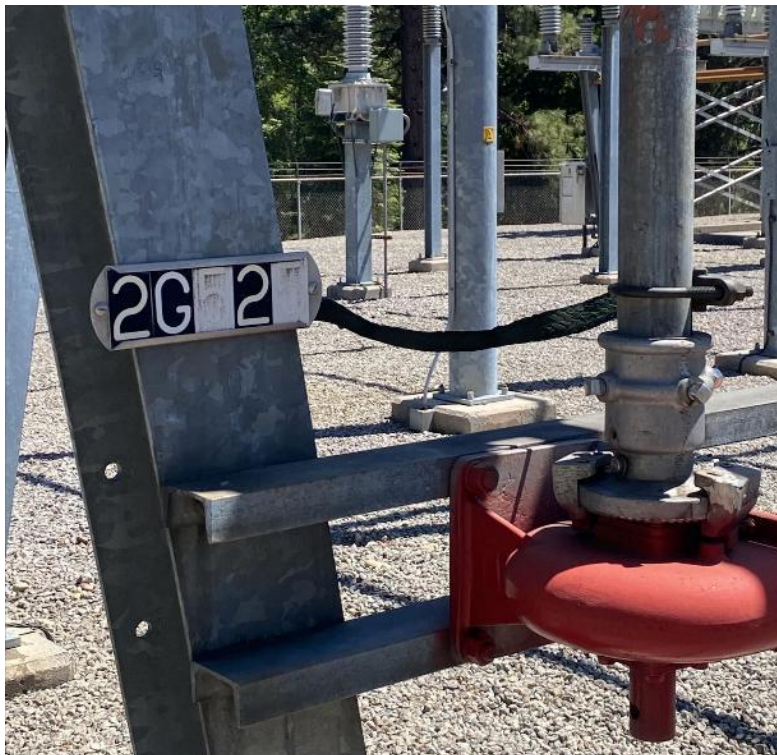
3.4. Switch 2G525 has a faded label.

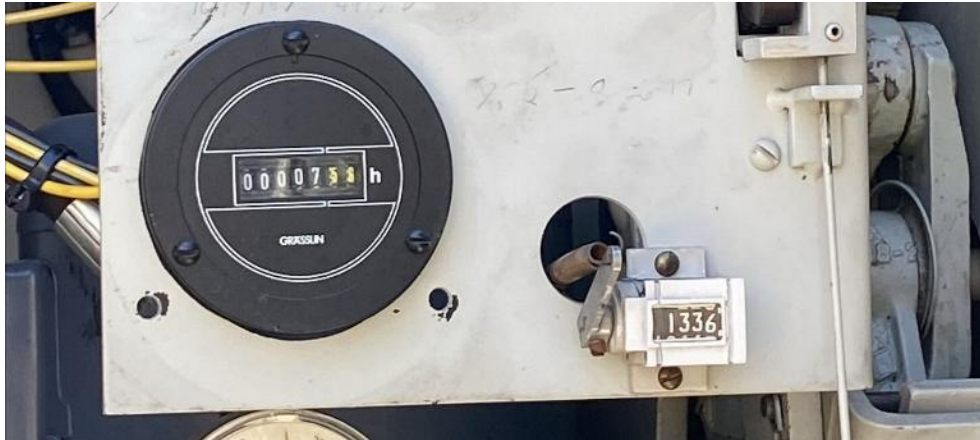
3.5. Circuit Breaker 3G280 has a faded counter.

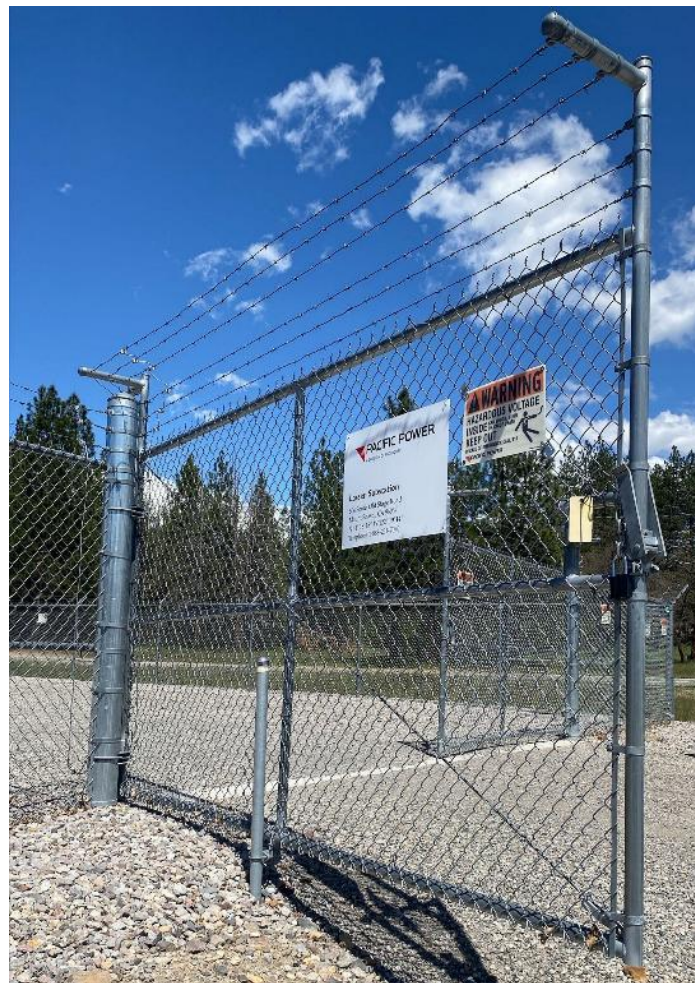
4.1. The station gate is missing an NFPA symbol.

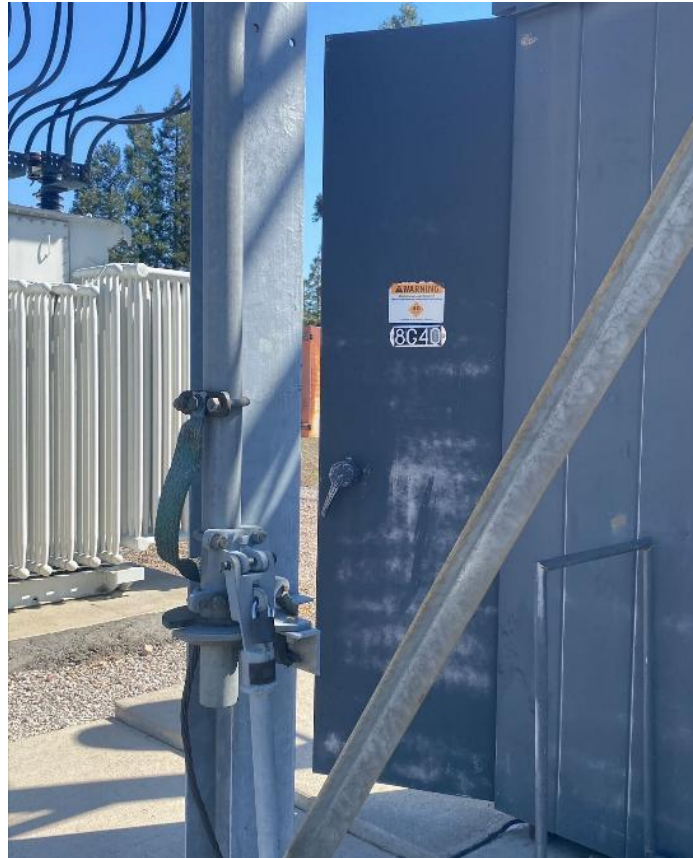
5.1. Switch 8G40 Bypass is missing a label.

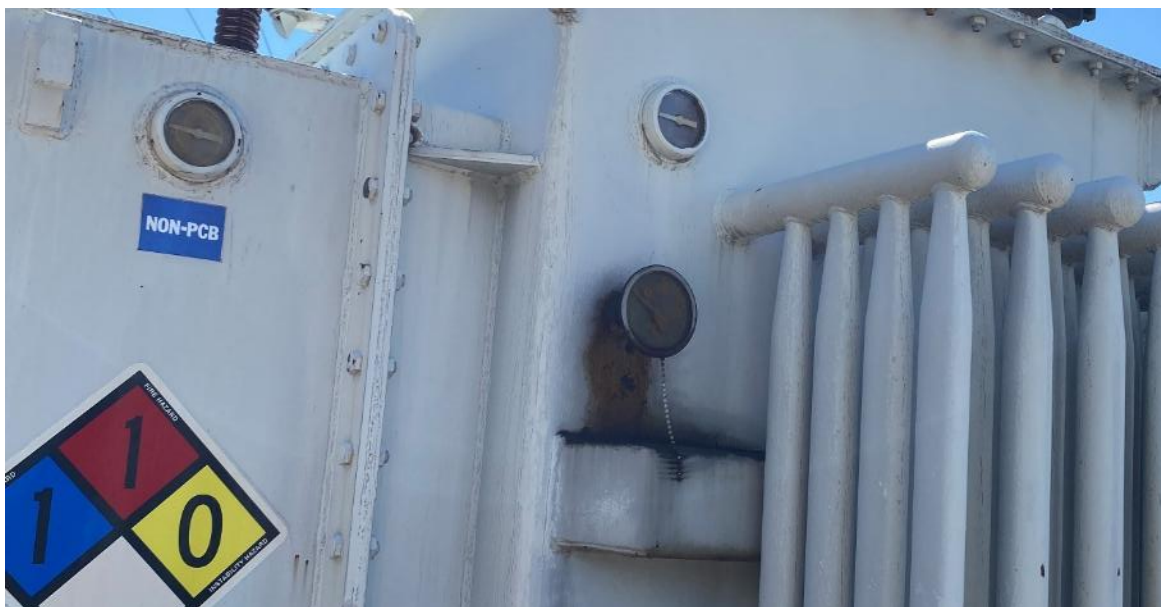
5.2. Regulator 284 shows signs of an oil weep at the maximum temperature gauge.

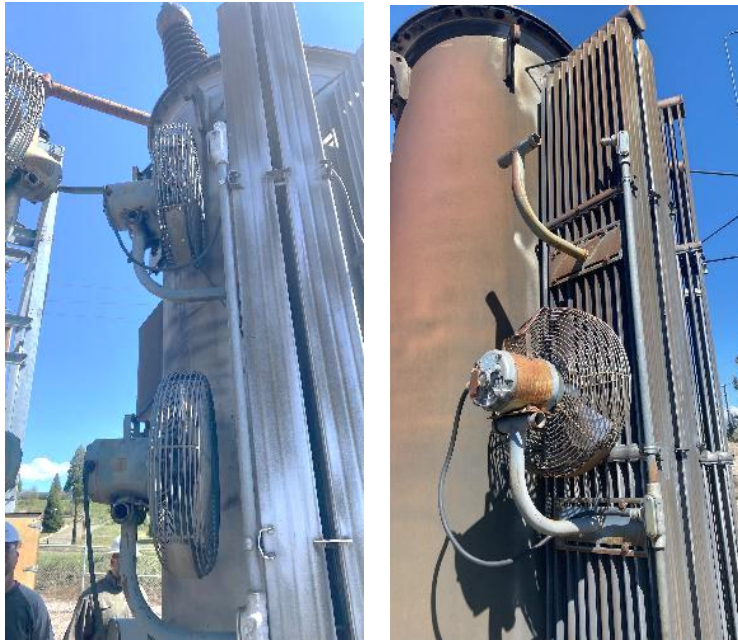
5.3. Transformer 2901 has a missing fan and a broken fan.

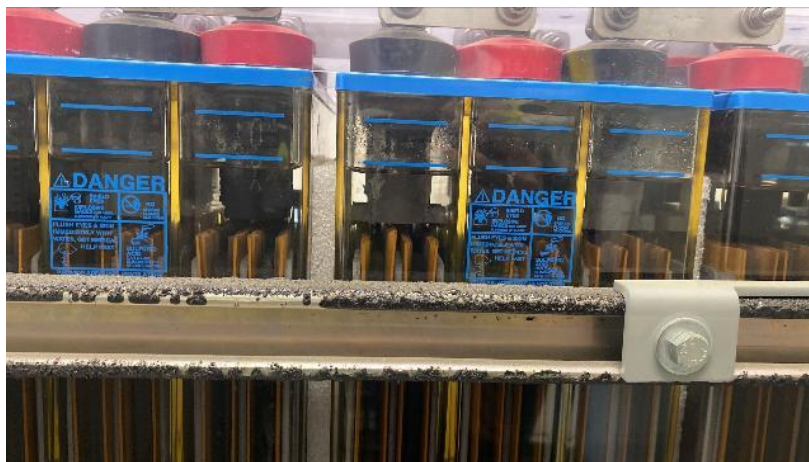
6.2. The station batteries have low water levels.<sup>13</sup>

<sup>13</sup> Post-Audit DR Response, Field Question 2 requested battery manufacturing documentation detailing requirements for water levels and refills. *Energys PowerSafe Type CC Performance Specs US-CC-PS-001 Apr06* provided by PacifiCorp did not provide information on water level requirements or detail that the water level only needs to cover the plates regardless of the minimum and maximum lines, as was discussed in the field.

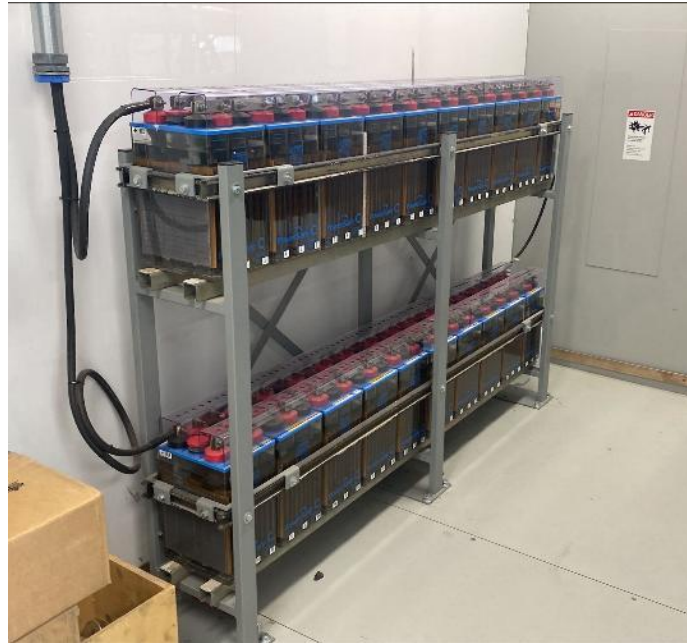
6.3. The station batteries have no provision for containing spilled electrolytes.<sup>14</sup> Containing electrolytes can be accomplished by secondary containment, dams, absorbent materials, or spill pillows.

<sup>14</sup> National Electric Safety Code (NESC 2017), Part 1 Section 14, Item 144 states “Floors of battery areas should be of an acid-resistive material, painted with acid-resistive paint, or otherwise protected. Provision should be made to contain spilled electrolyte.”

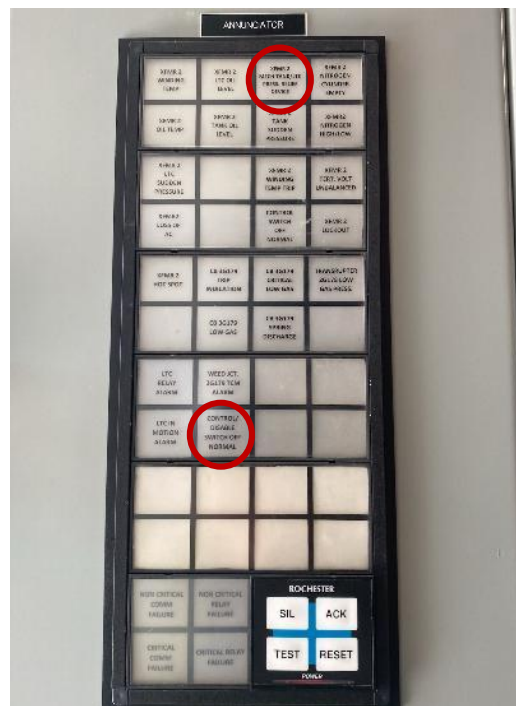
6.4. The station annunciator panel has two lights that are faded and/or inoperable.

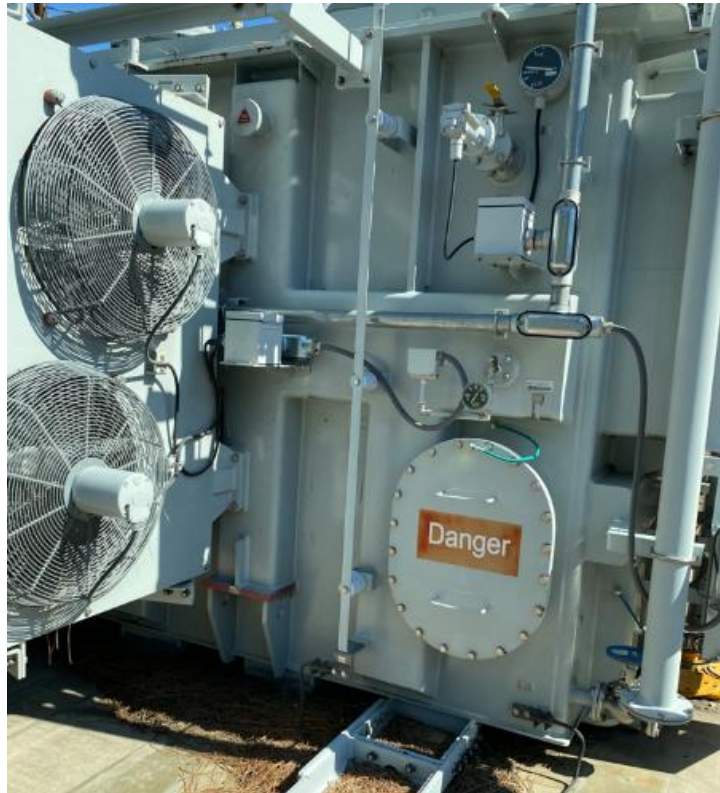
6.5. Transformer 2 compartment access does not have Confined Space signage and is only marked “Danger”.

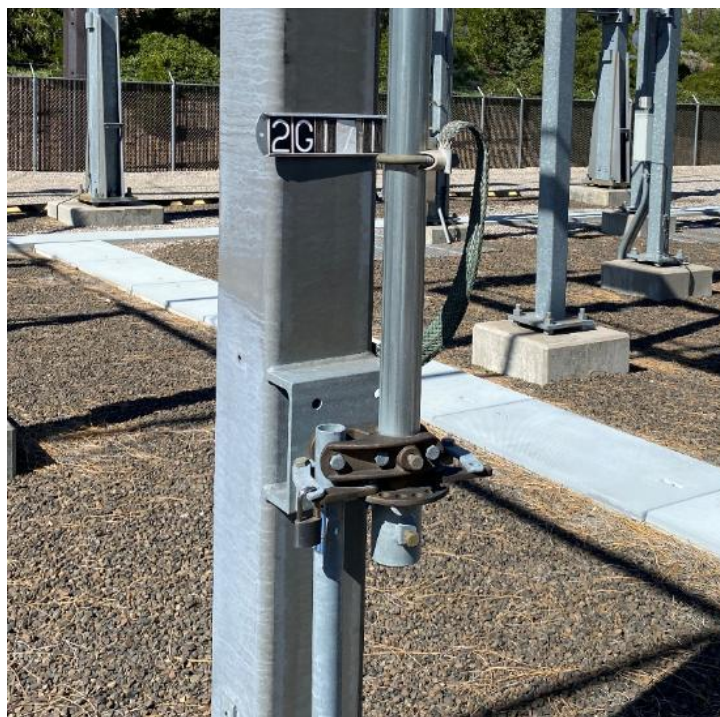
6.6. Switch 2G171 has a faded label.

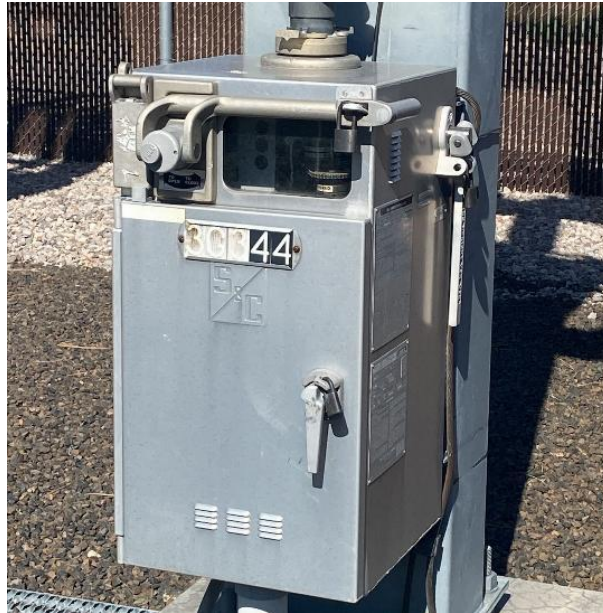
6.7. MOAS 3G344 has a faded label.

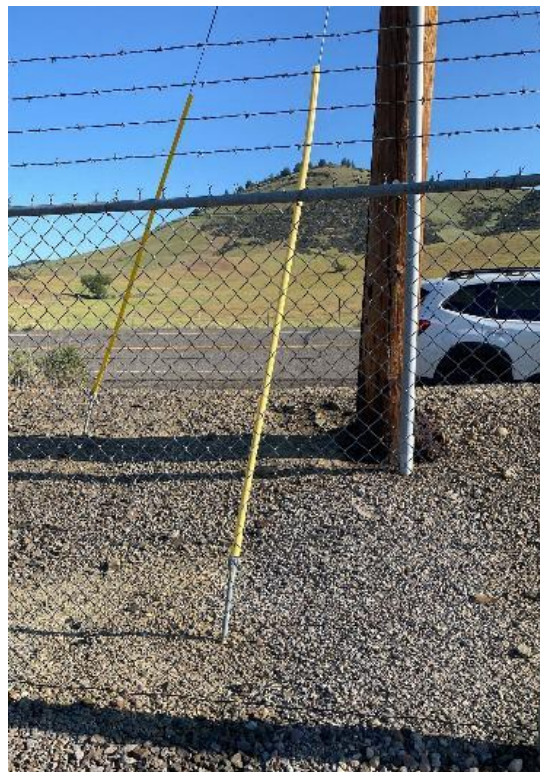
7.1. The station perimeter fence and a down guy wire outside of the fence have touch potential.

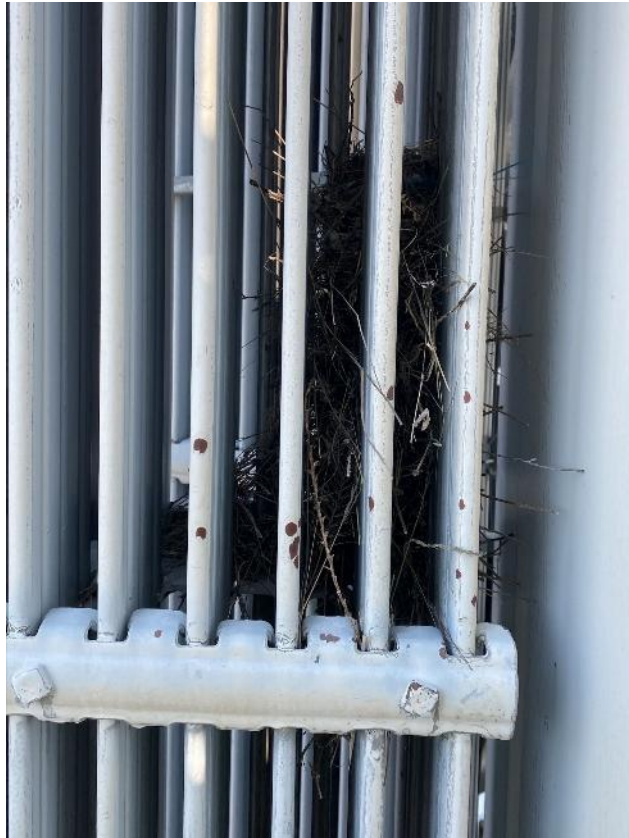
7.2. Transformer 2947 radiator has a bird's nest.

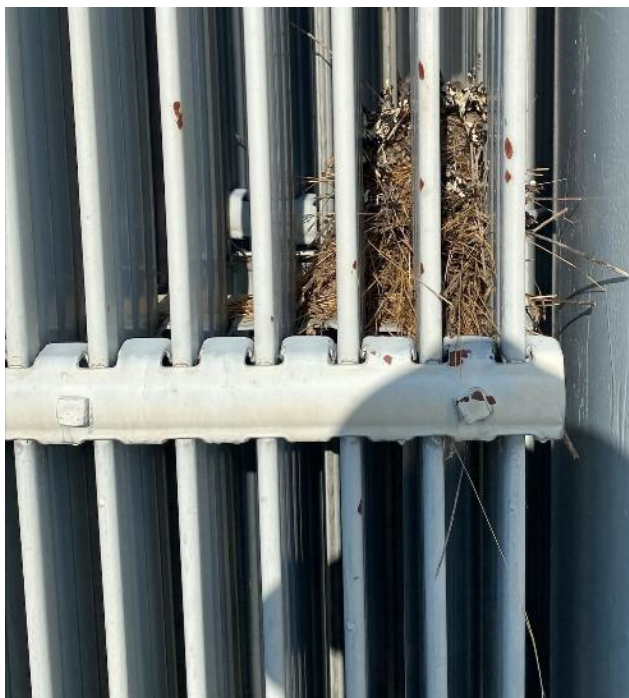
7.3. Transformer 2946 radiator has a bird's nest.

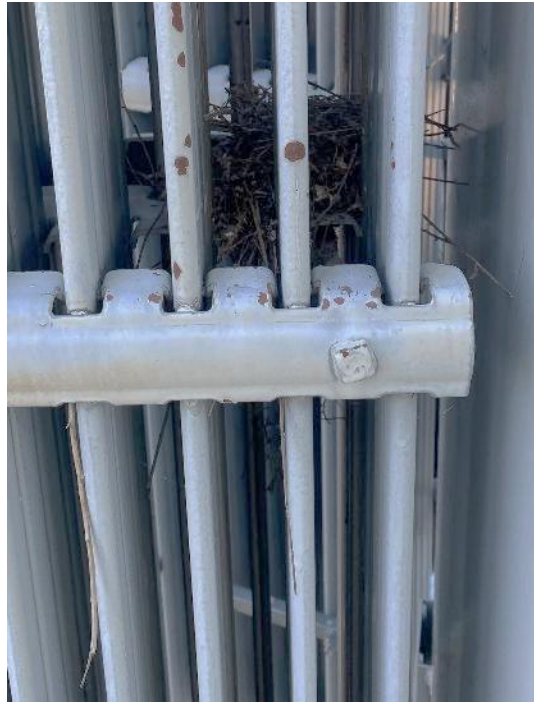
7.4. Transformer 2948 radiator has a bird's nest.

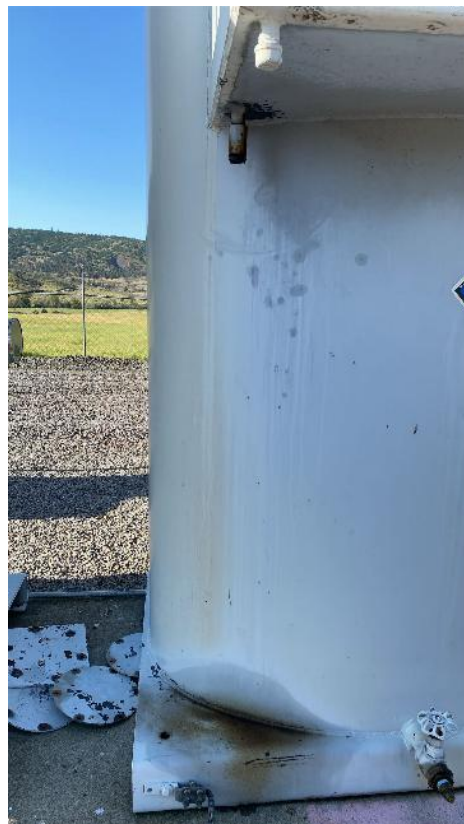
7.5. Transformer 2948 has an oil weep on the conservator tank oil release valve.

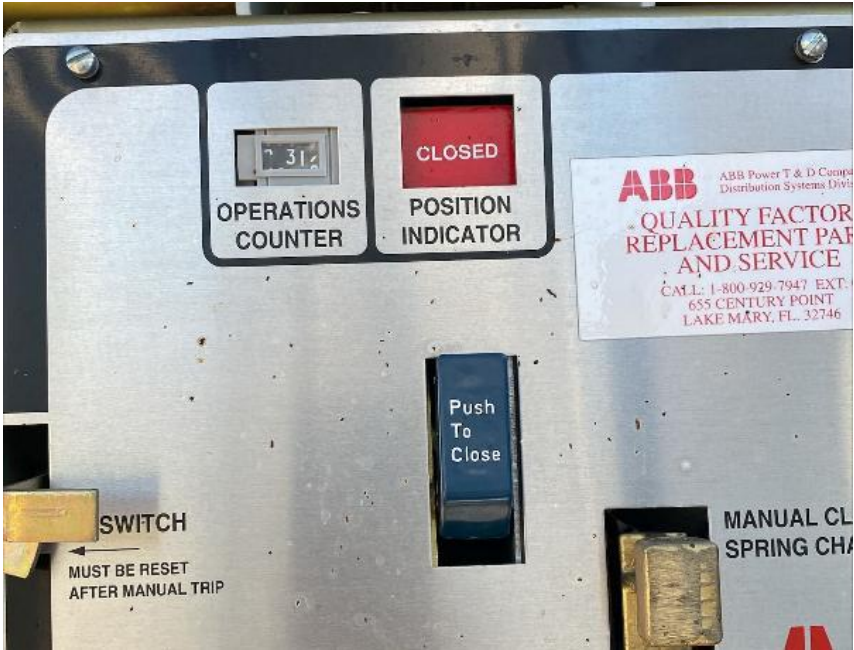
7.6. Circuit Breaker 5G19 has a faded counter.

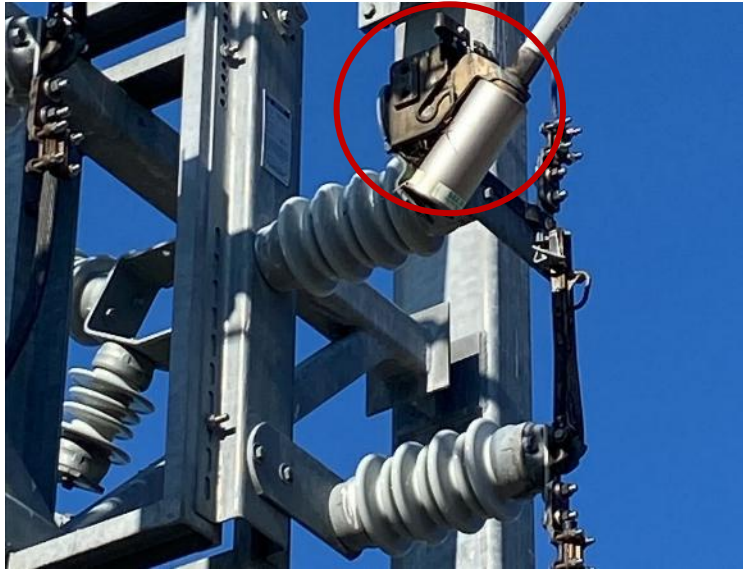
7.8. Low side Bypass Fuses have a bird's nest.

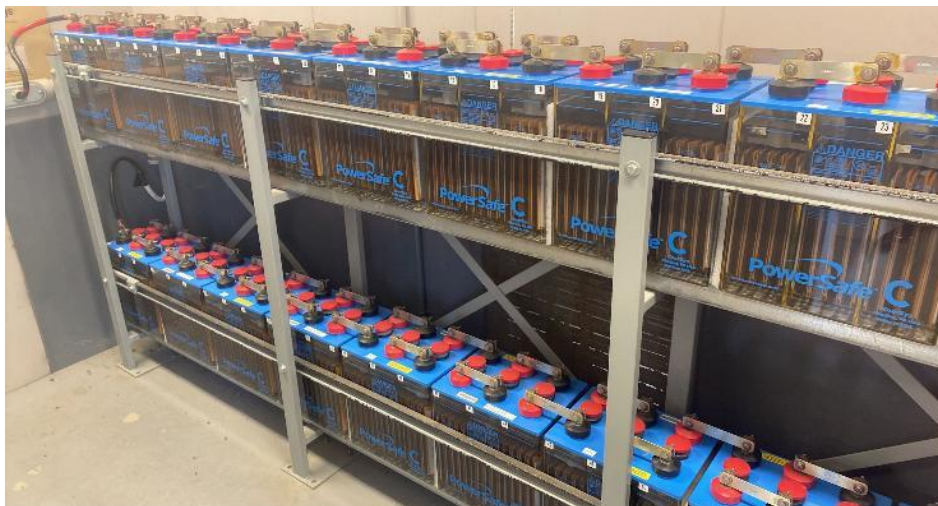
- 8.1. The station single line diagram (SLD) needs to be updated. The SLD shows Transformer Bank 1 as future build and does not show the capacitor banks and Circuit Breaker 1G20, but the equipment is installed at the substation.
- 8.2. The station batteries have no provision for containing spilled electrolytes.<sup>15</sup> Containing electrolytes can be accomplished by secondary containment, dams, absorbent materials, or spill pillows.

<sup>15</sup> National Electric Safety Code (NESC 2017), Part 1 Section 14, Item 144 states “Floors of battery areas should be of an acid-resistive material, painted with acid-resistive paint, or otherwise protected. Provision should be made to contain spilled electrolyte.”

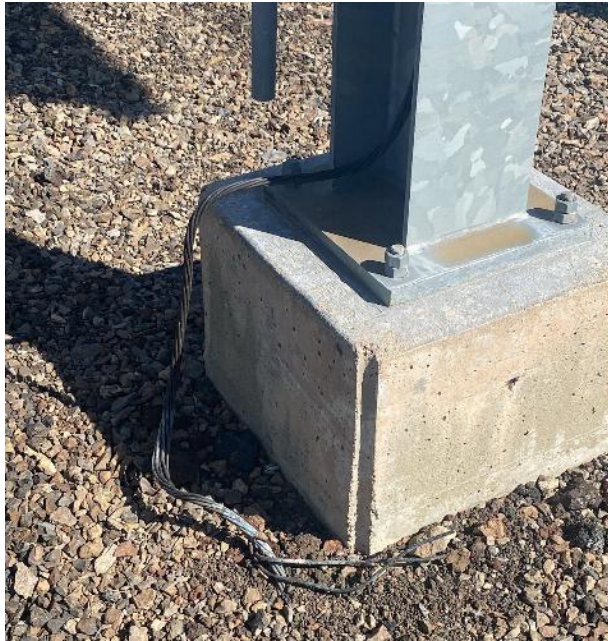
8.3. Switch 1G5 has a damaged and splitting ground wire.

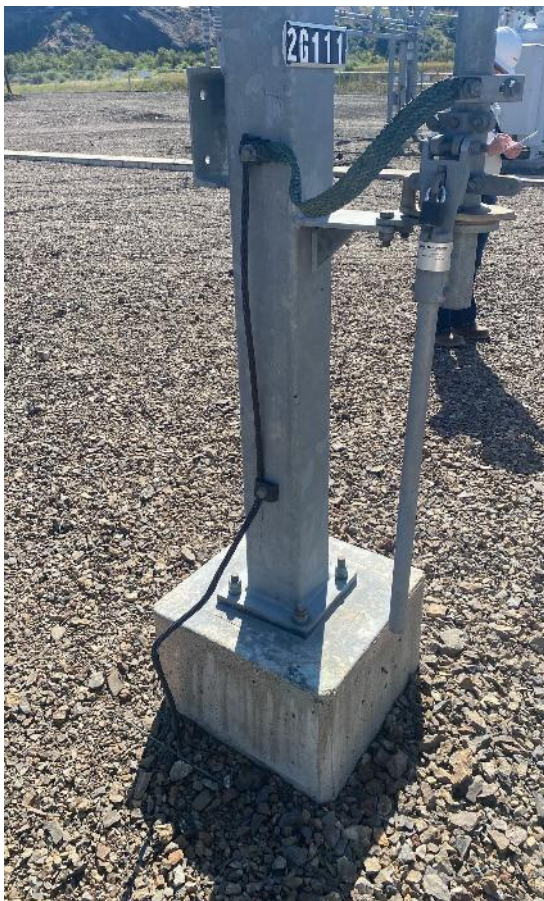
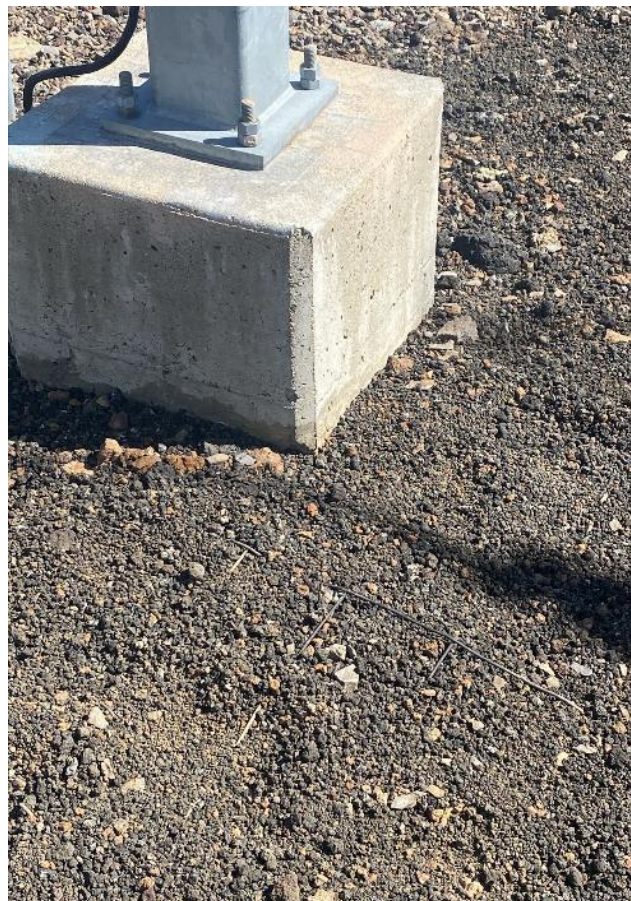
8.4. The station ground grid is exposed near Switch 2G111 and Switch 2G117.

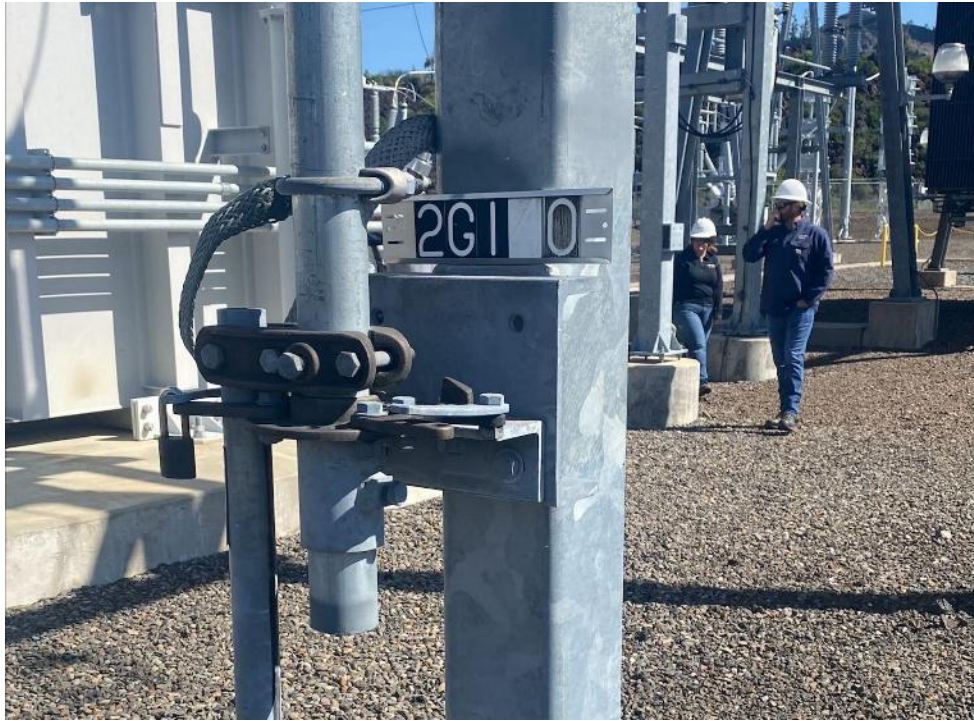
8.5. Switch 2G140 has a faded label.

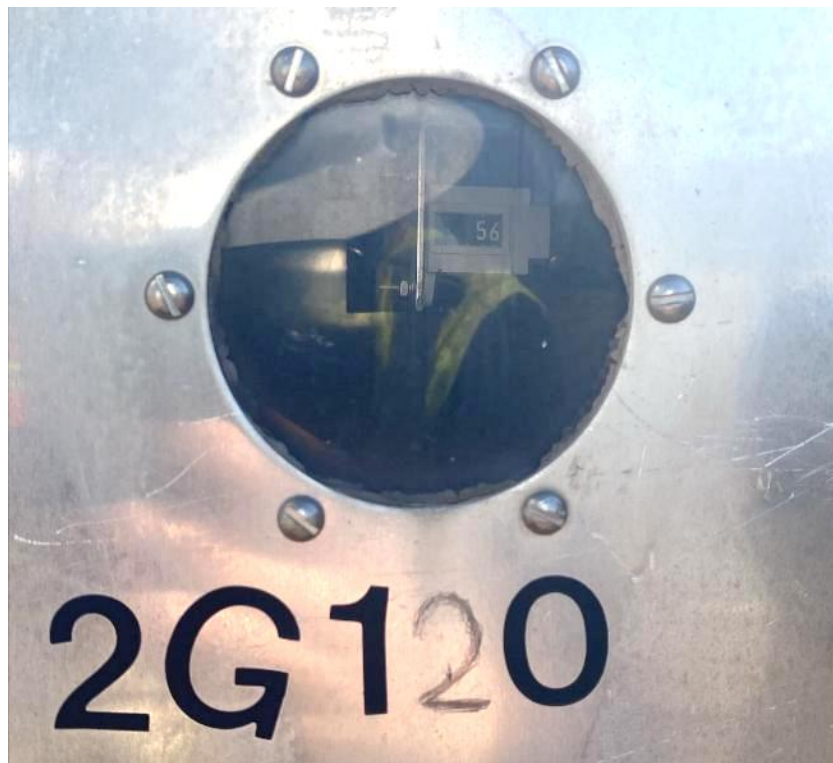
8.6. Switch 2G120 has a faded counter.

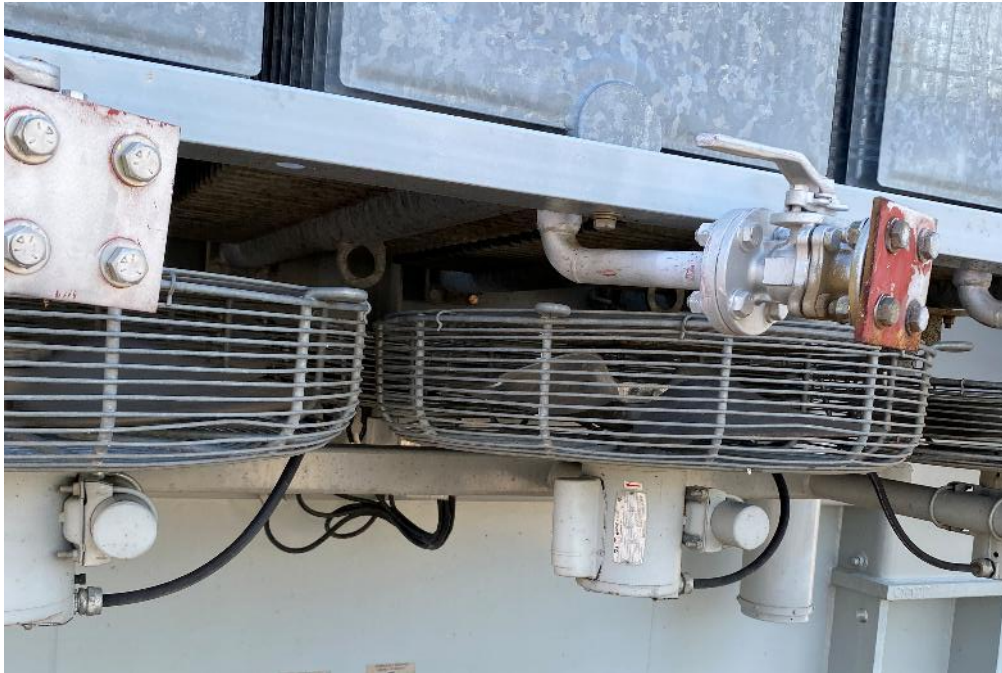
8.7. Transformer Bank 1 (SAP 373187) has a broken fan.

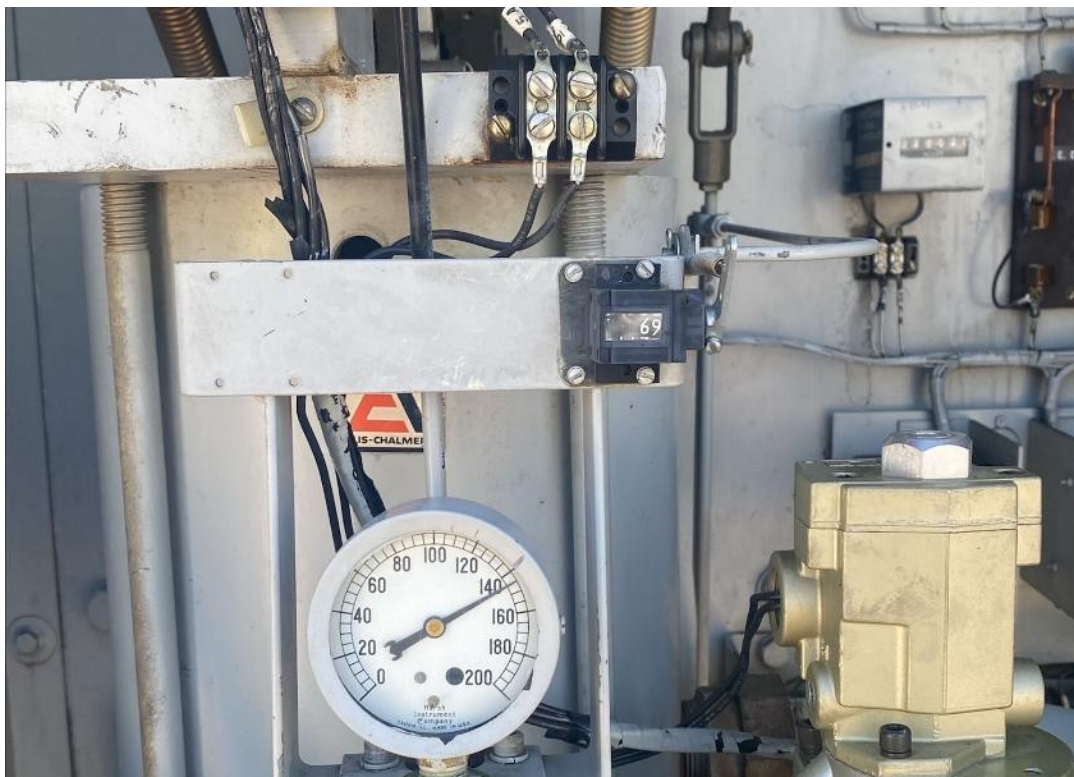
8.8. Circuit Breaker 2G110 has a faded counter.

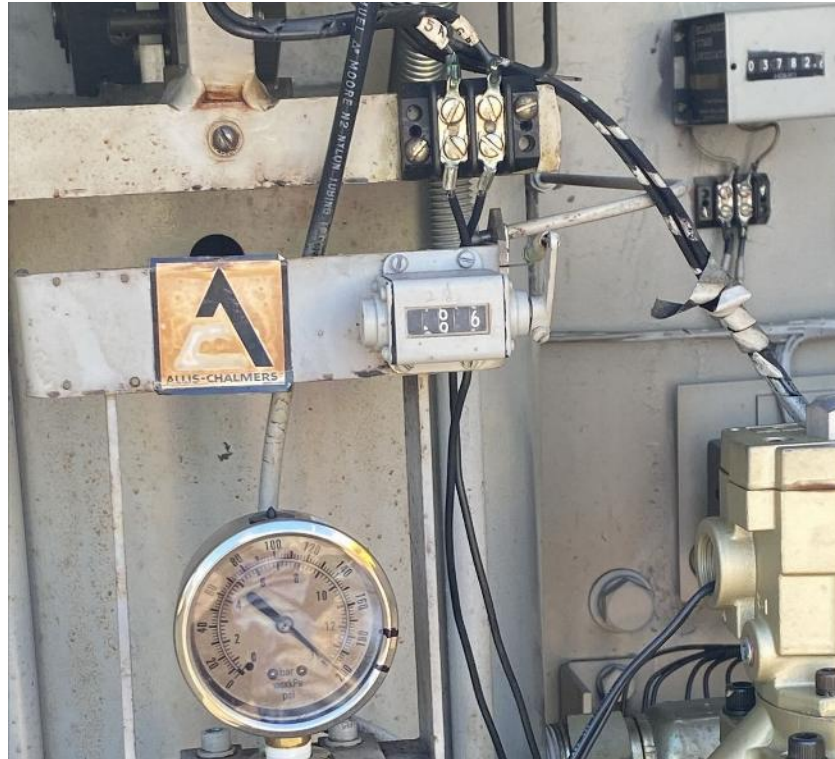
8.9. Circuit Breaker 2G114 has a faded counter.

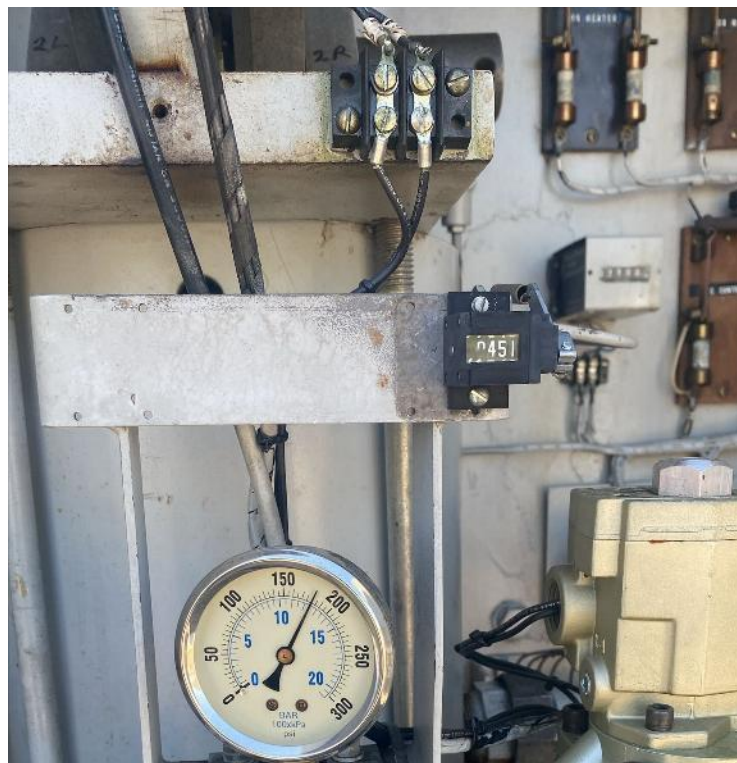
8.10. Circuit Breaker 2G106 has a faded counter.
