**SUBJECT:** Electric Substation Audit of PacifiCorp Yreka Headquarters

## **CPUC SUBSTATION AUDIT FINDINGS**

### **PacifiCorp Yreka Headquarters**

**May 4 – 8, 2026**

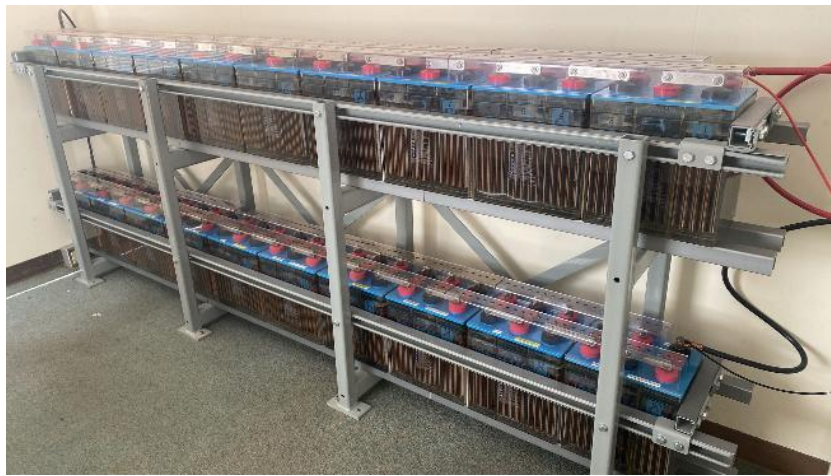
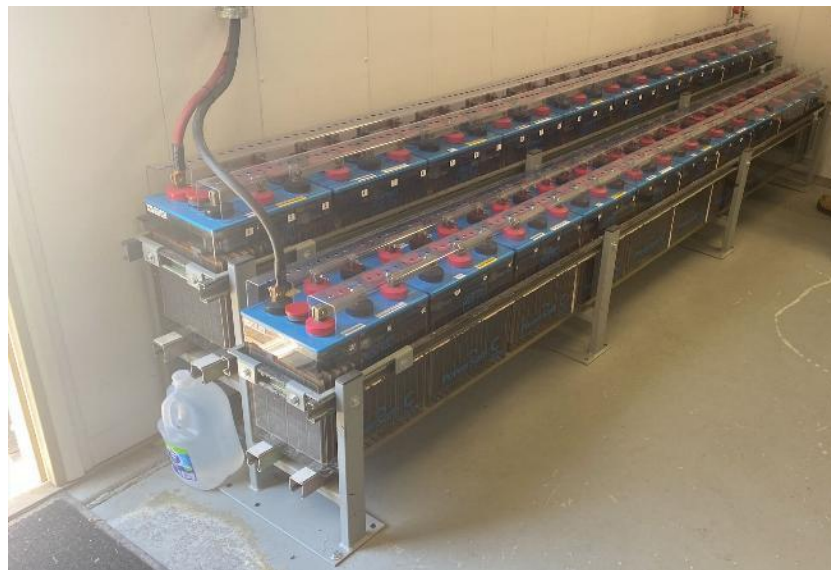
- 9.1. The station single line diagram (SLD) needs to be updated. The SLD shows Circuit Breaker 5G6 as future build, but the equipment is installed at the substation. The SLD also shows Switch 3G44 as in-service, but the equipment is non-operational and not labeled at the substation.
- 9.2. Switch 3G501 is mislabeled. The switch is labeled as Switch 3G507 on the Single Line Diagram and Switch 3G501 at the substation.
- 9.3. The station batteries have no provision for containing spilled electrolytes.<sup>16</sup> Containing electrolytes can be accomplished by secondary containment, dams, absorbent materials, or spill pillows.

<sup>16</sup> National Electric Safety Code (NESC 2017), Part 1 Section 14, Item 144 states “Floors of battery areas should be of an acid-resistive material, painted with acid-resistive paint, or otherwise protected. Provision should be made to contain spilled electrolyte.”

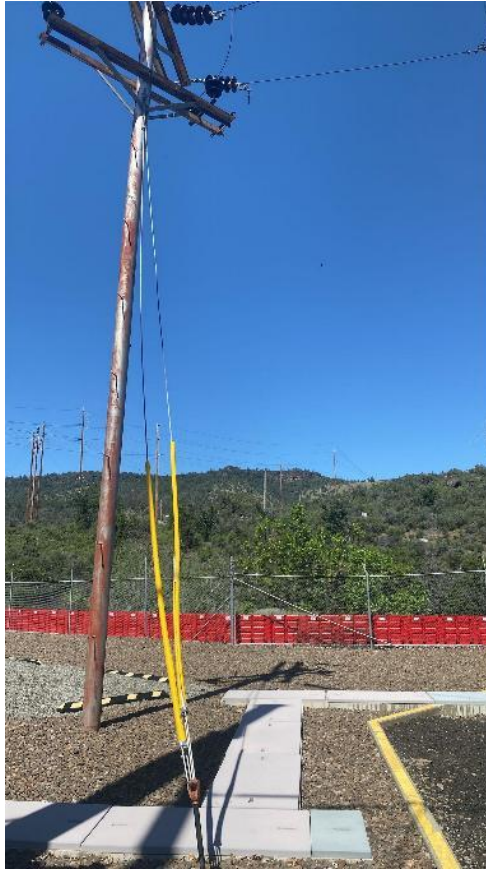
- 9.4. Pole 1/1 inside the station has a slack down guy wire. PacifiCorp will remove this pole when the equipment is moved to Copco #2 230kV Substation.

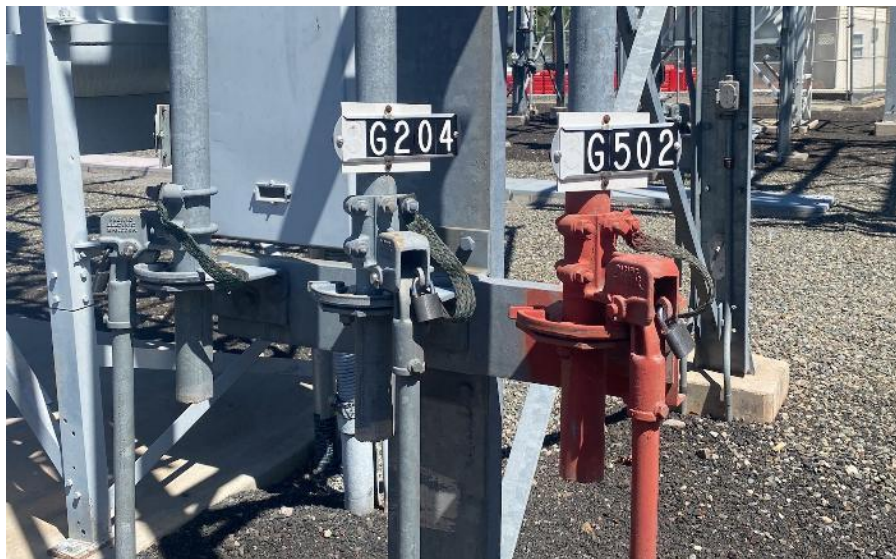
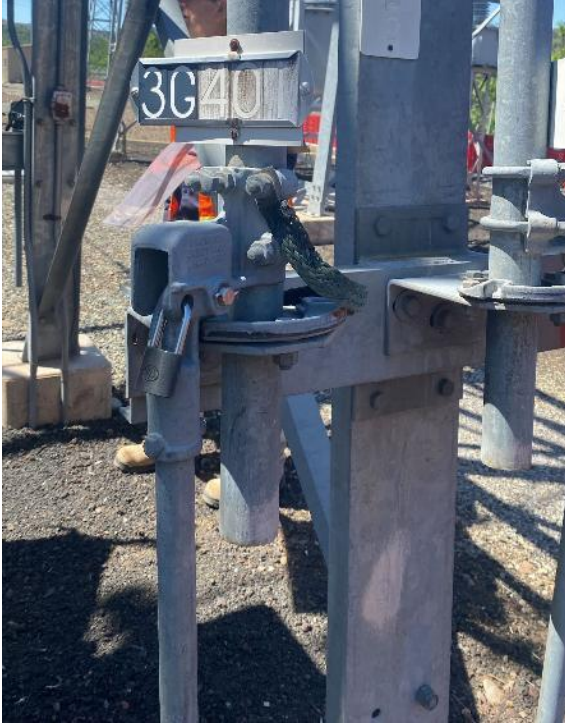
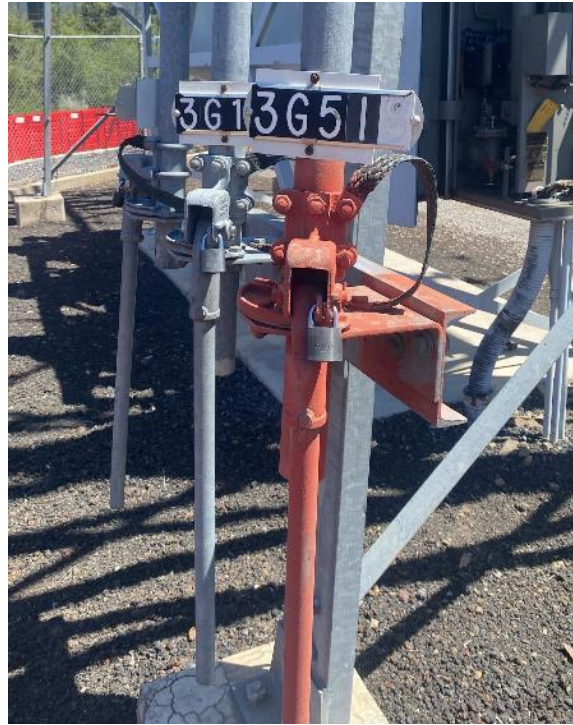
- 9.5. The substation has multiple faded switch labels, including Switch 3G401, Switch 3G 402, Switch 3G403, Switch 201, Switch 3G204, Switch 3G502, Switch 3G518.

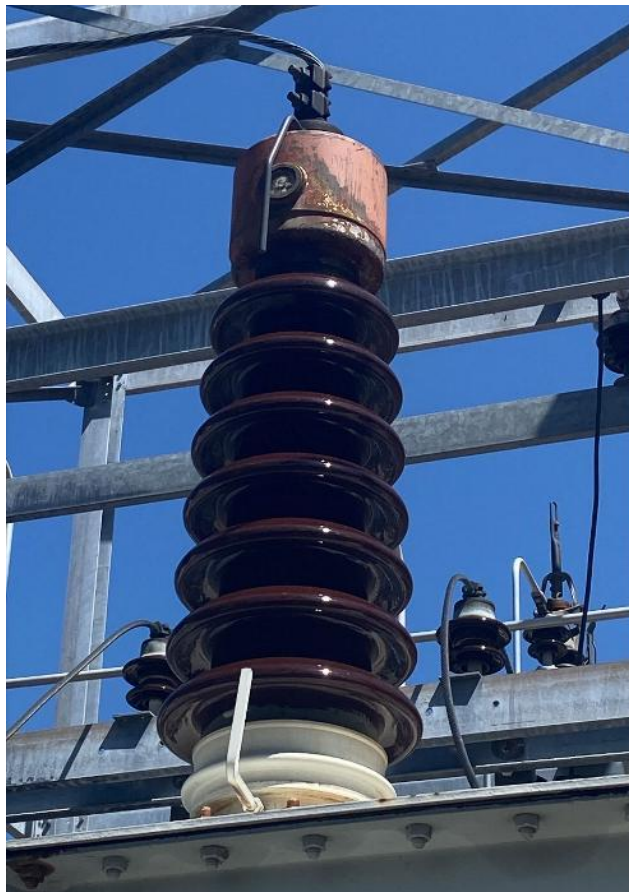
9.6. Transformer 2936 has an illegible and damaged bushing oil gauge.

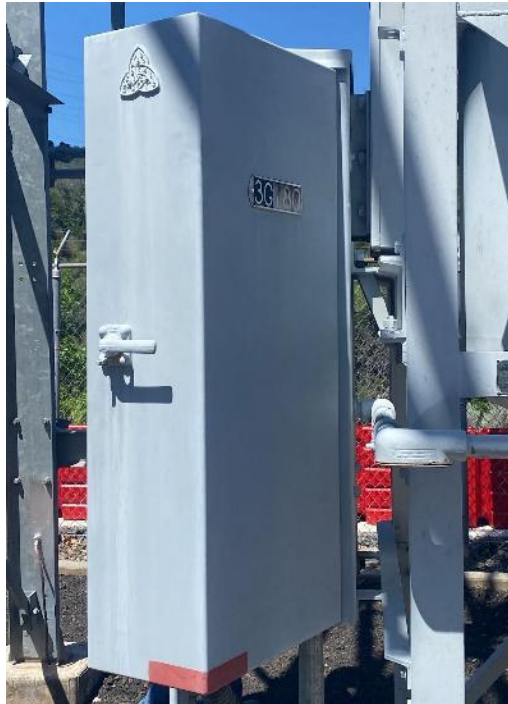
9.7. Circuit Breaker 3G180 has a faded label.

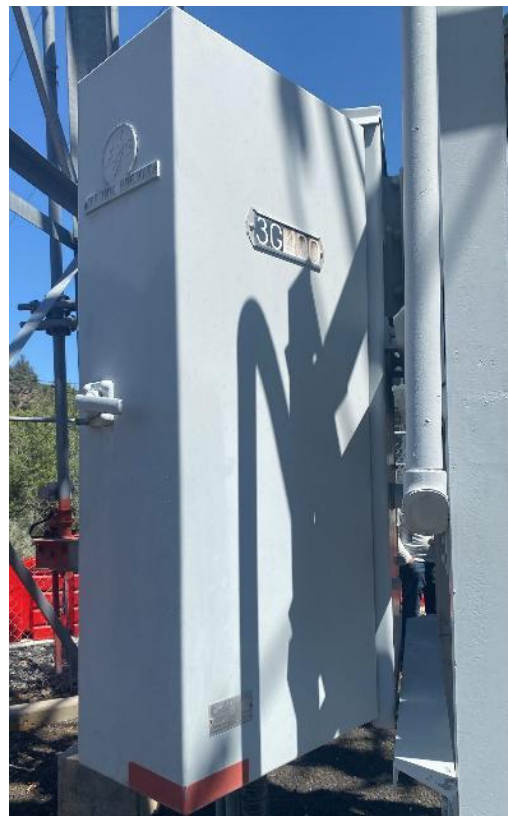
9.8. Circuit Breaker 3G400 has a faded label.

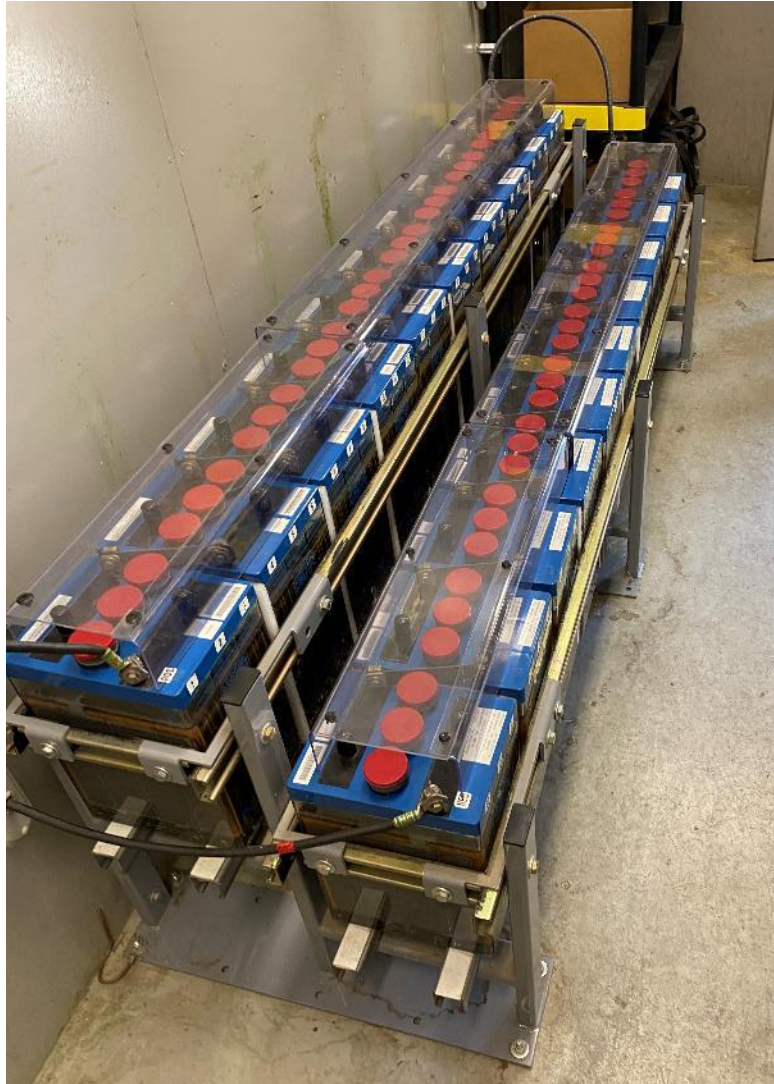
- 10.1. The station single line diagram (SLD) needs to be updated. The SLD shows Switch 2G101, but the equipment is motor operated by Circuit Switcher 2G49 at the substation and should be removed from the SLD.
- 10.2. The station batteries have no provision for containing spilled electrolytes.<sup>17</sup> Containing electrolytes can be accomplished by secondary containment, dams, absorbent materials, or spill pillows.

<sup>17</sup> National Electric Safety Code (NESC 2017), Part 1 Section 14, Item 144 states “Floors of battery areas should be of an acid-resistive material, painted with acid-resistive paint, or otherwise protected. Provision should be made to contain spilled electrolyte.”

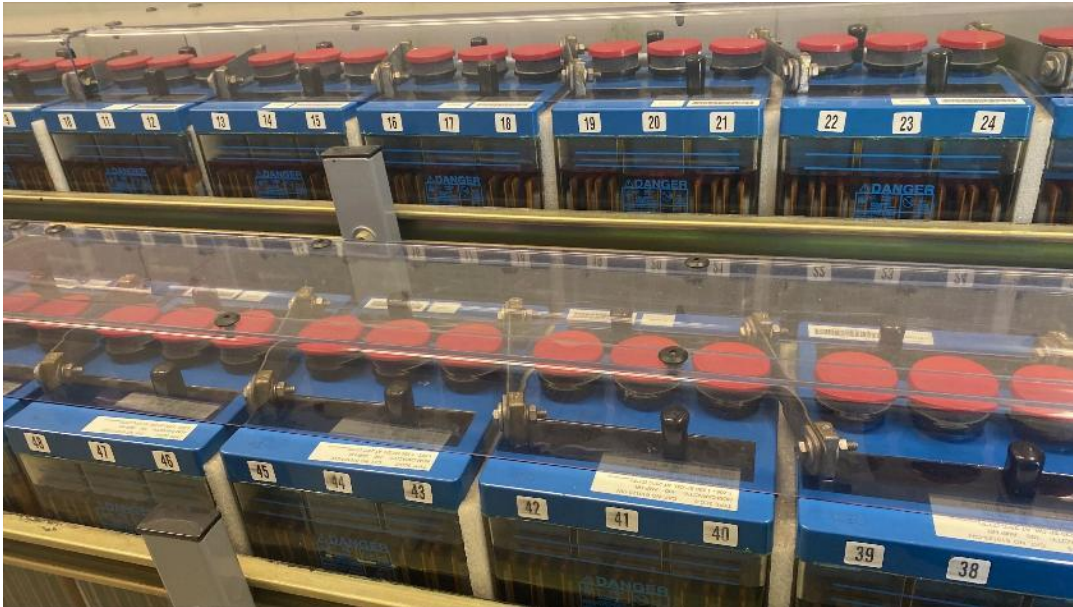
10.3. The station batteries have low water levels.<sup>18</sup>

<sup>18</sup> Post-Audit DR Response, Field Question 2 requested battery manufacturing documentation detailing requirements for water levels and refills. *Energys PowerSafe Type CC Performance Specs US-CC-PS-001 Apr06* provided by PacifiCorp did not provide information on water level requirements or detail that the water level only needs to cover the plates regardless of the minimum and maximum lines, as was discussed in the field.

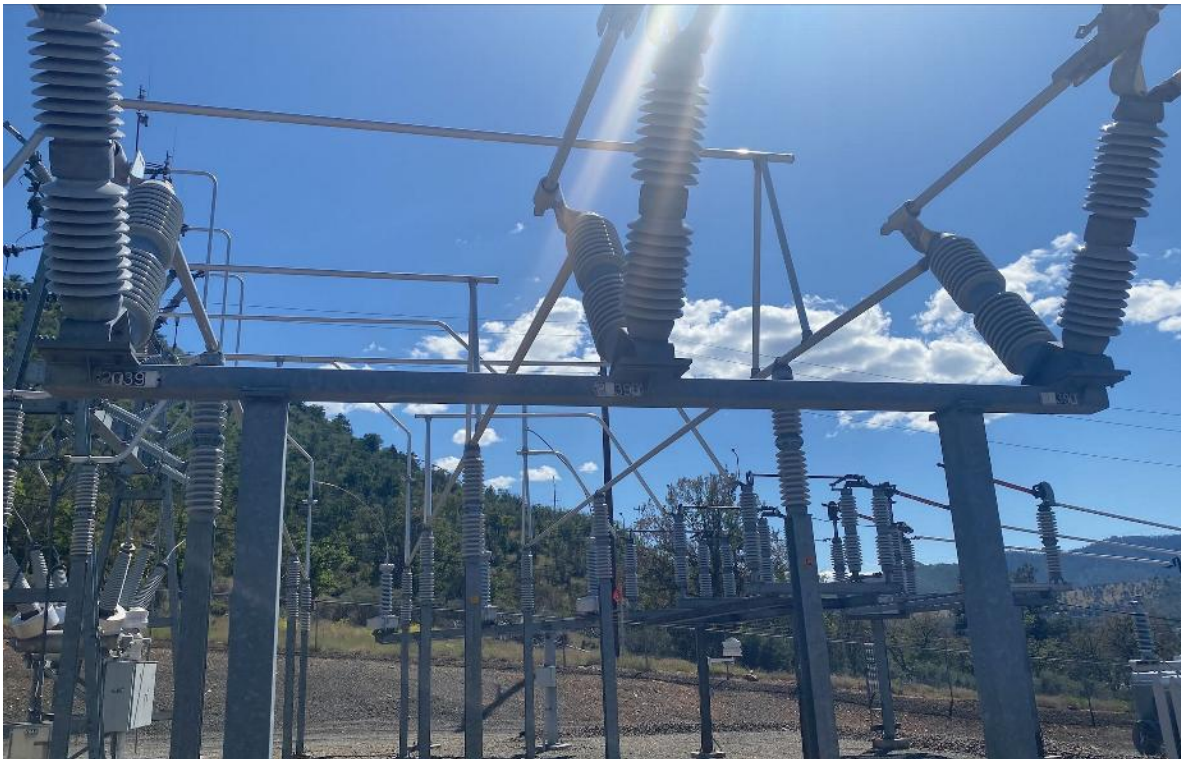
10.4. Switch 2G39 A Phase, B Phase, and C Phase have faded labels.

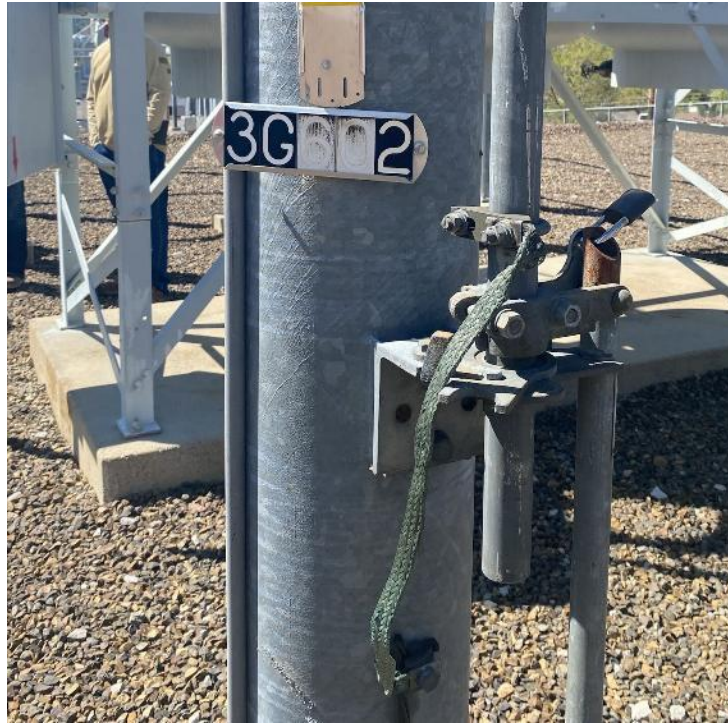
10.5. Switch 3G602 has a faded label.

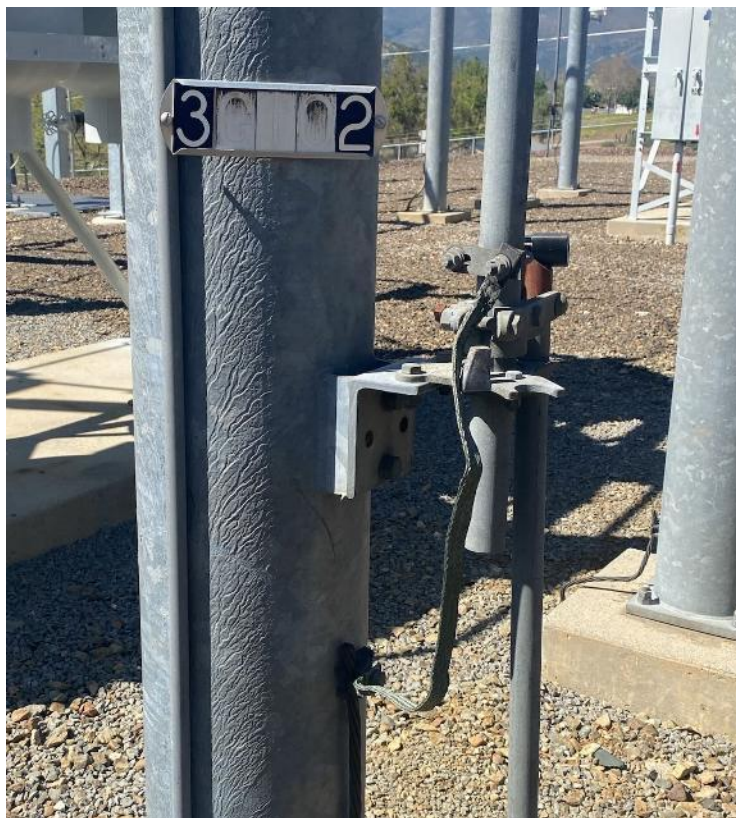
10.6. Switch 3G102 has a faded label.

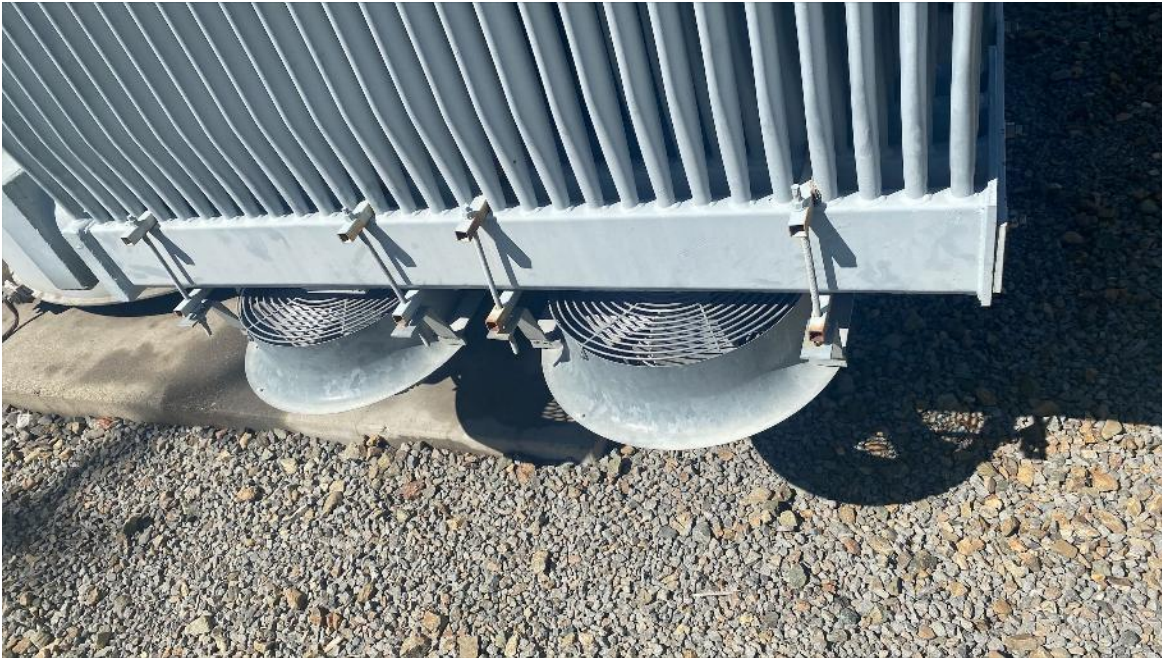
10.7. Transformer 2255 has two broken fans.

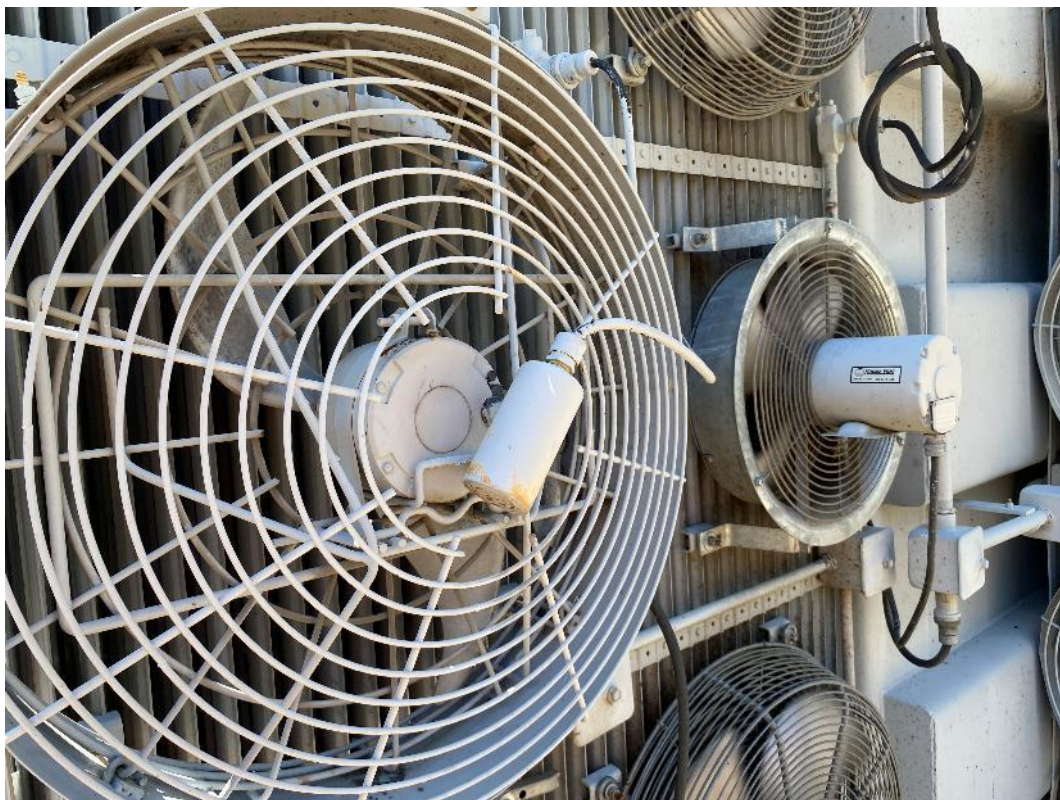
10.8. Transformer Bank 2 has a broken fan.

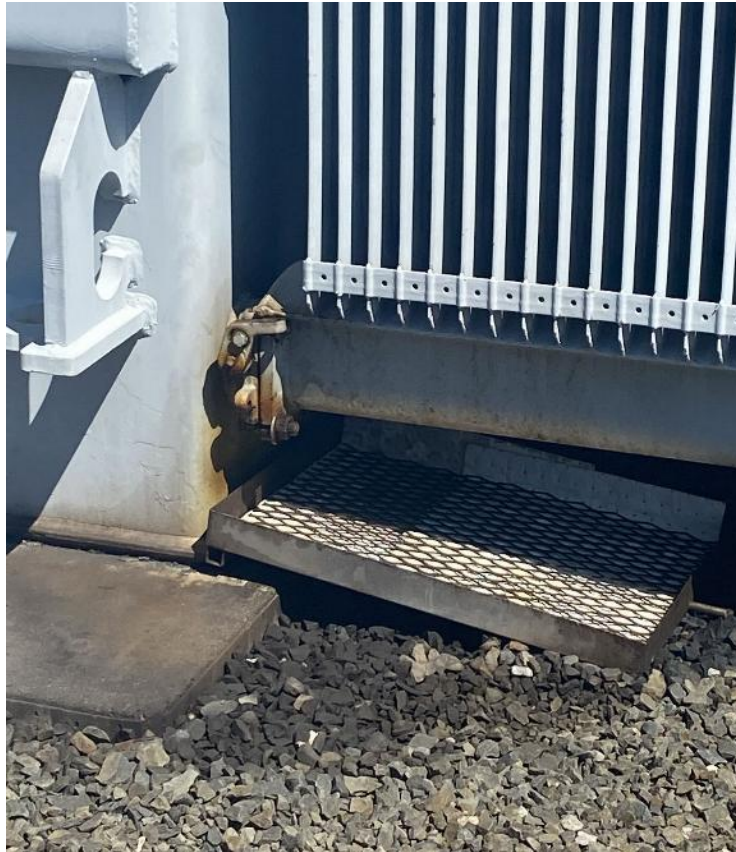
10.9. Transformer Bank 2 radiator has an oil weep.

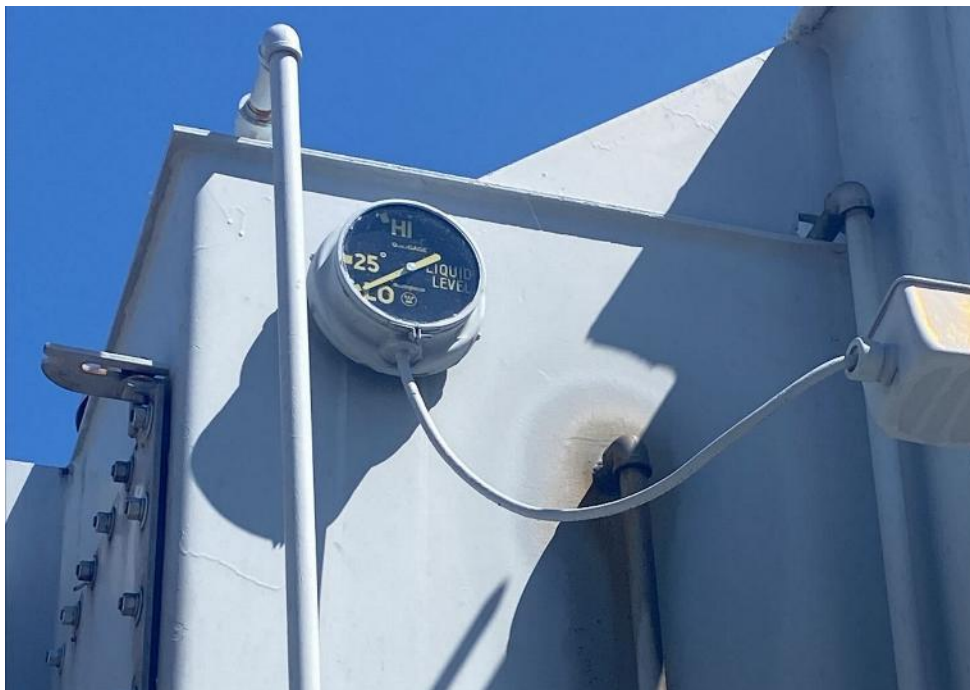
10.10. Transformer Bank 2 LTC has a low liquid level gauge.

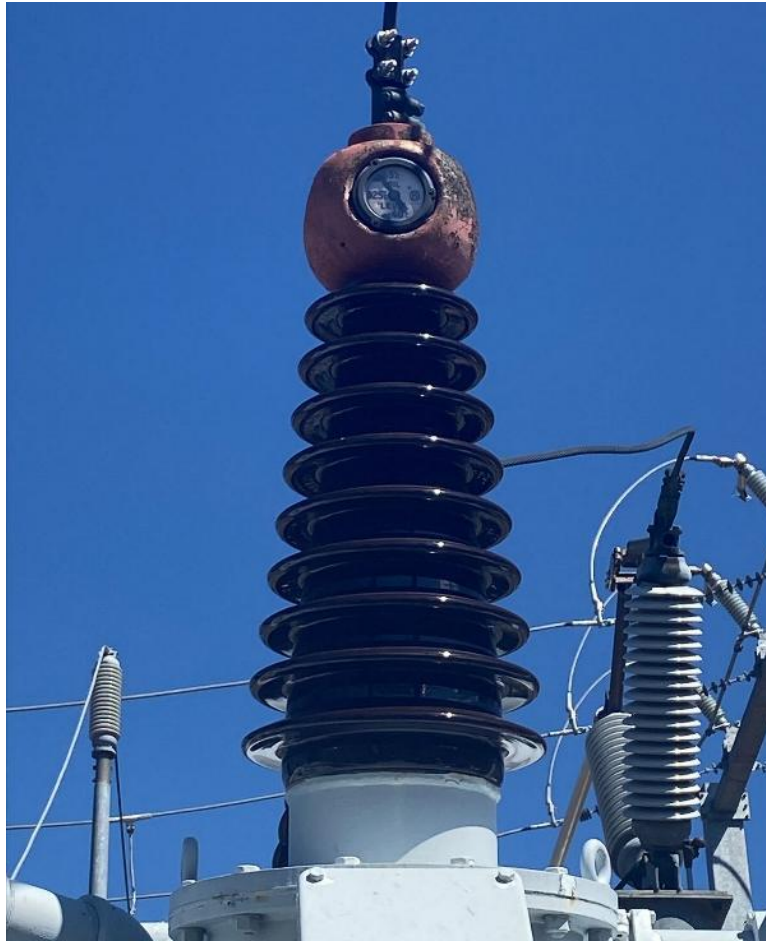
10.11. Circuit Breaker 3G100 bushing gauge is showing high oil level.

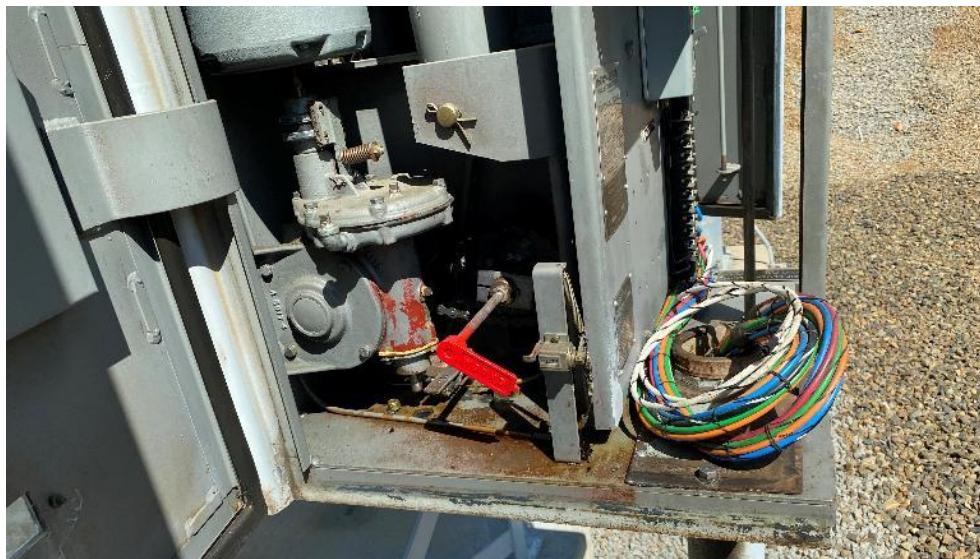
10.12. Circuit Breaker 3G100 has the wound semaphore past the viewing window (over wound).

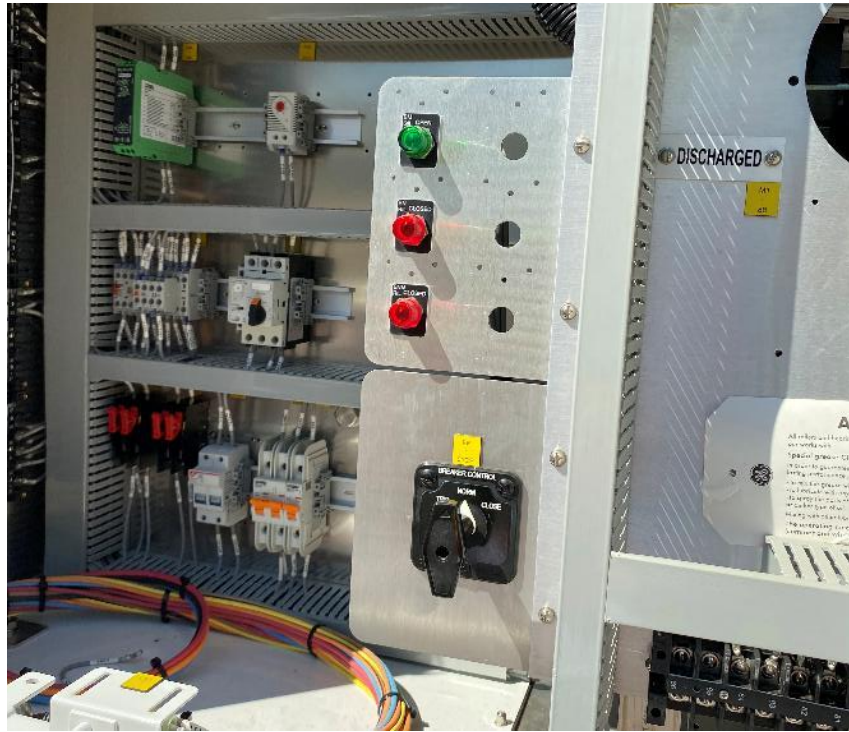
10.13. Circuit Breaker 3G85 has a broken status indicator light.

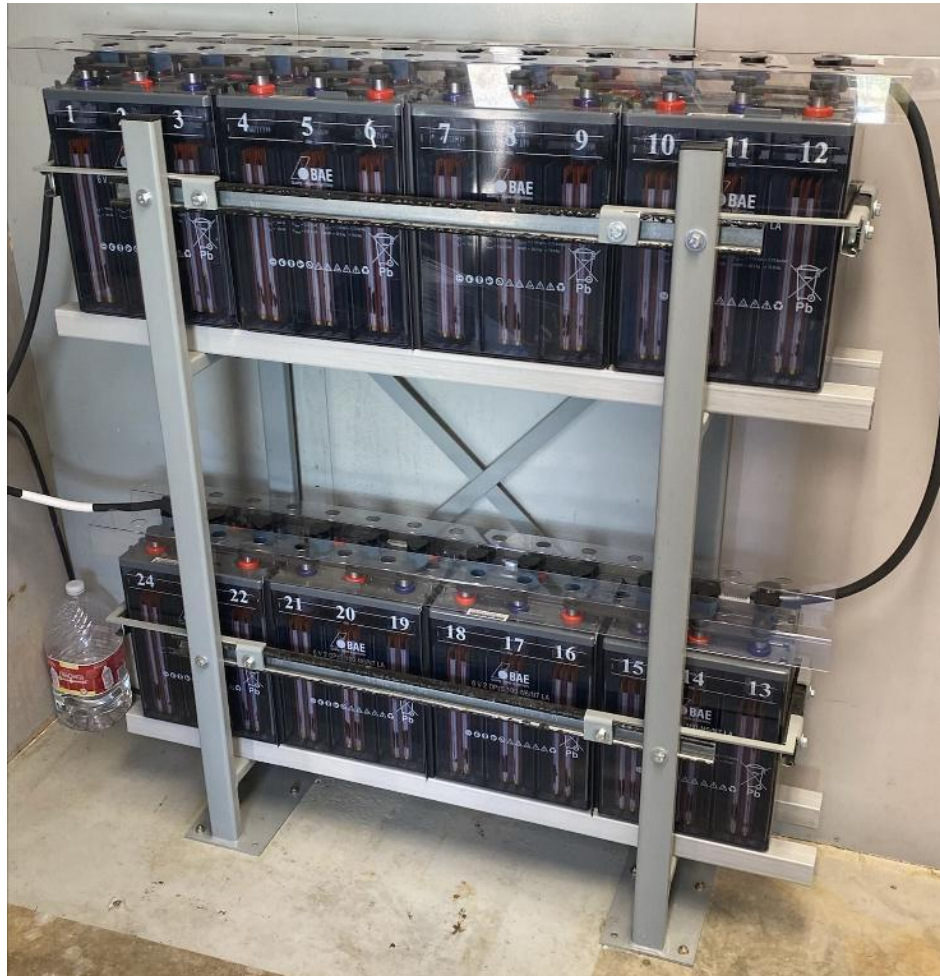
- 12.1. The station single line diagram (SLD) needs to be updated. The SLD does not show Circuit Breaker 3G4, Switch 3G605, and Switch 3G606, but the equipment is installed at the substation. The SLD also incorrectly shows Switch 15-1200 as gang operated.
- 12.2. The station batteries have no provision for containing spilled electrolytes.<sup>19</sup> Containing electrolytes can be accomplished by secondary containment, dams, absorbent materials, or spill pillows.

<sup>19</sup> National Electric Safety Code (NESC 2017), Part 1 Section 14, Item 144 states “Floors of battery areas should be of an acid-resistive material, painted with acid-resistive paint, or otherwise protected. Provision should be made to contain spilled electrolyte.”

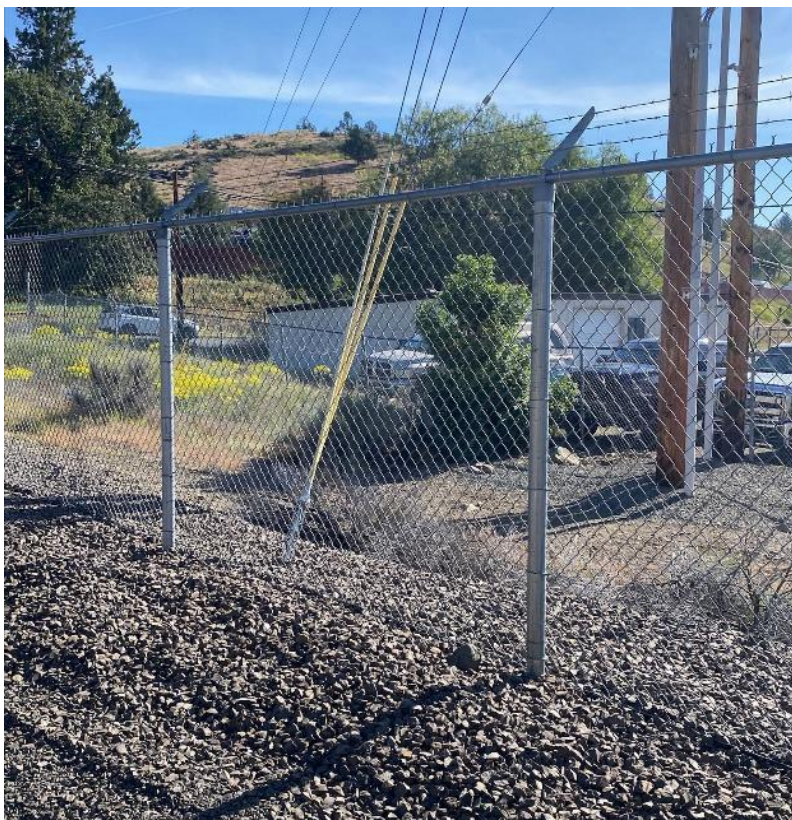
- 12.3. The station perimeter fence and a down guy wire outside of the fence have touch potential.

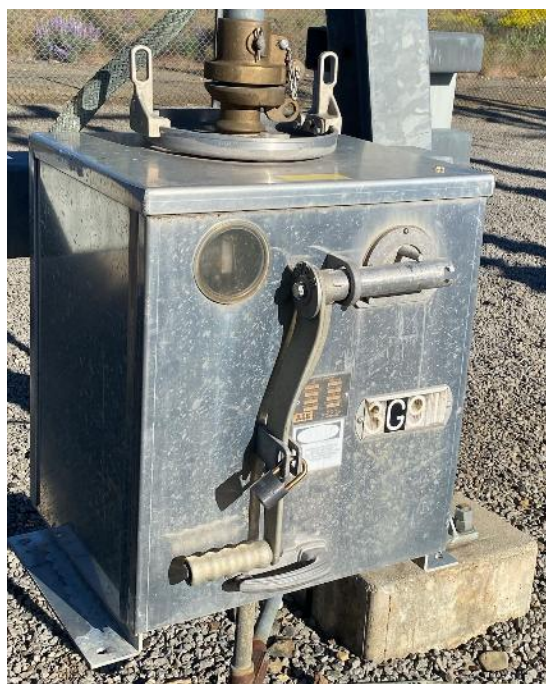
- 12.4. Switch 3G91 has a faded label.

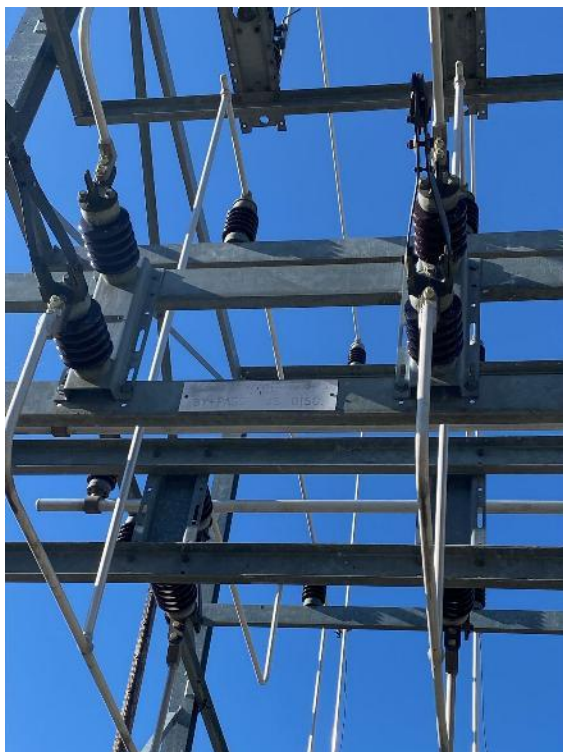
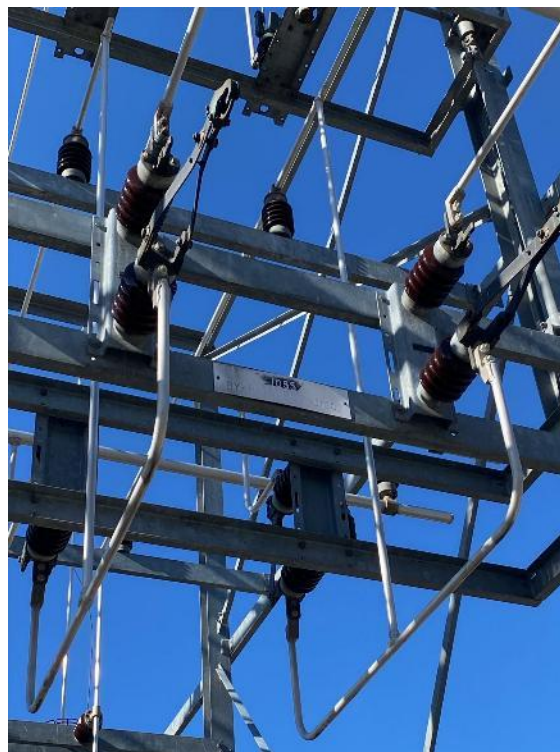
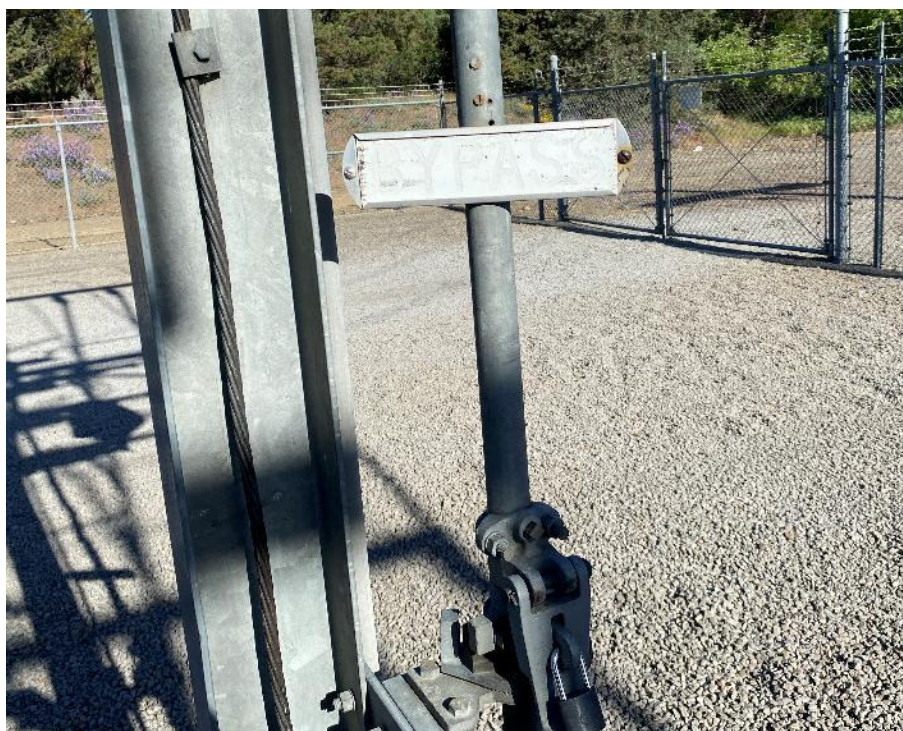
12.5. Switch 5G54 Bypass and Switch 5G57 Bypass have missing and faded labels. PacifiCorp replaced the faded labels following the field audit.<sup>20</sup>

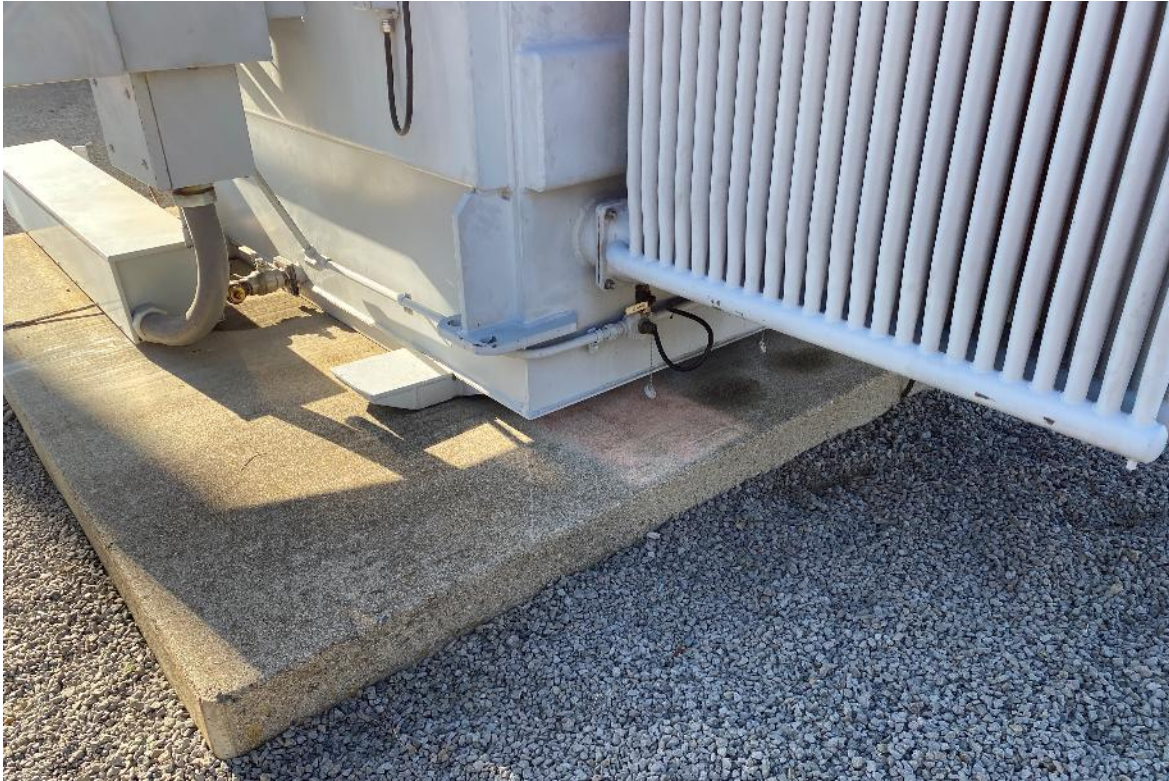
- 12.6. Transformer T2437 is not bolted to the pad (transformer installed after May 2025).

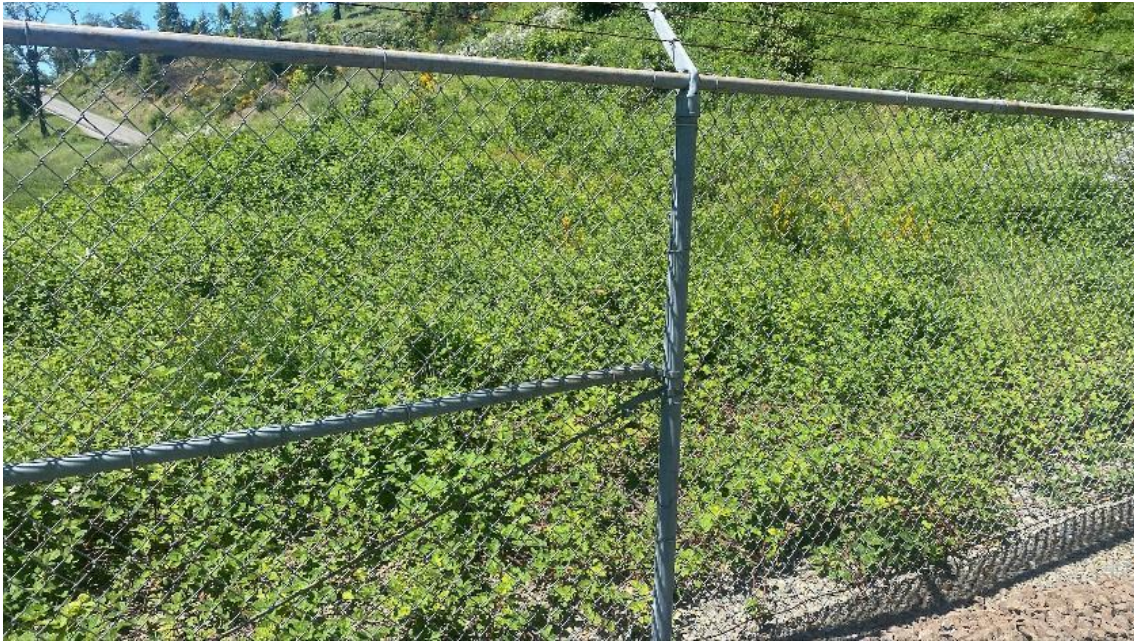
15.2. The station has vegetation encroaching on the perimeter fence.

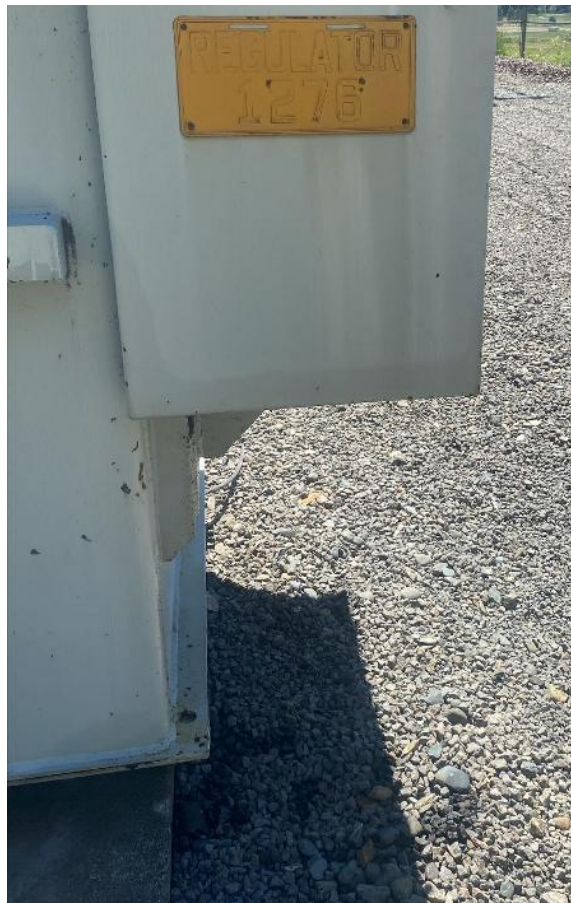
15.3. Regulator 1276 motor gear box has an oil leak.

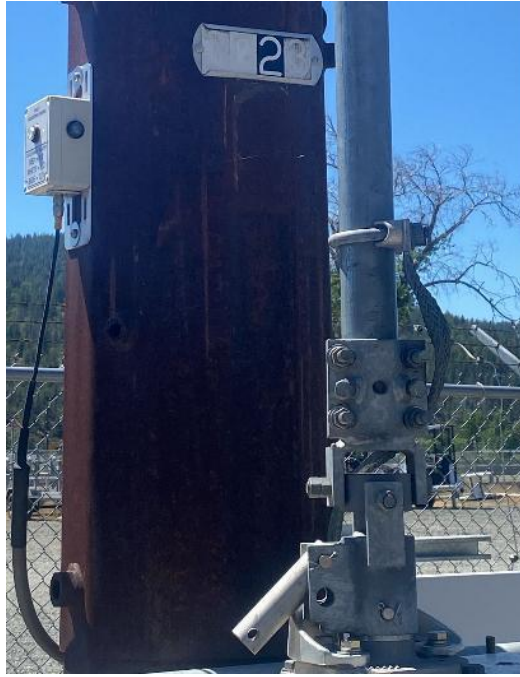
16.2. Switch 3G23 has a faded label.

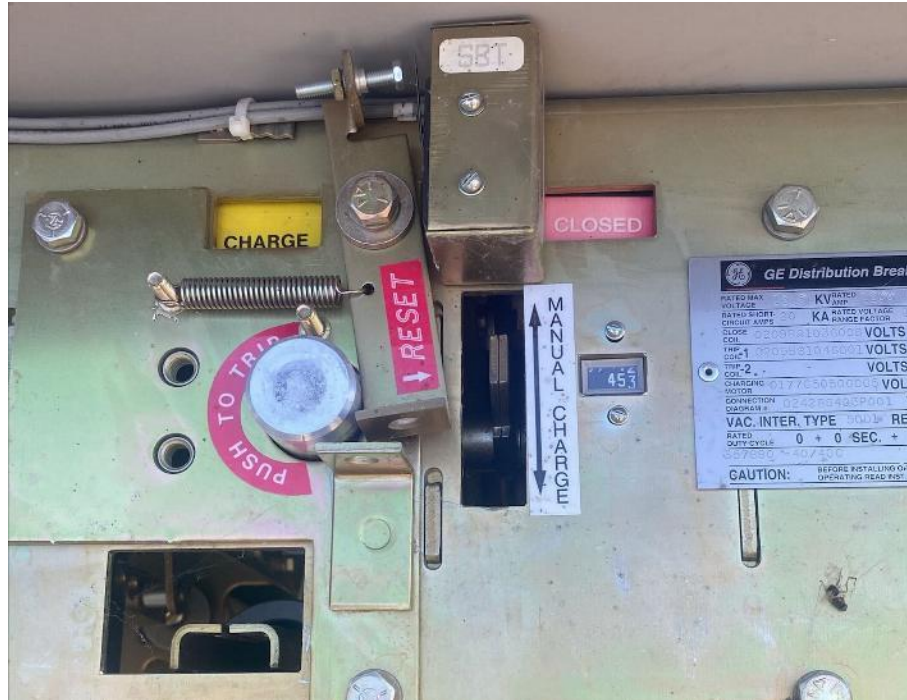
16.4. Circuit Breaker 5G2 has a faded counter.

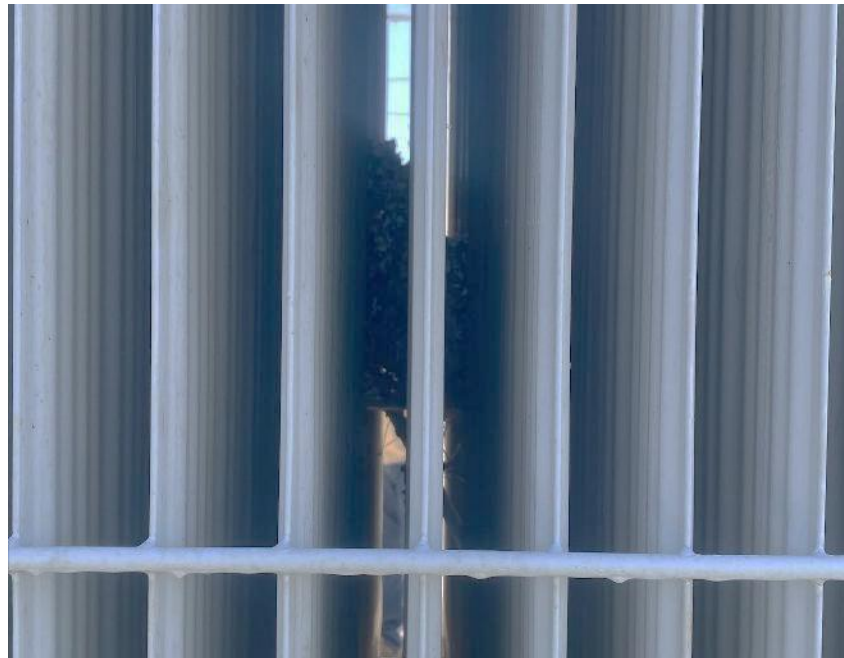
17.1. Transformer 373245 radiator has a bird's nest.
