**SUBJECT:** Electric Substation Audit of PG&E Ukiah Headquarters

Enclosure: CPUC Electric Substation Audit Report for PG&E Ukiah Headquarters

**CPUC SUBSTATION AUDIT FINDINGS**  
**PG&E UKIAH HEADQUARTERS**  
**May 11-14, 2026**

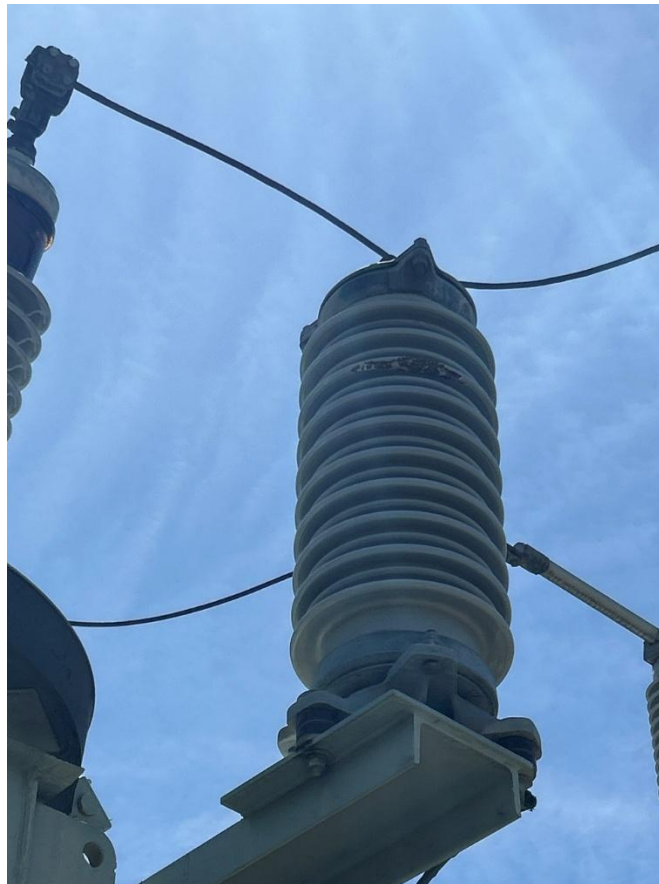
1.1. There is a broken insulator on Transformer Bank 2.

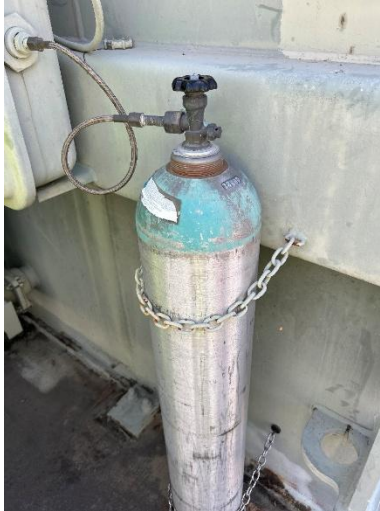
1.2. There was an empty nitrogen tank. The empty nitrogen tank was subsequently replaced in the field.

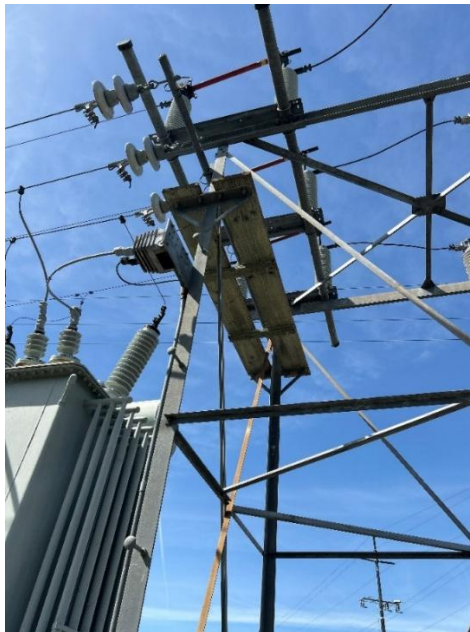
- 2.1. There is a wood platform on the substation support structure. There is an existing tag for this finding.

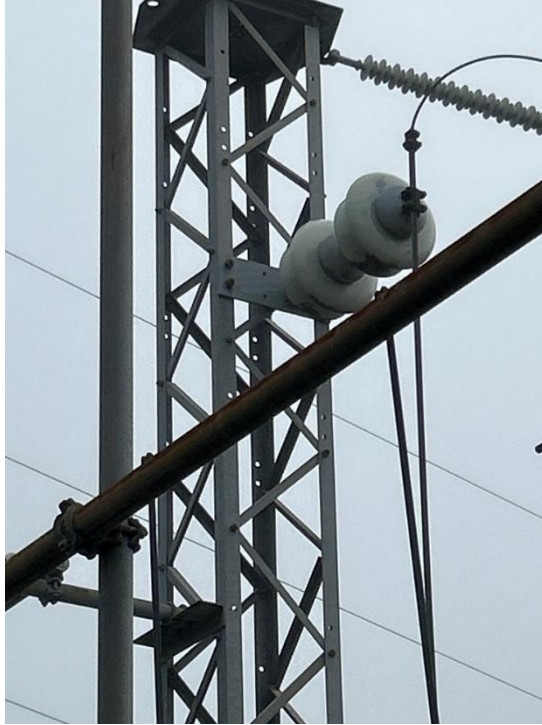
- 3.1. There is a damaged insulator on the support structure by the transformer bank. There is an existing tag 133374047.

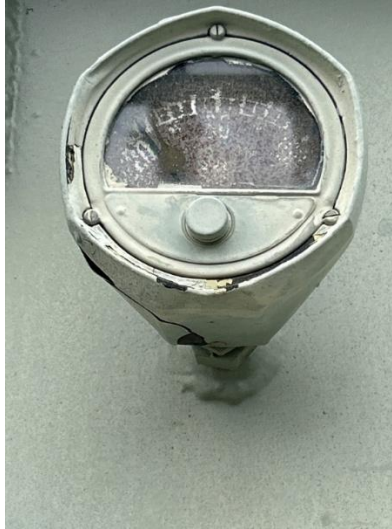
- 4.1. The temperature gauge on Regulator 1 is illegible. There is an existing tag 133375029.

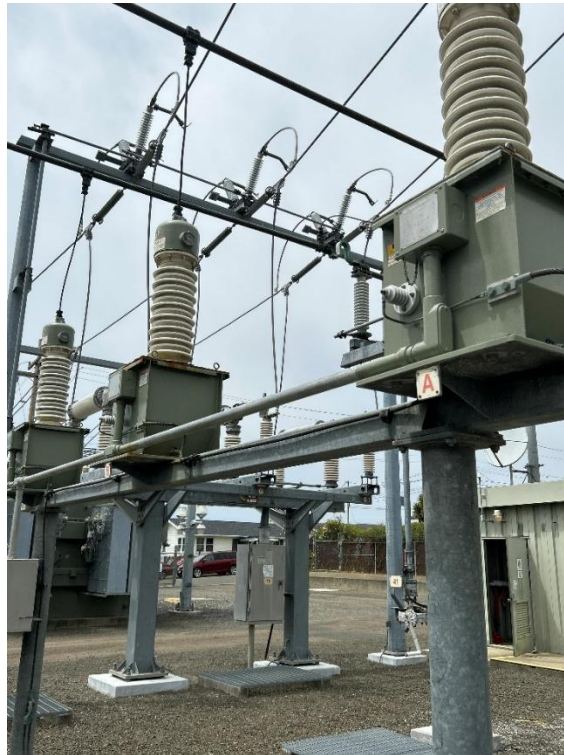
- 5.1. There is corrosion on the B Phase potential transformer of the high side bus. There is also corrosion on the other phases. There is an existing tag 131099689.

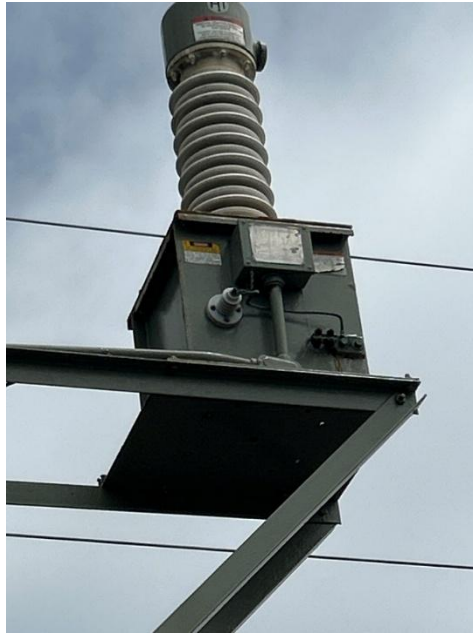
5.2. There is rust on Elk-Fort Bragg line structure. There is an existing tag 133376140.

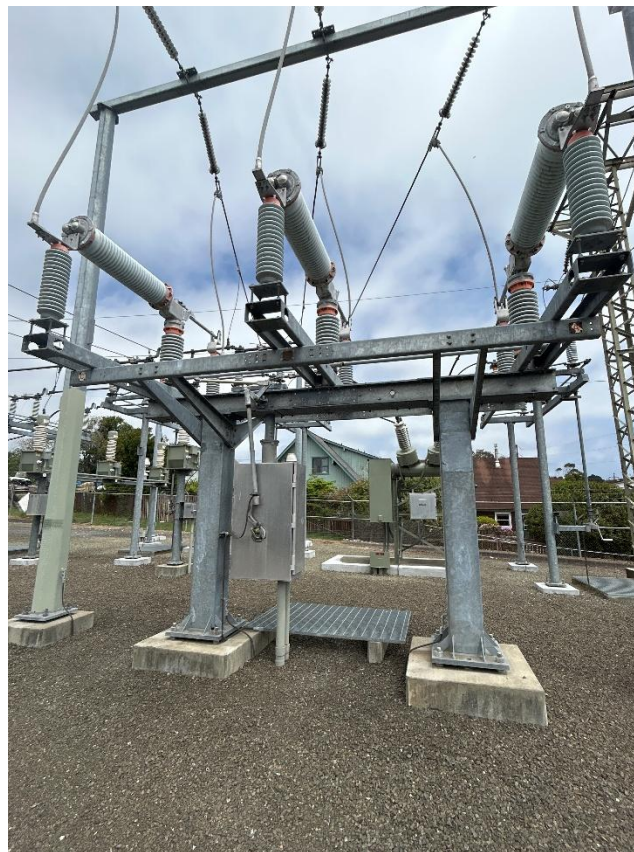
5.3. The labeling (target plate) on B Phase is illegible near Switch 86. There is an existing tag 133376148.

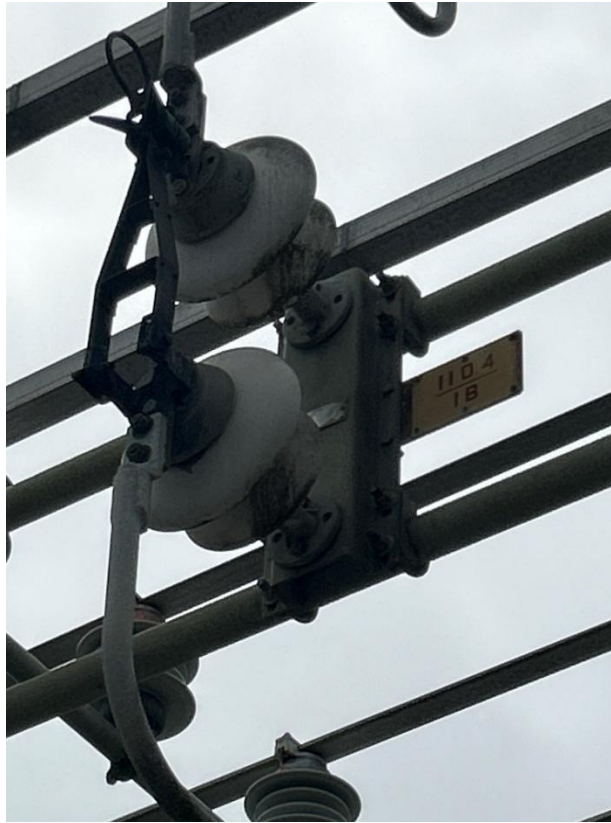
5.4. There are dirty insulators on 1104/1B.

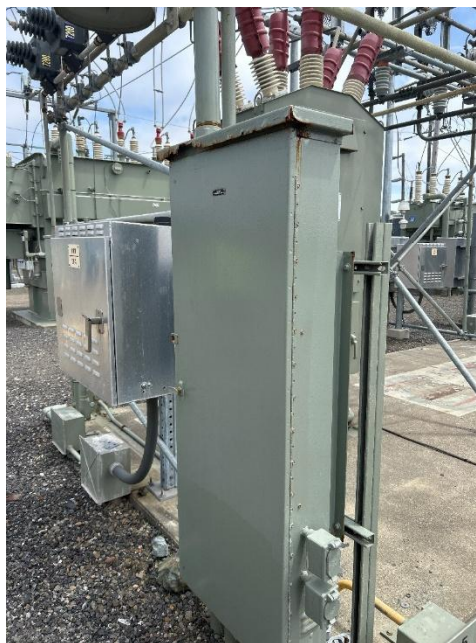
5.5. There is corrosion on outdoor AC Panel 1. There is an existing tag 131099687.

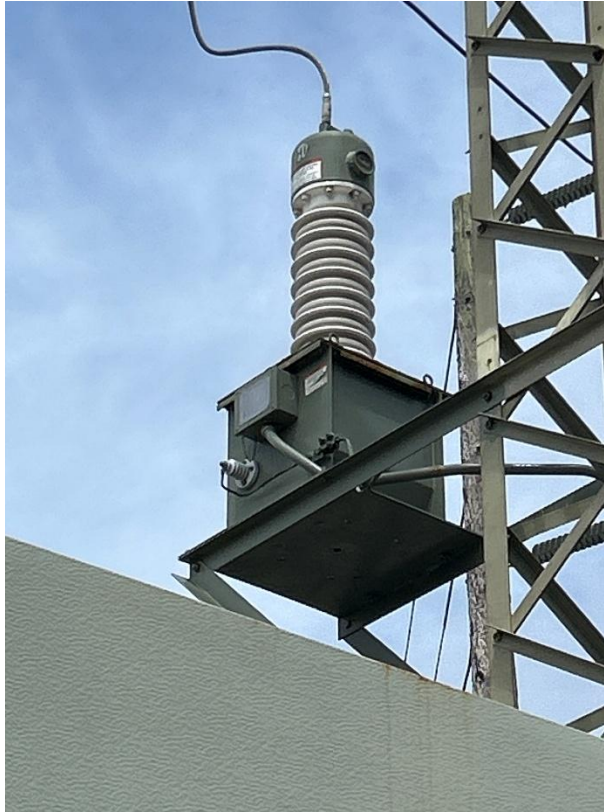
- 5.6. The Mendocino-Willits-Fort Brag line structure potential transformer has corrosion. There is an existing tag 133376142.

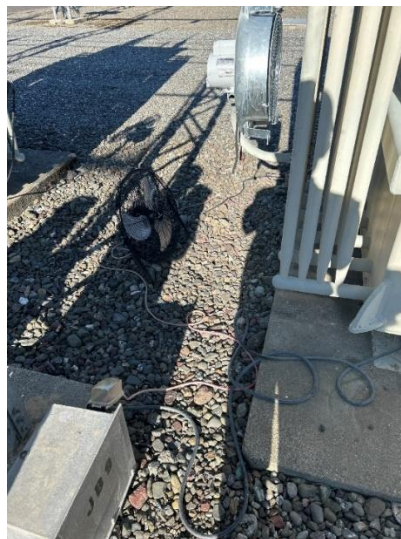
- 6.1. A temporary fan is not working on the spare transformer bank. There is an existing tag 132921604.

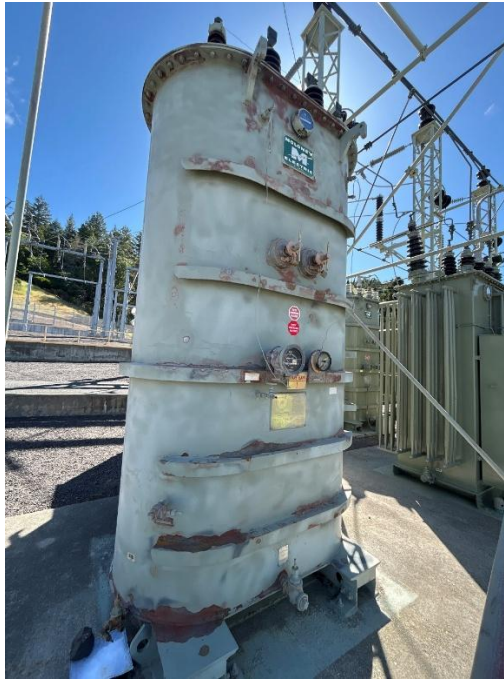
- 7.1. There is corrosion on the spare transformer bank. There is an existing tag 129859400.

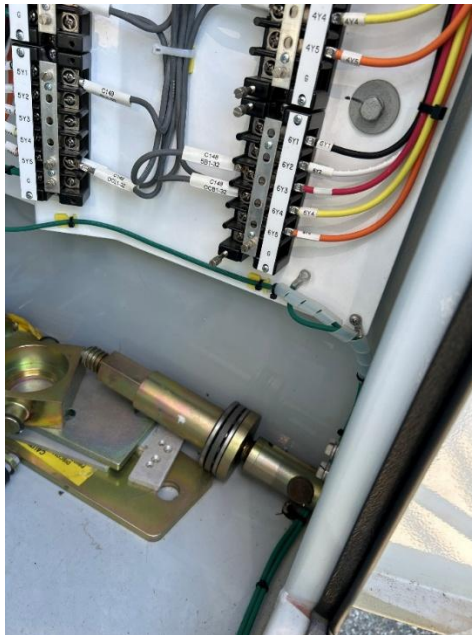
- 8.1. There was a lifted wire inside HVCB 32. This was resolved on site.

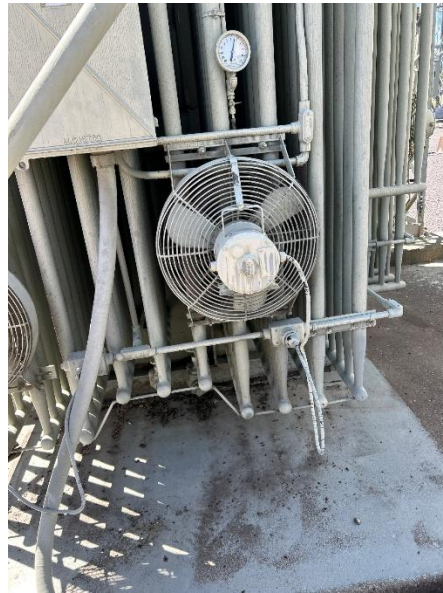
8.2. A fan for Transformer Bank 1 C is not operational. There is an existing tag 133377033.

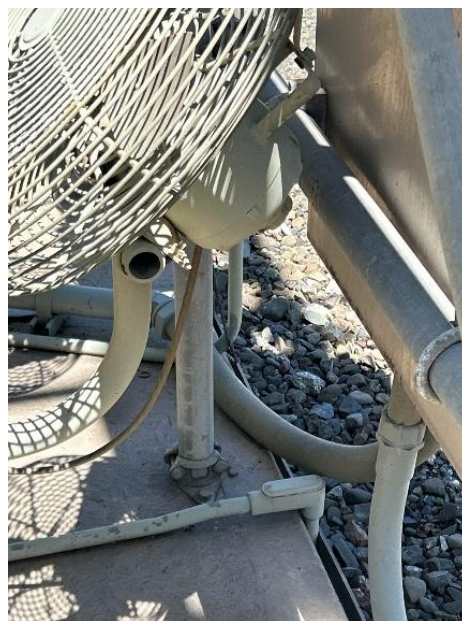
9.1.A Regulator 2 fan is not operational. There is an existing tag 133299299.

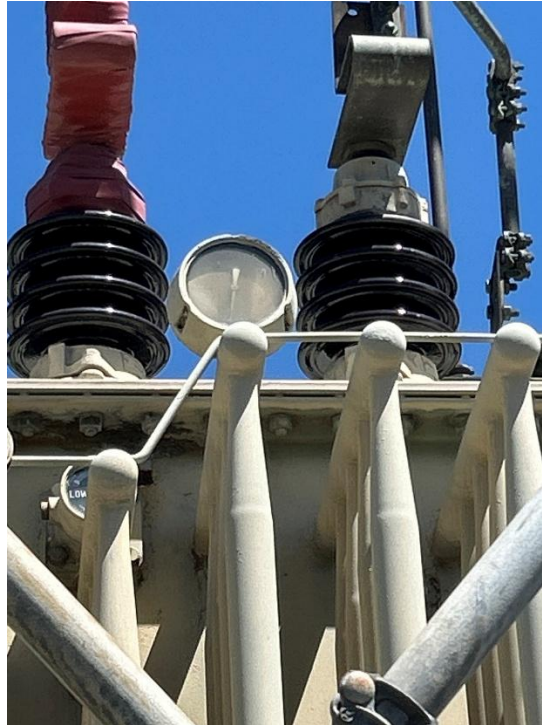
- 9.2. There is a gauge that shows a low reading and is illegible on Transformer Bank 2A. There is an existing tag 133376873.

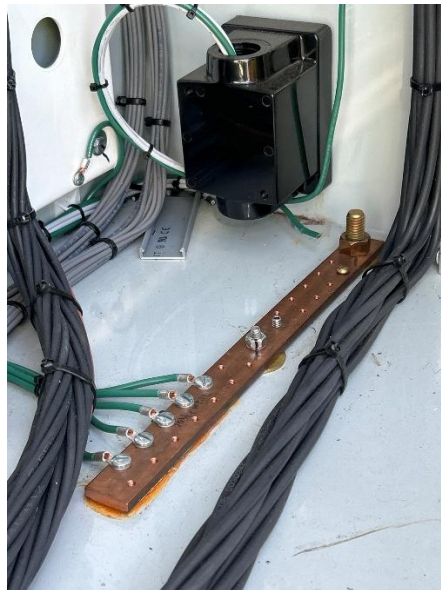
- 9.3. There was a lifted cable at HVCB 12. This was resolved on site.

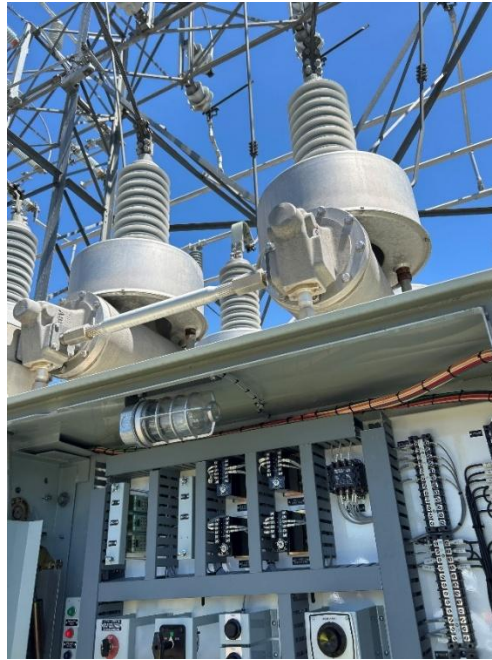
9.4. There is a light out in the cabinet of HVCB 12. There is an existing tag 133299621.

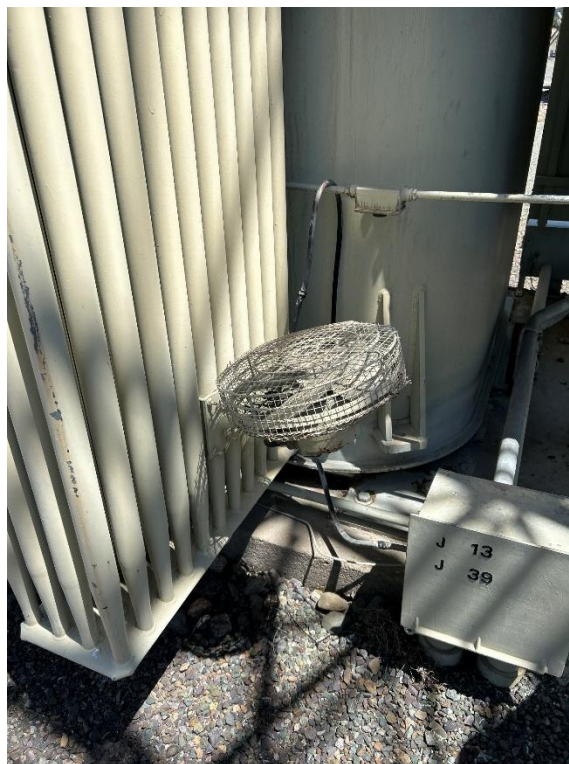
9.5. A fan for Regulator 1 is not operational. There is an existing tag 133300150.

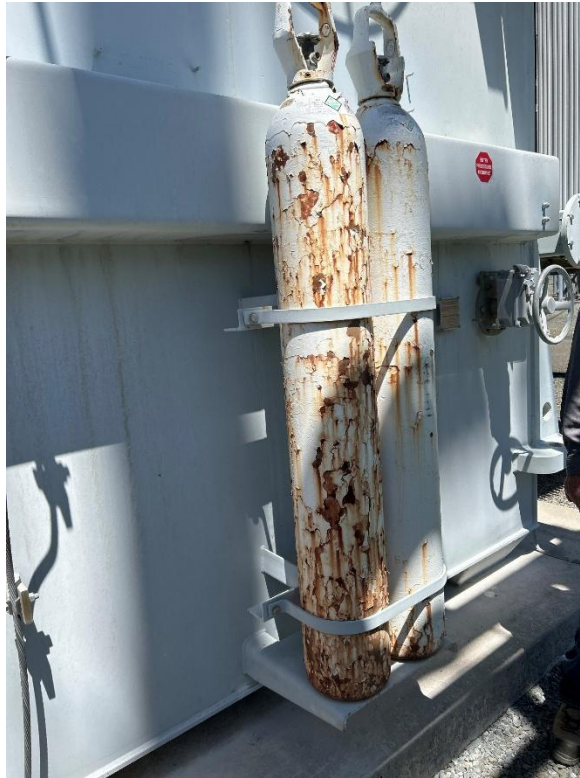
9.6. There is corrosion on the nitrogen tanks at Transformer Bank 3.

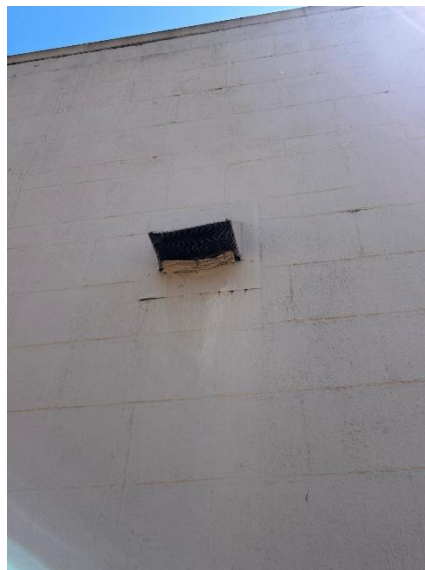
9.7. PG&E was unable to confirm that the battery room exhaust fan is operational. The exhaust fan controls could not be found.

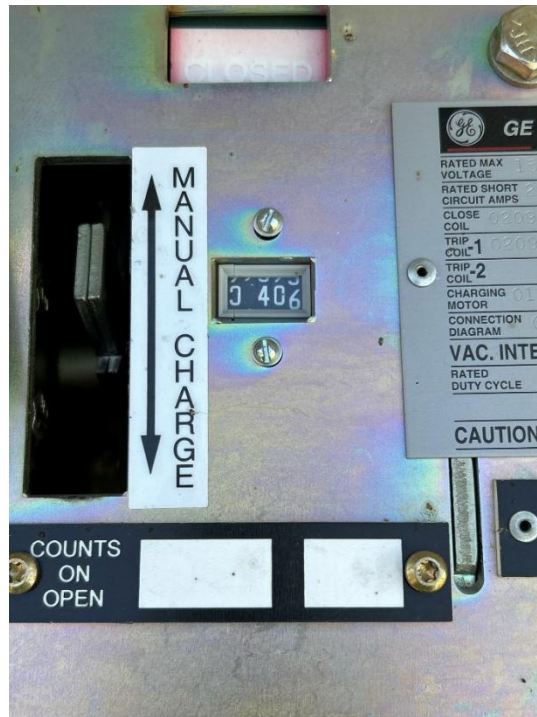
10.1. The CB 1101/2 counter is illegible. There is an existing tag 132979362.

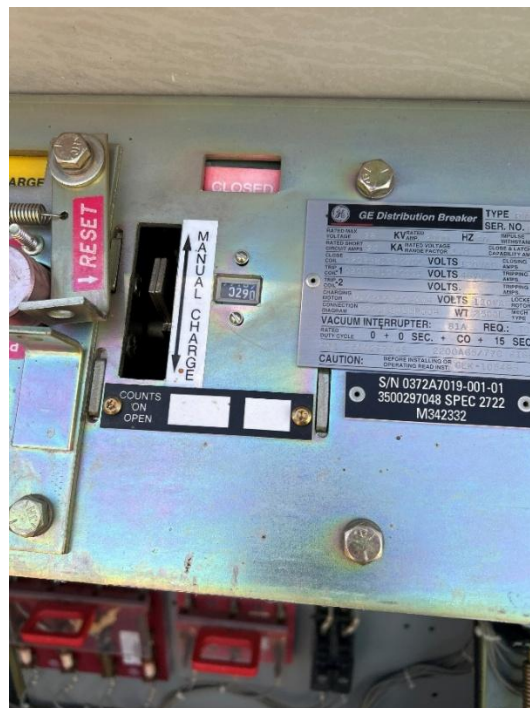
10.2. The CB 1100/2 counter is illegible. There is an existing tag 132979365.

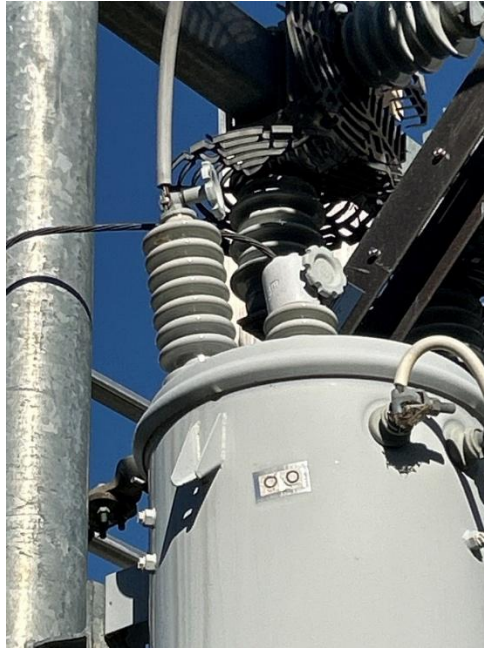
11.1. A bird abatement device fell off at the station service number 2 transformer.

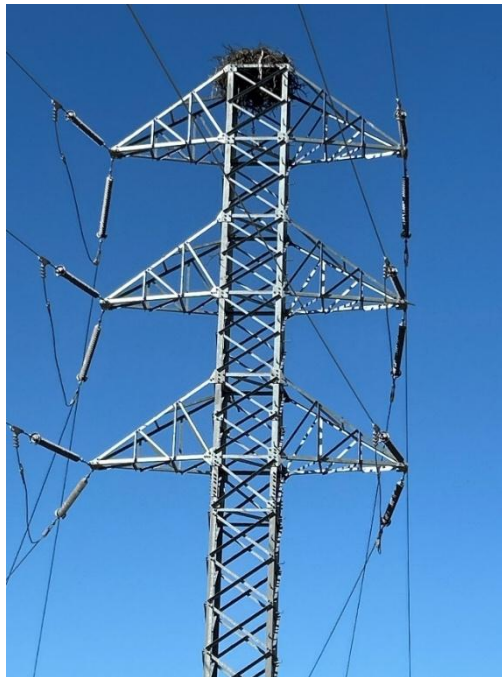
12.1. There is a large bird nest on a 115 kV tower. There is an existing tag 132947123.

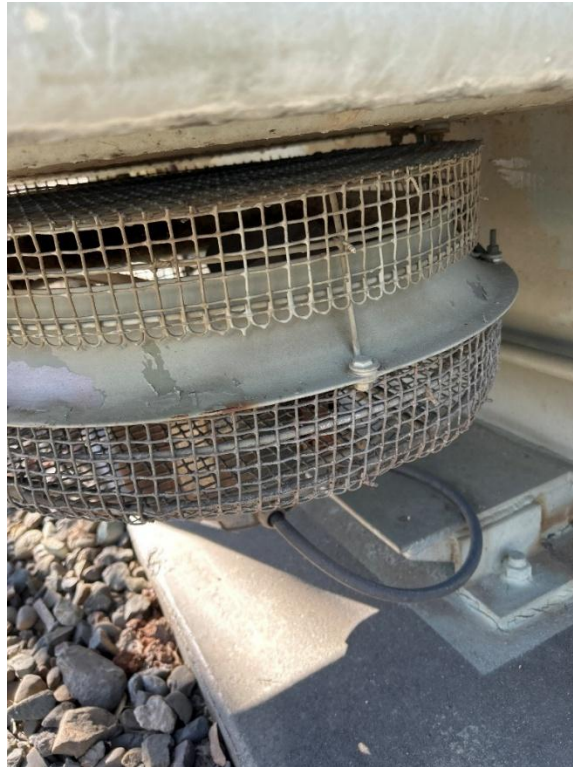
12.2. A fan for Transformer Bank 3 is not operational.

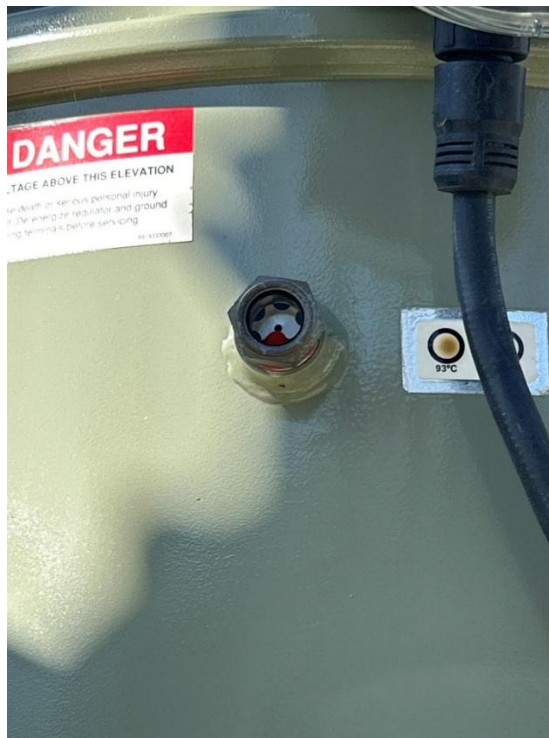
12.3. The oil level indicator is low on Regulator 3 C phase.

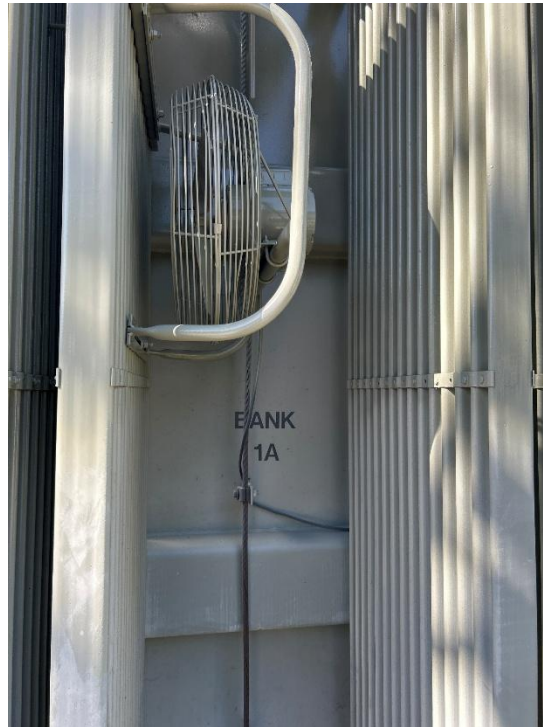
12.4. There are Transformer Bank 1A fans that are not operational. There is an existing tag 133377019.

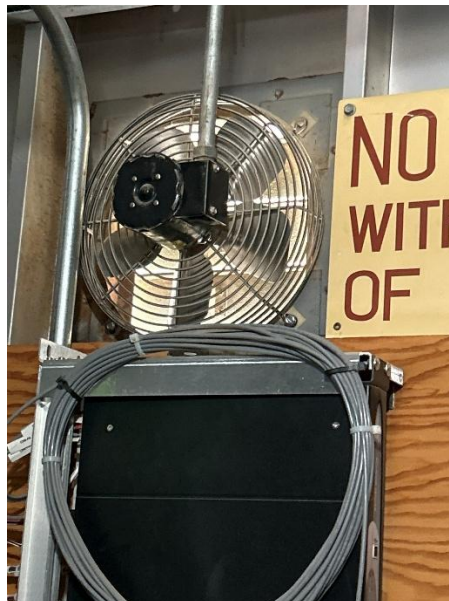
13.1. The battery room exhaust fan is not functioning. There is an existing tag 133376855.

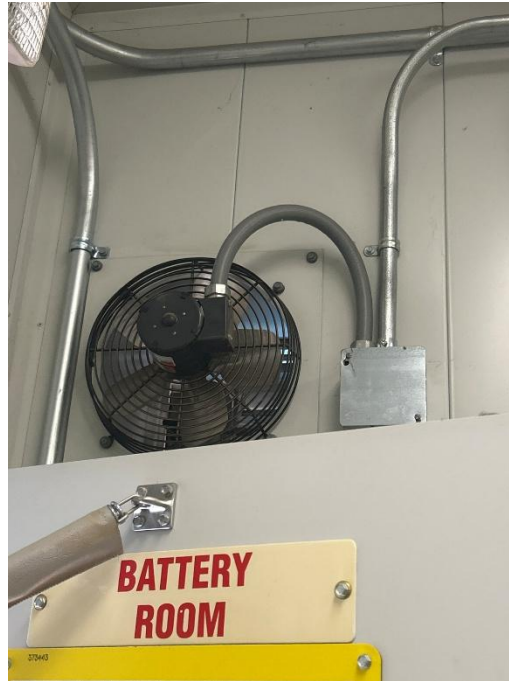
- 14.1. The exhaust fan is inoperable. PG&E was unable to demonstrate that the exhaust fan was functioning properly.

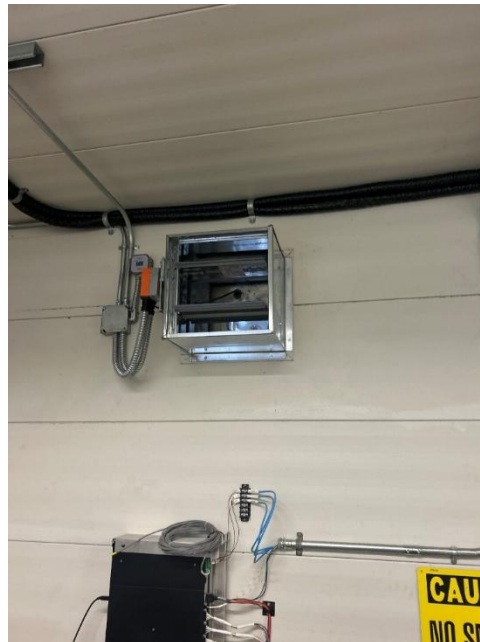
- 15.1. The exhaust fan in the battery room is not operational. There is an existing tag 133297505.

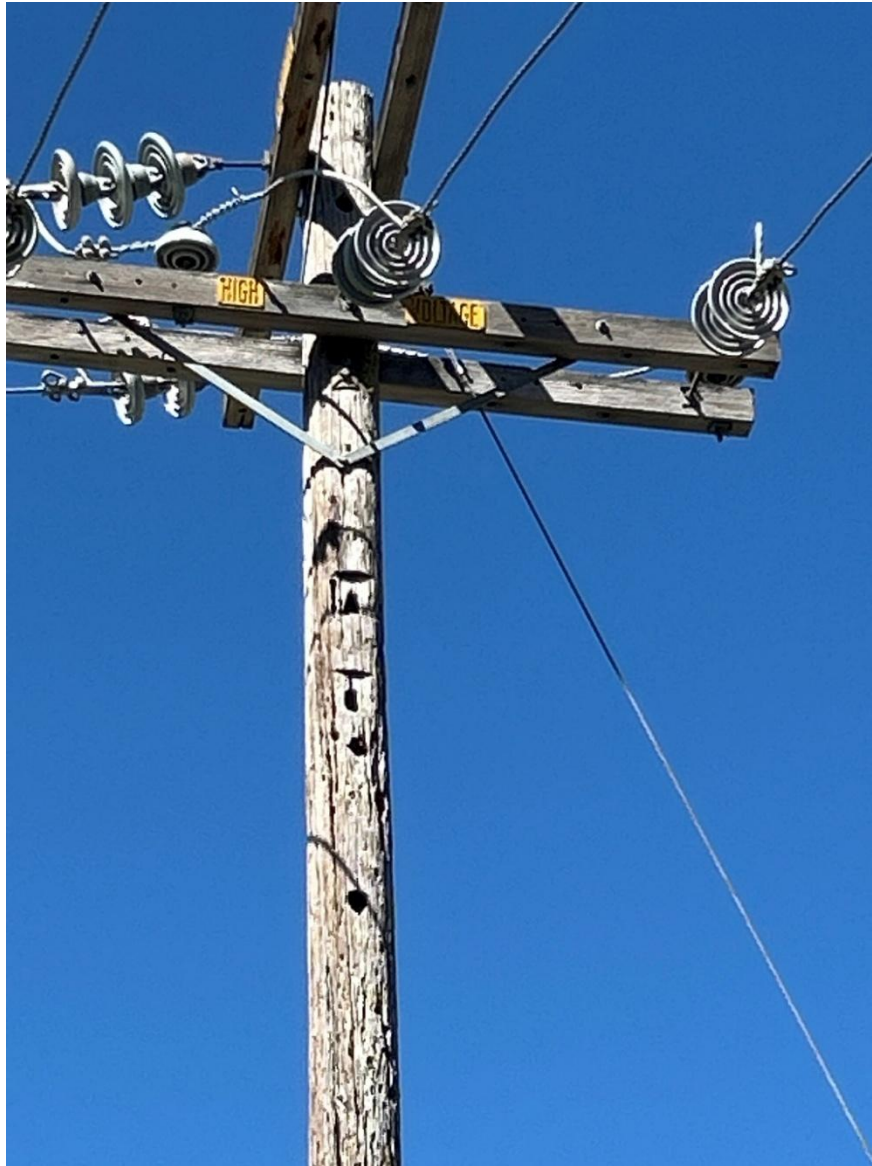
**1. Laytonville Substation**

*“Lines or parts thereof shall be replaced or reinforced before safety factors have been reduced (due to factors such as deterioration and/or installation of additional facilities) in Grades “A” and “B” construction to less than two-thirds of the safety factors specified in Rule 44.1 and in Grade “C” construction to less than one-half of the safety factors specified in Rule 44.1. Poles in Grade “C” construction that only support communication lines shall also conform to the requirements of Rule 81.3–A.. In no case shall the application of this rule be held to permit the use of structures or any member of any structure with a safety factor less than one.”*

- a. A pole in the substation has several holes in it.
