**SUBJECT: Energy Storage System Audit of Gateway Energy Storage Audit Number  
ESS2025-01GW**

# CPUC Audit Findings of Gateway Energy Storage June 2 – 5, 2025

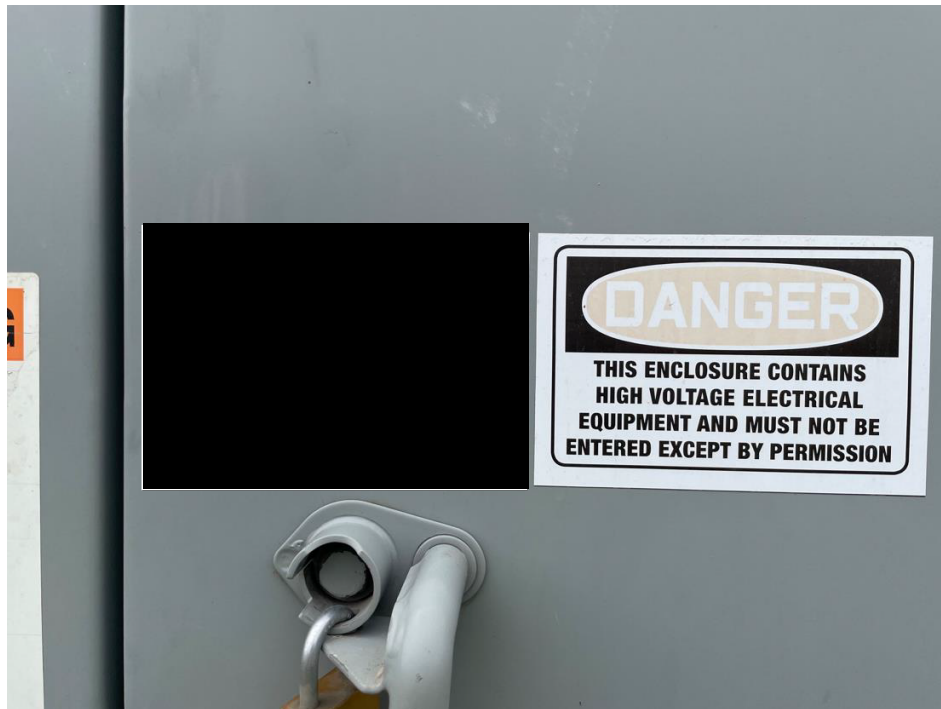
### **Finding 1: Gateway Energy Storage (Gateway) has not conducted an Arc Flash analysis for Gateway 1 and substation equipment since 2020.**

During the audit, Electric Safety and Reliability Branch (ESRB) inspectors reviewed Gateway’s arc flash documentation and found that the most recent arc flash analysis for equipment at Gateway 1 and the substation was completed in 2020. Gateway did not provide an updated study for this portion of the site, and several arc flash labels on equipment still reflected the 2020 analysis date. Gateway must perform an updated arc flash analysis for all applicable equipment at Gateway 1 and the substation to maintain compliance with NFPA 70E and ensure personnel are protected from arc flash hazards. Additionally, Gateway must implement a process to ensure arc flash and incident energy analyses are reviewed and updated at least once every five years. Gateway must submit the updated arc flash documentation to ESRB for review and verification.

Figure 1: Arc flash sticker with a 2020 analysis date.

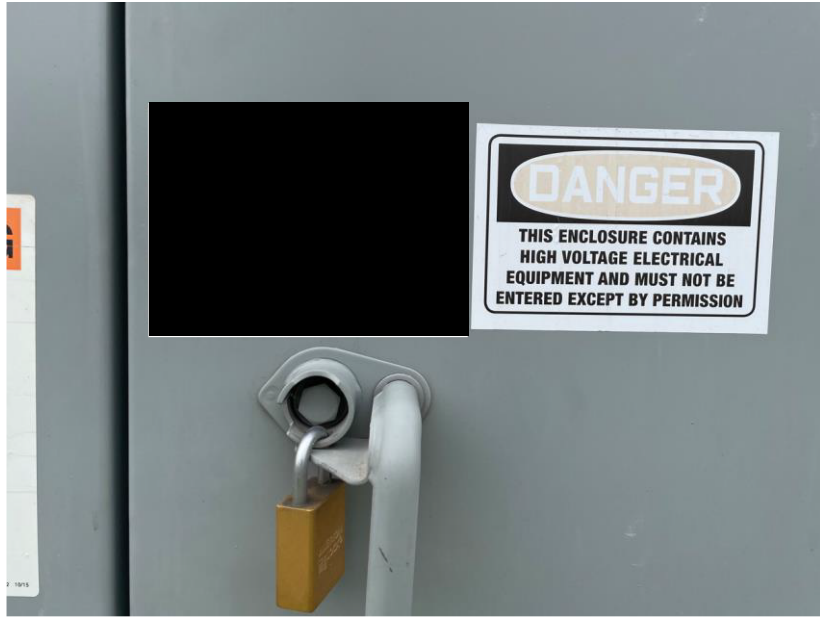
**Finding 16: Gateway must replace deteriorated signage.**

ESRB inspectors observed faded safety signage throughout the Gateway facility. Clear and legible signage is essential to ensure worker safety and regulatory compliance. During the audit, inspectors noted that prolonged sun exposure and general wear had reduced the legibility of various labels. Gateway must conduct a site-wide review of all safety signage and labeling, replace any that are faded or illegible, and incorporate signage checks into routine inspection procedures to ensure labels remain in good condition. Gateway must also provide photographic evidence of the replaced signage and a description of the implemented inspection process to ESRB for review and verification.

Figure 10: Deteriorated signage.
