Re: CPUC Audit Findings of High Winds Energy Center October 21-24, 2024
Audit Number GA2024-13HW
Due Date: January 24, 2025

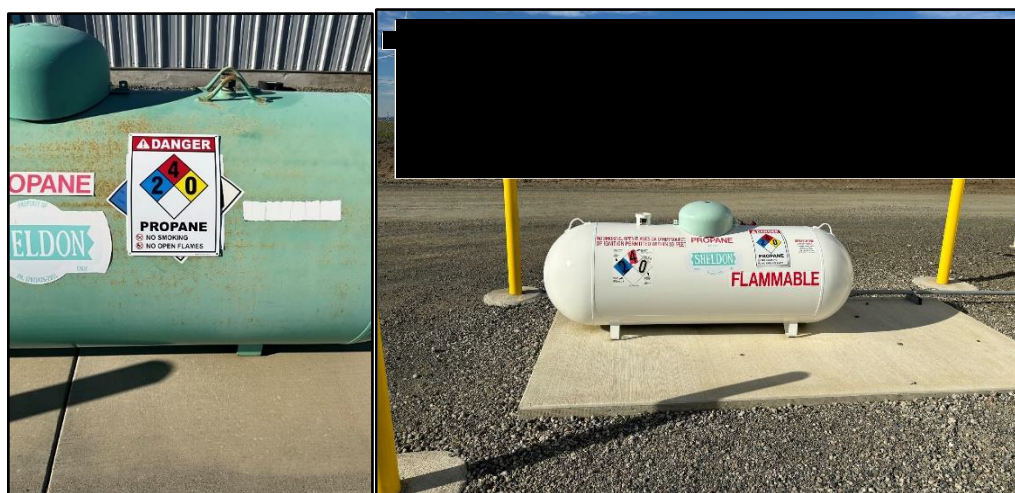
1. The NFPA 704 placard on the propane tank was faded. This sign should be replaced so that the colors on the sign are legible. Colors on the NFPA 704 placard help easily identify the hazards associated with the material, such as propane.
 - a. NFPA 704 Placard on the propane tank has been replaced.
 - b. Completed 1/10/25:

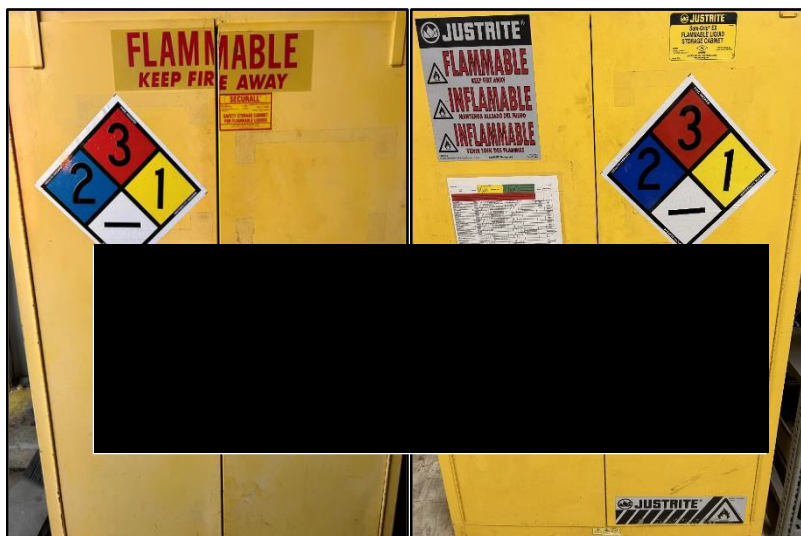
2. The flammable material storage cabinets at both the Montezuma and High Winds O&M Buildings did not have the appropriate NFPA 704 placards showing the fire hazard of the contents in the cabinet. The appropriate NFPA 704 placards must be located on the cabinets and the at the primary entrances of the buildings housing them.

- a. NFPA 704 placards were ordered and posted on all cabinets as per the audit. Pictures shown below.
- b. Completed 1/15/25.
