SUBJECT: Generation Audit of High Winds Energy Center - Audit Number GA2024-13HW

CPUC AUDIT FINDINGS OF HIGH WINDS ENERGY CENTER OCTOBER 21 – OCTOBER 24, 2024

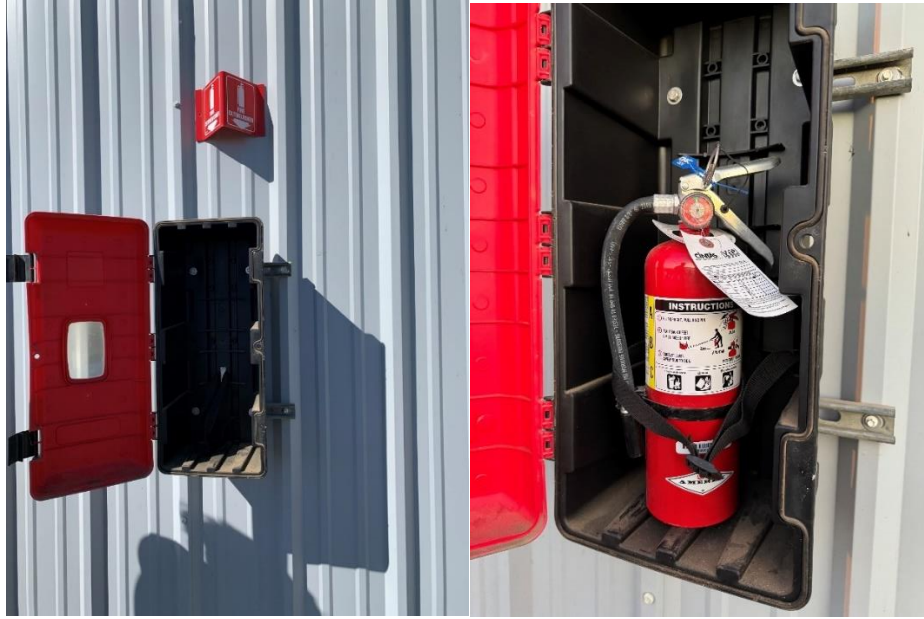
1. ESRB observed that there was a missing fire extinguisher at the Montezuma Operations and Maintenance (O&M) Building.⁵ Safety equipment must be readily available at the identified locations in the event of an emergency. The Plant placed a fire extinguisher at this location during the audit.

Figure 1: Missing (Left) and Replaced (Right) fire extinguisher [REDACTED]

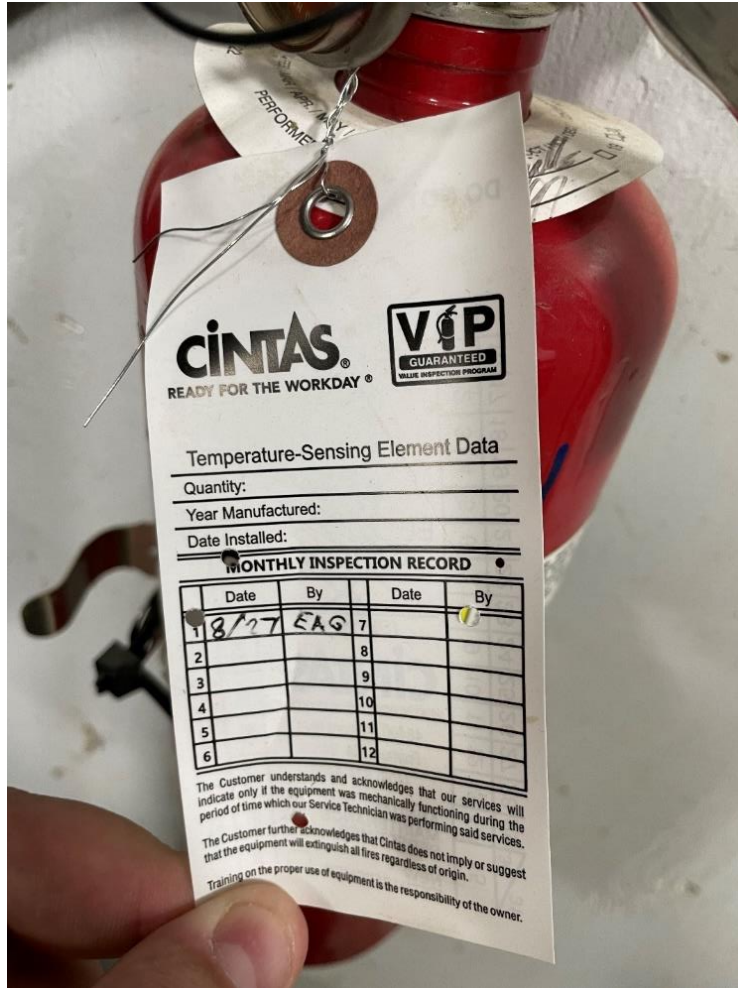
2. Three fire extinguishers located in the High Winds Spare Parts Building had not been inspected in September, the month prior to ESRB's audit. These fire extinguishers were later inspected by the Plant during the audit.

Figure 2: One example of the fire extinguishers in the High Winds Spare Parts Building.

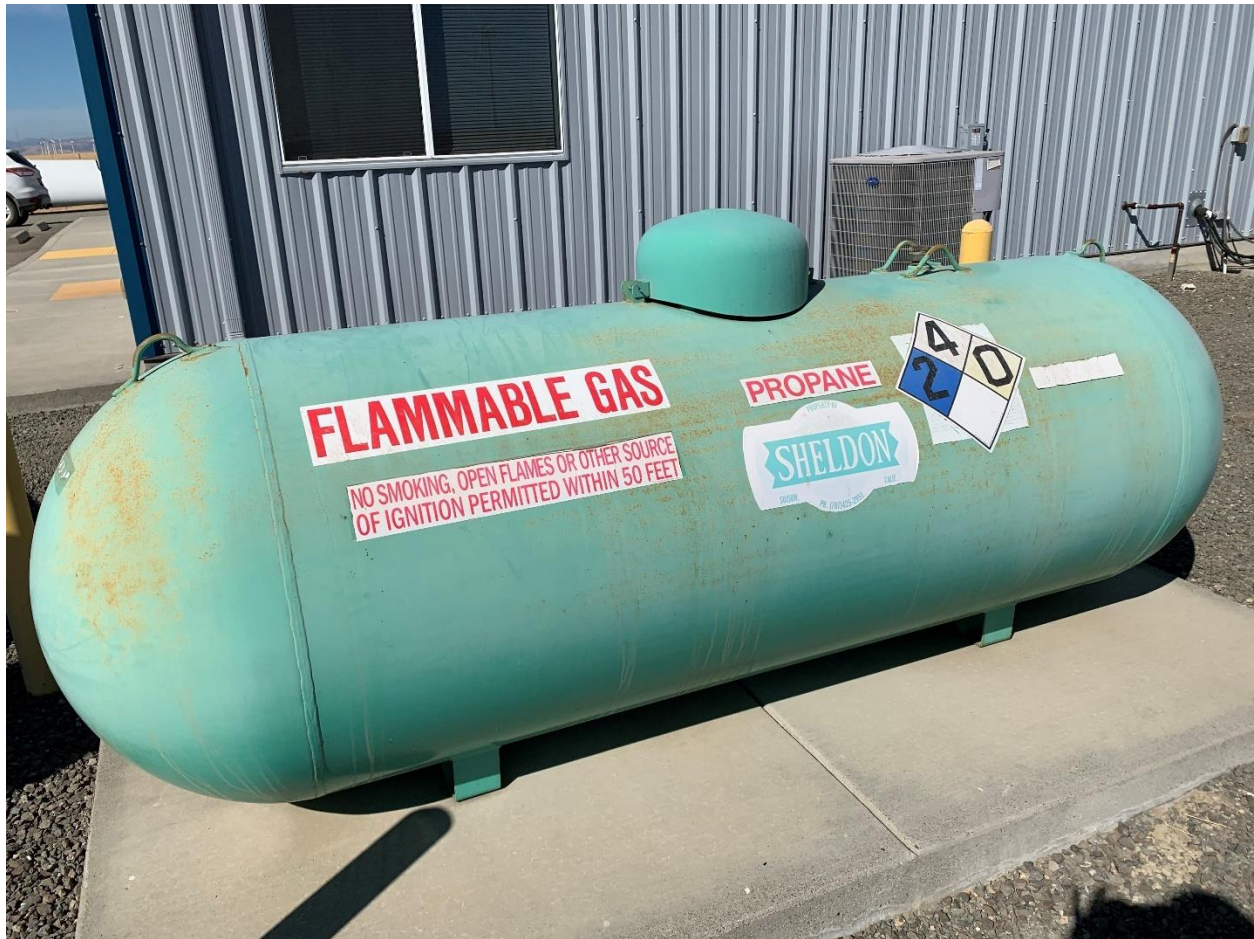
1. The NFPA 704 placard on the propane tank was faded. This sign should be replaced so that the colors on the sign are legible. Colors on the NFPA 704 placard help easily identify the hazards associated with the material, such as propane.

Figure 3: NFPA 704 placard on propane tank [REDACTED] s faded.

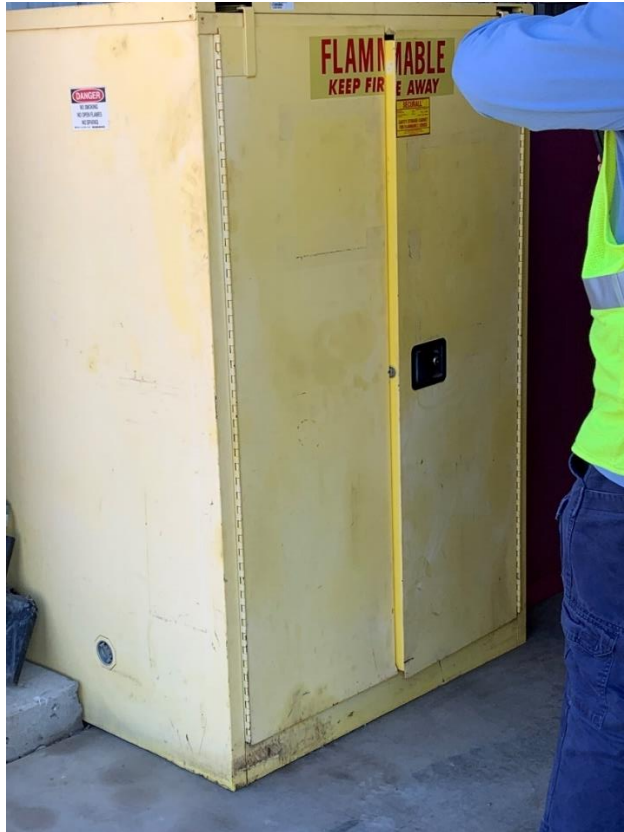
Figure 4: Fire cabinet [REDACTED]

2. The flammable material storage cabinets at both the Montezuma and High Winds O&M Buildings did not have the appropriate NFPA 704 placards showing the fire hazard of the contents in the cabinet. The appropriate NFPA 704 placards must be located on the cabinets and the at the primary entrances of the buildings housing them.

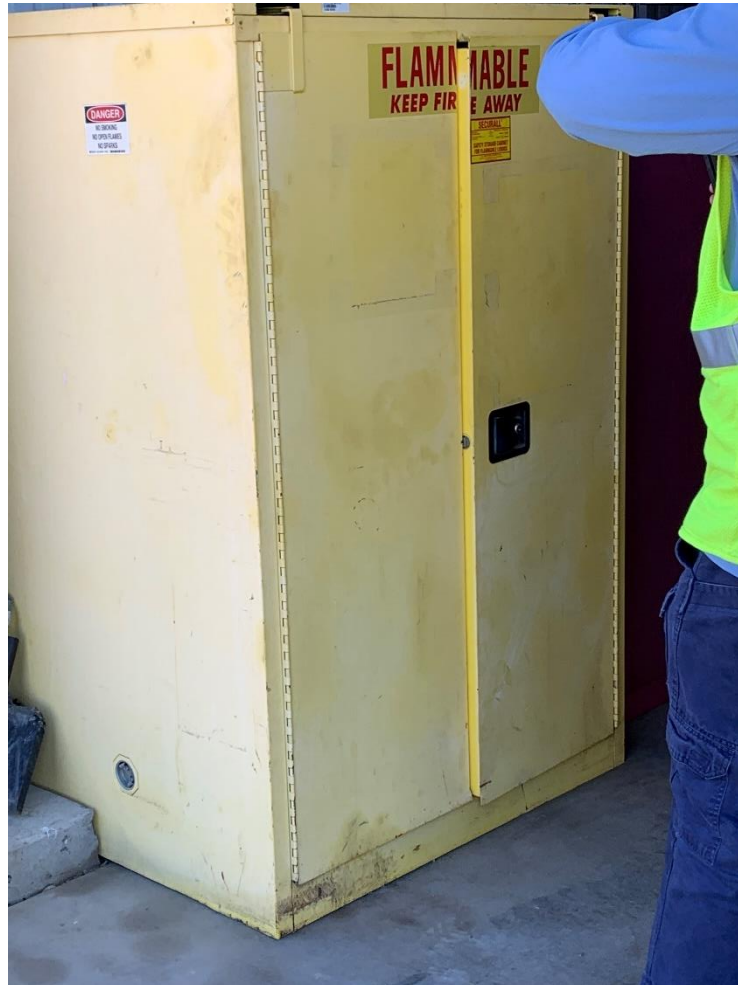
ESRB staff observed a flammable material storage cabinet that did not have self-closing mechanisms. The Plant performed a repair of the cabinet during the audit. Plant management must ensure that all flammable material storage cabinets on site are fitted with self-closing mechanisms including the following:

Figure 6. Flammable material storage cabinet [REDACTED] after letting the door attempt to close freely.

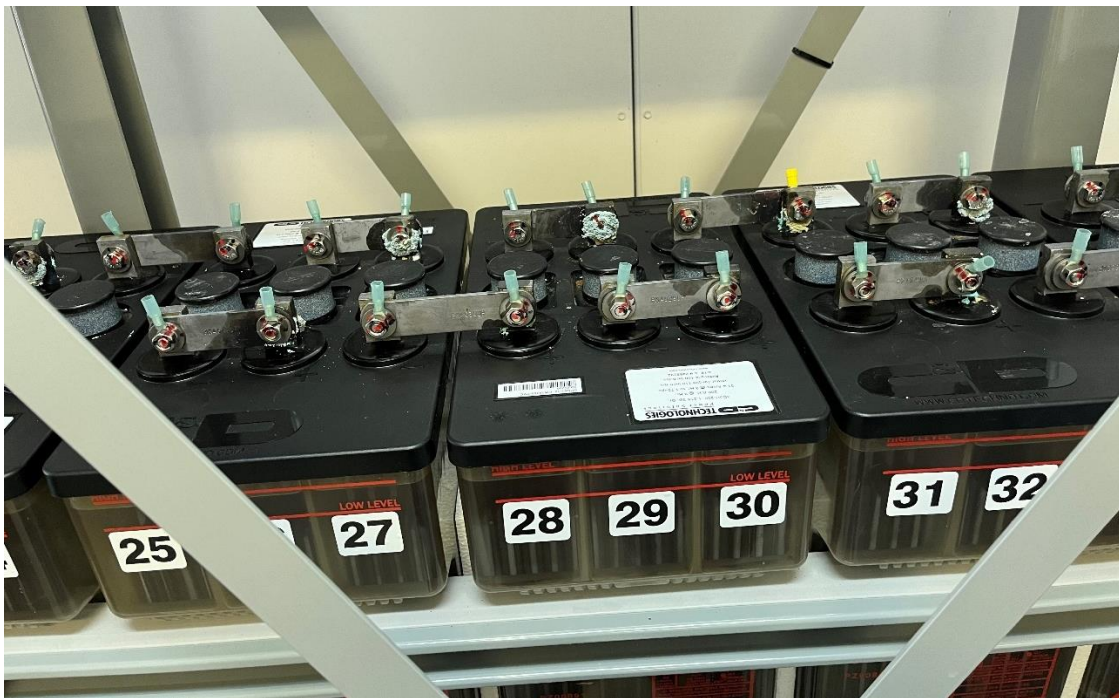
Some of the battery terminals located in the substation control room had built up corrosion that required cleaning. Corrosion on battery terminals can impede electrical flow, reduce efficiency, accelerate terminal damage and risk further corrosion. The Plant cleaned the battery terminals during the audit.

Figure 7: Battery rack with corrosion on terminals.

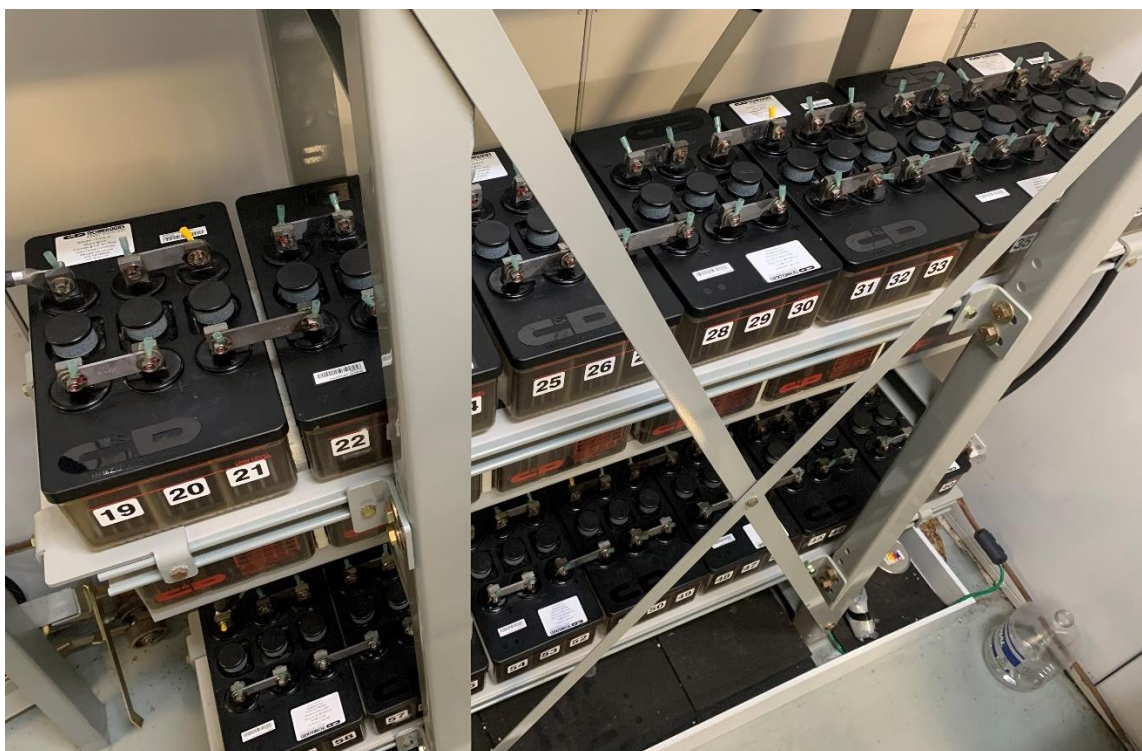
Figure 8: Battery rack after cleaning the terminals

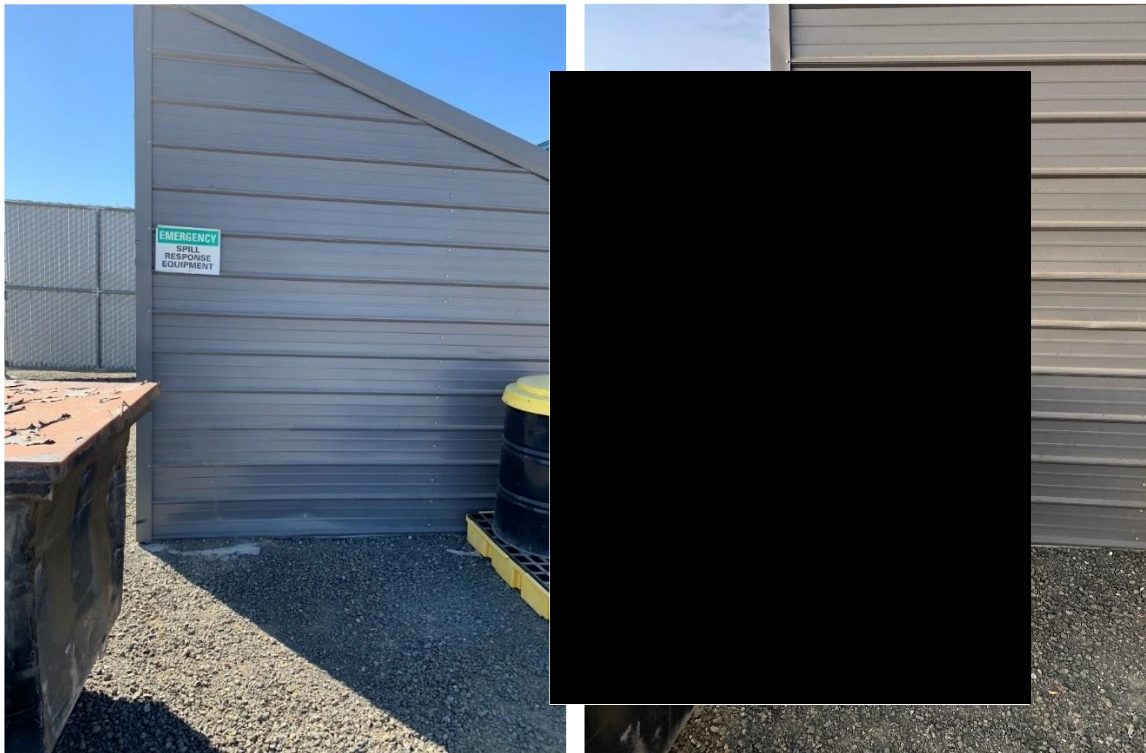
Two spill kits were not at their designated locations. This includes one spill kit located at the Montezuma Wind O&M Building and one at the High Winds O&M Building. Spill kits are required to be where indicated, as the location of spill kits are strategically set to respond to possible emergencies in the immediate vicinity. The Plant placed spill kits at those locations during the audit. The Plant must mark the locations of the spill kits on the Emergency response Plan Map and include this in the Spill Prevention Control and Countermeasure (SPCC) Plan. Routine inspections must verify the availability and condition of this emergency equipment.

Figure 9: Missing (Left) and Replaced (Right) spill kit at the Montezuma O&M Building.

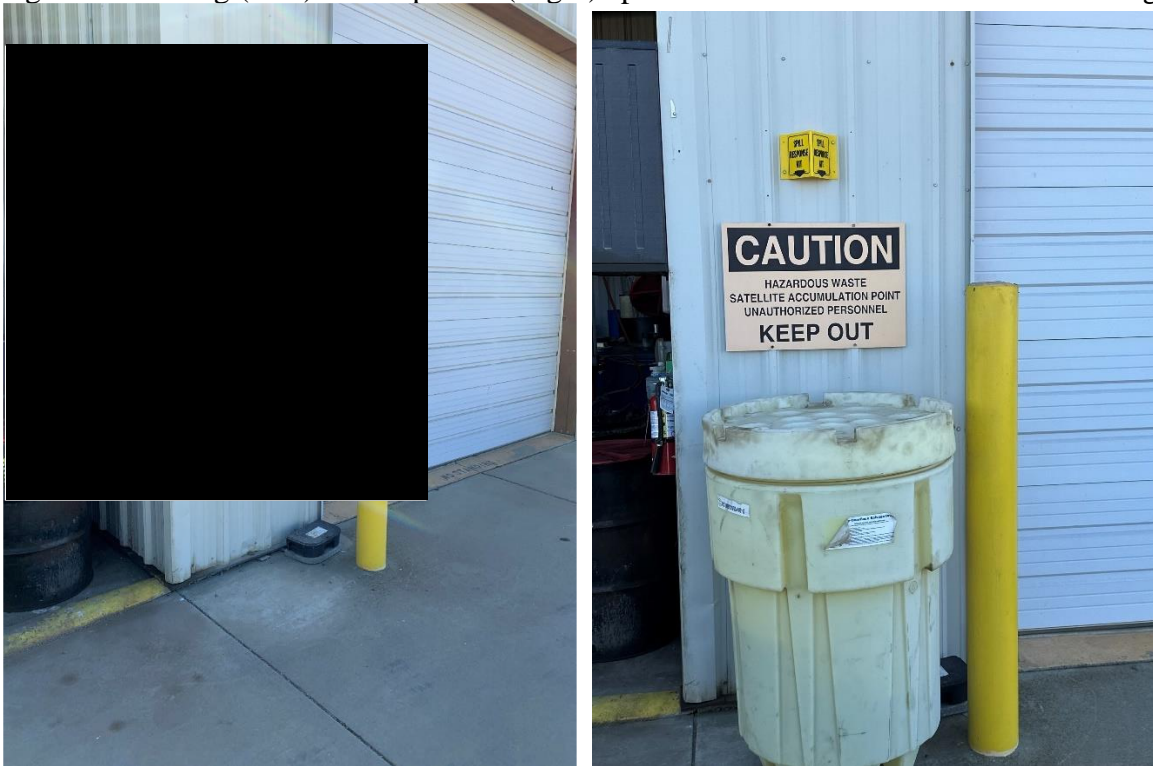
Figure 10: Missing (Left) and Replaced (Right) spill kit [REDACTED].

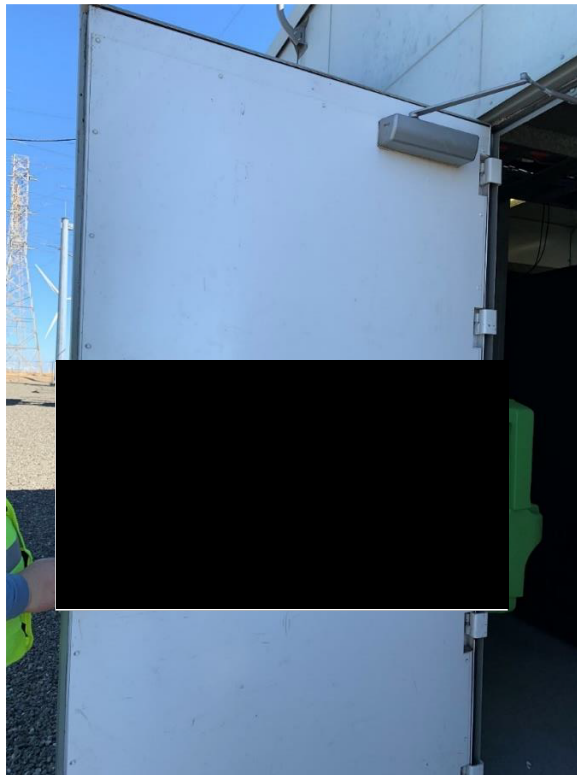
1. The [REDACTED] did not have an evacuation map posted. The Plant installed a new map during the audit.

Figure 11: Interior side of [REDACTED] is missing an evacuation map.

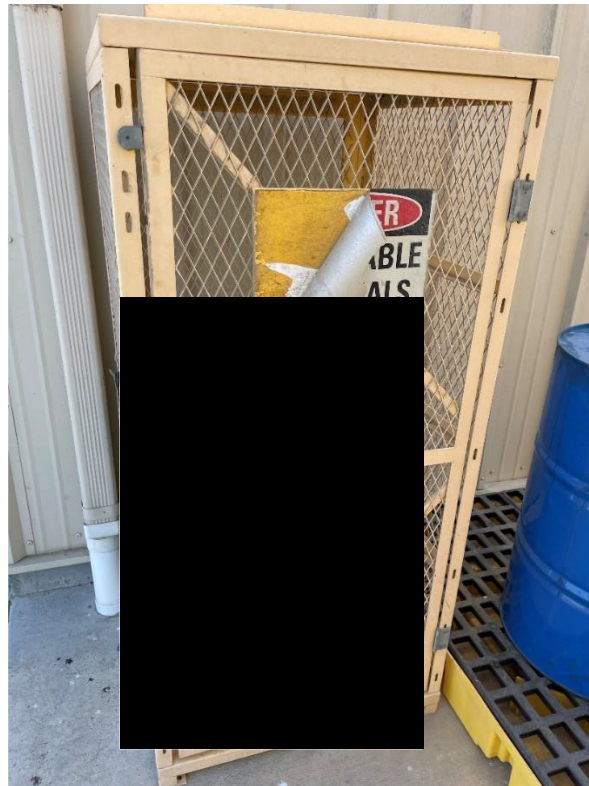
2. At the High Winds O&M Building there were signs that were faded and tearing.

Figure 13: Canister cage at the High Winds O&M Building with torn signs.
