**SUBJECT: Generation and Energy Storage Audit of IP Oberon I, LLC and IP Oberon II, LLC,
Audit Number: GA2025-07OS**

CPUC AUDIT FINDINGS OF IP OBERON I, LLC & IP OBERON II, LLC MARCH 24 – MARCH 27, 2025

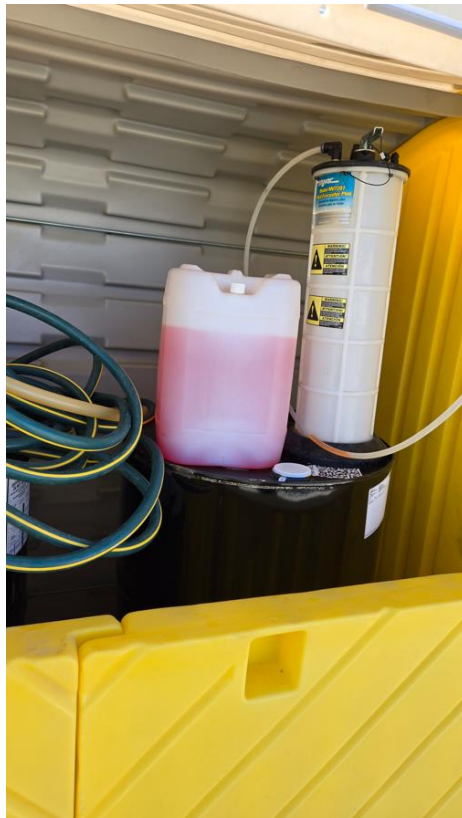
Additionally, ESRB inspectors observed an unlabeled container of coolant placed inside of the satellite hazardous waste pallet within the Oberon 1 BESS yard. The container did not include a label or any information identifying the chemical contents. All containers with chemicals must be properly labeled with the chemical name or composition, and an indication of the associated hazards. Failure to properly label hazardous waste containers increases the risk of improper handling, exposure, and delayed emergency response in the event of a spill or incident.

Figure 1: Unlabeled chemical container.

Oberon must clearly identify the satellite hazardous waste accumulation area in the field and ensure that it is labeled accordingly on all applicable site documentation, including site maps. Additionally, Oberon must ensure that the unlabeled container is immediately labeled with all required information and must submit photographic documentation of the corrective action to ESRB for review and verification.

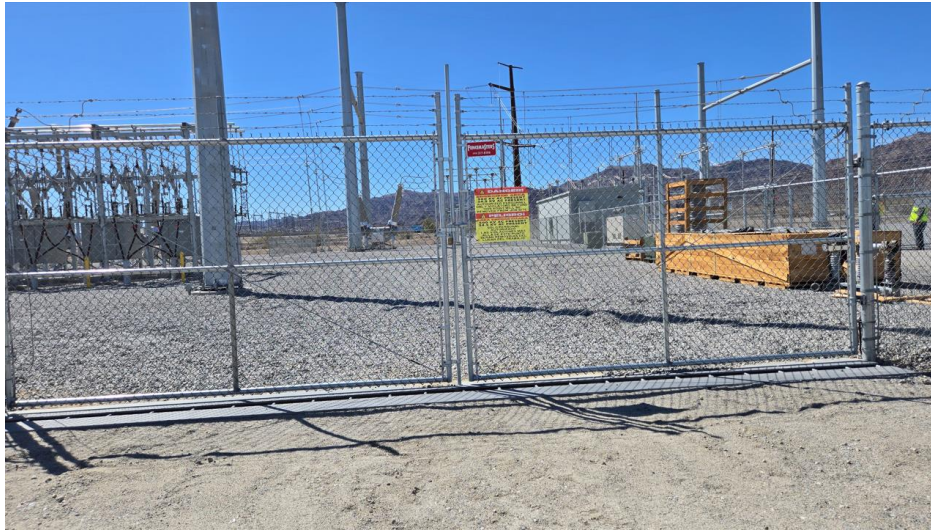
During the site inspection, ESRB inspectors observed that Oberon did not post NFPA hazard diamond placards on the front gates of the Oberon 1 and 2 BESS yards or the substation. The absence of these placards represents a potential safety and emergency response concern, as NFPA hazard diamonds provide critical information to first responders regarding flammability, health, and reactivity hazards present on-site. Without proper hazard identification signage, emergency

Figure 2: Substation gates missing an NFPA hazard placard.

Oberon must review all Safety Data Sheets (SDS) and label the front gates of the BESS yards and the substation with NFPA 704 placards reflecting the maximum hazard ratings contributed by the chemicals present in each area. Oberon must submit photographic documentation of the installed NFPA 704 placards to ESRB for review and verification

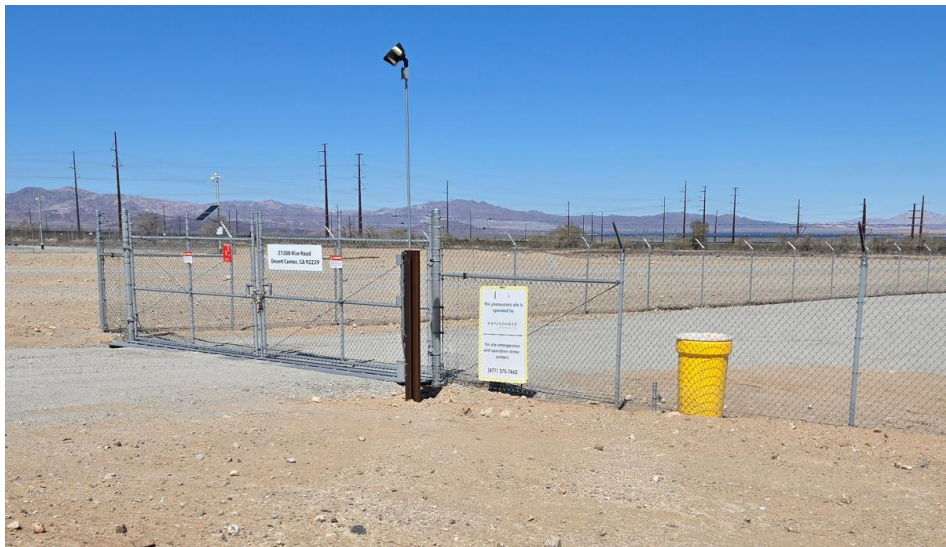
Figure 3: Oberon 1 BESS yard gates missing an NFPA hazard placard.

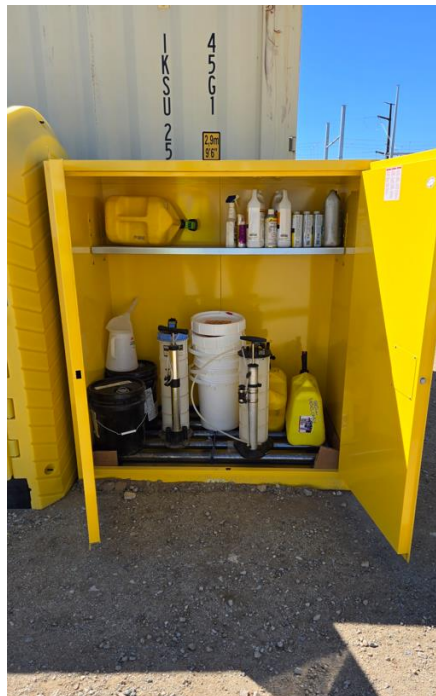
During the site inspection, ESRB inspectors observed that a flammable storage cabinet located in the Oberon 1 BESS yard does not have an automatic self-closing mechanism installed on the door. Flammable storage cabinets must be equipped with self-closing doors to minimize fire propagation risk.

Figure 4: Flammable material storage cabinet without a self-closing mechanism.

Although the cabinet belongs to Tesla personnel, Oberon is responsible for ensuring that all equipment within their site complies with applicable safety requirements. Oberon must ensure that all flammable material storage cabinets on site are fitted with self-closing mechanisms and are in proper operating condition. Oberon must submit photographic documentation of the corrective action to ESRB for review and verification.

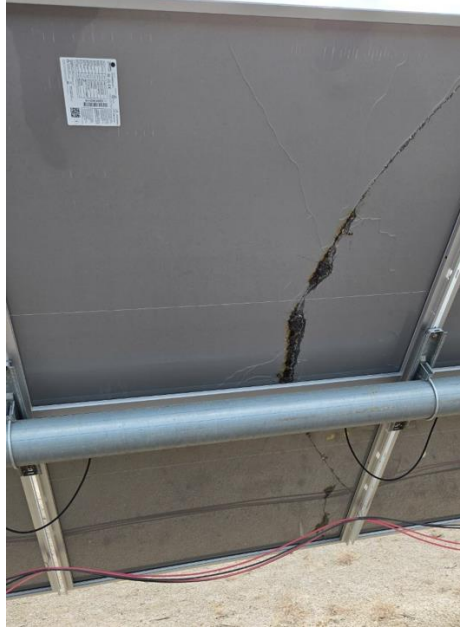
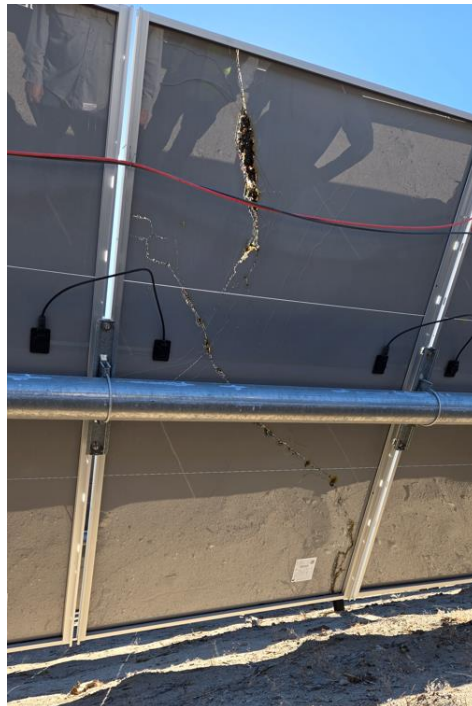
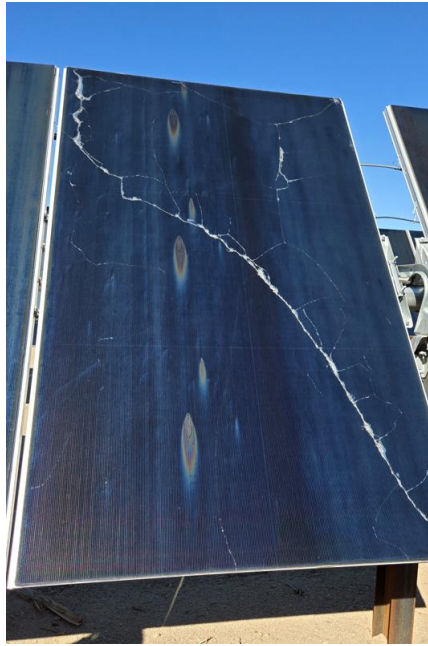
During the site inspection, ESRB inspectors observed multiple solar photovoltaic (PV) panels across the site exhibiting physical damage. Typical damage included long branching cracks across the rear and front side of the modules, localized burn marks, and in some cases, visible charring or discoloration consistent with thermal degradation. The nature and pattern of the damage suggest possible electrical issues and may also indicate manufacturing defects.

Cracked or thermally compromised panels present operational concerns, including degraded energy production, and potential for further equipment failure if left unaddressed. The presence of similar damage across multiple panels indicates a recurring issue that requires investigation.

Figure 5: Damaged solar PV panel.

Figure 6: Damaged solar PV panel.

Figure 7: Damaged solar PV panel.

Oberon must closely monitor the affected panels and develop a written plan of action that outlines the steps being taken to investigate the cause of the damage. The plan must include a timeline for requesting a formal Root Cause Analysis (RCA) from the manufacturer and must describe how findings will be tracked and resolved. Oberon must submit the action plan to ESRB for review and verification.
