## PUBLIC UTILITIES COMMISSION

**SUBJECT: General Order (GO) 167-C Audit of Midway Sunset Cogeneration Company,  
Audit Number GA2026-07MS**

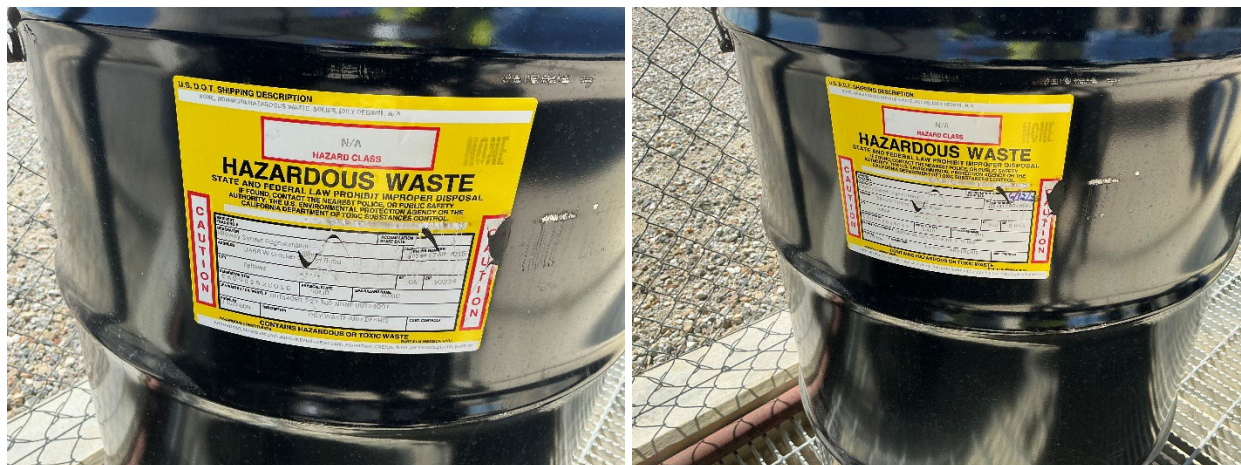
ESRB inspectors observed that a hazardous waste accumulation container was missing the required accumulation start dates. The accumulation start date is necessary to document when

hazardous waste begins accumulating and to demonstrate compliance with hazardous waste storage time limits. During the audit, Midway Sunset Cogeneration personnel updated the containers with the required accumulation start dates. The facility must ensure that hazardous waste container labeling is routinely reviewed and maintained to prevent similar deficiencies.

Figure 1: Left before without accumulation date. Right with added accumulation date added during the audit.

Midway Sunset Cogeneration must ensure that all hazardous waste containers, storage drums, and compressed gas cylinders are properly labeled and maintained. The facility must implement routine inspections to verify that required labels remain present, accurate, and legible.

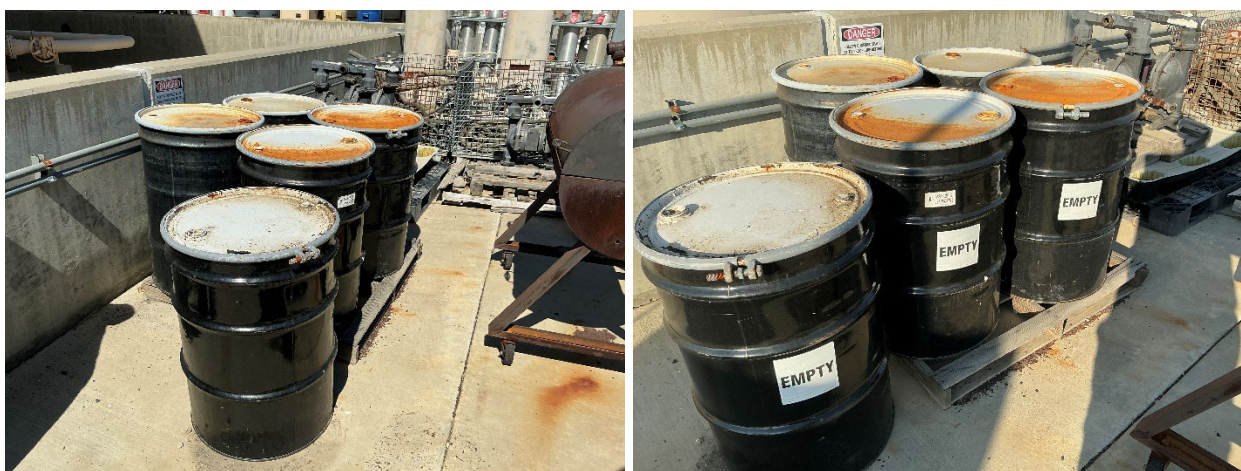
ESRB inspectors also observed that several empty barrels were not labeled to indicate they were empty, creating uncertainty regarding their contents and prior use. Personnel could not readily determine whether the containers were empty, contained residual material, or were designated for future use. Prior to the conclusion of the audit, Midway Sunset Cogeneration personnel labeled the empty barrels to indicate their status. The facility must ensure that storage containers remain properly identified through routine inspections and housekeeping activities.

Figure 2: Left barrels found unmarked. Right with empty labels during the audit.

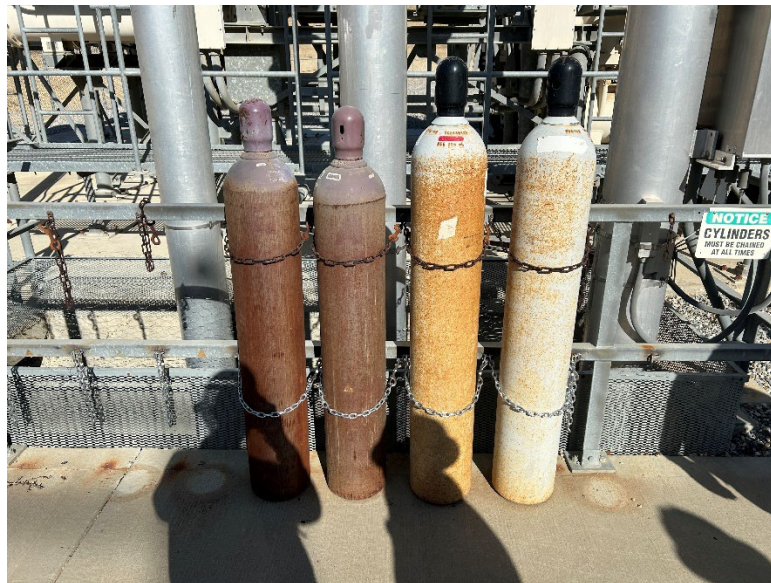
Additionally, ESRB inspectors observed that sulfur hexafluoride SF<sub>6</sub> cylinders located in the switchyard were not labeled. SF<sub>6</sub> is a specialized insulating gas used in electrical equipment, and

cylinders should be clearly identified to ensure personnel and first responders can readily recognize their contents during routine operations, maintenance activities, and emergency response. Missing cylinder identification may create confusion during emergency situations and increase the likelihood of improper handling or delayed response.

Figure 3: Unmarked SF6 gas cylinder in substation.

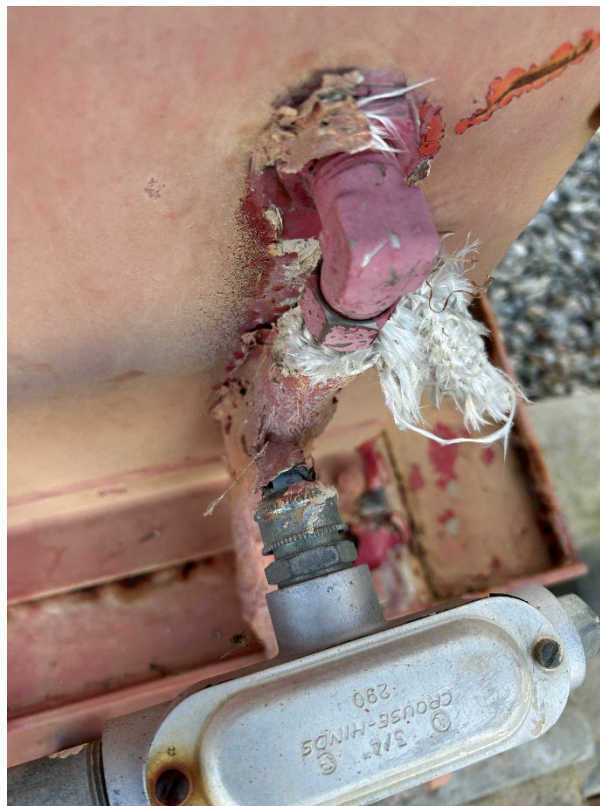
During the field inspection, ESRB inspectors observed that the wire shielding connected to the pressure sensor serving the fire pump was deteriorated. Damaged wire shielding may affect the reliability of the pressure sensor and could impair proper monitoring or operation of the fire pump system. The fire pump is a critical component of the facility's fire protection system, and associated wiring must be maintained in good condition to ensure reliable operation during an emergency. Deteriorated wiring may increase the likelihood of sensor malfunction or failure when the system is needed. Midway Sunset Cogeneration must inspect the pressure sensor wiring serving the fire pump and repair or replace any deteriorated wiring.

Figure 5: Deteriorated wire shielding on pressure sensor serving the fire pump.

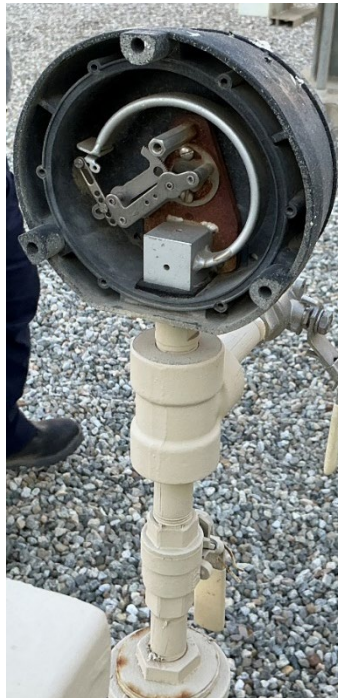
ESRB inspectors also identified that multiple gauges at the plant were missing backplates. Backplates are critical because they protect internal gauge components from dust, dirt, moisture,

insects, and debris. They also provide structural stability by holding internal parts firmly in place. Without them, vibrations, wind, or exposure to outdoor elements can cause premature failure. In addition, missing backplates can affect accuracy, as exposed internal mechanisms may respond more slowly, provide inaccurate readings, or become unreliable underload. This poses a safety risk because operators may not recognize unsafe operating conditions if gauges provide false or inconsistent readings. Midway Sunset Cogeneration must install all missing backplates on the affected gauges and ensure that future site inspections identify and fix backplates as they are damaged.

Figure 6: Missing backplate on liquid Gauge.

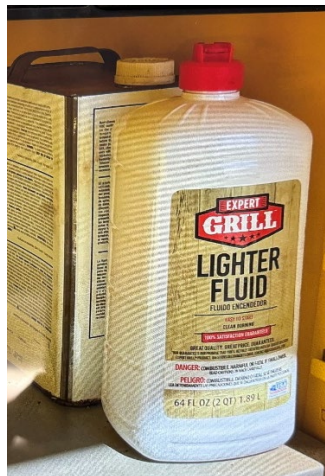
During the field inspection and documentation review, ESRB inspectors identified that multiple SDSs were missing for various chemicals found at the plant, including SDSs for Landa pump oil, antifreeze products, and a name brand lighter fluid, even though an off-brand product was present on site. Additionally, several SDSs provided by Midway Sunset Cogeneration were outdated despite newer revisions being available. The use of chemicals without SDSs, or with outdated SDSs, presents a significant safety and compliance risk, as these documents contain critical information necessary for effective response to incidents involving hazardous materials.

Figure 7: Lighter fluid found on-site without a corresponding SDS.

Missing or outdated SDSs may result in inaccurate or incomplete guidance during an accident or emergency, potentially leading to improper first aid measures, delayed treatment, or increased harm to affected personnel. This condition compromises both worker safety and the facility’s ability to respond appropriately to hazardous material events. Midway Sunset Cogeneration must ensure that SDSs for all chemicals and products found at the plant are included and must update all SDSs in its database to the most current versions. These documents must be readily accessible to all plant personnel.

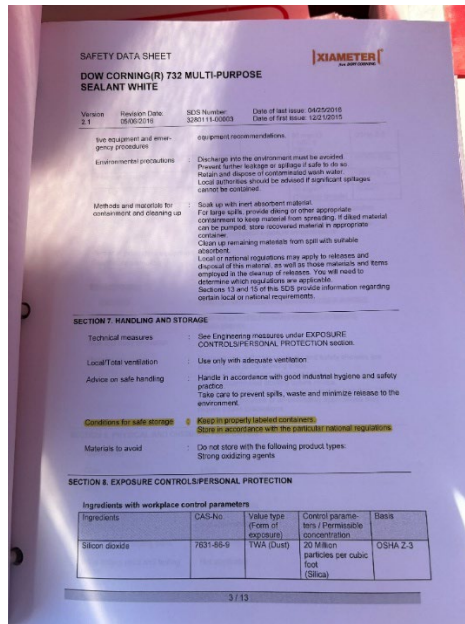
Figure 8: Outdated SDS is SDS binder.

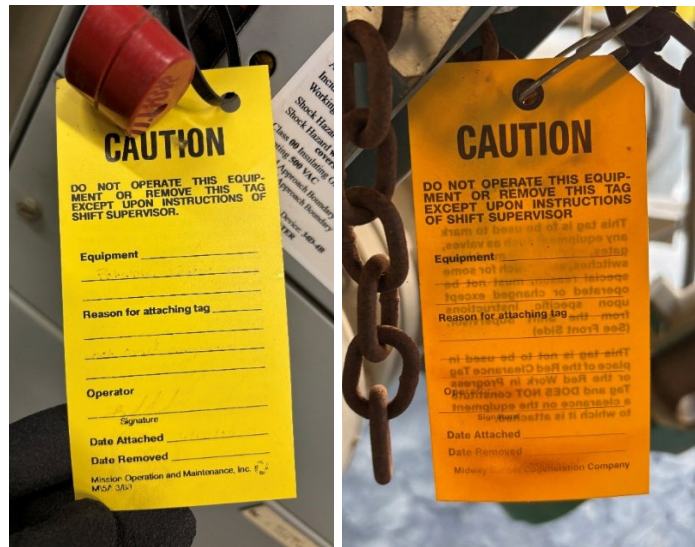
During the field inspection, ESRB inspectors observed that multiple equipment caution tags were degraded due to weather exposure and aging. Several tags were faded, peeling, or no longer clearly legible. Equipment and site caution labeling are necessary to ensure personnel can readily identify equipment status (such as whether equipment is out of service), associated hazards, and

required safety precautions. Degraded labels and tags reduce the effectiveness of hazard communication and may result in improper operation or delayed recognition of hazards during routine work activities or emergency response situations.

Figure 9: Illegible caution tags.

Midway Sunset Cogeneration must replace the degraded caution tags with durable materials suitable for outdoor conditions. Midway Sunset Cogeneration must also implement periodic inspections of caution tags and hazard signage to ensure required information remains clearly visible and properly maintained.

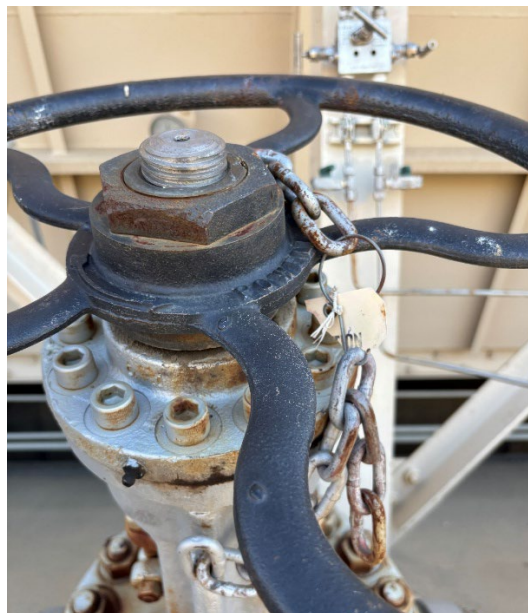
Figure 10: Completely worn and deteriorated caution tag.

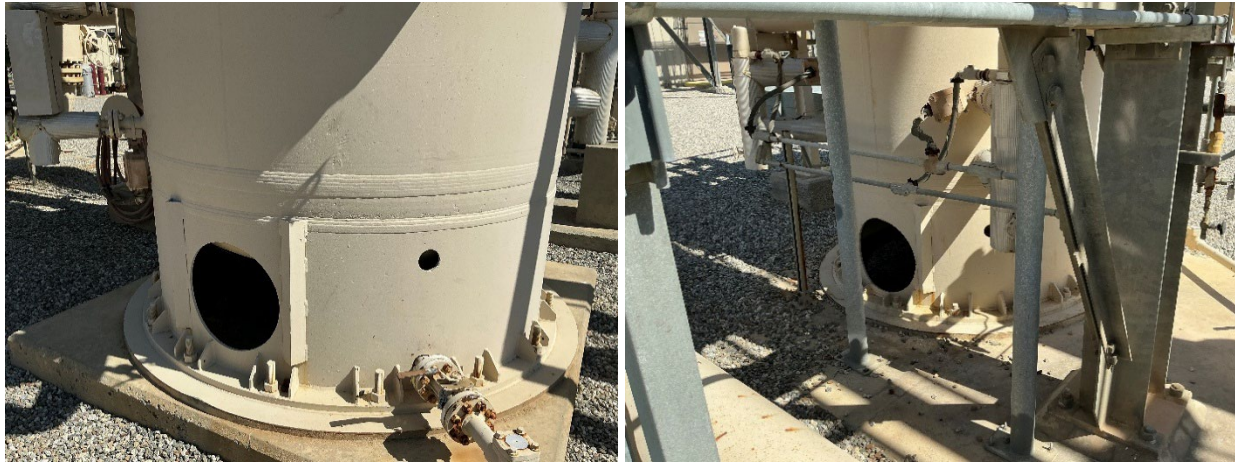
During the field inspection, ESRB inspectors observed that the confined space entry sign at the gas compressor area was missing from one side of the access point. As a result, personnel approaching the area from one direction may not receive the required confined space hazard notification prior to entry. Confined space signage is necessary to clearly identify confined spaces and alert personnel to applicable restrictions and hazards. Missing signage may reduce hazard awareness and increase the potential for unauthorized or unsafe entry.

Figure 11: Confined space entry point without signage.

Midway Sunset Cogeneration personnel installed the missing confined space sign prior to the conclusion of the audit. Midway Sunset Cogeneration must ensure that confined space signage is maintained at all designated access points and be included in routine inspections to verify that signs remain present, legible, and properly maintained.

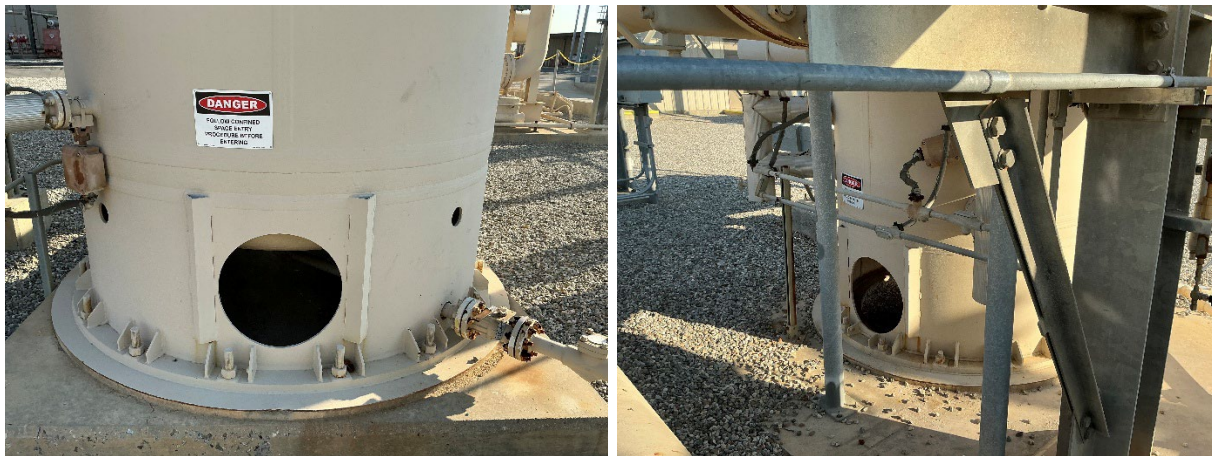
Figure 12: Signage added before conclusion of audit.

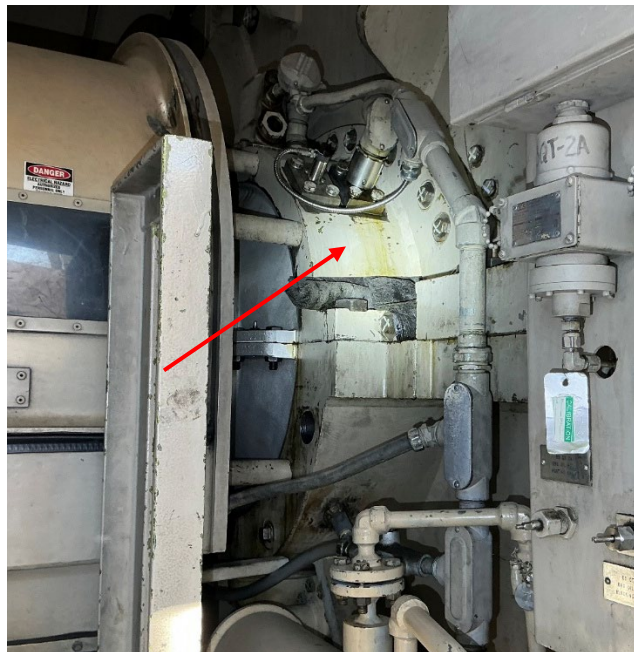
During the field inspection, ESRB inspectors observed evidence of an oil leak on the Unit A generator equipment. Proper lubrication of all equipment promotes longevity, reliability, and safe operation. Unaddressed oil leaks may indicate equipment degradation, create housekeeping concerns, and reduce the facility’s ability to maintain equipment in proper material condition. Additionally, oil leaks can create hazards such as slipping and fire risks.

During the document review, no work order was found or associated with this concern, indicating that there are no current plans in the work order management system to repair the oil leak. Midway Sunset Cogeneration must provide ESRB with a plan of action and an estimated completion timeline for addressing the Unit A generator equipment oil leak. After completing the corrective action, Midway Sunset Cogeneration must submit documentation demonstrating that the condition has been resolved or in the process of being resolved.

Figure 13: Oil leak on Unit A Generator equipment.

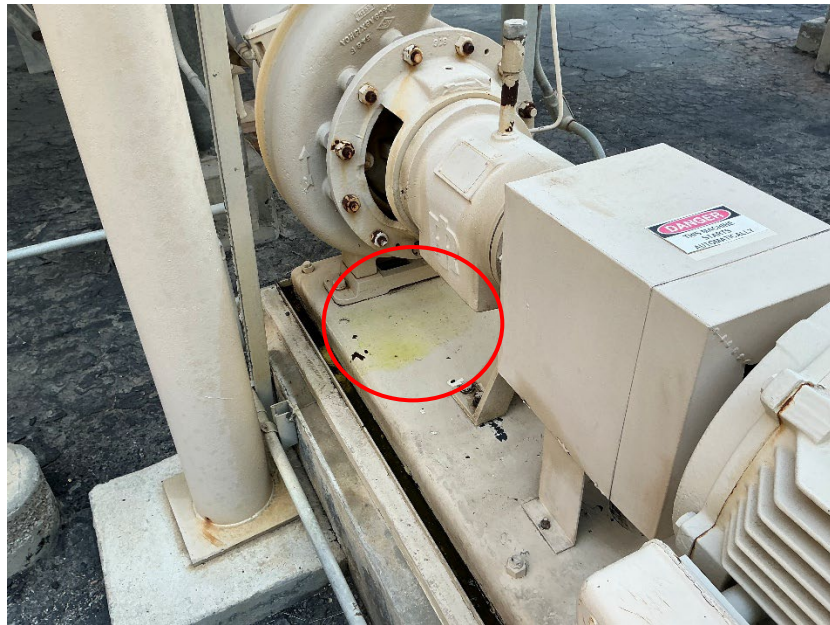
ESRB inspectors also observed excessive oil residue on Pump P408-B resulting from the equipment being overfilled with oil. Although no active leak was observed, the accumulation of

oil residue indicates improper lubrication practices and can make it difficult to identify future equipment leaks or developing mechanical issues. Excessive oil residue contributes to poor housekeeping and can mask changes in equipment condition. Maintaining proper oil levels is essential to support reliable equipment operation and facilitate effective equipment inspections. Midway Sunset Cogeneration must clean the accumulated oil residue from Pump P408-B and ensure that lubrication activities are performed in accordance with manufacturer recommendations.

Figure 14: Oil residue on Pump P408-B.

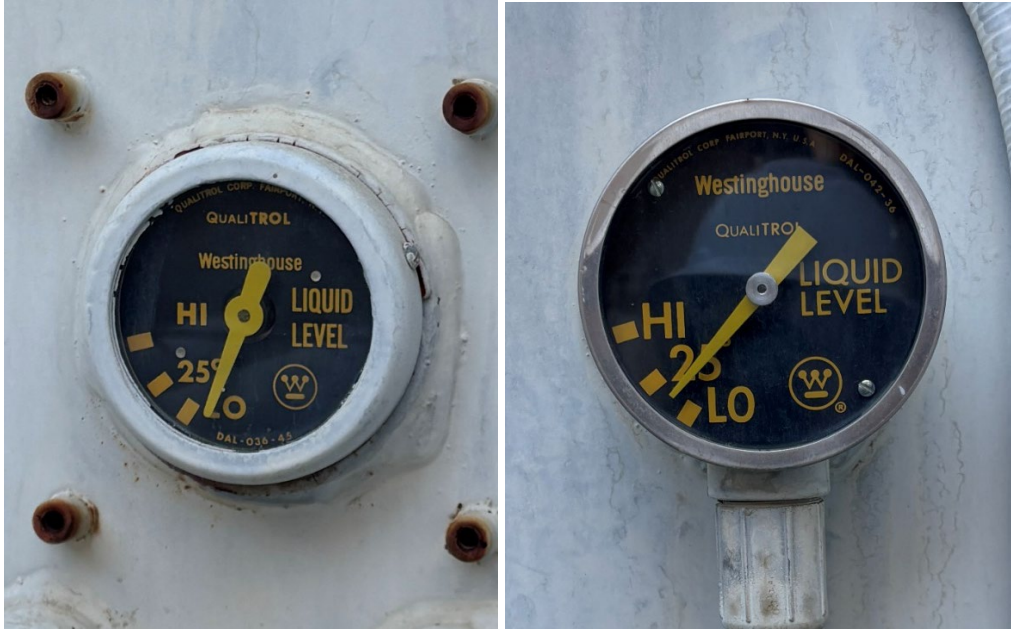
During the field inspection, ESRB inspectors observed that the liquid gauge for the Unit C turbine was not providing a reading, displaying either no value, zero, or “Lo.” When asked about the issue, plant personnel stated that the gauge was no longer in service because a new gauge installed beside it had replaced its function. Out-of-service gauges must be either removed or clearly labeled as out of service. Leaving an inactive gauge in place without proper labeling can create confusion for plant personnel and contractors. It may also pose safety risks, as a nonvalid reading can lead operators or contractors to mistakenly attempt to troubleshoot a nonexistent problem or assume that the unit is malfunctioning. Midway Sunset Cogeneration must remove the out-of-service liquid gauge or clearly label it as out of service to prevent confusion.

Figure 15: (Left) Out-of-service liquid gauge displaying “Lo” with no labeling indicating it is out of service. (Right) Inservice gauge installed beside the unlabeled out-of-service gauge.

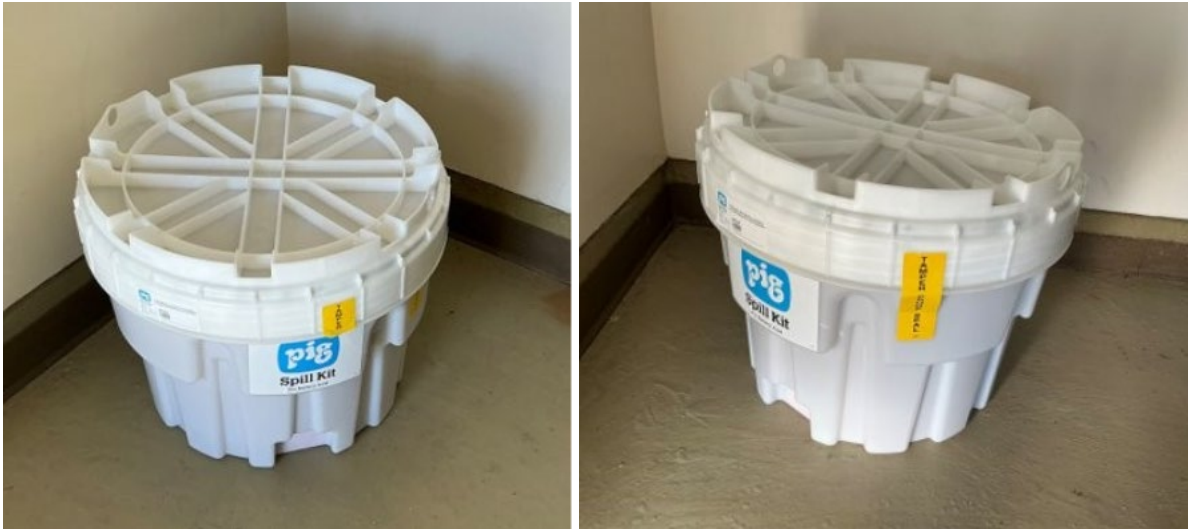
During the inspection, ESRP inspectors found that a spill kit located in the battery room adjacent to the control room had a broken tamper seal. All other spill kits on site had intact tamper seals, indicating they contained all the necessary emergency response material. A broken or missing tamper seal creates uncertainty regarding whether the spill kit has been open, partially used, or is missing required equipment. Without confirmation that the kit is fully stocked, its readiness for an emergency cannot be assured. After any use, spill kits must be restocked, inspected, and a new tamper seal must be applied so that personnel can easily verify readiness during routine inspection or under emergency conditions. Midway Sunset Cogeneration must ensure that all spill kits are properly stocked and are maintained with intact tamper seals to confirm emergency readiness.

Figure 16: Torn tamper seal corrected during audit.
